EPA CHEMICAL ACCIDENT INVESTIGATION REPORT

Tosco Avon Refinery Martinez, California

EPA550-R-98-009
November 1998

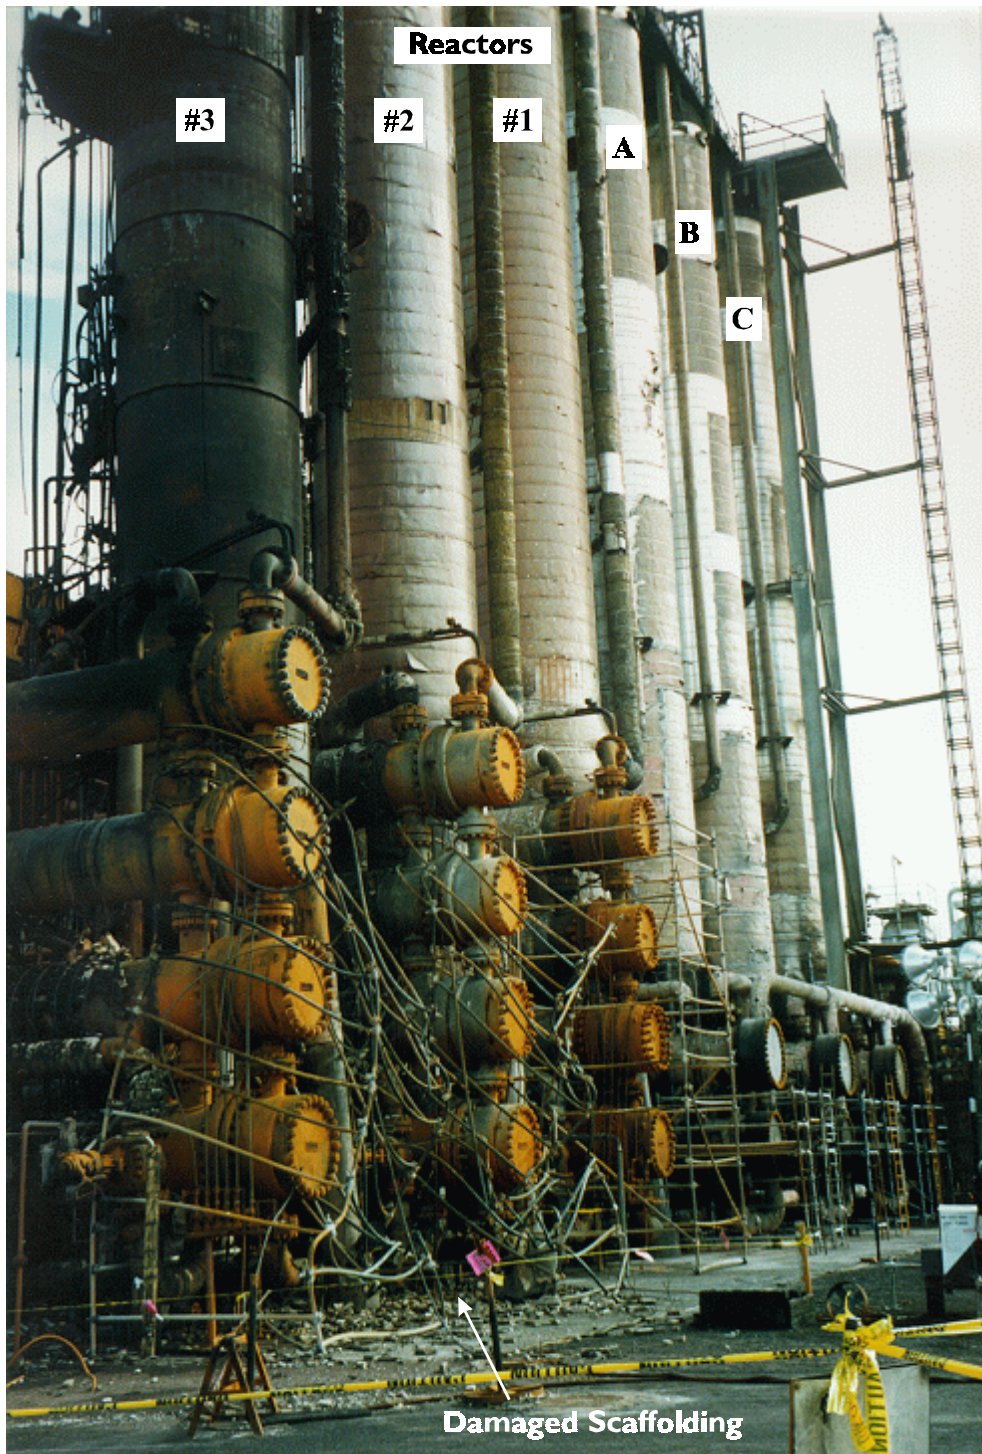
Figure 9 First and Second Stage Reactors

The rupture created about an 18 inch long tear in the Reactor 3 effluent piping. The photographs in Figures 9-13 show some of the resulting damage. The fire melted a light pole on the road next to the reactors. The lower part of a metal ladder on Reactor 3 was damaged by the heat. Scaffolding around the Stage 1 and 2 reactors was misshapen from the heat of the fire, but there did not appear to be much blast damage. The fire fighting equipment next to Reactor Road (see Figure 6) was damaged. Wooden platforms near the unit were charred. The six reactors were covered with asbestos insulation overlaid with aluminum, which was blackened by the fire. A large valve on the fire water piping near the road was damaged.

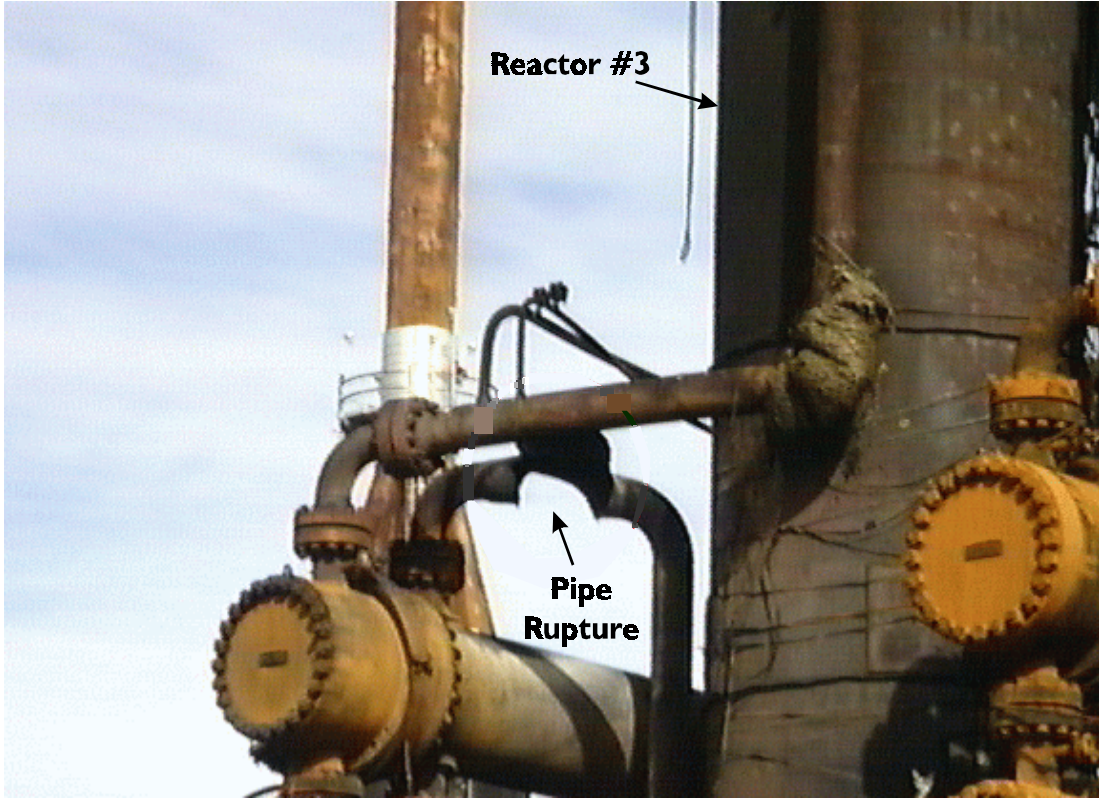
Figure 10 Reactor 3 Effluent Piping Rupture

Several Tosco and contractor employees reported hearing a pop or crack sound, followed by two explosions, one small and one bigger. A horizontal straight section of 12" diameter Reactor 3 effluent piping had ruptured just upstream of a 12"x 10" diameter reducer. Beyond the reducer, the 10" diameter pipe entered the top of the 40-foot high feed/effluent exchanger structure for Reactor 3. The hydrocarbon and hydrogen mixture released from the pipe rupture apparently autoignited very shortly after the initial release, causing a fireball over 100 feet high.
