Appendix A. River corridor severity scores for impaired sites in the Yellow River Basin, Alabama and Florida

Appendix C. Clear Creek Watershed Focal Area. Sites with orange headings are unpaved road sites. Specific definitions and calculations described for calculating the Sediment Risk Index (SRI) are detailed in Witmer (2009).

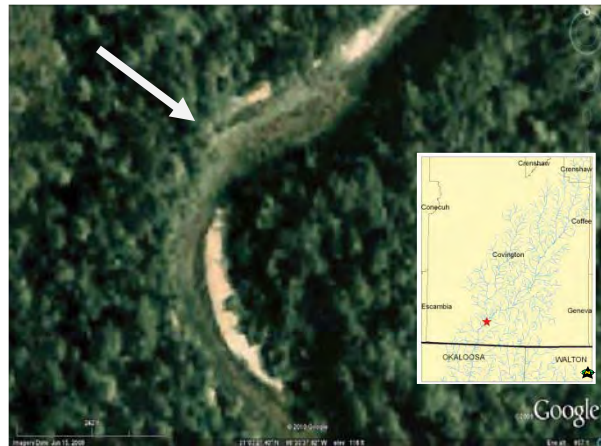
LB

Notes: New growth on bank degradation

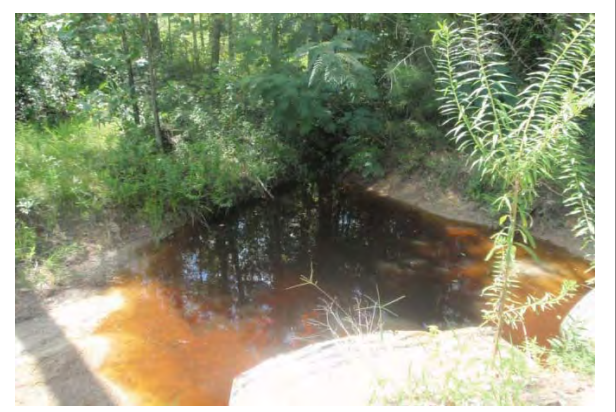
Notes: Significant difference between US and DS channel conditions. No flow through Lt Culvert.

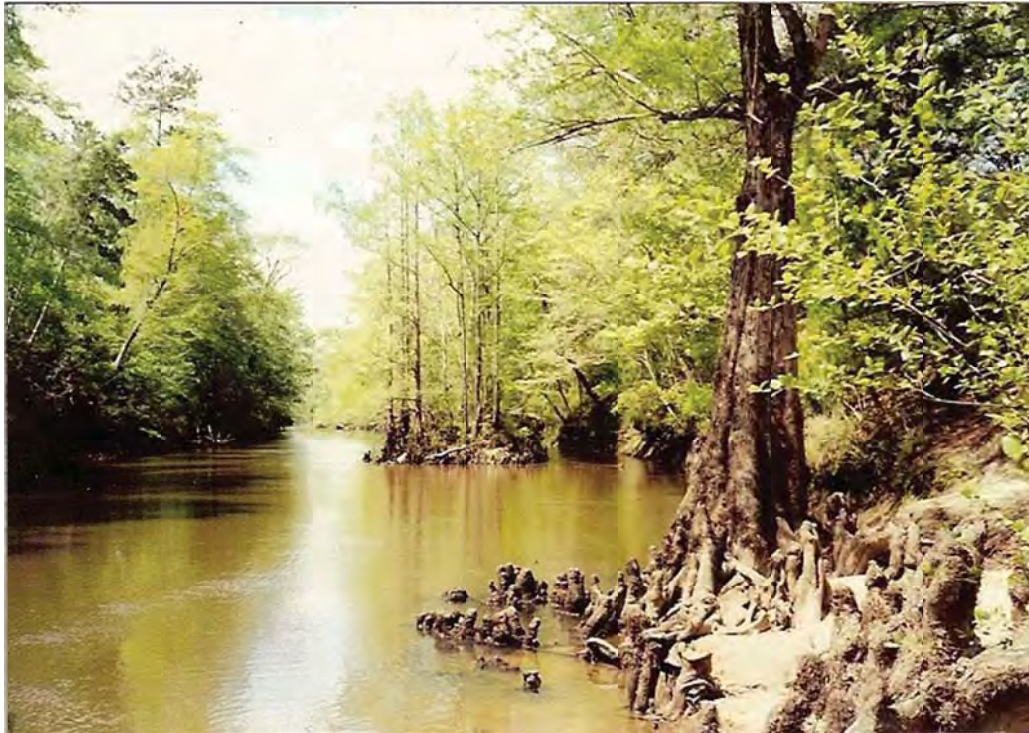
**Figure 3. Existing conditions of the Dripping Rock site on the Yellow River.**

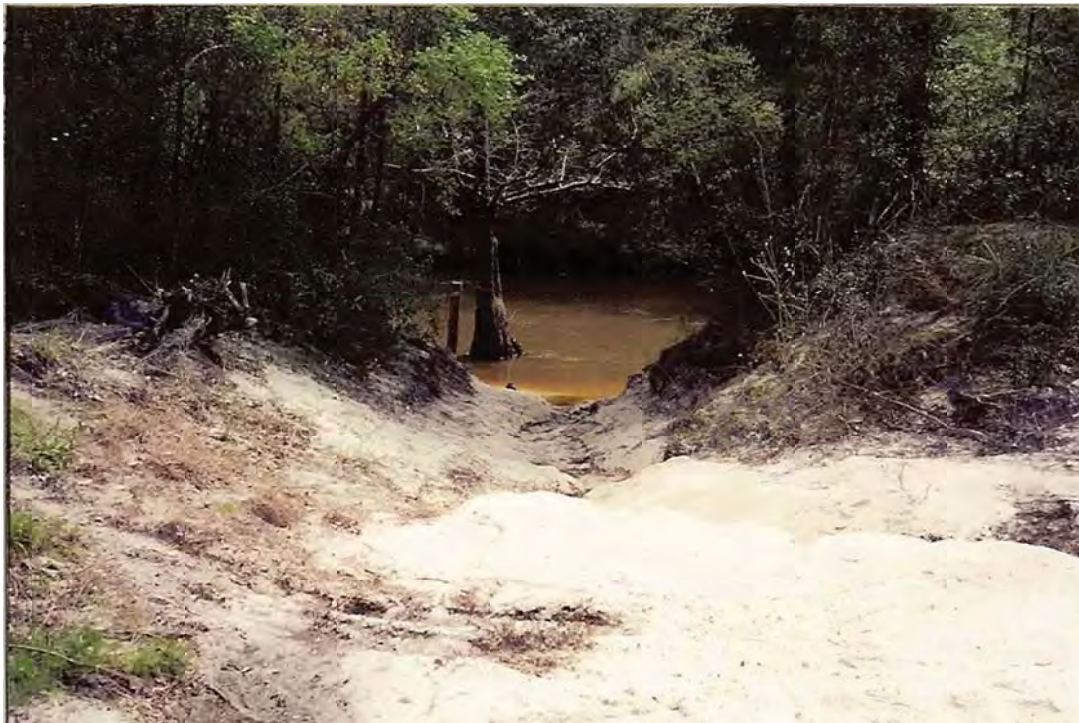
**Figure 4. Erosional site discharging into the Dripping Rock site, Yellow River.**
