Special Investigation Report on Emergency Medical Services Operations

Aviation Special Investigation Report

NTSB/SIR-06/01

**National
Transportation
Safety Board**

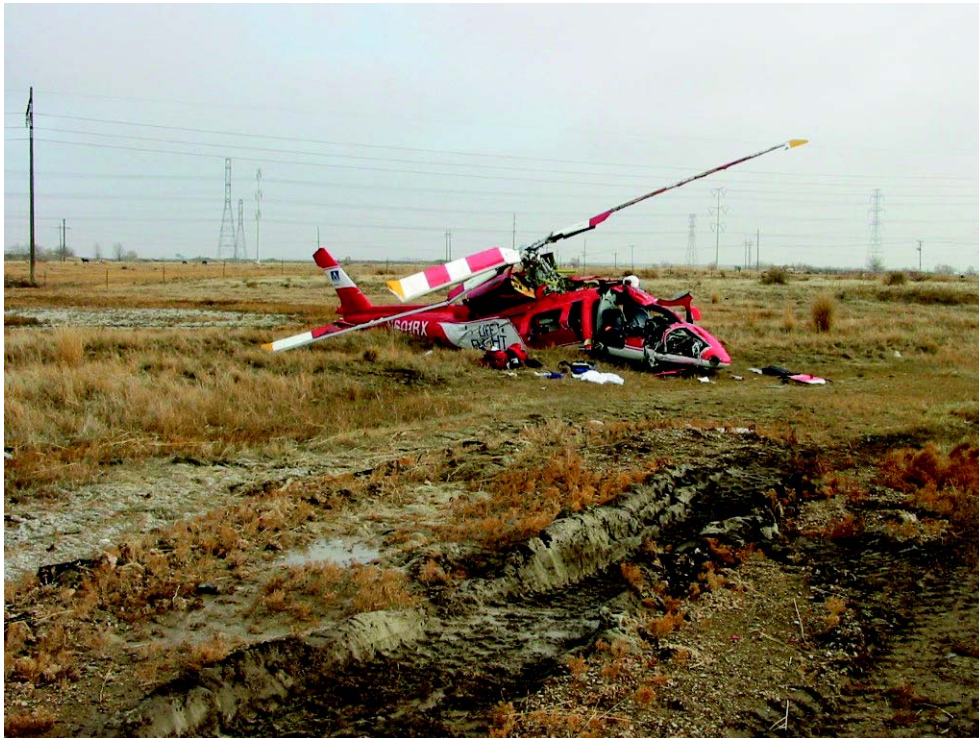
Figure 1. N601RX Wreckage Near Salt Lake City, Utah

Before the accident flight, a pilot working for another EMS helicopter operator located in Salt Lake City had attempted the same mission but aborted the mission because of deteriorating weather conditions.¹ After returning to the helicopter's departure base, he

learned that a pilot from IHC Health Care Services would be attempting the mission and radioed the IHC pilot to inform him of the deteriorating weather conditions. According to the pilot who aborted the mission, the IHC pilot indicated that he was going to attempt to “get over” the fog and complete the mission. Before attempting the mission, the IHC pilot checked the weather conditions via a company weather computer station and reported to the company dispatcher that the weather “had gotten really bad [near SLC]” but that he would try to fly.

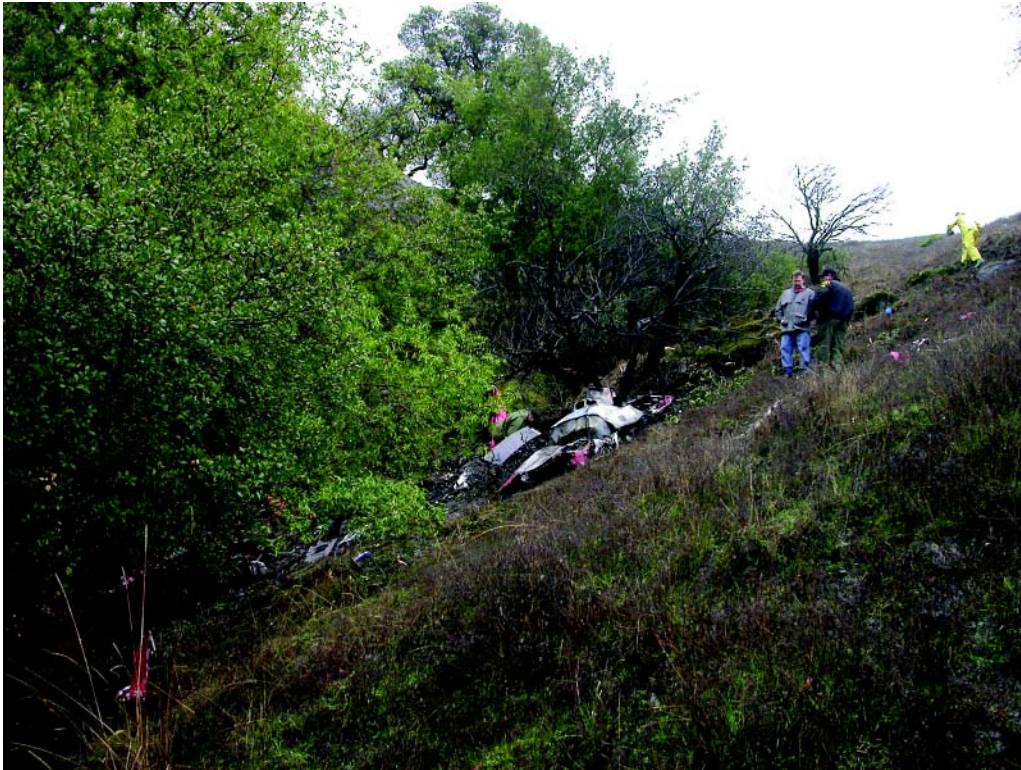
Figure 2. N25RX Wreckage Near Redwood Valley, California

About 1930, the pilot told the CDF that the helicopter would be returning to Ukiah because of an inadvertent encounter with IMC. No further transmissions were received from the pilot. Residents and rescue personnel near the accident site stated that high winds and heavy rain were present at the time of the accident. Recorded data indicated that the pilot obtained a weather report from an aviation-specific weather reporting service before departing Santa Rosa.

The Safety Board determined that the probable cause of this accident was the pilot's improper in-flight planning and decision to continue flight under VFR into deteriorating weather conditions, which resulted in an inadvertent in-flight encounter with IMC and a collision with rising terrain while attempting to reverse course.

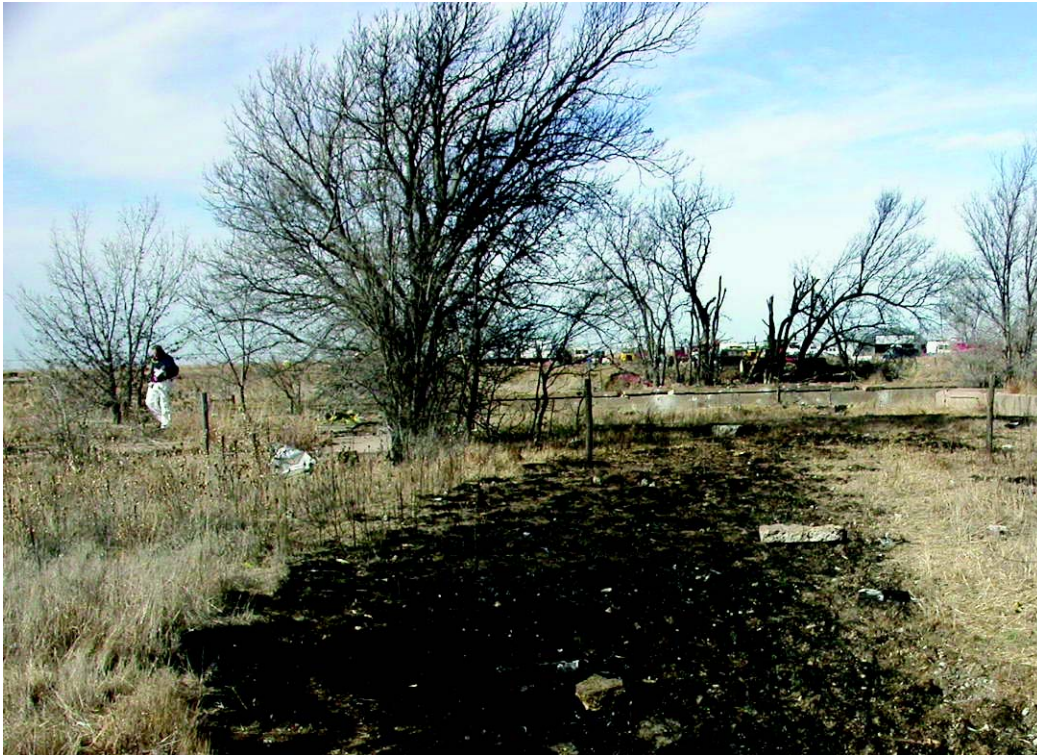
Figure 3. N777KU Wreckage Near Dodge City, Kansas

The Safety Board's investigation revealed that the pilot had been awake for as long as 21 hours at the time of the accident. Additionally, the accident occurred 14.5 hours after his duty day began. Recorded radar data indicate that the airplane initiated a gradual, straight-line descent toward the airport but flew past the airport before descending into the ground. No communications from the airplane were made during this descent, which suggests that the pilot was fatigued.

The Safety Board determined that the probable cause of this accident was the pilot's failure to maintain clearance with terrain due to pilot fatigue (lack of sleep).

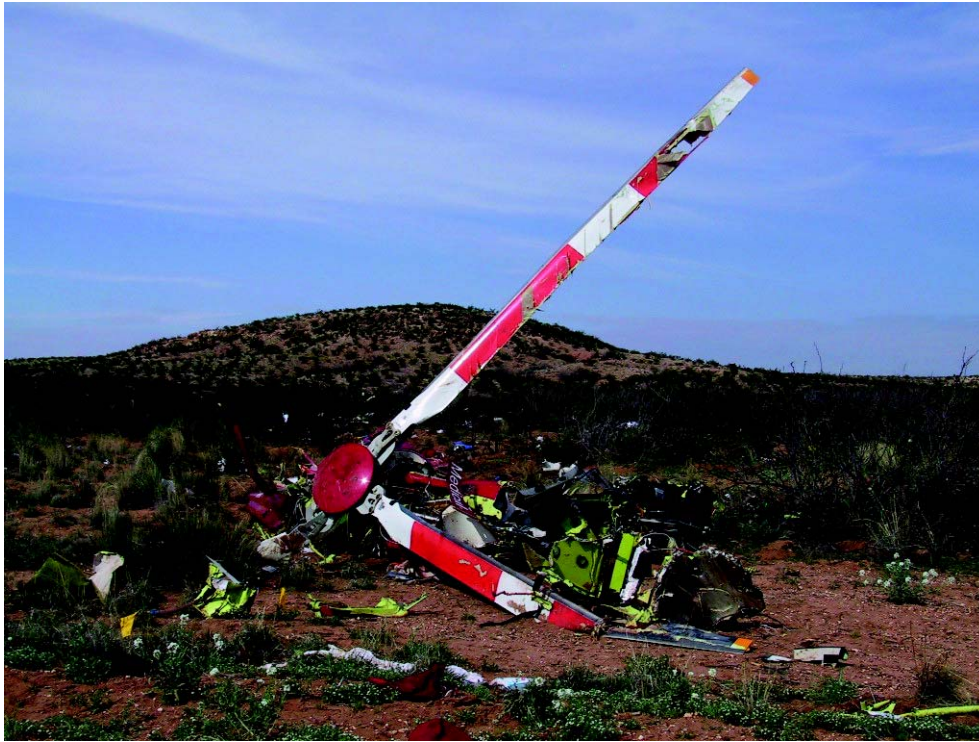
Figure 4. N502MT Wreckage Near Pyote, Texas

According to company personnel, the aircraft arrived at Big Bend Regional Medical Center in Alpine, Texas, about 0044 to pick up the patient and passenger; they boarded the helicopter about 0139. The flight then departed for the University Medical Center in Lubbock, Texas. About 1 minute before the accident, the pilot contacted the dispatcher at the Medical Center Hospital and began to provide a position report when he stated, “hold on a [minute] dispatch.” The Safety Board’s investigation revealed that severe thunderstorms were moving through the area at the time of the accident and that the pilot had not obtained a weather briefing from the FAA flight service station. In addition, witnesses reported brown-out³ conditions at the time of the accident.

The Safety Board determined that the probable cause of this accident was the pilot’s inadvertent encounter with adverse weather, which resulted in the pilot failing to maintain terrain clearance. Contributing factors were the dark night conditions, the pilot’s inadequate preflight preparation and planning, and the pressure to complete the mission induced by the pilot as a result of the nature of the EMS mission.

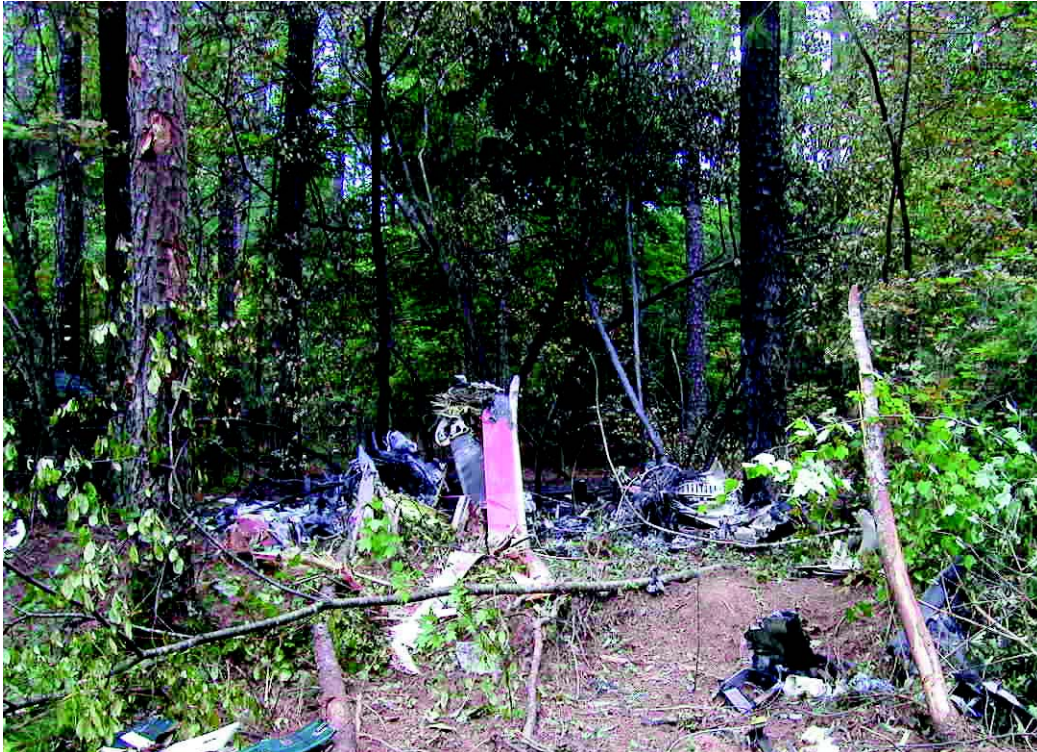
Figure 5. N503MT Wreckage Near Newberry, South Carolina

The flight was on a company flight plan and was receiving flight-following from Regional One Communications provided by Spartanburg County 911. The Med-Trans Spartanburg EMS operation was a VFR program only. The Bell 407 helicopter that Med-Trans operated was not authorized for flight into IMC, and Med-Trans pilots were not required to train for flight in IMC. The accident pilot had logged about 2,133 flight hours, which were all in helicopters. He had flown about 104 hours in the Bell 407, including 6.1 hours in the last 30 days. He had logged 250 hours of total night flight, including 2.7 hours of night flight in the last 30 days.

The Safety Board determined that the probable cause of this accident was the pilot's failure to maintain terrain clearance as a result of fog conditions. A contributing factor was inadequate weather and dispatch information relayed to the pilot.

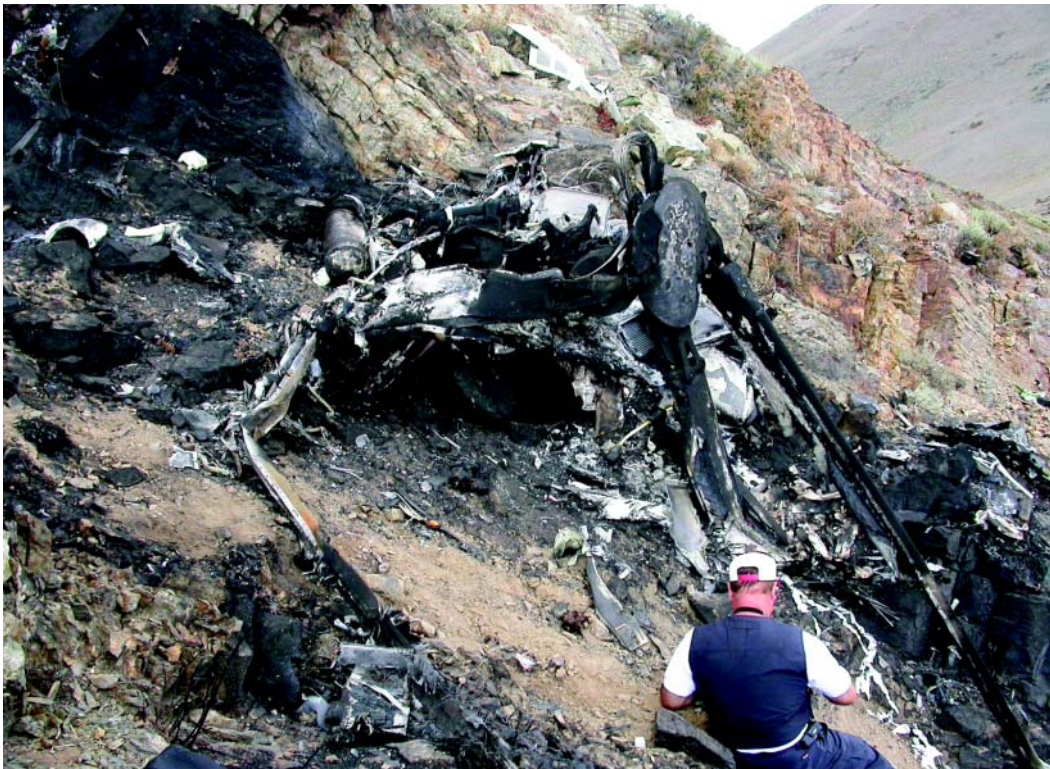
Figure 6. Wreckage Near Battle Mountain, Nevada

After takeoff, the pilot reported his departure to the Lander County dispatch center (where the hospital was located) and stated that his estimated time en route was 1 hour 20 minutes. No further radio communications were received from the helicopter. Radar data, which showed that about 4 minutes of the helicopter's flight before coverage was lost due to mountainous terrain, were consistent with the flight following the direct route. The helicopter impacted terrain about 75 feet below the top of a ridgeline at an elevation of about 8,600 feet along the intended course line between the departure location and the intended destination. Evidence indicated that the helicopter was in level flight, which is consistent with CFIT. Weather reports indicated clouds and light rain before and at the time of the accident. Although company flight-following procedures stated that an aircraft would be reported missing as soon as it failed to make a required 15-minute position report, the search for the helicopter was not initiated until about 4 hours after the accident,

The Safety Board determined that the probable cause of this accident was the pilot's failure to maintain clearance from mountainous terrain. Contributing factors were the pilot's improper decision to take the direct route over mountainous terrain, the dark night conditions, and the pressure to complete the mission induced by the pilot as a result of the nature of the EMS mission.

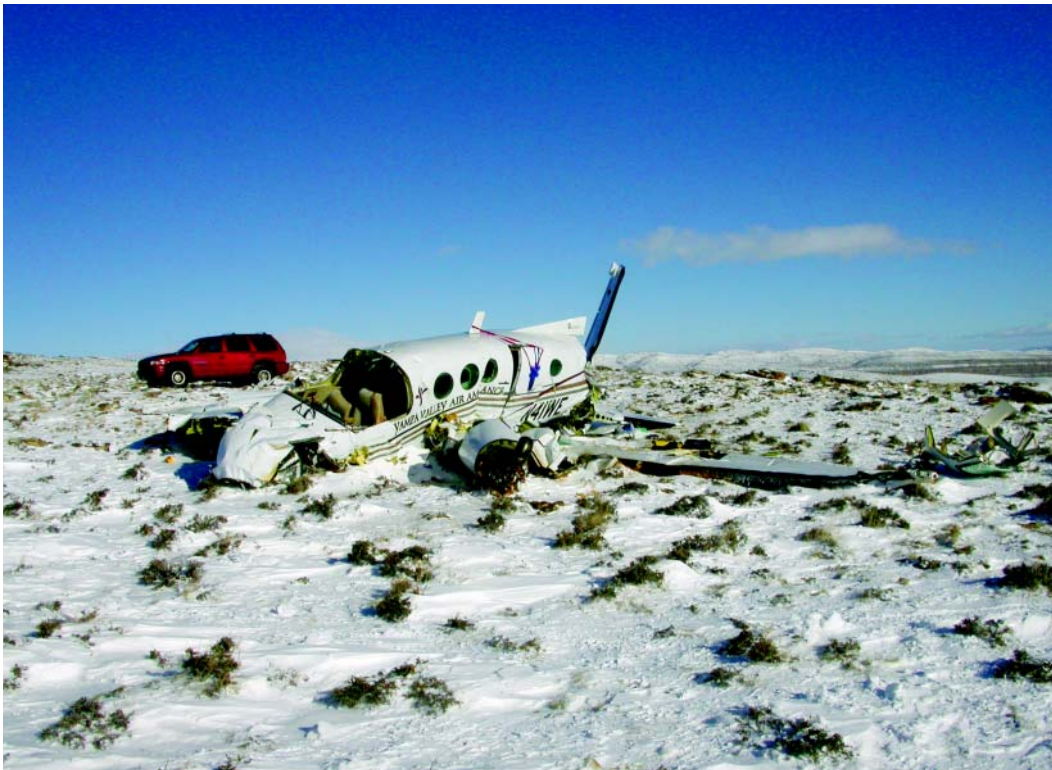
Figure 7. N41WE Wreckage Near Rawlins, Wyoming

The flight originated at Steamboat Springs, Colorado, about 2116 and was en route to RWL to pick up a patient for transfer to Cheyenne, Wyoming. Radar contact was lost about 2142. At that time, the airplane was at 9,200 feet mean sea level and midway

Several witnesses near the accident site reported surface weather conditions varying from freezing rain to heavy snow. The airplane impacted the windward side of a 7,269-foot msl ridgeline, 2 1/2 nm from RWL in a wings-level attitude and aligned with runway 22. About 1 1/2 inch of clear ice was found on the leading edges of the airplane's wings, the leading edge of the vertical tail, portions of the main landing gear tires and portions of one of the two propellers.

The Safety Board determined that the probable cause of this accident was the pilot's inadvertent flight into adverse weather [severe icing] conditions, resulting in an aerodynamic stall impact with rising, mountainous terrain during approach. A factor contributing to the accident was the pilot's inadequate planning for the forecasted icing conditions.
