UNITED STATES  
**NUCLEAR REGULATORY COMMISSION**  
REGION IV  
1600 EAST LAMAR BLVD  
ARLINGTON, TEXAS 76011-4511

**SUBJECT: SAN ONOFRE NUCLEAR GENERATING STATION – NRC AUGMENTED  
INSPECTION TEAM REPORT 05000361/2012007 and 05000362/2012007**

On March 19, 2012, an Augmented Inspection Team (AIT) was dispatched to San Onofre Nuclear Generating Station to gather facts and understand the circumstances surrounding the January 31, 2012 Unit 3 primary-to-secondary leak and failure of eight steam generator tubes to maintain structural integrity as required by plant technical specifications during testing the week of March 13, 2012. The primary-to-secondary leak was the result of a single tube in Unit 3 steam generator 3E0-88 failing to maintain structural integrity.

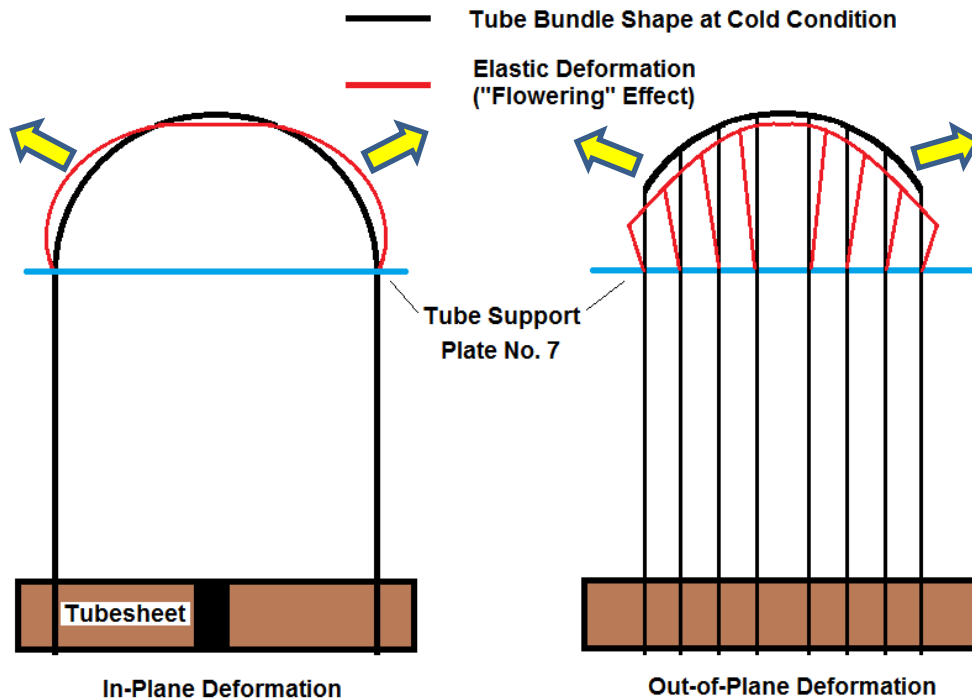
### Description of "Flowering" Effect (Conceptual Drawing – For Illustration Purposes Only)

The failure mechanism model also considered a fluid dynamic effect associated with the spreading of the tubes in the U-bend region during normal operating conditions. This effect was informally referred to as "flowering," due to the characteristic shape in which the tube bundle spreads transverse to the plane of the u-bends at normal operating conditions. "Flowering" was described as the elastic deformation of the anti-vibration bar structure and the tube bundle in the U-bend region, as a result of thermal expansion and fluid dynamic pressure acting on the secondary side of the tubes (see figure below). The deformation caused by the "flowering" effect was believed to result in multiple areas of no contact between the anti-vibration bars and the tubes, which minimized resistance to in-plane motion of the u-bend area of the tubes.

Mitsubishi considered that the collective contribution of the factors described above resulted in conditions in the U-bend that were highly susceptible to excessive tube vibration. The in-plane vibration of the tubes in the U-bend region allowed direct contact between free-span sections of the tubes, resulting in the unanticipated tube-to-tube wear.

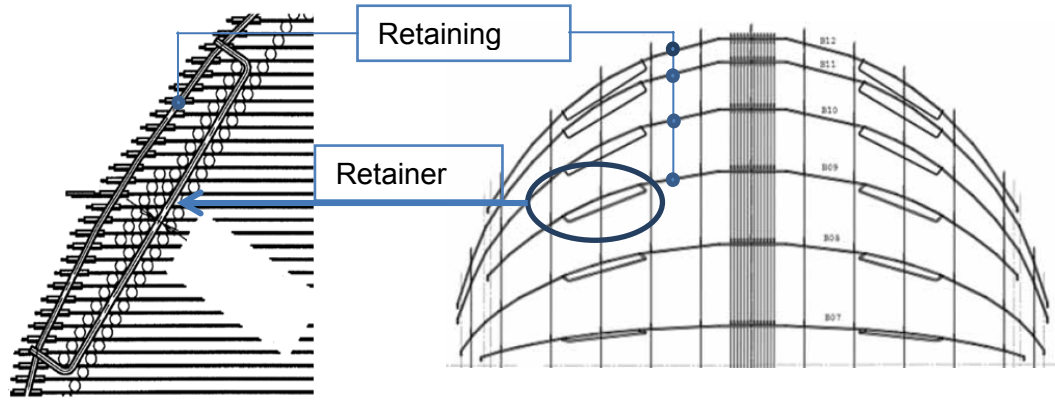
#### Retainer Bar Design and Location of Affected Tubes (For Illustration Purposes Only)

Description: In February 2012, the licensee identified wear indications in Unit 2 replacement steam generators at the tube locations in contact with the retainer bars (see figure below). Some of the indications showed excessive wear with a maximum degradation of 90 percent through wall.

The team identified that the design of the replacement steam generators did not expect any potential vibration concerns in the area of the tube bundle where the retainer bars were located. The basis for Mitsubishi's design philosophy relied on the following factors:

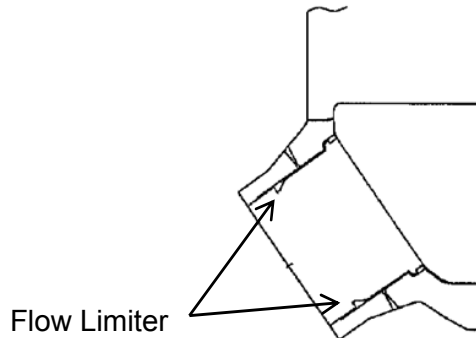
#### Replacement Steam Generator Primary Inlet Nozzle (For Illustration Purposes Only)

- Flow Limiter for Primary Inlet Nozzles** – The replacement steam generators were designed with a flow limiter located in the primary inlet nozzle (see figure below) in order to make the reactor coolant system flow similar to the flow rate of the

original steam generator and not exceed the maximum allowable reactor coolant system flow rate. The licensee's evaluation for the engineering design package determined that although the original steam generators had a number of plugged tubes, the reactor coolant system flow rate of the original steam generators was near the design requirement. Because the replacement steam generators has 377 more tubes than the original steam generators, and contained tubes with u-bends versus "square bends", the pressure drop of the replacement steam generators with no plugged tubes would be much less than the original steam generators resulting in a higher flowrate.

The flow limiter was designed to ensure the total "best estimate" reactor coolant flow rate with the replacement steam generators installed would not exceed 106.5 percent of the design volumetric flow rate of 396,000 gallons per minute at a reactor coolant system cold leg temperature of  $T_{cold} = 540.9^{\circ}\text{F}$ . For Unit 2 replacement steam generators, the flow limiter diameter to nozzle inner diameter ratio was 0.94 while the ratio for Unit 3 steam generators was 0.915 due to Unit 3 reactor coolant pump replacement. The flow limiter dimensions resulted from a scaled model test performed by Mitsubishi and it was designed to be machined as part of the nozzle base metal.

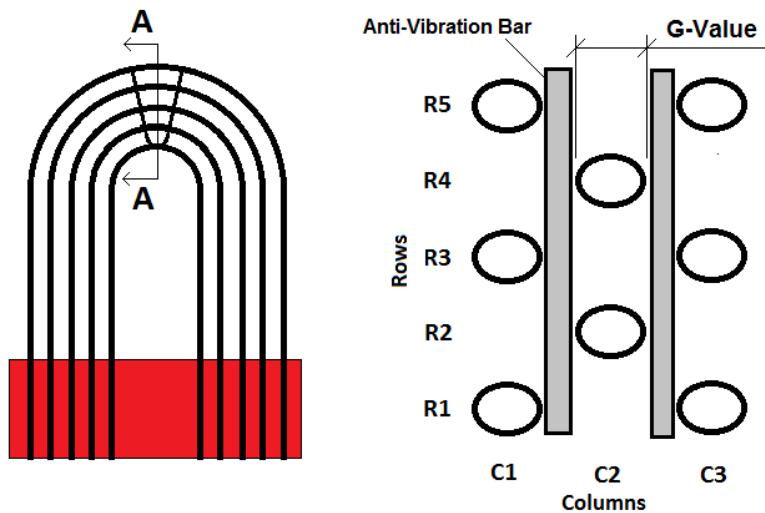
#### Description of G-Value Parameter (Conceptual Drawing – For Illustration Purposes Only)

- Dimensional Controls of Anti-Vibration Bar Structure – According to Mitsubishi's preliminary cause evaluation taking place at the time of this inspection, the controls of critical dimensions affecting the clearances between the tube and the anti-vibration bars were gradually improved throughout the fabrication of the Unit 2 and Unit 3 steam generators. This improvement on dimensional controls was a consideration for the determination of the failure mechanism leading to tube-to-tube wear in Unit 3.

The first dimensional control under consideration was the improvement of tube roundness in the section of the tubes that was bent to form the U-bend shape. During fabrication of Unit 2 steam generator 2E0-89, the supplier of tubular product for Mitsubishi (i.e. Sumitomo), experienced quality issues to meet the G-values established in the design specifications, resulting in a high number of tube rejections. The G-value was a measure of departure from roundness, or "ovality," after the tubes were bent and it was controlled in order to control the gap between tubes and anti-vibration bars (see figure below). The G-values were measured at different locations along the U-bend section of the tubes for a selected number of tubes per row, as established in Mitsubishi's procedure. The acceptance criteria for G-value varied depending on the row where the tubes were installed. The acceptance criteria also remained the same throughout the fabrication of Unit 2 and Unit 3 replacement steam generators.

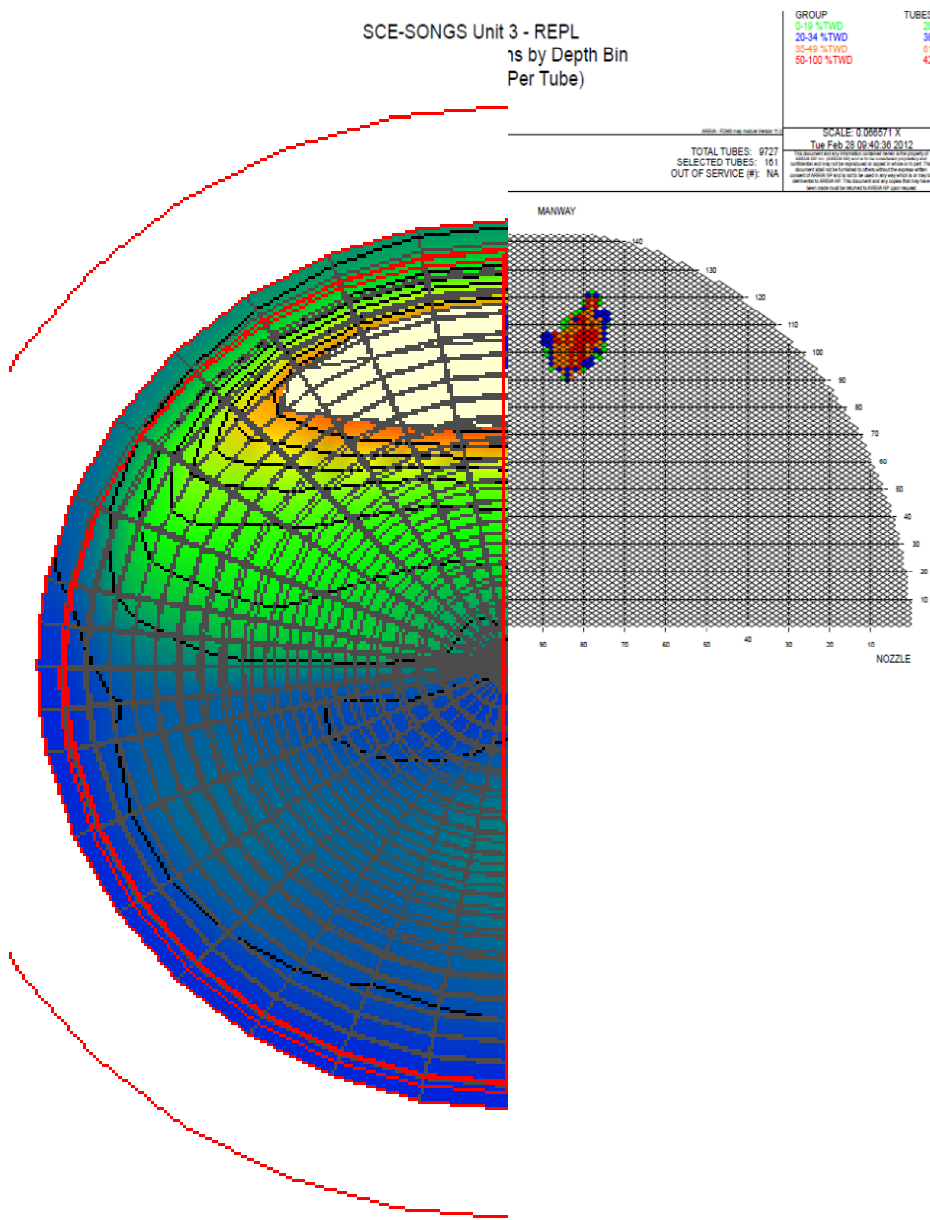
**Figure 5**

The ATHOS code predicted regions of high void fraction and high steam velocities are superimposed with tube-to-tube wear indications from Unit 3 steam generator 3E0-88

The NRC analysis indicated a correlation with the tube-to-tube wear based on a combination of high void fraction and high steam velocities. It should be noted that the traditional forcing function, fluid velocity squared times density, does not show good agreement with the tube-to-tube wear patterns. This indicated that the high quality steam fluid velocities and high void fraction may be sufficiently high to cause conditions in the generators conducive for onset of fluid-elastic instability.

The above analyses apply equally to Units 2 and 3, so it does not explain why the accelerated fluid-elastic instability wear damage was significantly greater in Unit 3 steam generators. The ATHOS thermal-hydraulic model predicts bulk fluid behavior based on first principals and empirical correlations and as a result it is not able to evaluate mechanical, fabrication, or structural material differences or other phenomena that may be unique to each steam generator. Therefore this analysis cannot account for these mechanical factors and differences which could very likely also be contributing to the tube degradation.

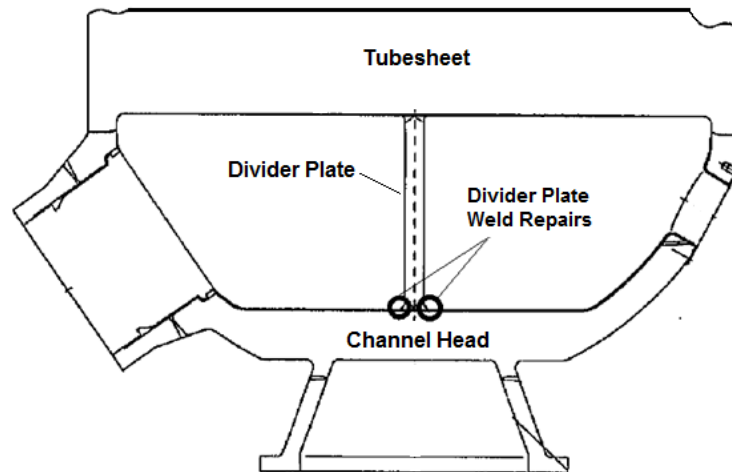
**Location of Divider Plate Weld Repairs in Unit 3 Steam Generators (For Illustration Purposes Only)**

On March 18, 2009, after completion of the primary and secondary side hydrostatic pressure tests, a crack in the weld between the divider plate and the channel head on Unit 3 steam generator 3E0-88 was identified. Examination showed that the dissimilar metal weld, between the Alloy 690 divider plate and the low alloy steel channel head, had separated. Specifically, the failure occurred between the channel head and the Alloy 152 butter weld, which is the weld filler wire equivalent of Alloy 690. Upon examination, a similar weld failure was found in steam generator 3E0-89 although the size of the failure was not as large.

Mitsubishi performed a root cause evaluation and found that air carbon-arc gouging was used to remove the stainless steel cladding from the channel head, in preparation for making the divider plate-to-channel head dissimilar metal weld. The air carbon-arc gouging had resulted in carbon deposits in the channel head that were not completely removed by grinding that was performed after the gouging operation. The high carbon area increased the hardness of the channel head (due to carburization) and was the most probable cause of the failure between the channel head and the Alloy 152 butter weld. Mitsubishi also found that it was possible, but less probable, that the increased hardness of the channel head promoted hydrogen induced cracking in areas of the divider plate-to-channel head weld that had higher local stresses due to geometric configurations (i.e., at the corner of the divider plate).

On March 18, 2009, Mitsubishi identified cracking indications in the weld between the divider plate and the channel head of Unit 3 replacement steam generator 3E0-88 (see figure below), after completion of the ASME Section III hydrostatic test on the secondary side. The extent of condition investigation also identified similar cracking indications in Unit 3 replacement steam generator 3E0-89. As discussed in Section 4 of this report, the cause of the cracking was attributed to the air carbon-arc gouging process used to remove the clad weld from the channel head. The team reviewed information associated with the repair of the cracking indications to assess whether the repair activities resulted in relevant differences in design and fabrication that could be considered as contributing factors for the cause of the tube-to-tube wear issue in Unit 3.
