Enbridge Incorporated
Hazardous Liquid Pipeline Rupture and Release
Marshall, Michigan
July 25, 2010

NTSB/PAR-12/01
PB2012-916501
Notation 8423
Adopted July 10, 2012

Pipeline Accident Report

On Sunday, July 25, 2010, at 5:58 p.m., eastern daylight time, a segment of a 30-inch-diameter pipeline (Line 6B), owned and operated by Enbridge Incorporated (Enbridge) ruptured in a wetland in Marshall, Michigan. The rupture occurred during the last stages of a planned shutdown and was not discovered or addressed for over 17 hours. During the time lapse, Enbridge twice pumped additional oil (81 percent of the total release) into Line 6B during two startups; the total release was estimated to be 843,444 gallons of crude oil. The oil saturated the surrounding wetlands and flowed into the Talmadge Creek and the Kalamazoo River. Local residents self-evacuated from their houses, and the environment was negatively affected. Cleanup efforts continue as of the adoption date of this report, with continuing costs exceeding \$767 million. About 320 people reported symptoms consistent with crude oil exposure. No fatalities were reported.

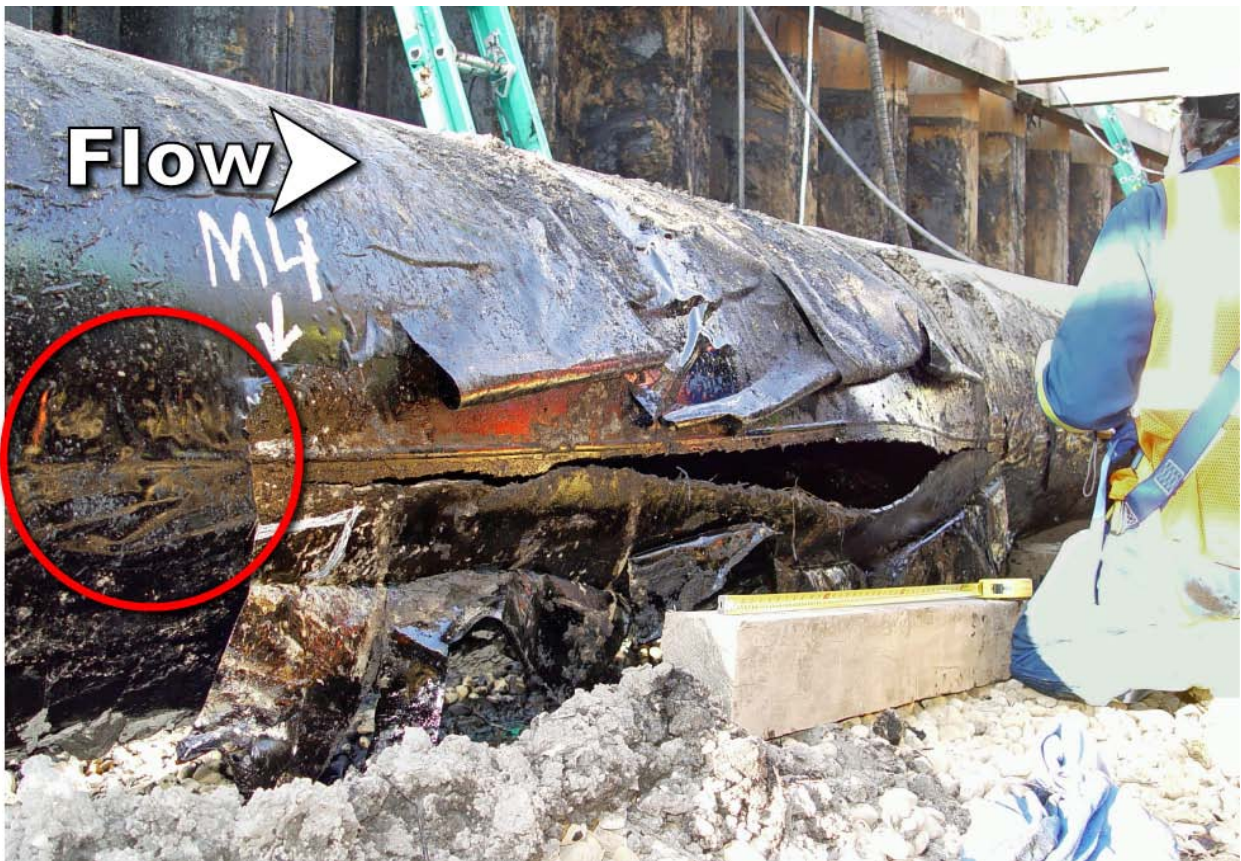
The fracture in the ruptured segment measured 6 feet 8.25 inches long and up to 5.32 inches wide. (See figure 2.) External corrosion was present along the longitudinal weld seam and in areas where the adhesive bond between the pipe and its protective polyethylene tape coating had deteriorated (disbonded). The coating was wrinkled and had separated from the pipe surface as shown in the red circle in figure 2.

Figure 2. The ruptured segment of Line 6B in the trench following the July 25, 2010, rupture. The fracture face measured about 6 feet 8.25 inches long and was 5.32 inches wide at the widest opening. The fracture ran just below the seam weld that was oriented just below the 3 o'clock position. A red circle shows a location where the coating was wrinkled and had separated from the pipe surface.

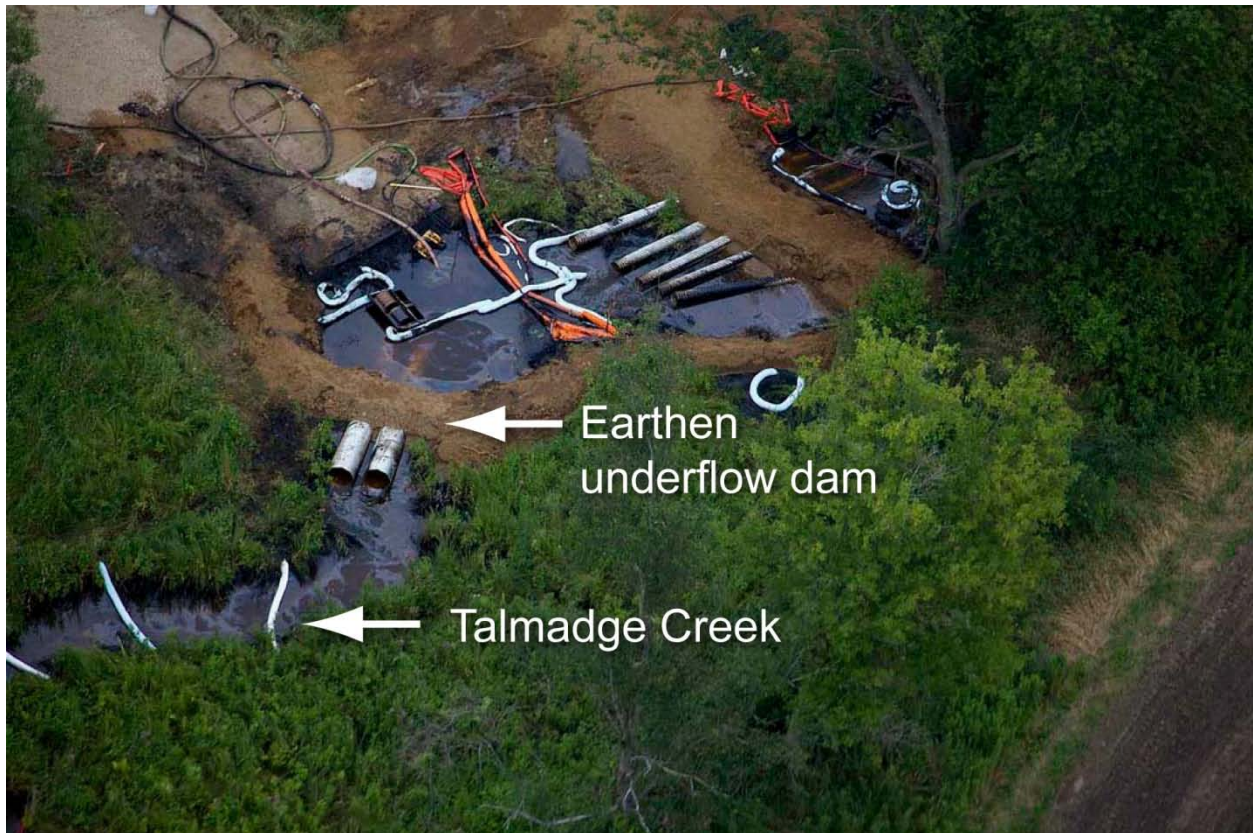
Working with a six-person crew, the Marshall PLM supervisor constructed an earthen underflow dam, which consists of a mound of soil holding back oil-contaminated water with pipes submerged on the dam side and rising toward the discharge end. The angle of the pipe allows the deeper water in the dam to flow downstream, preventing the contaminated surface waters from flowing into Talmadge Creek. (See figure 10.)

Figure 10. Underflow dam on Talmadge Creek on July 30, 2010.

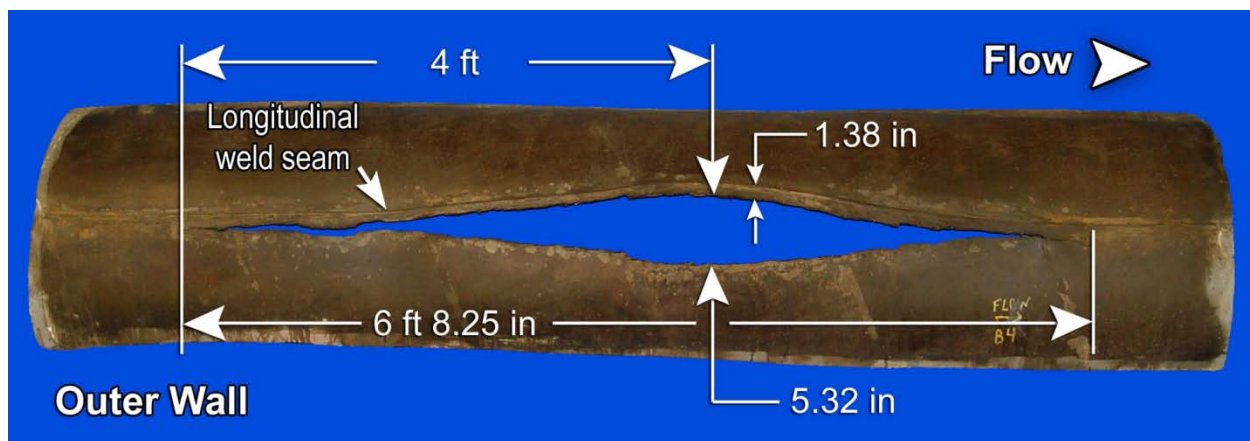
The fracture measured 6 feet 8.25 inches in length with the upstream end of the fracture located 24 feet 5.75 inches away from the upstream girth weld. The widest point along the fracture measured 5.32 inches and was about 4 feet from the upstream end of the rupture. The upper fracture face at the widest opening was measured at 1.38 inches below the longitudinal seam weld away from the heat-affected zone, with this offset ranging from 0.5 to 1.5 inches below the longitudinal weld seam for the length of the fracture face. (See figure 12.)

Figure 12. The outside surface of the pipe looking at the fracture area cut for lab examination.

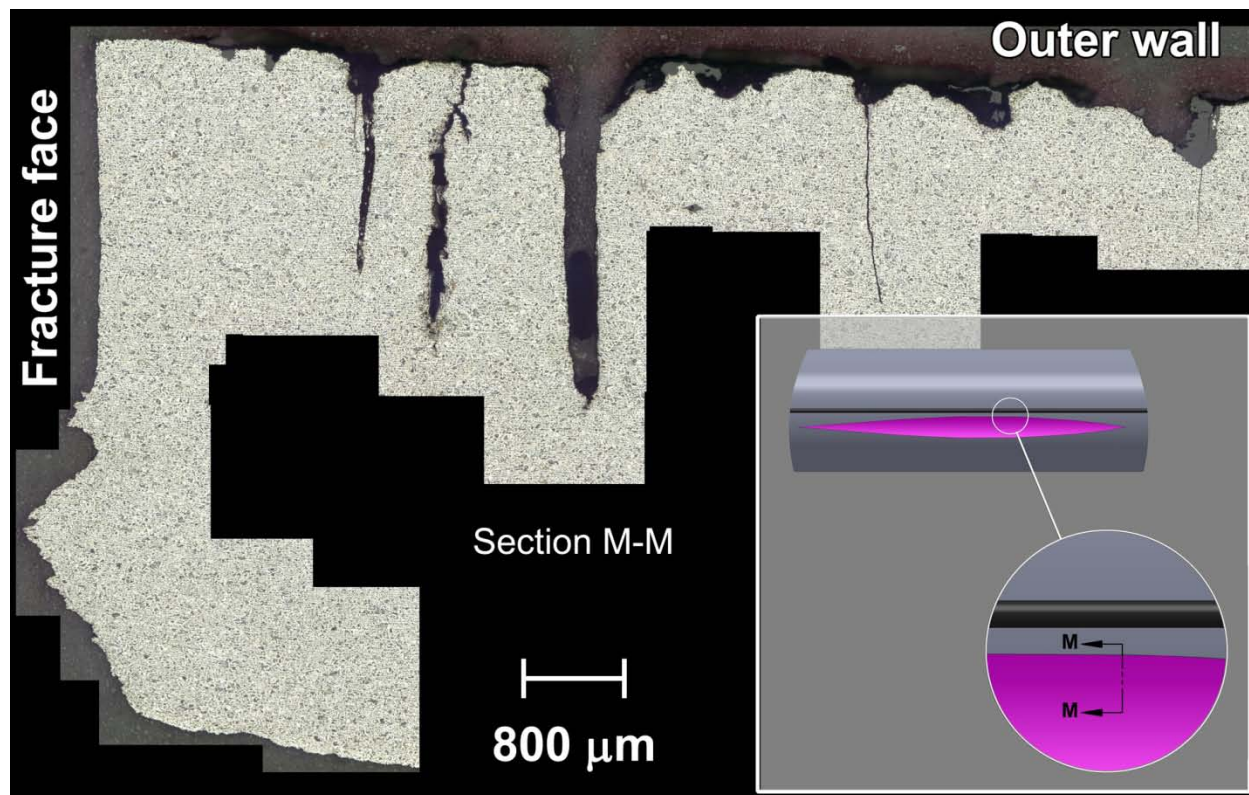
A cross-section through the fracture was prepared as shown in figure 15. The preexisting crack portion of the fracture showed a transgranular⁴⁹ fracture path with limited crack branching, consistent with near-neutral pH SCC or corrosion fatigue. Multiple closely spaced and parallel secondary cracks (with transgranular propagation paths and limited crack branching) emanated from corrosion pits on the outside wall near the fracture face, also consistent with corrosion fatigue or near-neutral pH SCC. The deepest secondary crack extended through about 43 percent of the wall thickness.

Figure 15. Transverse section through the top of the fracture showing multiple parallel cracks emanating from corrosion pits on the outside surface.
