Collision of BNSF Coal Train With the Rear End of Standing  
BNSF Maintenance-of-Way Equipment Train  
Red Oak, Iowa  
April 17, 2011

NTSB/RAR-12/02  
PB2012-916302

## Railroad Accident Report

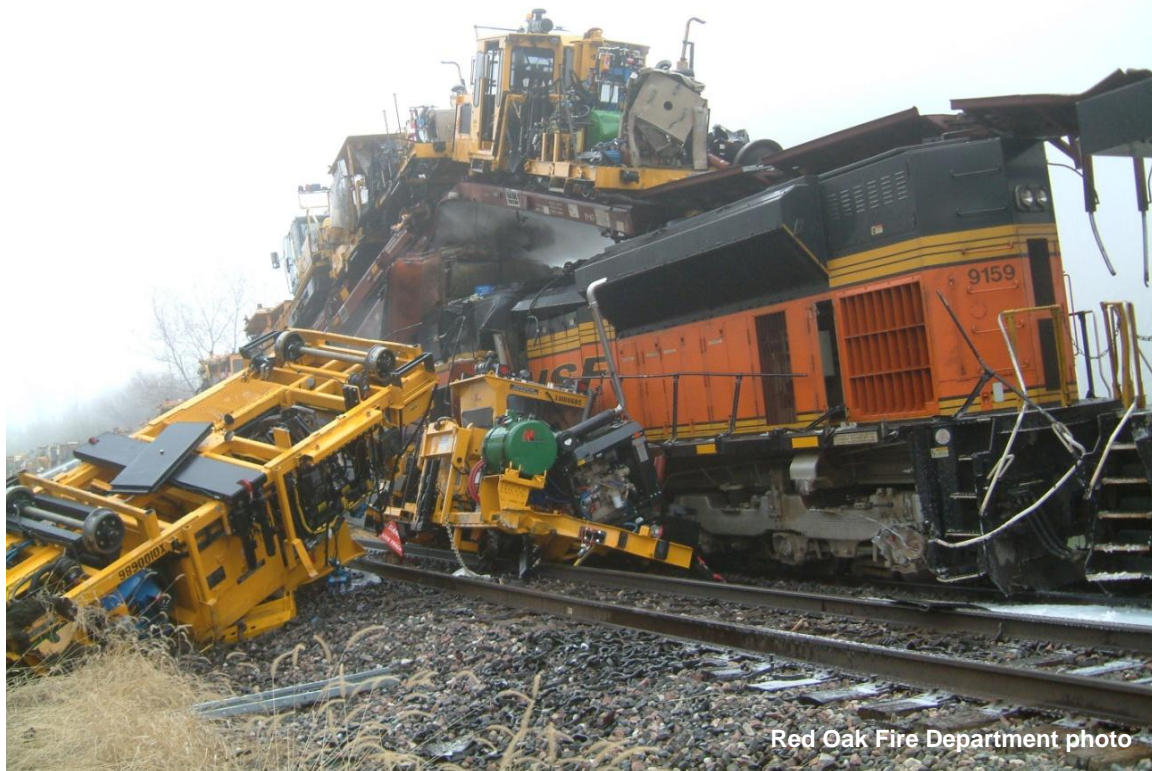
**Figure 6.** Wreckage including lead locomotive of striking train.

The striking train continued about 690 feet after the initial impact. The locomotive event recorder data indicated that following impact, the train speed dropped from 23 mph to 21 mph, and then the emergency brakes applied because of collision damage. The event recorder data indicated that neither the engineer nor the conductor activated the brakes before or after impact.

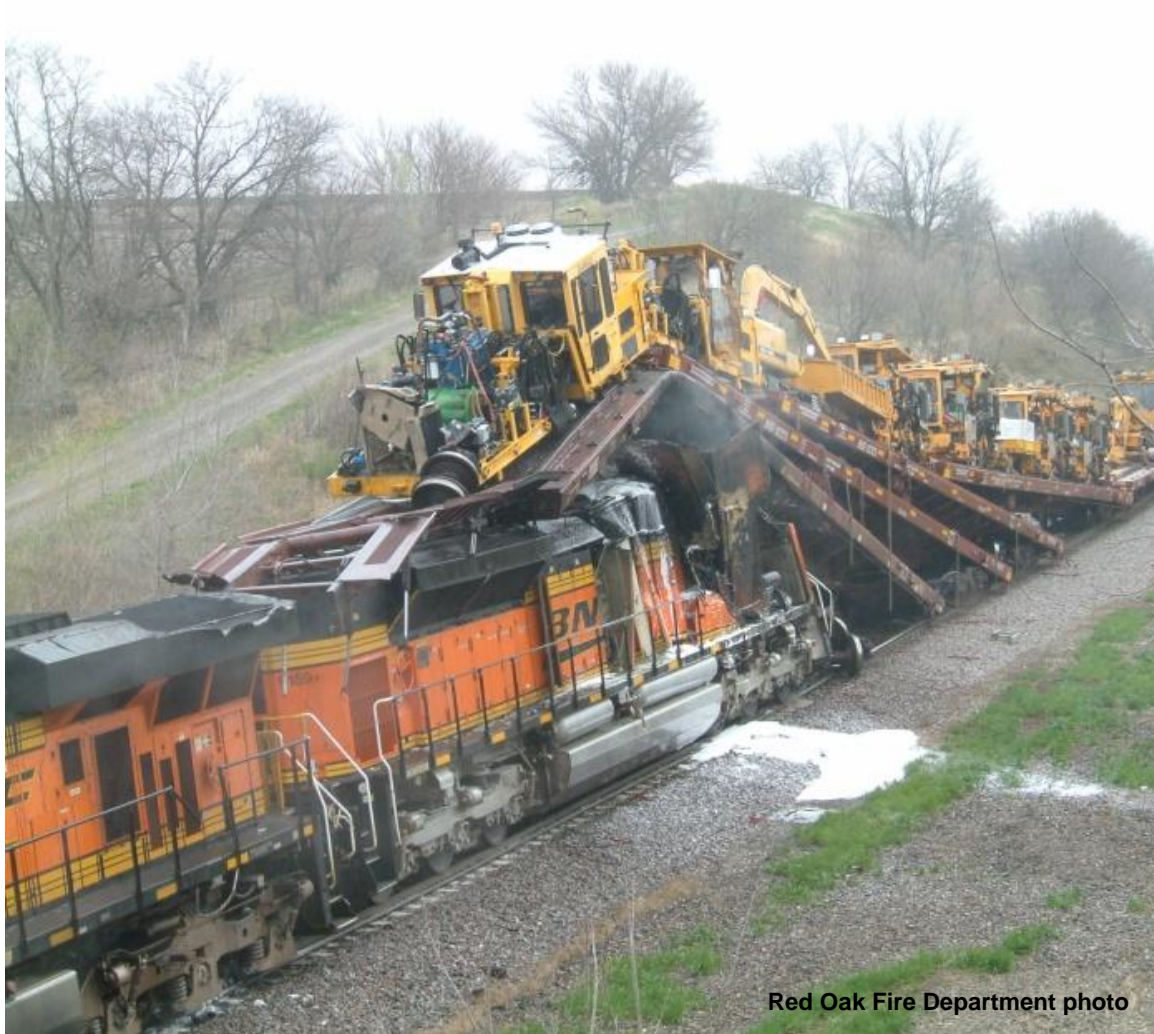
The next four cars (the 29th through the 32nd cars behind the locomotive) were 89-foot-long flatcars loaded with MOW equipment that were derailed and displaced to the north side of track two near the Highway M 37 overpass. (See map in figure 2 and figures 7 and 8.) Much of the cargo on these cars (MOW equipment) broke free from securements and was scattered along the right-of-way.

**Figure 7.** View of wreckage from highway overpass facing east.

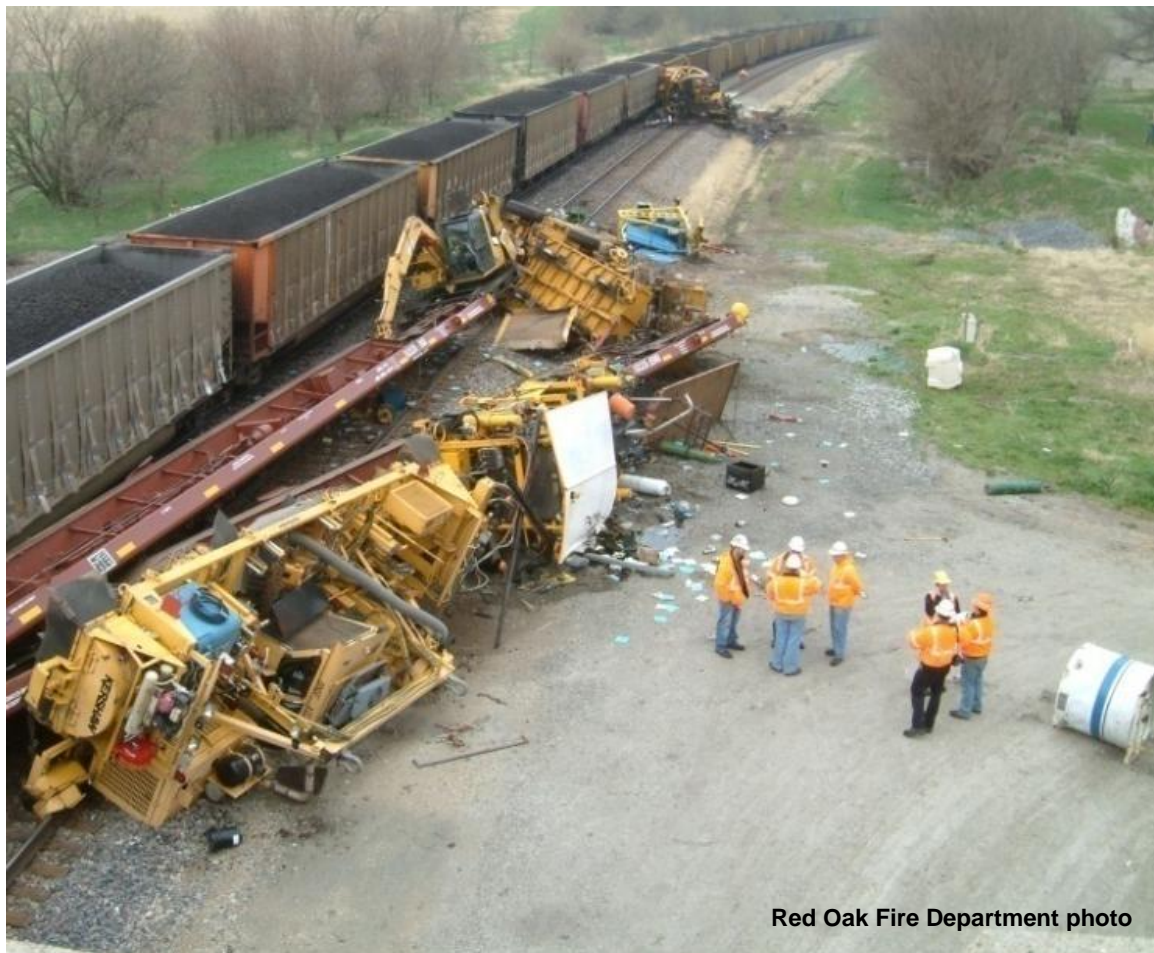
**Figure 8.** View of wreckage from highway overpass facing west.

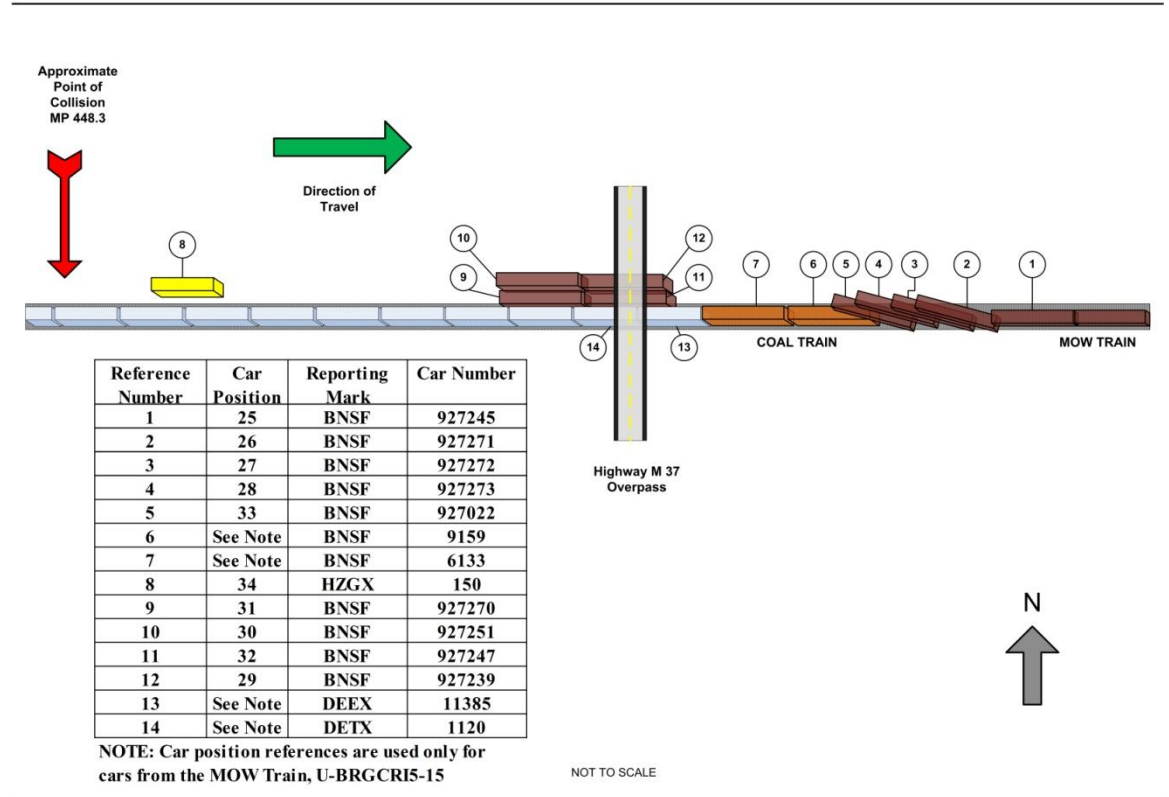
The next three cars (26th through 28th) also were 89-foot-long flatcars that were loaded with MOW equipment. These cars, along with the scorpion flatcar, came to rest lying against each other and overriding each other and leaning against the front end of the lead locomotive of the striking train. (See figure 9.) Trucks, wheel sets, and MOW equipment were scattered along the north and south sides of the tracks.

The last car to derail (25th) on the MOW equipment train was also an 89-foot-long flatcar loaded with MOW equipment. It derailed upright and generally in line with the track.

Figure 9. Wreckage diagram (not to scale).

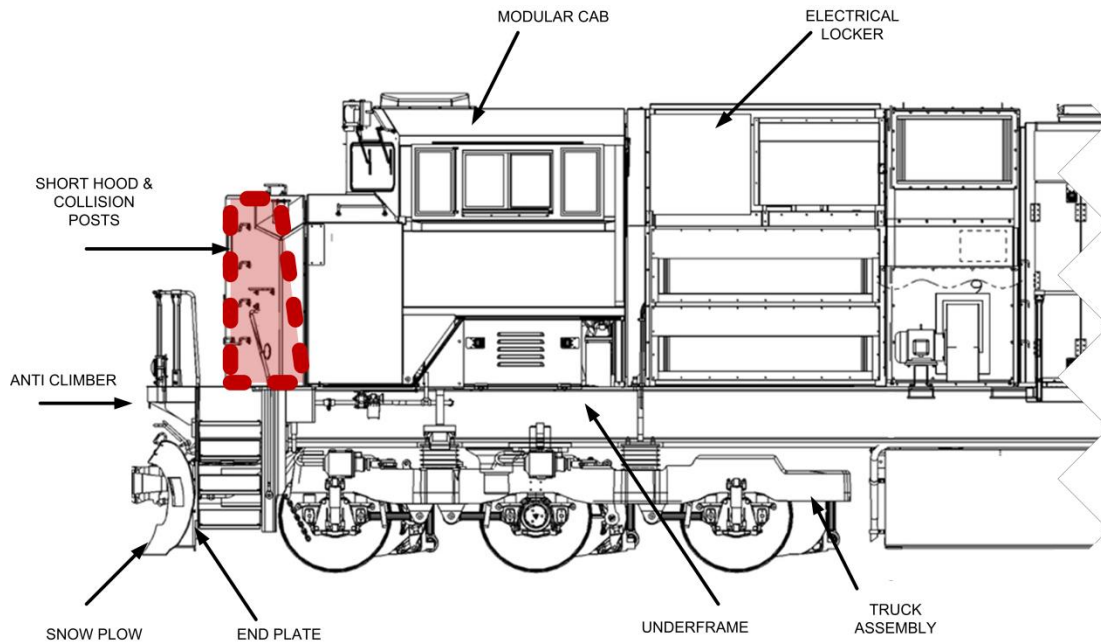
**Striking Train.** The lead locomotive of the striking coal train, BNSF 9159, sustained extensive frontal damage. (See figure 10.) It derailed, but the unit stayed upright and generally in line with the track. About 16 feet of the front end of BNSF 9159 was compromised as a result of the collision. The short hood and collision posts, normally positioned perpendicular to the deck, were pushed and deflected at an angle of about 35° to 40° in the direction of the cab. The end plate, snow plow, anti-climber,<sup>11</sup> short hood, and collision posts were severely damaged and deformed. A major impact area was identified on the front door frame of the operating cab. The frame was found to be split at the top right. The inner doorway, or vestibule, floor area had indications of severe loading and was bent rearward and upward.

**Figure 10.** Side view of front end of EMD SD70ACe locomotive, the same type of locomotive as striking train lead locomotive, BNSF 9159.

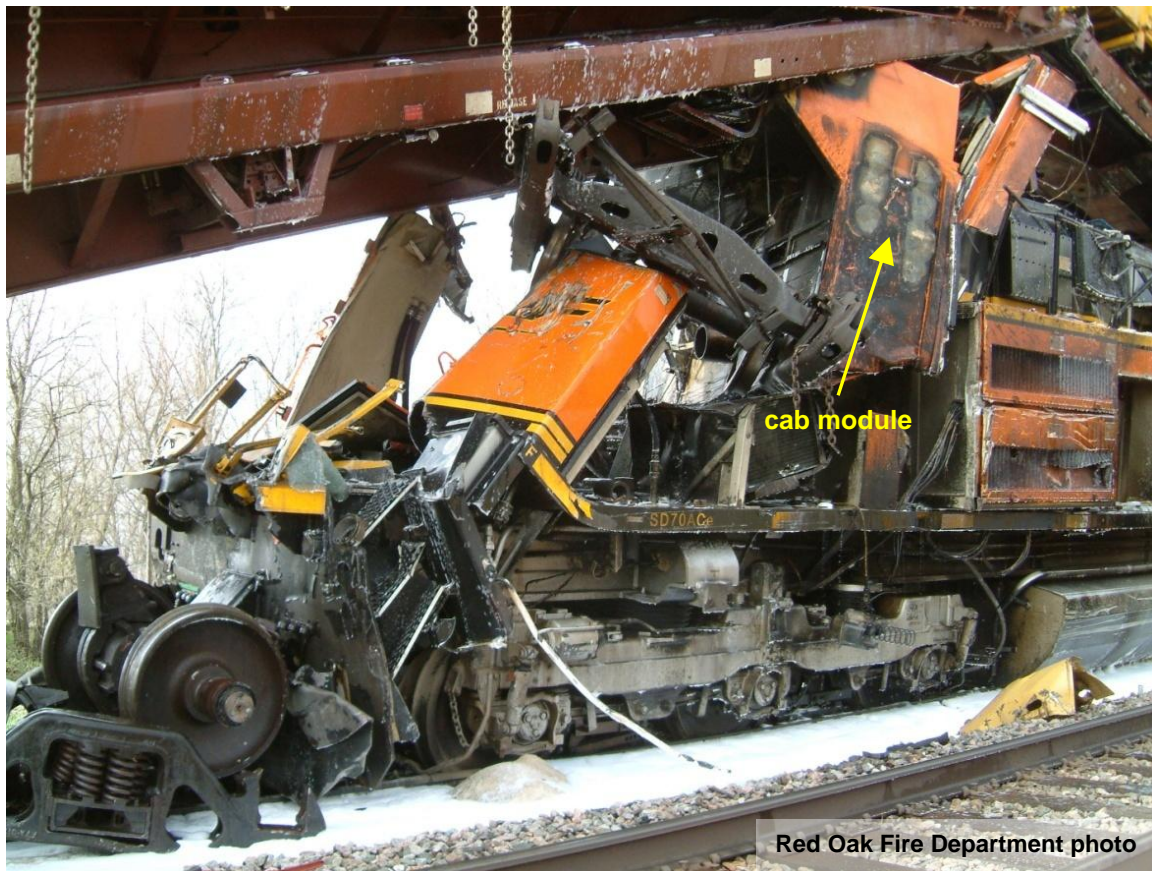
The modular cab of the locomotive sustained a substantial loss of occupied space. The cab was separated from the deck of the locomotive, and the bottom half of the cab rotated up just over 90 degrees. (See figure 11.) The cab was crushed at the rooftop, and the left rear corner of the cab was crushed in. The side walls remained intact to the point of the window line, which is about 4 feet from the roof. The underside of the cab was relatively intact and undamaged. The entire cab had extensive fire exposure and damage.

**Figure 11.** Upended striking train locomotive (BNSF 9159) modular operating cab.

The rear of the cab module abuts the electrical locker. The general condition of the electrical locker indicated that it had been subjected to severe longitudinal forces, and it was crushed at the upper right side. The locker became separated from the floor mounting system and was pushed back more than 2 feet.

The interior of the cab was severely damaged by fire.<sup>12</sup> The general condition of the modular cab attachment fixtures indicated that they had been subjected to severe vertical forces and shear. The rear posts were broken along the welds that hold the cylindrical posts to the deck. The forward-mounted floor brackets had indications of deep scoring on the inboard sides in a manner consistent with vertical loading. The modular cab assembly was examined, revealing the remaining volume of survivable space to be an estimated 65 cubic feet. Both the engineer's and the conductor's sides of the cab were severely damaged and burned. The engineer's seat was sheared from the floor mounts, and the control panel was bent downward and inward. The conductor's seat remained attached, and the desk area was crushed toward the floor.

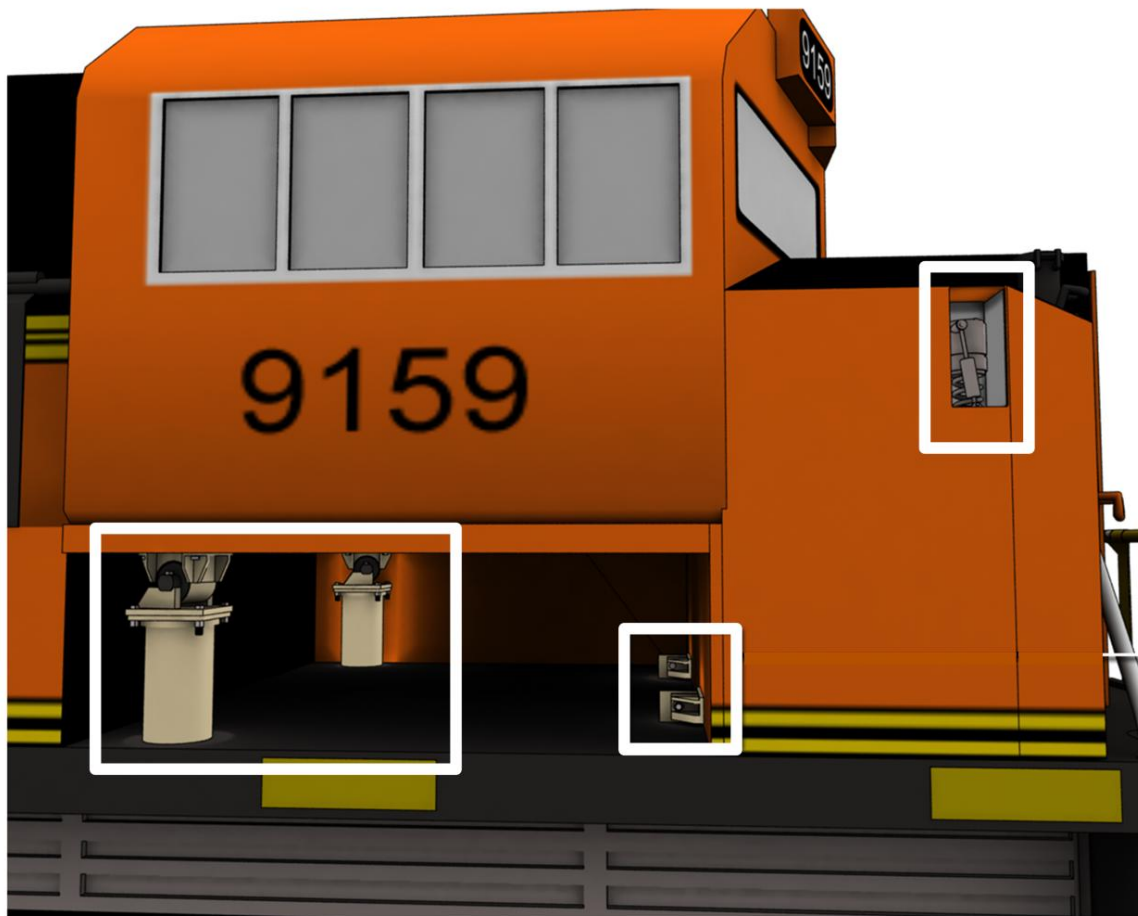
**Figure 14.** Illustration of EMD SD70Ace locomotive (same type as striking train locomotive) with white boxes indicating the points where the isolated cab attaches to the underframe.

On the underside of the modular cab at its front are two double shear pin joints. This system includes two brackets welded to the top plate and two brackets welded to the underside of the cab floor. These joints are designed as a clearance fit;<sup>21</sup> a 1-inch-diameter hardened steel pin passes through a wide (2-inch) hole in the deck-mounted bracket. When questioned, EMD stated that this design acted as a loosely coupled fastening system.

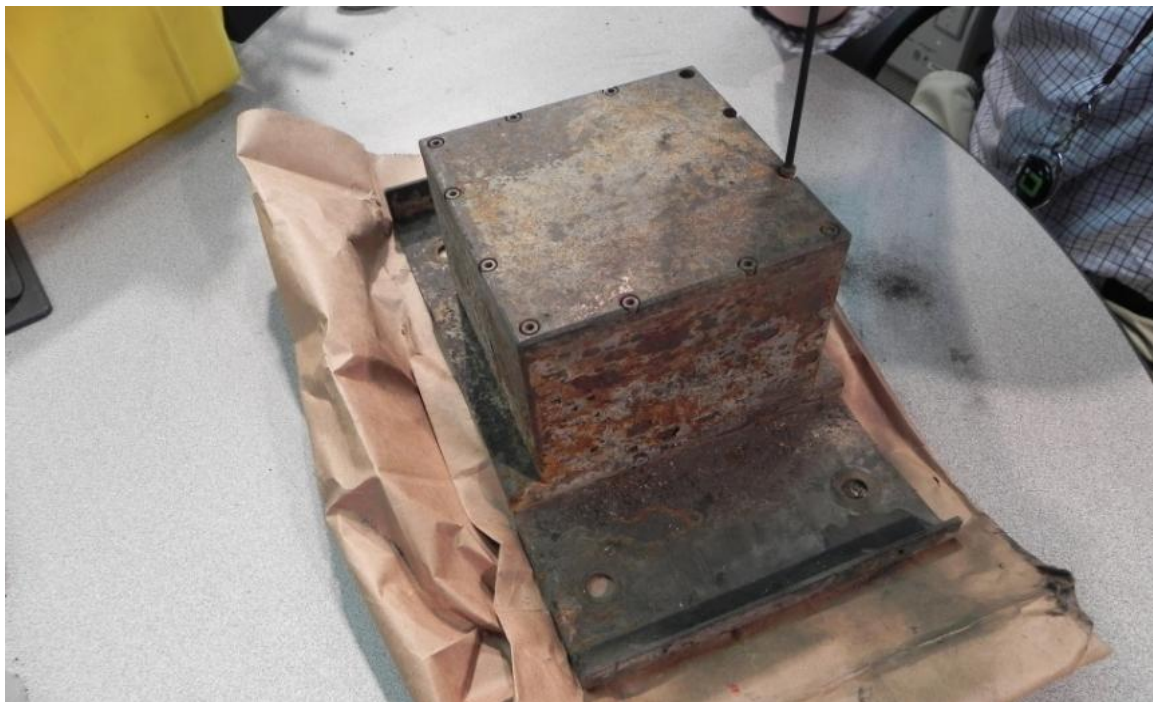
**Figure 19.** Fire-damaged memory module recovered from BNSF 9159.

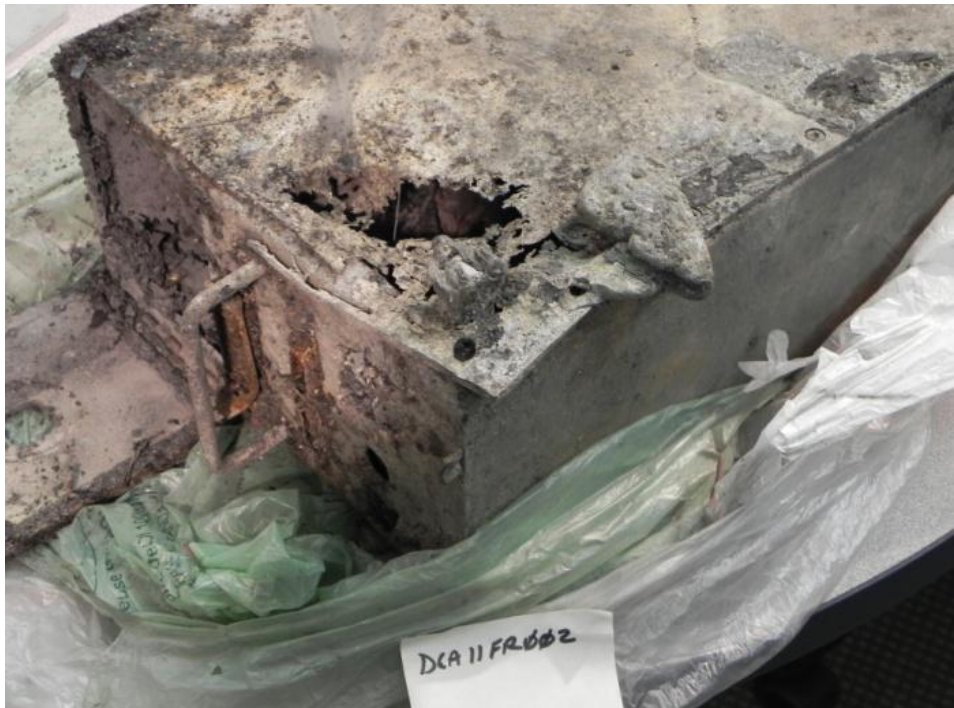
**Locomotive Cab Video Recorders.** The lead locomotive of the striking train, BNSF 9159, had a Wabtec Video Trax model forward-facing video recorder. The recorder hard drive enclosure was located in the wreckage, successfully recovered, and shipped to the NTSB laboratory in Washington, D.C. The enclosure and its contents were in poor condition because of the fire. (See figures 20 and 21.) Video data is stored on a hard drive within the enclosure. The hard drive was removed and transported to a vendor specializing in hard drive data recovery. After an examination and attempts to repair the damaged hard drive, it was determined that the hard drive was damaged beyond repair and its contents were unrecoverable. Forward-facing video recorders are not required by regulation.

**Figure 21.** Fire-damaged video recorder hard drive enclosure from BNSF 9159.
