Washington Metropolitan Area Transit Authority Hi-Rail
Maintenance Vehicle Strikes Two Wayside Workers Near the
Rockville Station
Rockville, Maryland
January 26, 2010

Accident Summary Report

NTSB/RAR-12/04/SUM
PB2012-916304

NTSB/RAR-12/04/SUM
PB2012-916304
Notation 8392
Adopted May 17, 2012

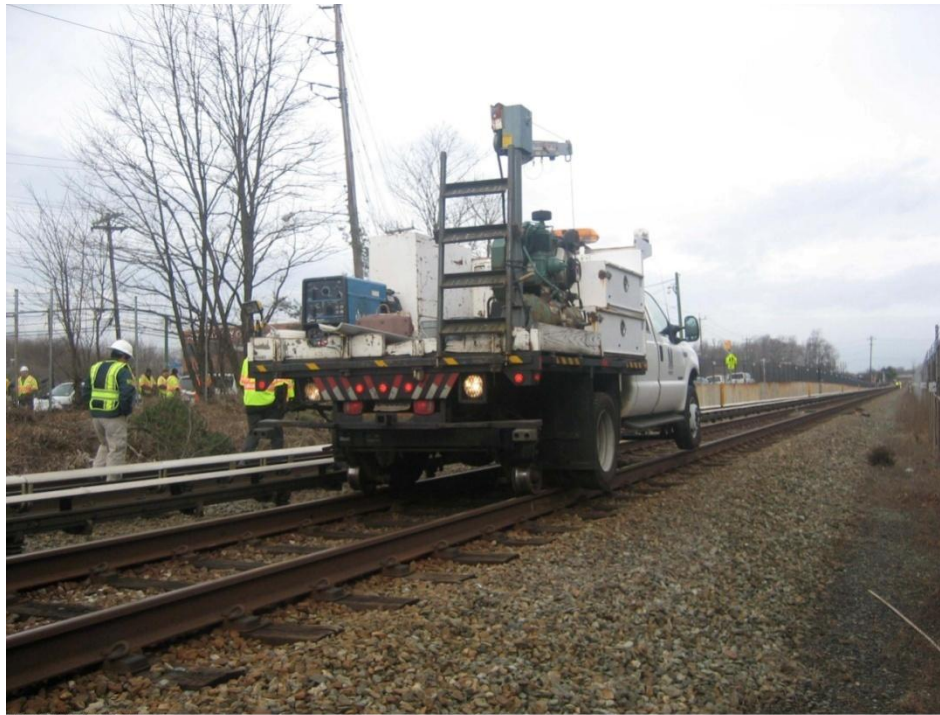
Figure 2. The striking hi-rail vehicle at the accident location.

Figure 2 shows the hi-rail vehicle at the location of the accident.

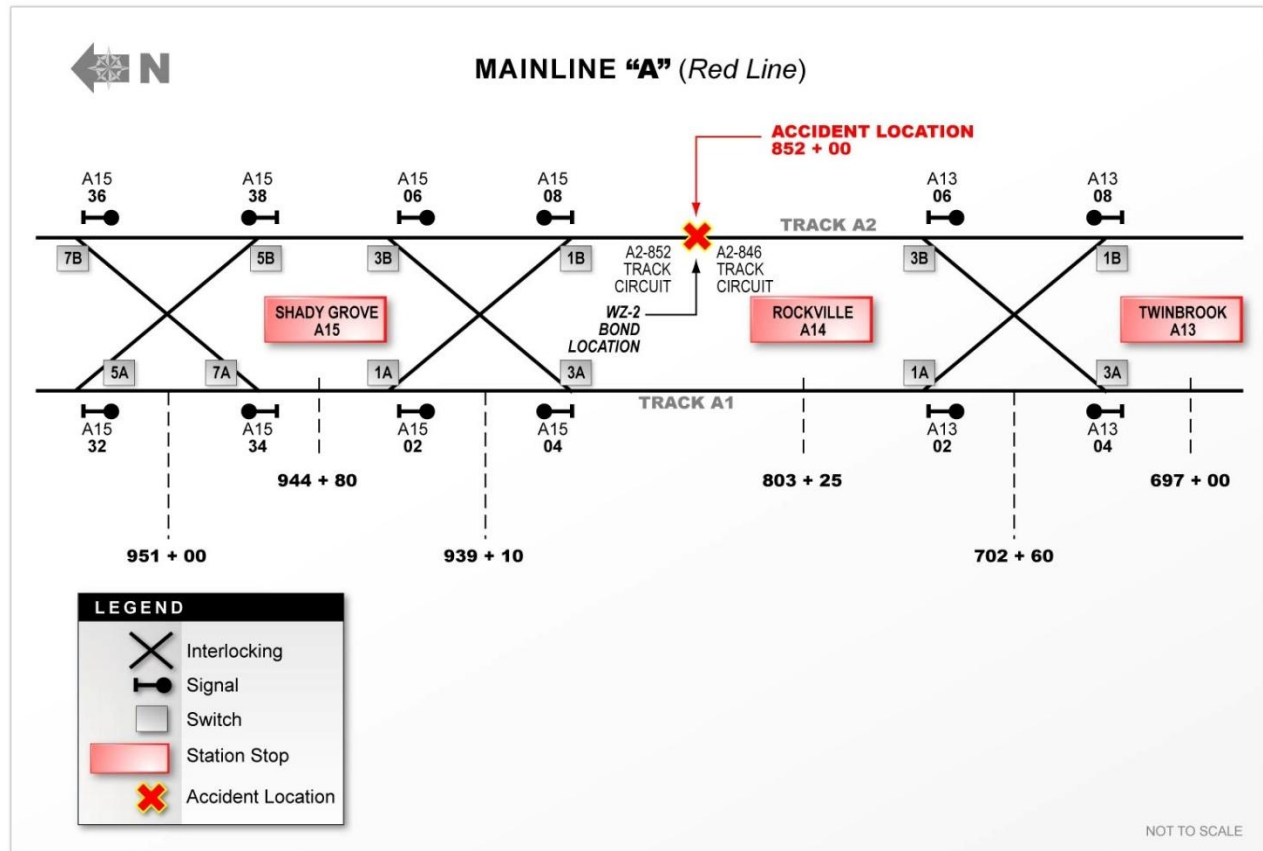
Figure 3. Track map of WMATA Red Line, showing accident location.

vehicle 15802 reported being clear of signal A15-08 on the A-2 track. The interlocking signals are located just south of the Shady Grove station. (See figure 3.) The OCC operator authorized a red tag traction power removal¹² to the hi-rail vehicle pursuant to Standard Operating Procedure (SOP) #28 at 1:26:24 a.m. The leadman requested and was given permission to perform a hot stick¹³ test at CM A-2 936+00, which is located just south of the Shady Grove station. The last instruction from the OCC operator to the leadman of hi-rail vehicle 15802 was to “place shunts per SOP.” This was a reference to Sections 28.2.f.5 and 28.2.f.6 in WMATA SOP #28, “Removal and Restoration of Third Rail Power for Work by WMATA Maintenance Forces – Mainline Revenue System.” This was published in the WMATA MSRPH dated January 2004.

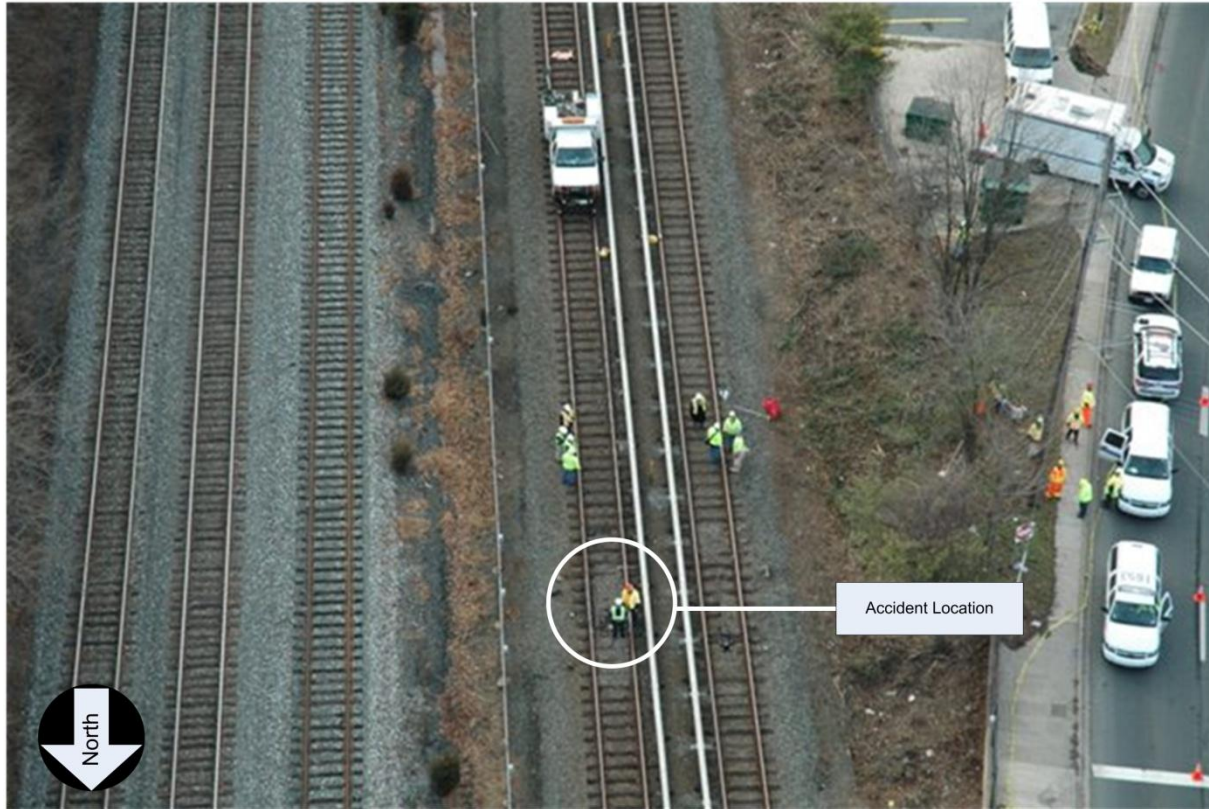
Figure 4. Aerial view of the accident location.

The next radio transmission from hi-rail vehicle 15802 was the initial notification of the accident, made to the OCC at 1:40:34 a.m. Figure 4 shows the accident location.

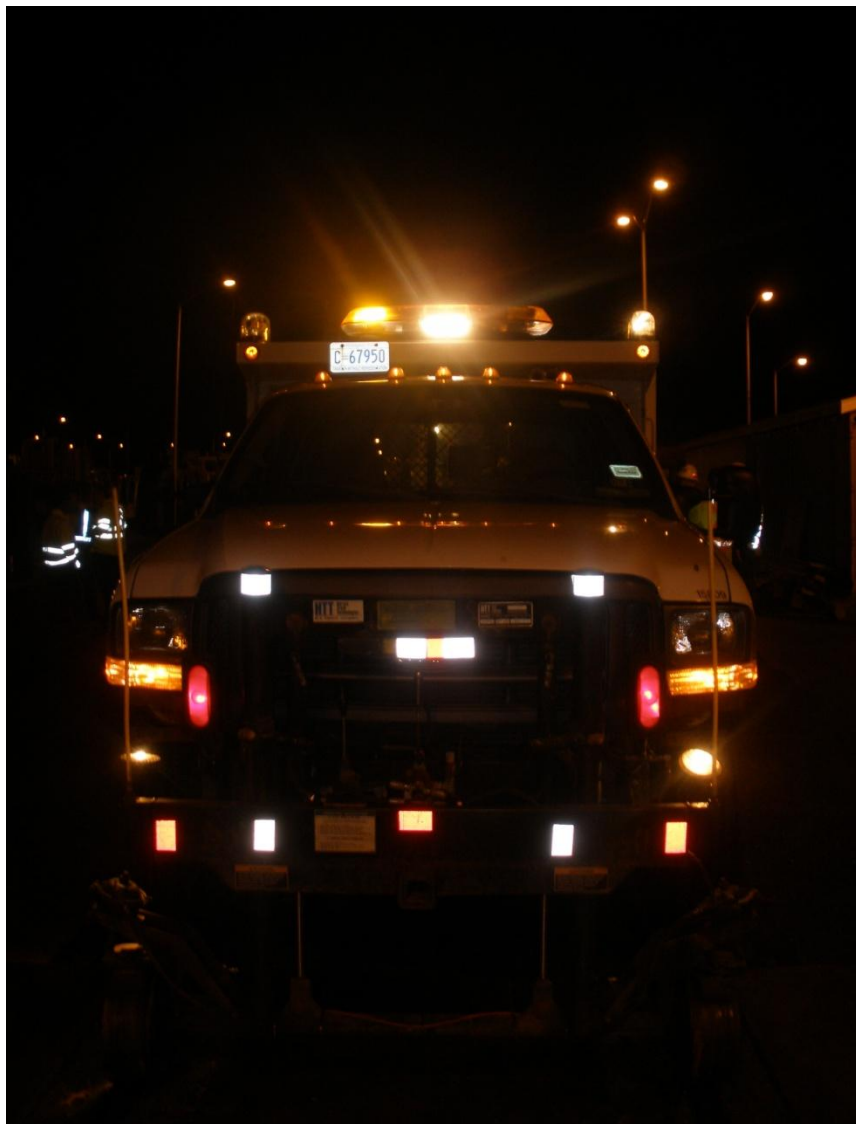
Figure 5. Front view of a hi-rail vehicle with the upgraded lighting package.

WMATA has also implemented a program to upgrade from its standard headlights and quartz lights on hi-rail vehicles to high-intensity xenon lights, which will improve lighting for both night work and tunnel work. The upgrade will provide three times the amount of light and should have an extended illumination of 1,475 feet in front of and behind the equipment.

Currently, seven hi-rail vehicles have been retrofitted with the new lighting package. Nine other hi-rail vehicles are also slated to receive the upgraded lighting package. Priority for the lighting package upgrade will be based on need and the use of the hi-rail vehicle. The lighting package will include a backup camera and a dashboard-mounted internal monitor, upgraded lights, and shunt straps. (See figures 5, 6, and 7.) The approximate cost to upgrade the existing hi-rail equipment is \$4,000 per vehicle.

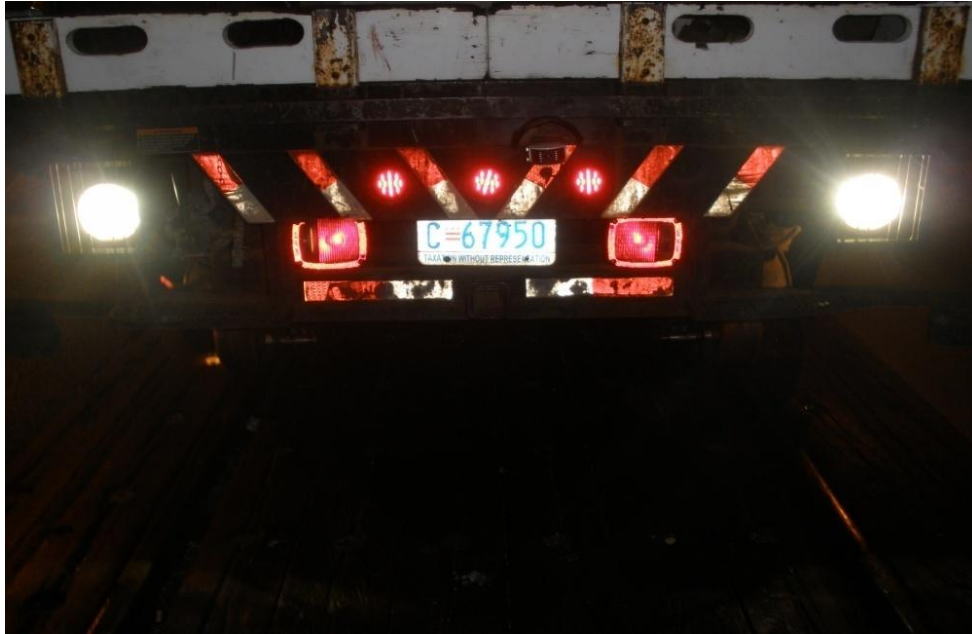
Figure 6. Rear view of a hi-rail vehicle with an upgraded lighting package.

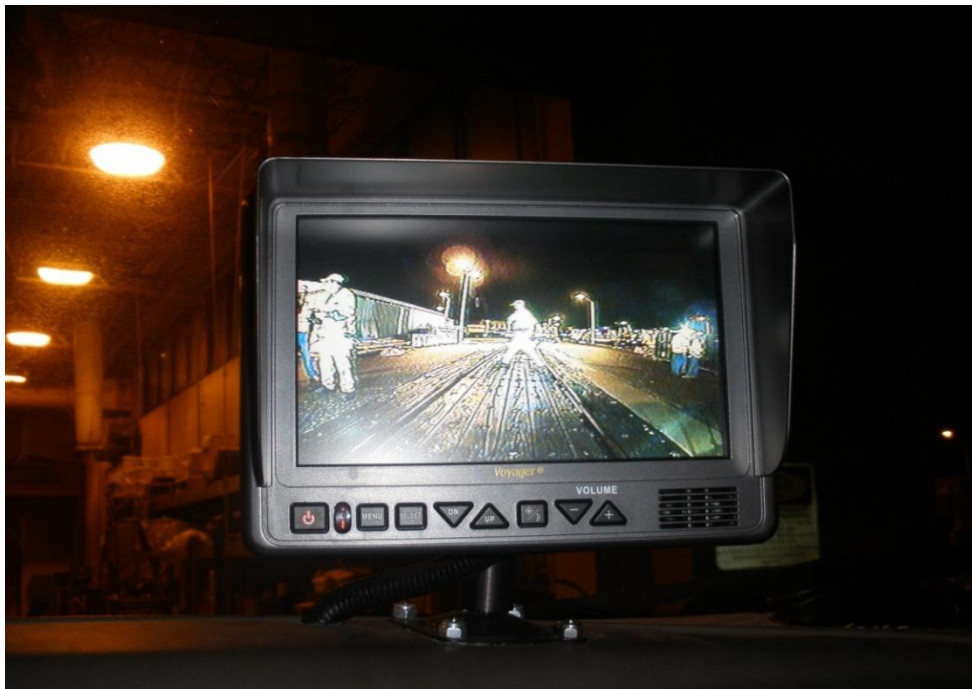
Figure 7. Video screen for backup movements in a hi-rail vehicle retrofitted with the upgraded lighting package.
