In-Flight Left Engine Fire American Airlines Flight 1400 McDonnell Douglas DC-9-82, N454AA St. Louis, Missouri September 28, 2007

NTSB/AAR-09/03 PB2009-910403

Aircraft Accident Report

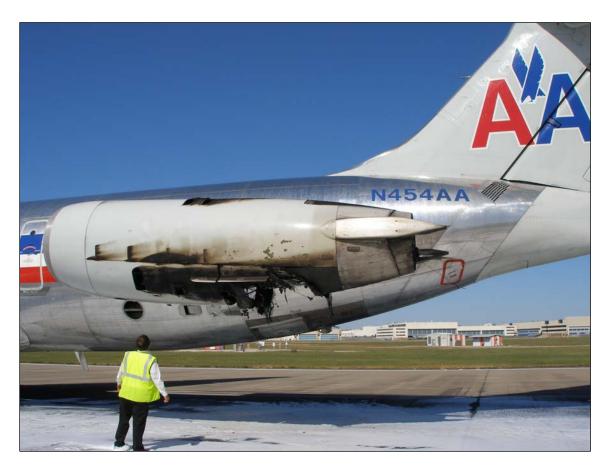
Figure 1. Photograph of the left side of the airplane after fire-extinguishing efforts were completed.

The airplane sustained substantial structural damage because of the fire.

The left engine nacelle cowling was destroyed by fire. The pylon skin and engine mounts and a small area of fuselage skin around the pylon intersection exhibited thermal damage. The external engine components, including the AGB, hydraulic pump, ATS, and ATSV, exhibited fire damage. The internal engine components were not damaged. No indications of case rupture or uncontainment were found. Multiple fluid leaks were found in the fuel and hydraulic lines. The segment of the ATSV wiring harness from the cockpit overhead panel to the left engine area was tested for continuity and short errors, and no fault was found.

³⁴ The airplane was returned to service after the accident after American Airlines removed and replaced the left engine, pylon, cowls, engine pylon apron, engine mounts, cone bolts, and inspected the structural area for fire damage in accordance with its maintenance procedures and structural repair manuals.

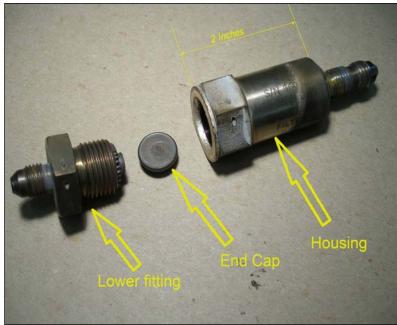
The recovered ATSV-air filter assembly components were removed and sent to the PTI facility, in Oxford, California, for teardown and examination under NTSB supervision. The filter element of the ATSV-air filter assembly was found fractured along a line from the lower air filter fitting to just above the fitting braze joint. About 70 percent of the filter element material was missing. The remaining material was found adhered to the inner wall of the housing and

appeared to be reddish-brown. Some mesh material was still attached to the end cap, and this mesh, as well as the cap edges appeared to be worn and rounded off.³² An incorrect housing was found installed on the assembly.³³ The end cap was found intact but separated from the filter element and in an inverted orientation, partially covering the air outlet within the ATSV-air filter housing.

The ATSV-air filter was then sent to the NTSB's Materials Laboratory in Washington, DC, for further examination. The filter element adjacent to the braze joints at the fitting and the end cap was separated through the filter mesh. Magnified optical examinations found severe

rubbing damage at the separations. The rubbing damage completely obliterated any fracture features at the separations and separation features on the portion of the mesh removed from the housing. The outer diameter edge of the end cap was rubbed and rounded. Comparisons of the accident end cap to exemplar end caps revealed that the accident cap was reduced in diameter by about 0.020 inches. The end cap's inner diameter was also rubbed and rounded, and a similar mating pattern was found on the inner diameter of the fitting.

Figure 5. Photograph of the damaged ATSV-air filter housing, end cap, and lower fitting.

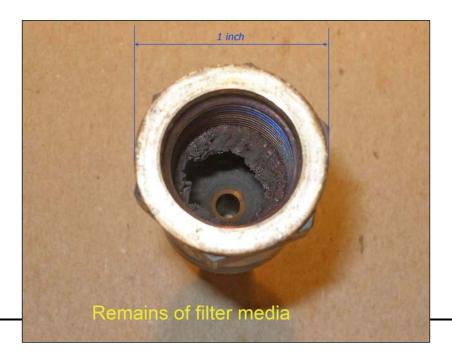
Figure 6. Photograph of the damaged ATSV-air filter housing and remaining filter material.

Investigators longitudinally sectioned the filter housing. The central region of the cylindrical interior surface was found burnished and polished smooth. The damage obliterated most of the original machined surface finish, which only remained in small bands at the upper and lower ends of the section. The damage to the interior of the housing, end cap, and filter mesh was consistent with vibratory motion of the filter mesh and end cap within the housing. The extent of the polishing of the housing was consistent with the downward progression of the end cap to the point of contact with the fitting end.
