**Federal Aviation  
Administration**

## ADVISORY CIRCULAR

43-16A

# AVIATION MAINTENANCE ALERTS

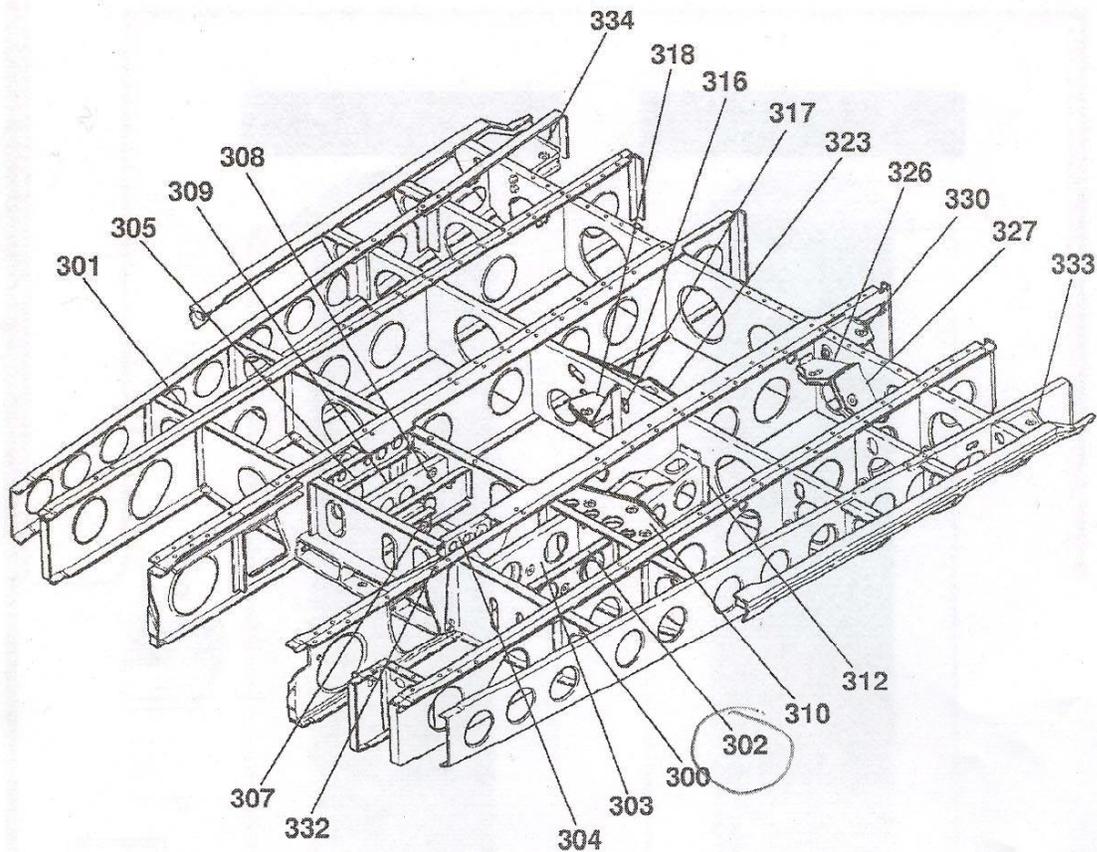
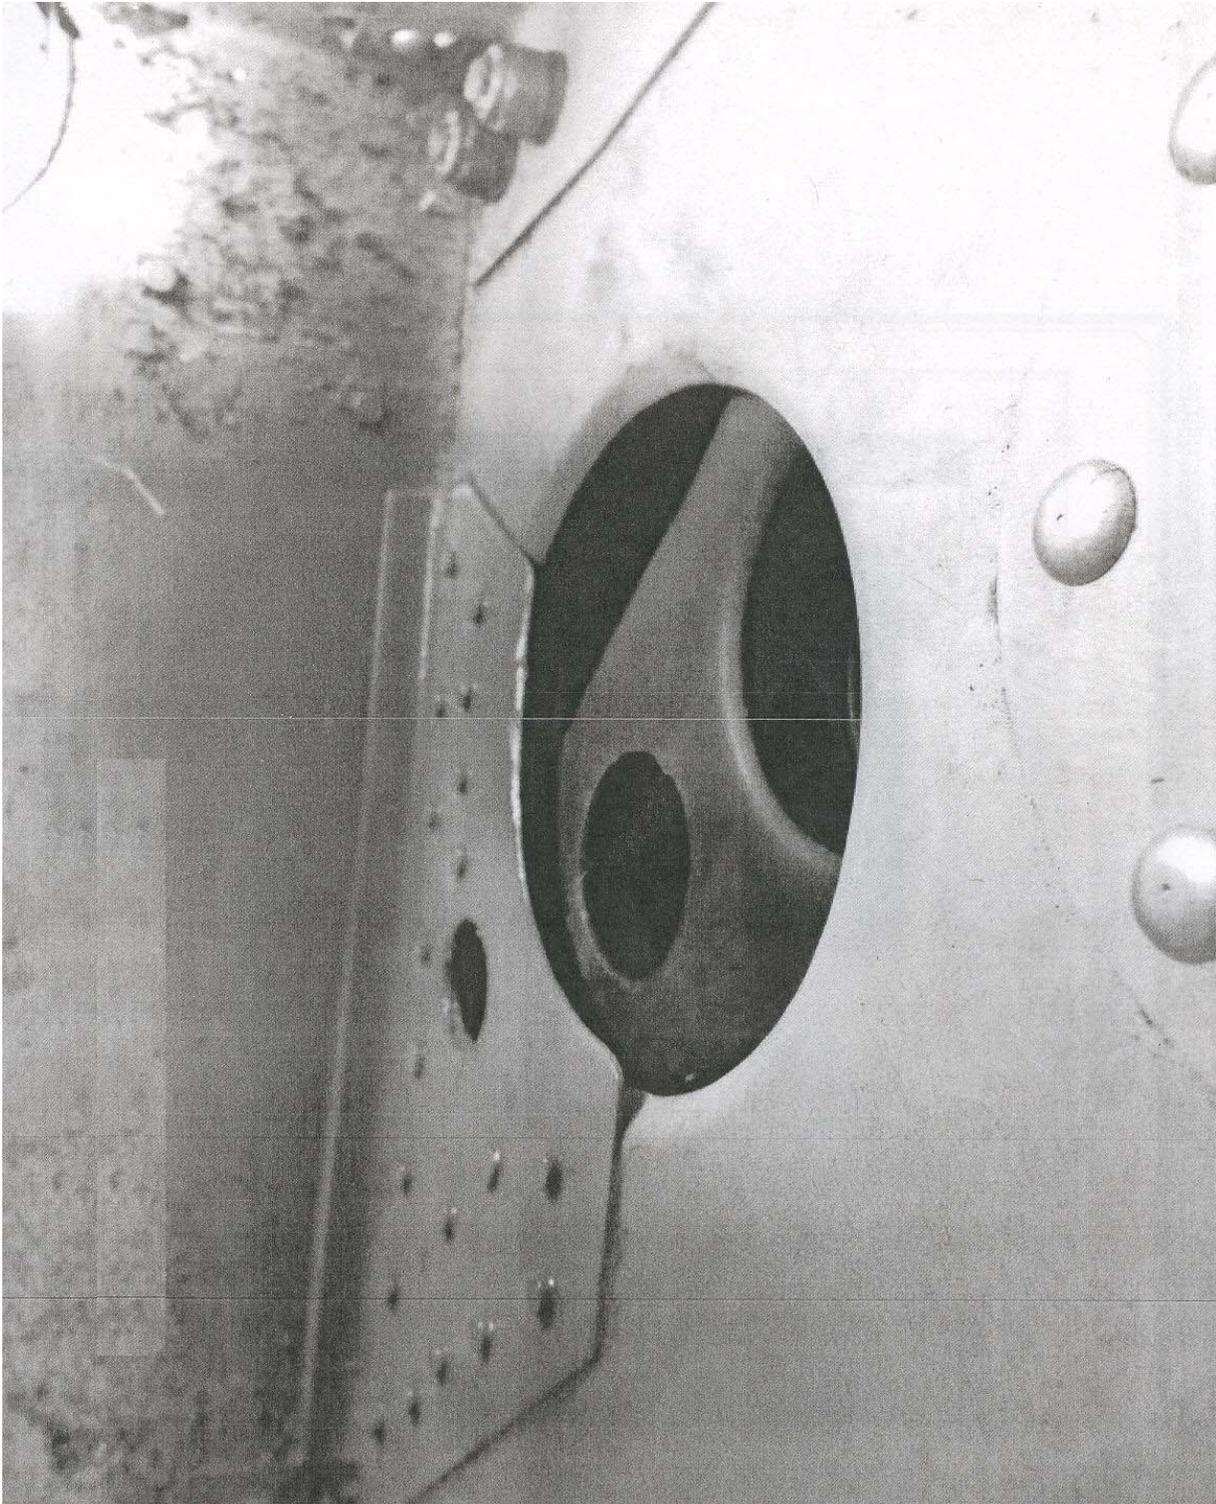
LOWER FORWARD FUSELAGE STRUCTURE  
FIGURE 01 (SHEET 5)

**Cessna: 208B; Cracked Elevator Pulley Support; ATA 5320**

An air operator's submission states, "The left pulley support web below the floor at FS (*fuselage station*) 120.0 and LBL (*butt line*) 10.0 cracked—from the left elevator bell crank mount bolt access hole to the end of the web." (*Pulley Support P/N: 2613083-1.*)

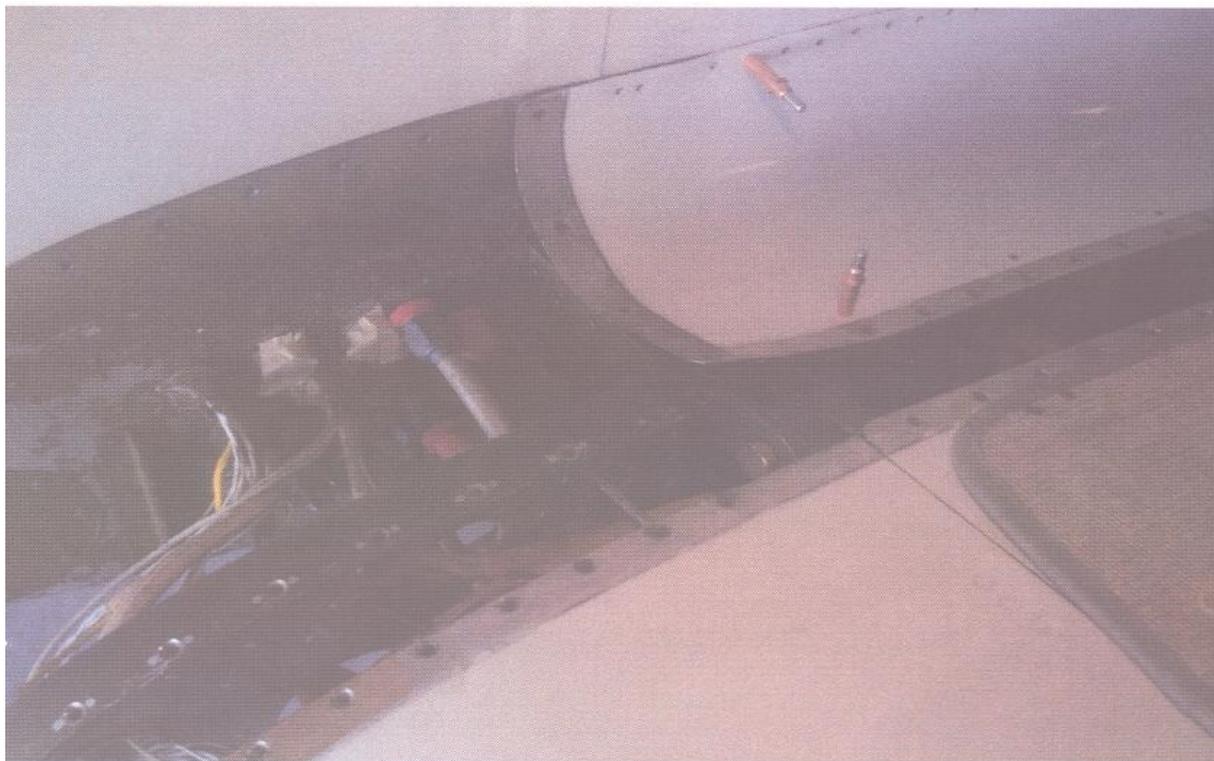
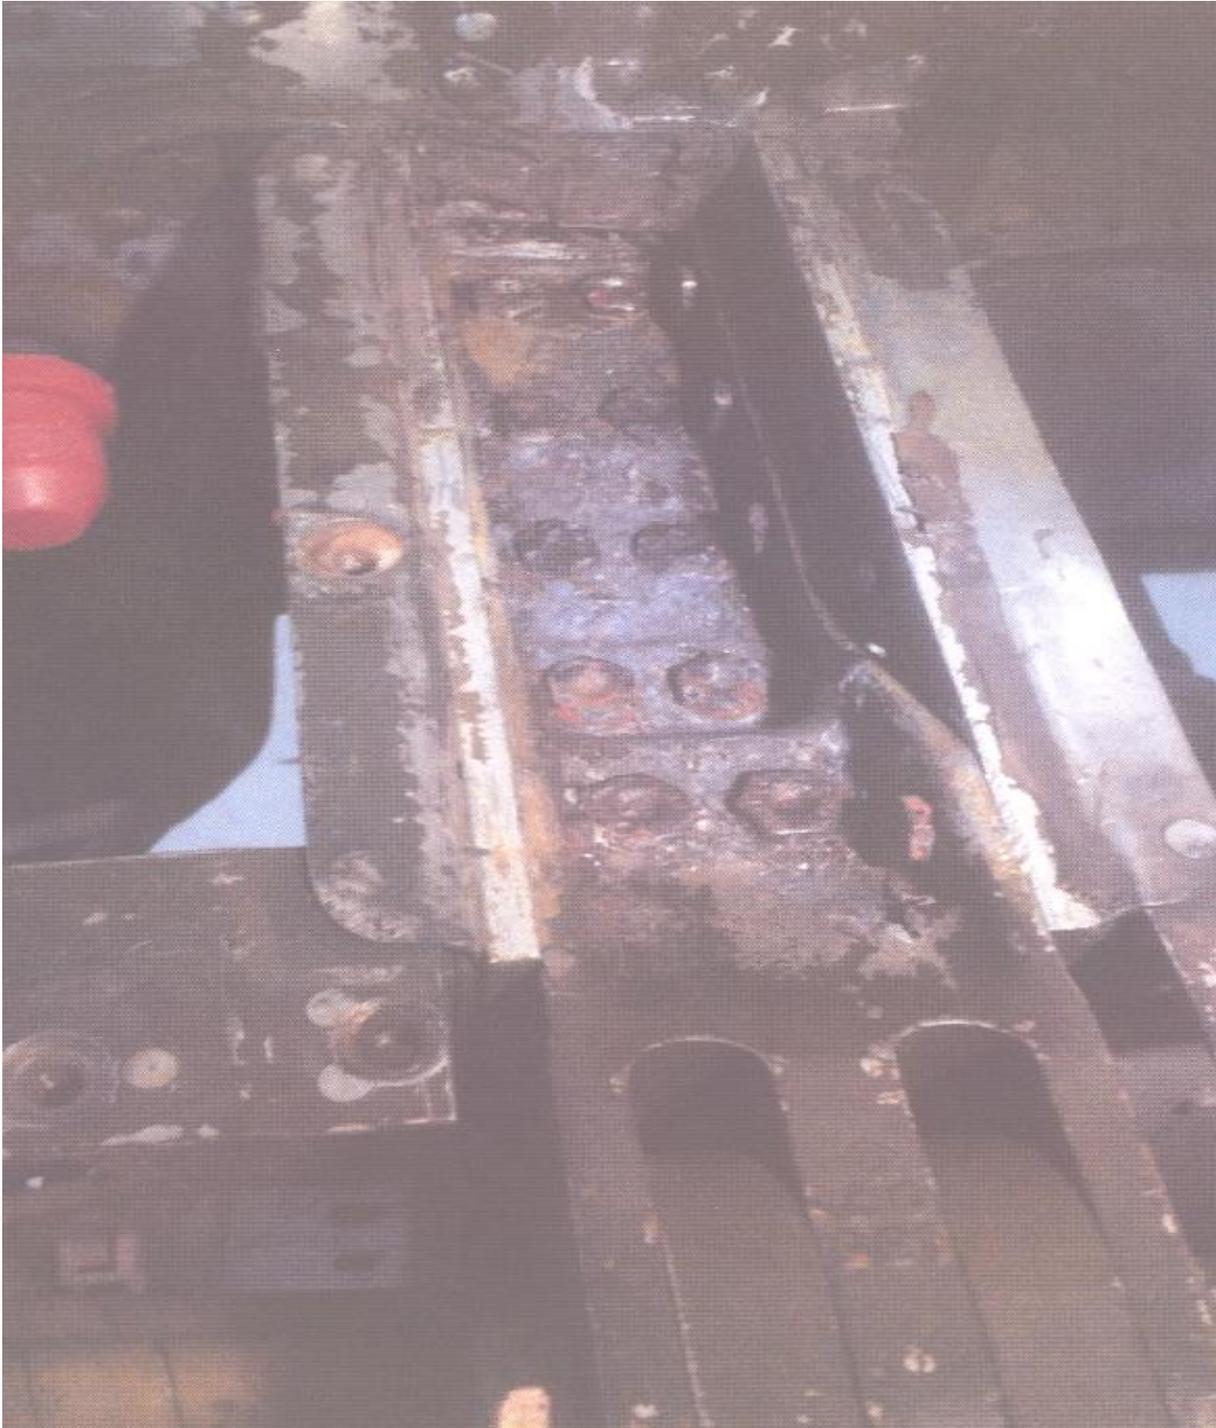
**Cessna: 335; Corroded Wing Attach Fittings; ATA 5741**

A technician for an air charter service says, "During a 100 hour inspection, the forward upper L/H wing attach point (*was found to have*) corrosion on the wing attach fitting (*P/N 08113507*). After removing the upper wing-fuselage fairing, inspection revealed intergranular corrosion on the fitting, and severe rust on the mounting bolt heads. The fitting was replaced due to the severity of the corrosion. Probable cause (*for this corrosion*) is the fuselage-wing fairing not being sealed properly in the area above the fitting. This allowed moisture to pool in the recessed area of the fitting, causing the rust and corrosion. The fuselage-wing fairing is riveted to the fuselage, making (*detailed*) inspection of the upper forward mounts difficult."

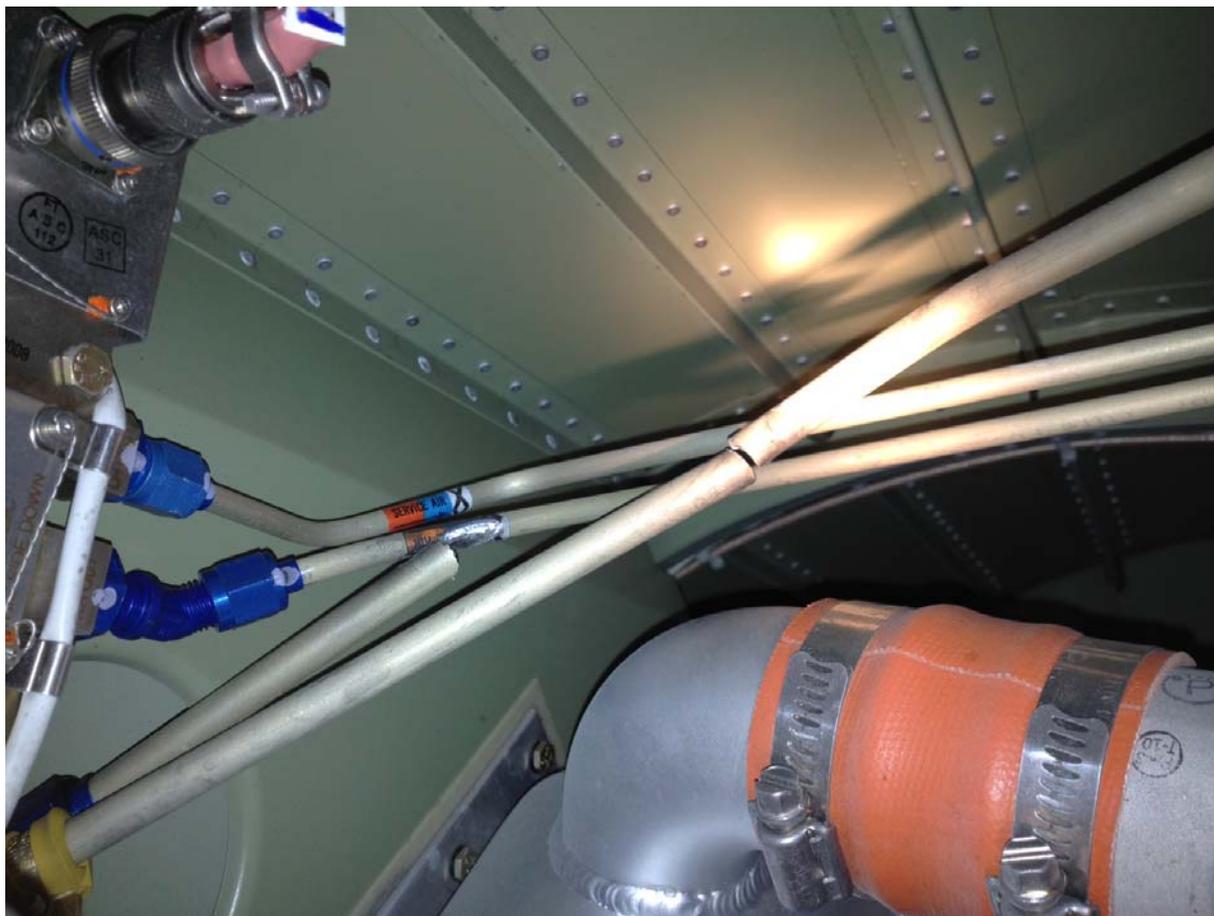
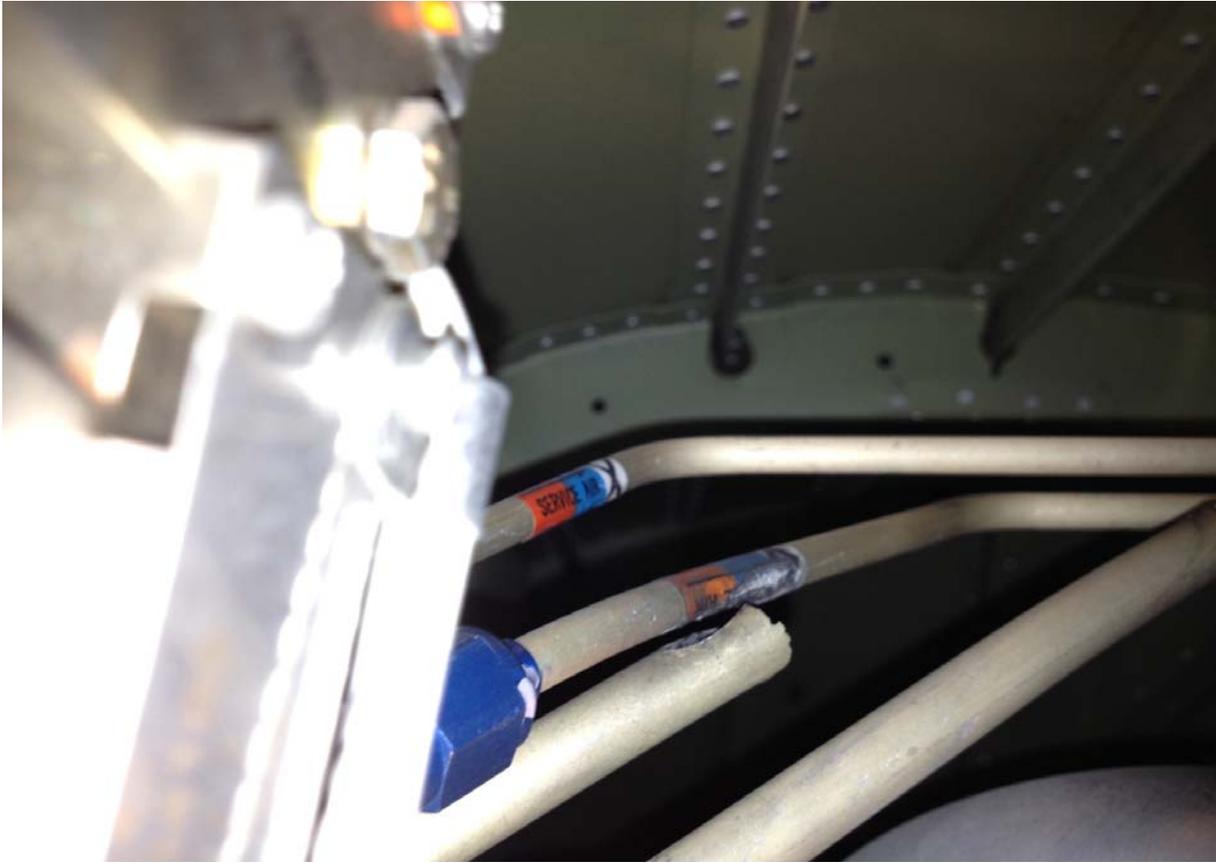
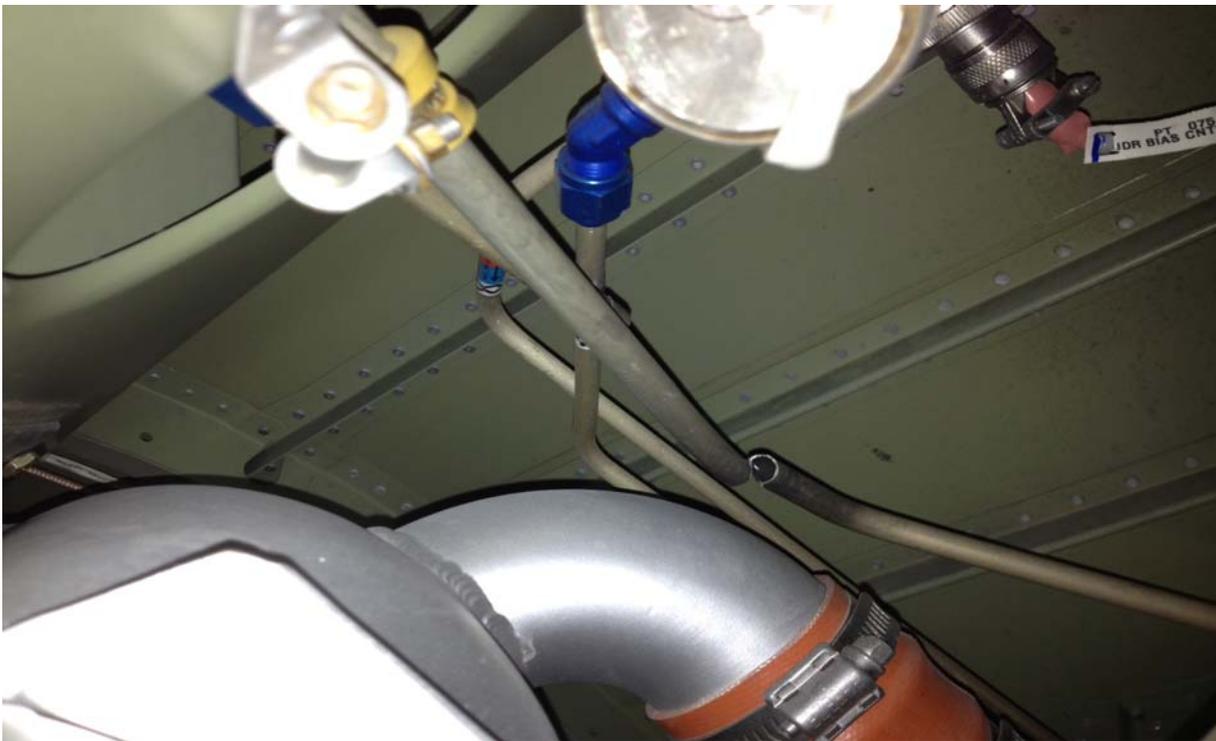
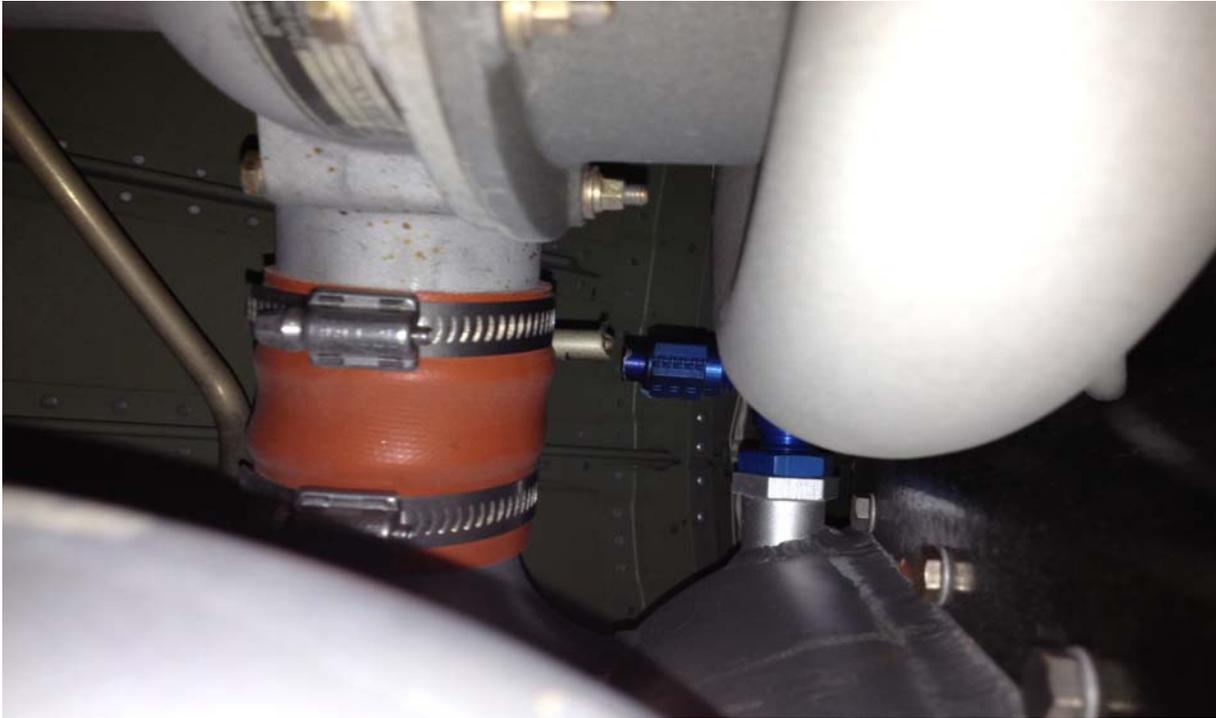
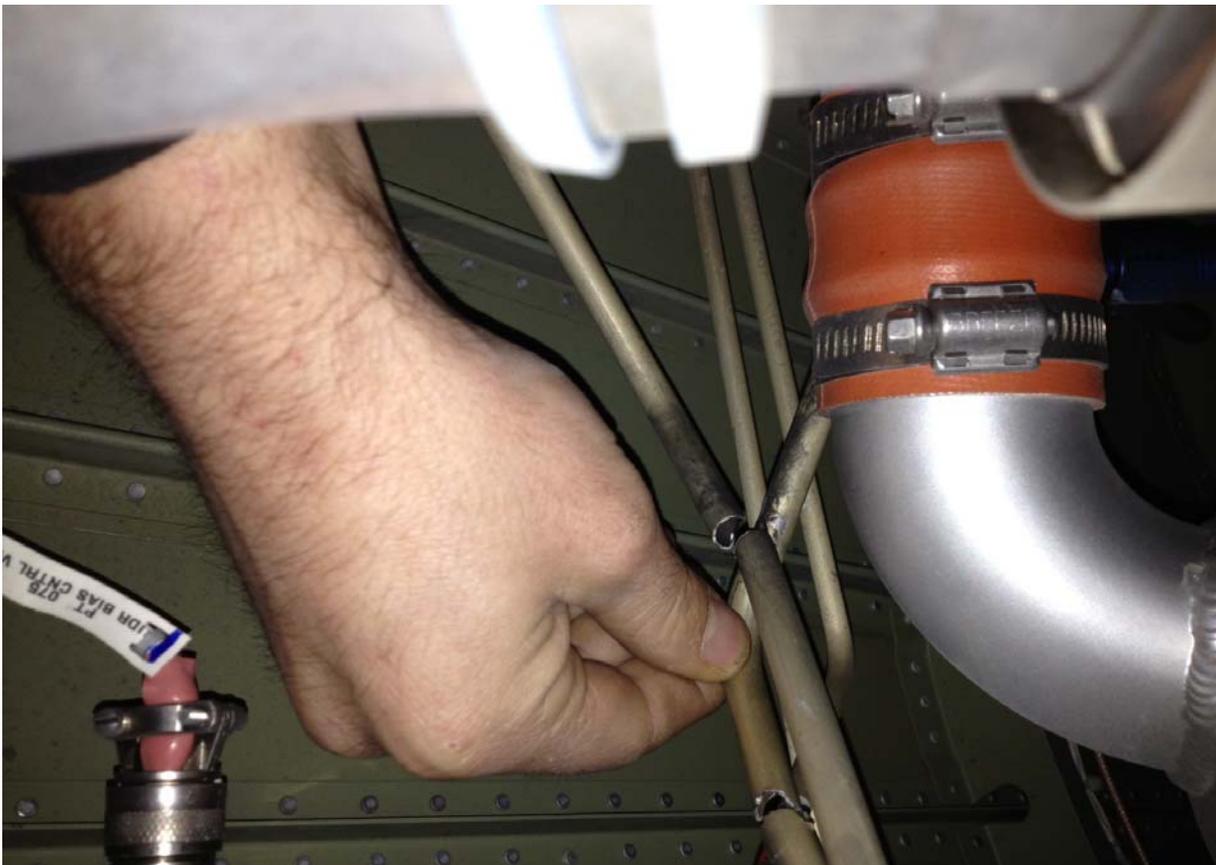
**Cessna: 560XL; Broken ECU Aspirator Tube; ATA 3600**

An unidentified submitter provides this defect report. *"(I) discovered this ECU aspirator high pressure tube...broken on preflight. I also found the bias bleed air tube chafed. This condition appears to be (caused) by poor tube routing, (creating) ongoing chafing over an unknown amount of time." (No part numbers were provided with this report. But a couple of nice photos leave little doubt as to which tube is in reference. The photos are distorted vertically—Ed.)*

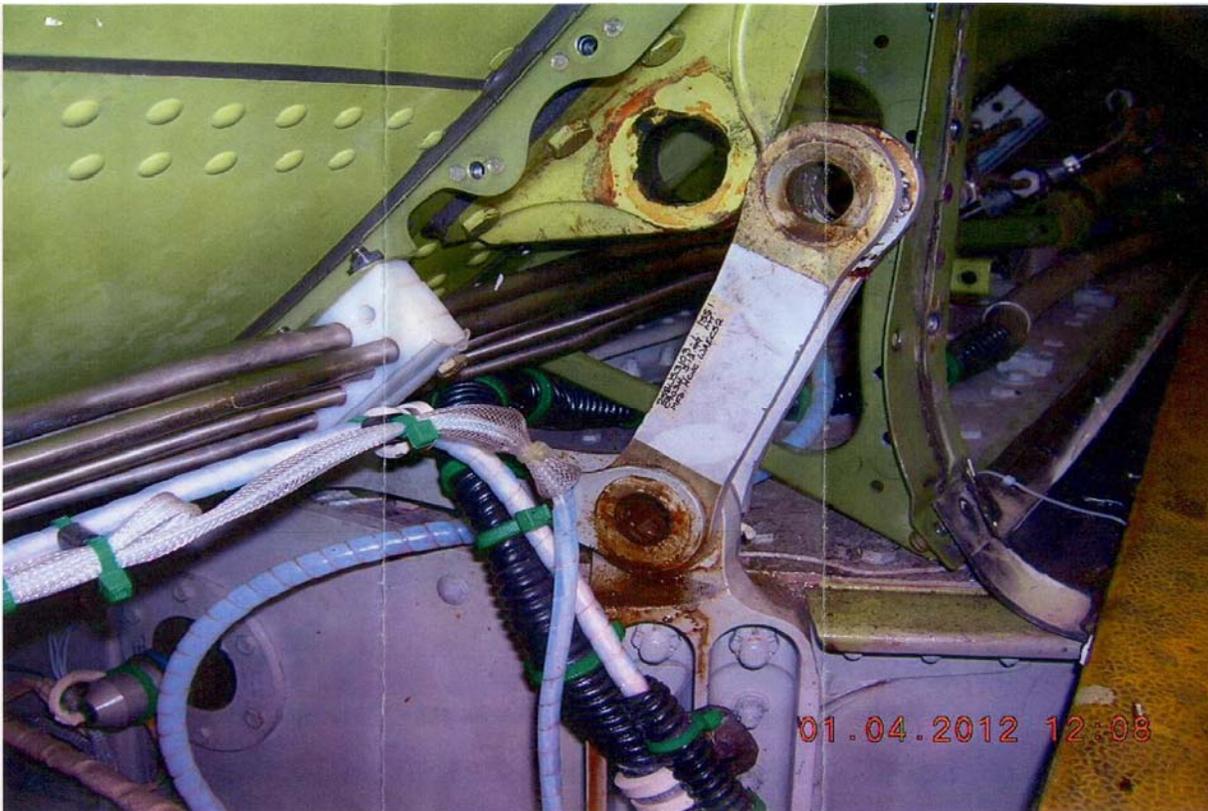
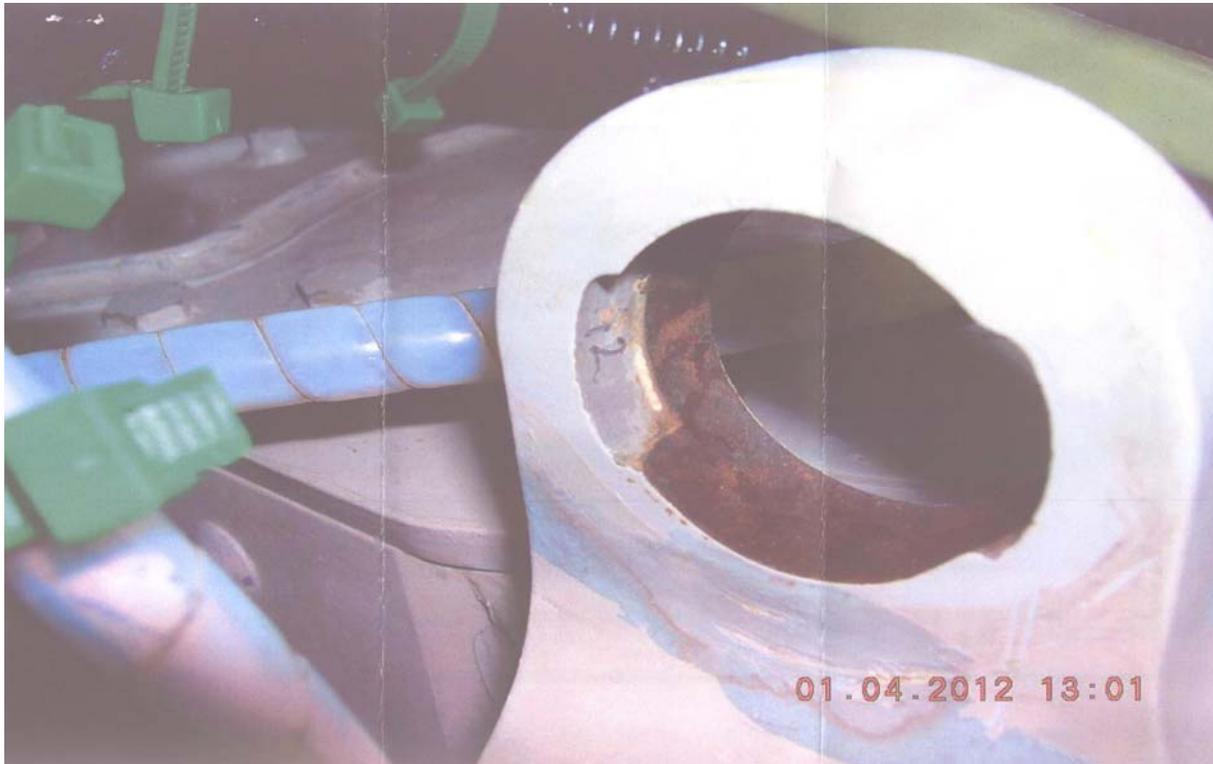
**Hawker: 800XP; Corroded Fuselage Attachment Links; ATA 5741**

A repair station technician says, "Severe corrosion was found in the L/H lower, wing-to-fuselage casting lug during a 12/8 year links/brackets/bolts inspection.

"Probable cause: exposure to constant moisture from improper fuselage-to-wing fairing sealing practices (*produced the corrosion*), and/or constant exposure to TKS anti-icing fluid from improper plumbing practices that may have lead to system leaks (*and then subsequent corrosion*).

"Recommendation: proper sealing methods (*should be employed*) when attaching wing-to-fuselage fairings. And proper plumbing practices (*should be used*) when performing maintenance on wing anti-ice systems. Note: Use of a corrosion preventative compound...at this location may prevent this condition ...with scheduled applications." (*Wing-to-fuselage link/bearing P/N: 25-8WS3103-1. The following photos are distorted vertically—Ed.*)

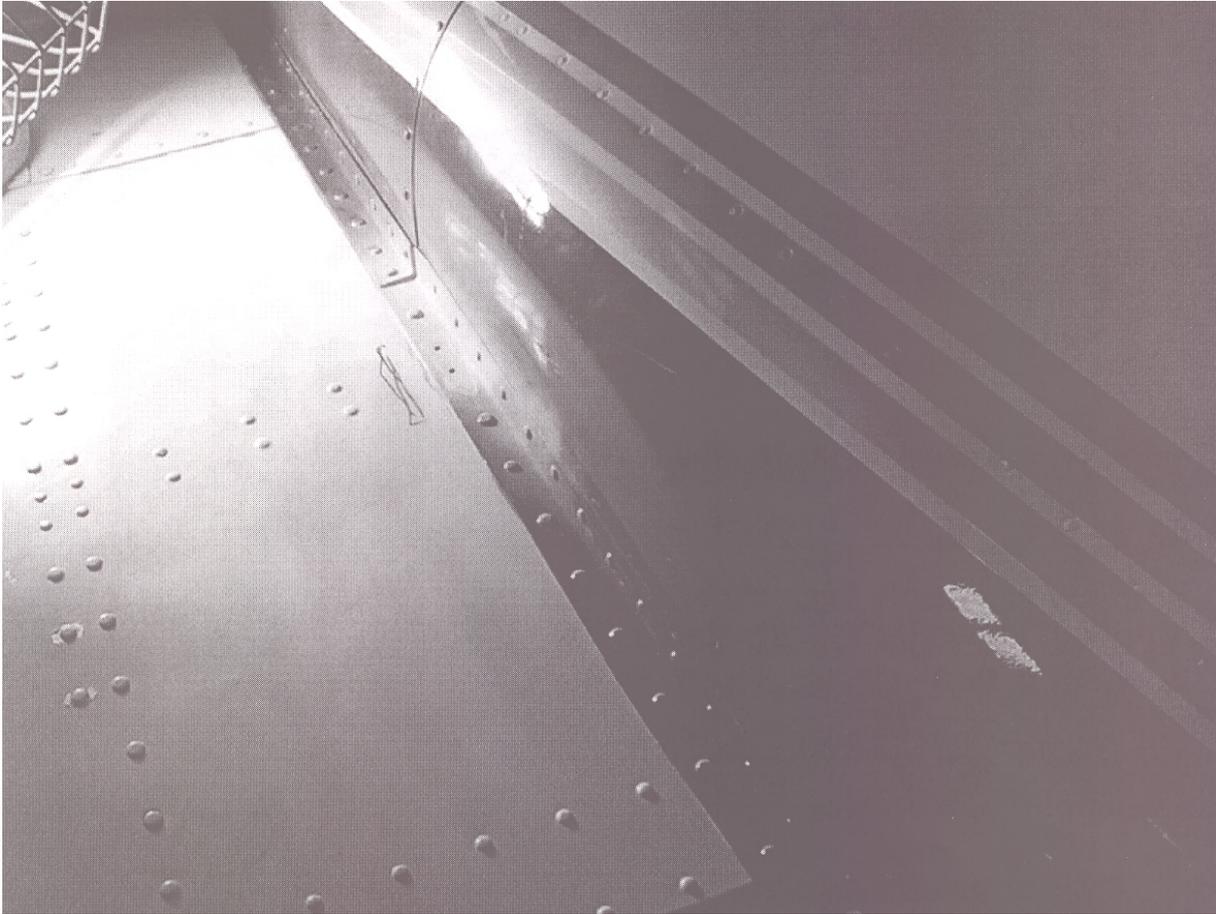
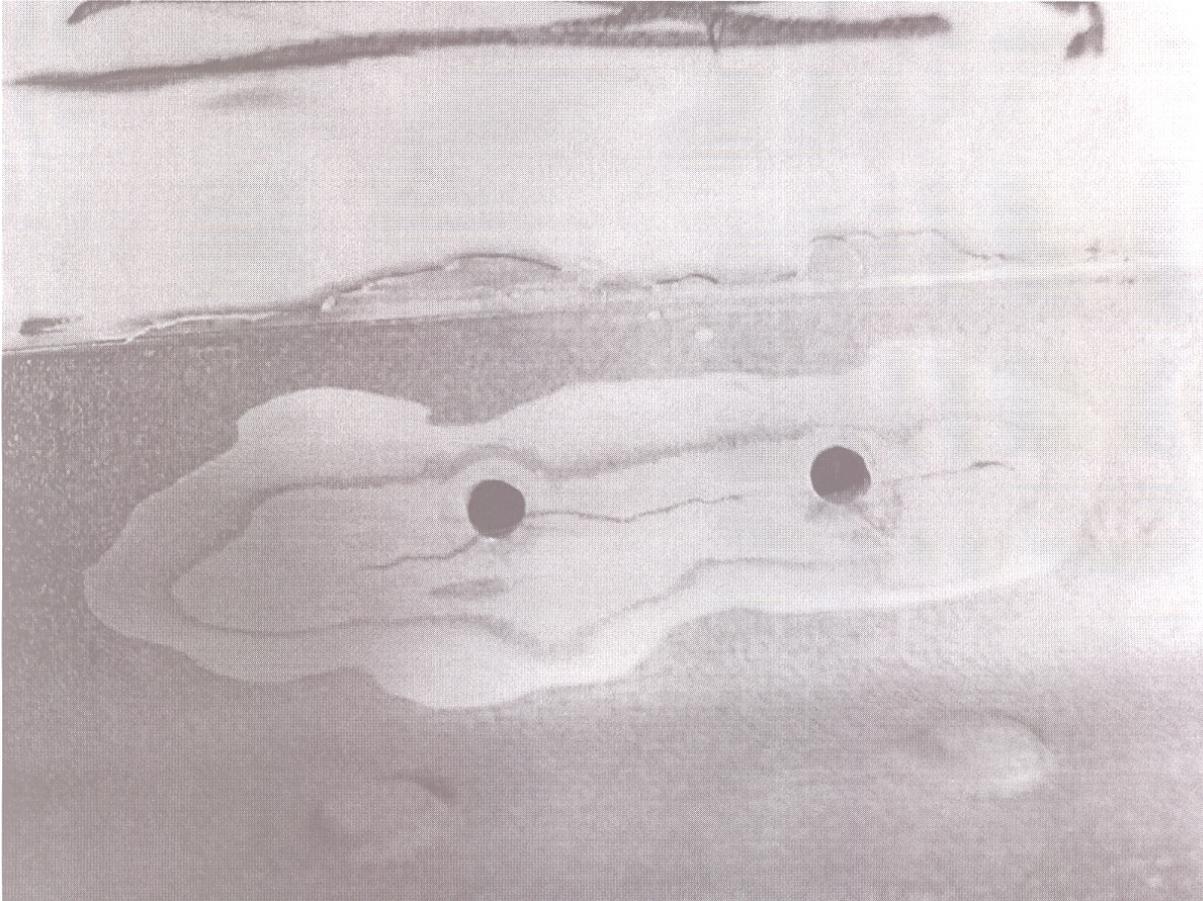
**Piper: PA44-180; Cracked Nacelle Angles; ATA 5413**

"During a scheduled inspection, a crack was found in the nacelle angle," states this mechanic. "Upon further investigation the crack was found to *(run)* between the two rivets that extend through the wing skin into the cap (P/N: 67097-002 or -003) which is attached to a web (P/N 67079-000 or 001). *(This web)* is where the main gear aft attach point is mounted.

"*(I)* suspect this failure is caused by fatigue."

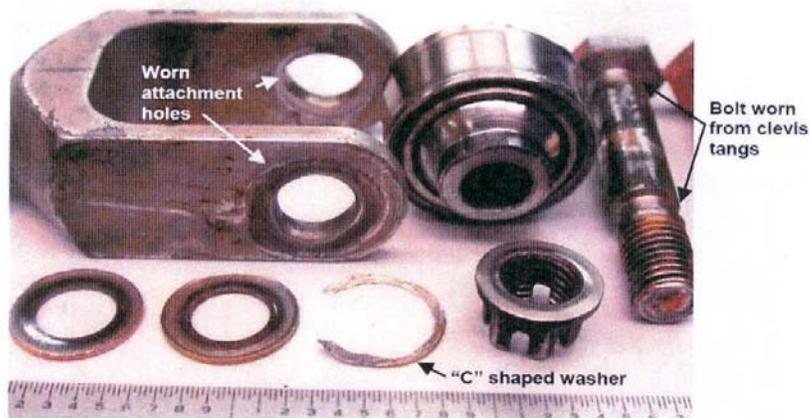
A lower main rotor pitch link clevis, bolt, washers, nut and associated spherical bearing installed on a Bell 206L-3 were returned to Bell Helicopter for investigation. The clevis and bolt were exhibiting excessive wear reportedly after only 14 hours in service. The investigation revealed that the heavy wear was a result of a loss of clamp-up torque due to a nearly completely worn away washer made of aluminium ("C" shaped washer in picture) in lieu of the required steel alloy washer.

The purpose of this Operations Safety Notice (OSN) is to remind owners/operators of the importance of using the specified hardware detailed in various aircraft manuals to avoid similar incidents.

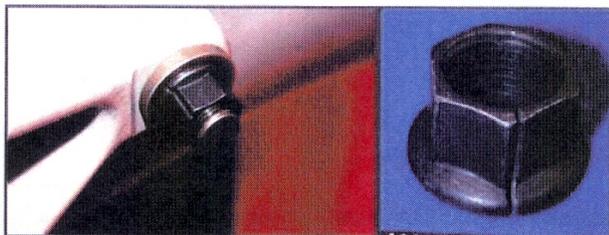
Bell Helicopter recently investigated reports of NAS1291-7/-9/-10 self-locking nuts and NAS626-24 bolts cracking after installation. Investigation has revealed that the nuts had a high concentration of hydrogen and the cracking was the result of hydrogen embrittlement. Root cause of the bolt failure was a result of a quenching crack during manufacture.

**Figure 1:** Typical NAS1291 nut application and crack due to hydrogen embrittlement.

This OSN is released to remind all operators of the importance of inspecting standard hardware for condition and to replace if required. Corrosion, loss of tare torque and cracks are all reasons for replacement.

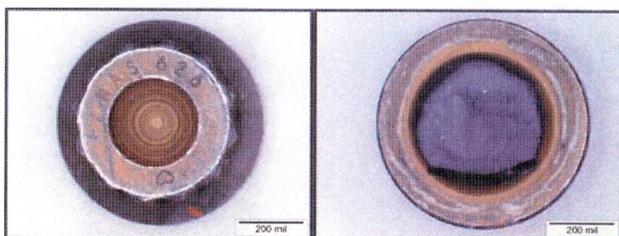
**Figure 2:** Broken NAS626-24 bolt has a result of incorrect quenching operation during manufacture

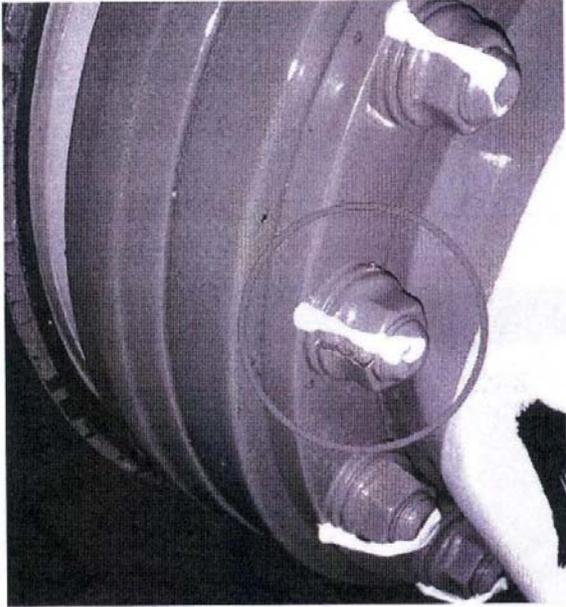
These failures are typical of hydrogen-induced delayed cracking (hydrogen embrittlement), a condition resulting from the presence of hydrogen in the steel (attributed to improper heat treatment at manufacture or following re-plating<sup>iv)</sup>) and a sustained tensile stress. The stress is induced from the moment the nut is torqued and may fail hours, days or weeks later, with one or more cracks appearing approximately in-line with the longitudinal axis of the nut, frequently splitting the nut wide open but staying in place, as if it were serviceable.

When the nut has failed in this way, it no longer functions as designed and it releases all the tension on the stud or bolt. This failure may have serious secondary effects. The bolt to which it was attached may fall out and/or as with the R22/44 main rotor blade cuffs, higher loads are now immediately transferred to the remaining fasteners, which may result in over-loading and subsequent failure of the bolts or studs some time after the nuts have been replaced.

Figure 1 - Example of a failed nut (Courtesy ATSB)

- (a) pilots and maintenance personnel closely monitor the occurrence of hydrogen-induced delayed cracking in high-strength steel standard aircraft hardware, such as nuts via close inspection following installation and thereafter at Daily / Preflight and periodic inspections.

- (b) Before simply replacing cracked/failed nuts with new items, consider contacting the manufacturer for advice regarding replacement of associated fasteners which may have suffered over-loading as a result of the failure of one or more nuts.
- (c) Report all MS 21042 and NAS 1291 series nut failures to CASA via the SDR system.

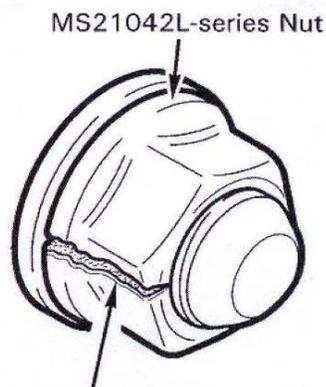
**BACKGROUND:** RHC has received two reports of cracked MS21042L4 self-locking nuts. Other helicopter manufacturers have received similar reports. A possible cause for cracking nuts is hydrogen embrittlement, which can be introduced during hardware manufacturing. Manufacturing processes for government- and industry-standard hardware are not controlled by RHC.

Any crack, if present, would be parallel with nut axis.

Pilots and maintenance personnel are reminded that hardware condition is equally important as hardware security. Cracked or corroded nuts require replacement.

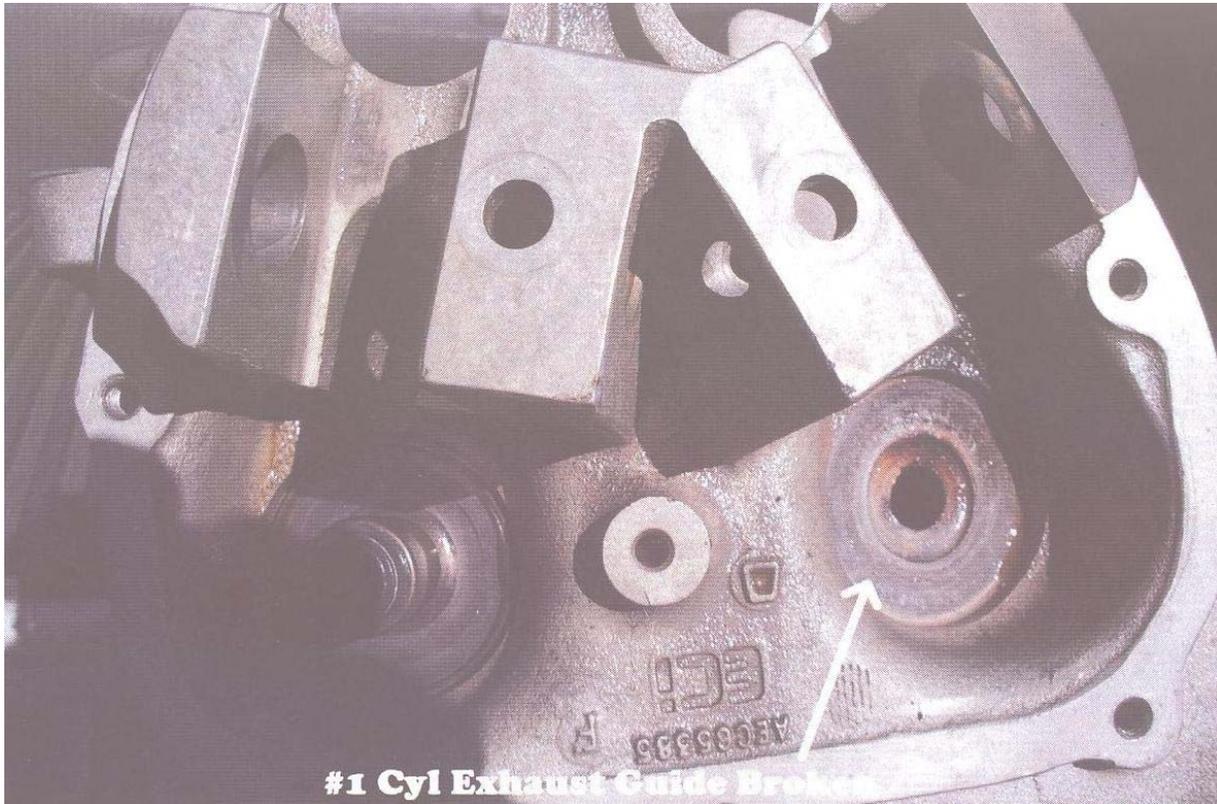
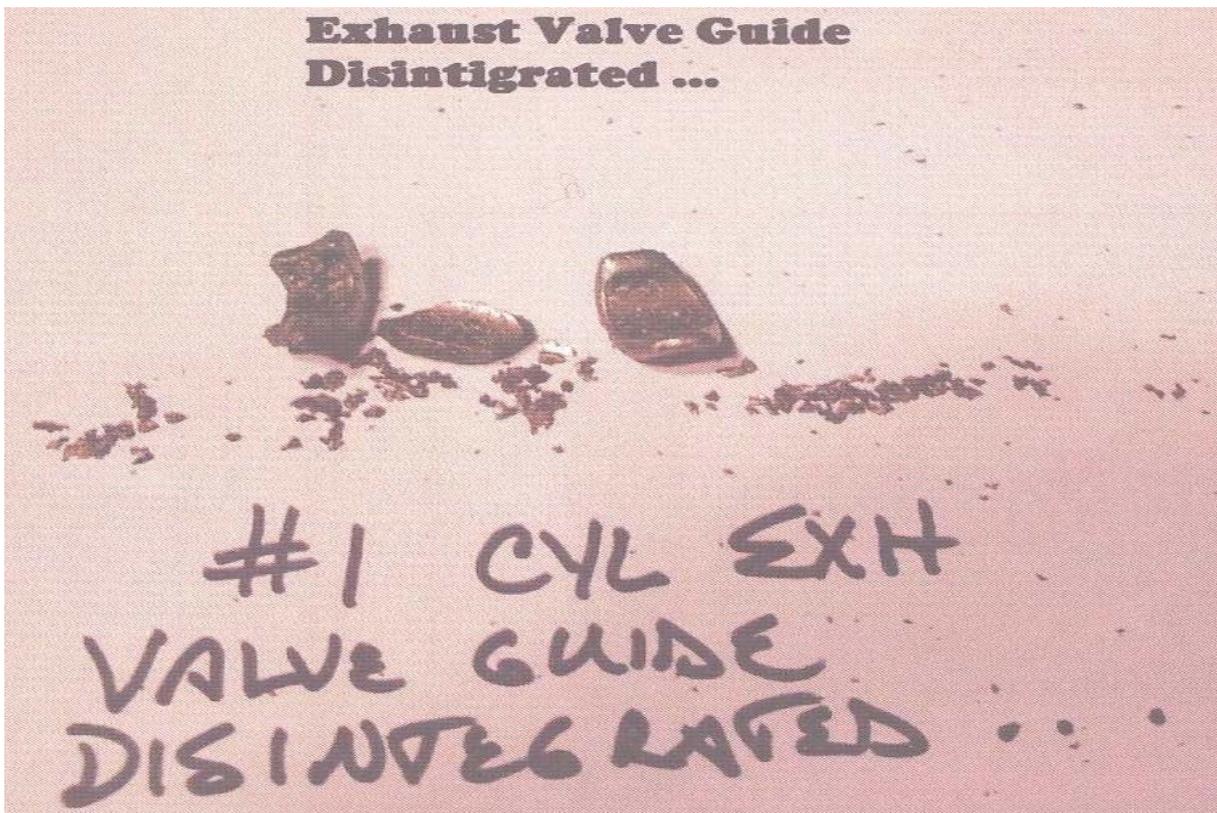
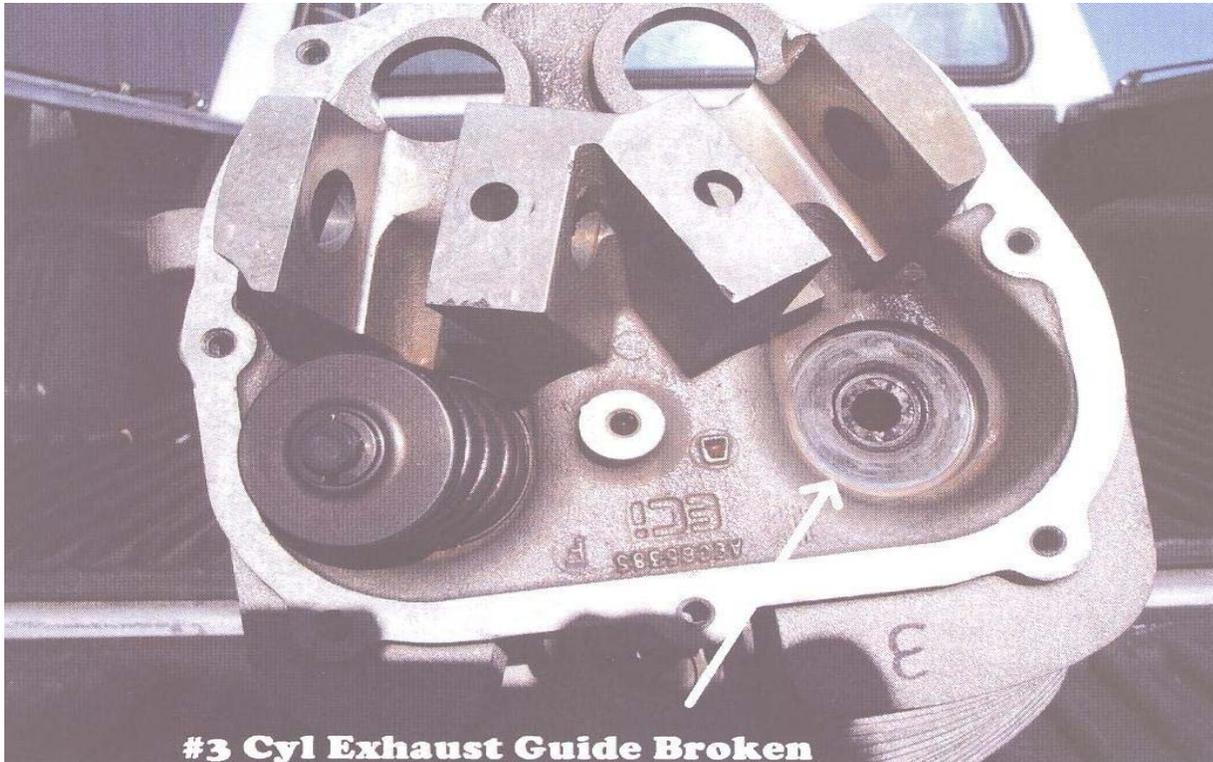
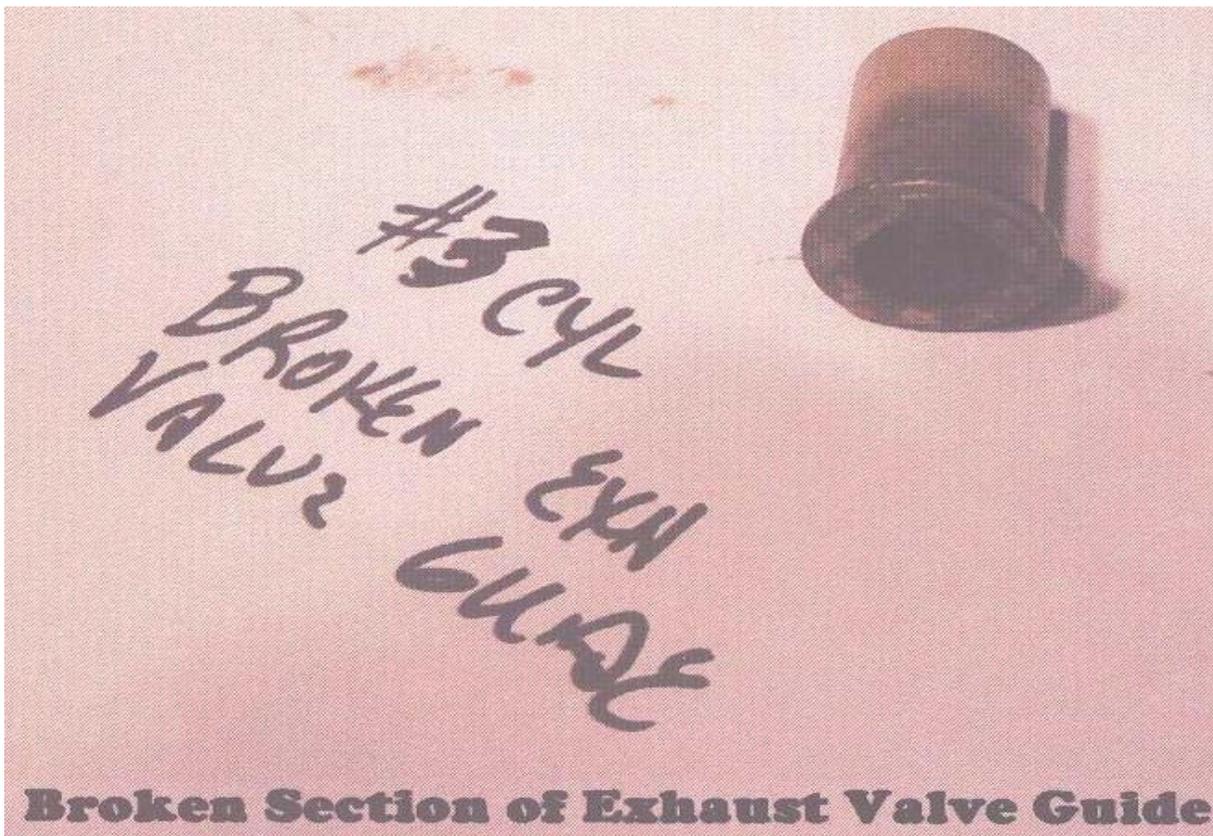
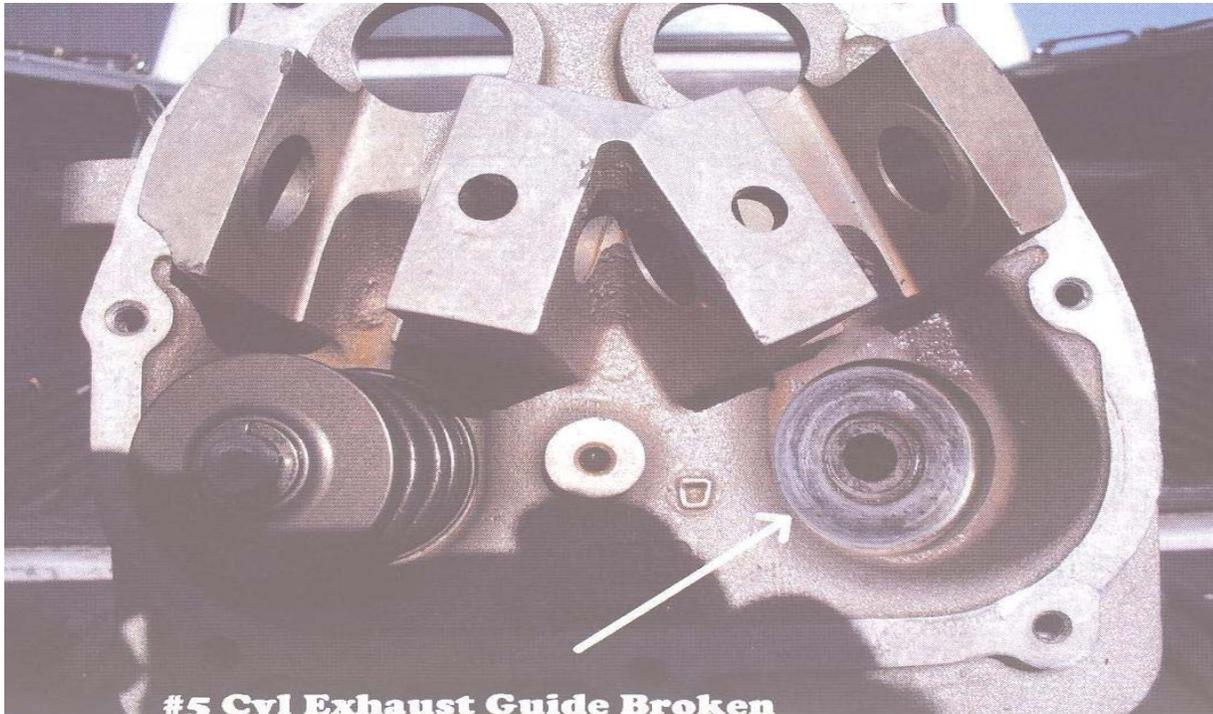
### **ECI Cylinders: TISN712BCA; Failed Valve Guides; ATA 8530**

This general aviation report states, "Six new Engine Components, Inc. (ECI) cylinders were installed...at 2,812 hours total time. The ECI cylinders experienced a failure of the valve guides on three of the six cylinders at 384 hours time in service. All three failed valve guides broke off at the insert point (see photos), and one completely disintegrated—contaminating the engine with metal debris. This (*debris*) caused chafing on at least two valve lifter assemblies, and damage to the camshaft. The engine will require a complete tear down because of the metal contamination and damage.

"The only initial, abnormal indication noted from the broken exhaust valve guides was excessive engine oil blowing through the engine crankcase breather. This was noted by a significant amount of oil on the belly of the aircraft. The engine operated normally with no apparent power loss or abnormal indications of EGT, TIT, or oil pressure/temperature. Eventually turbine operation became erratic, caused by momentary blockage within the turbine waste-gate controller. This condition was intermittent. Flaws were found by visual inspection after low compression was found on two of the effected cylinders...."
