**Federal Aviation  
Administration**

## ADVISORY CIRCULAR

43-16A

# AVIATION MAINTENANCE ALERTS

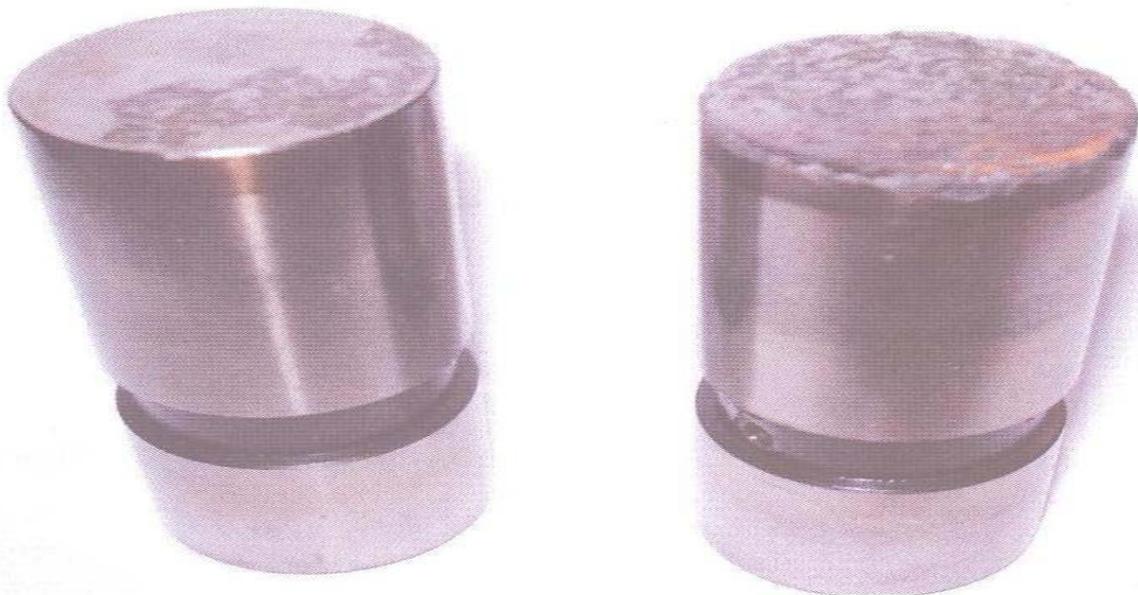
**Damage to Valve Lifters  
Due to metal contamination  
(Camshaft Damage also)**

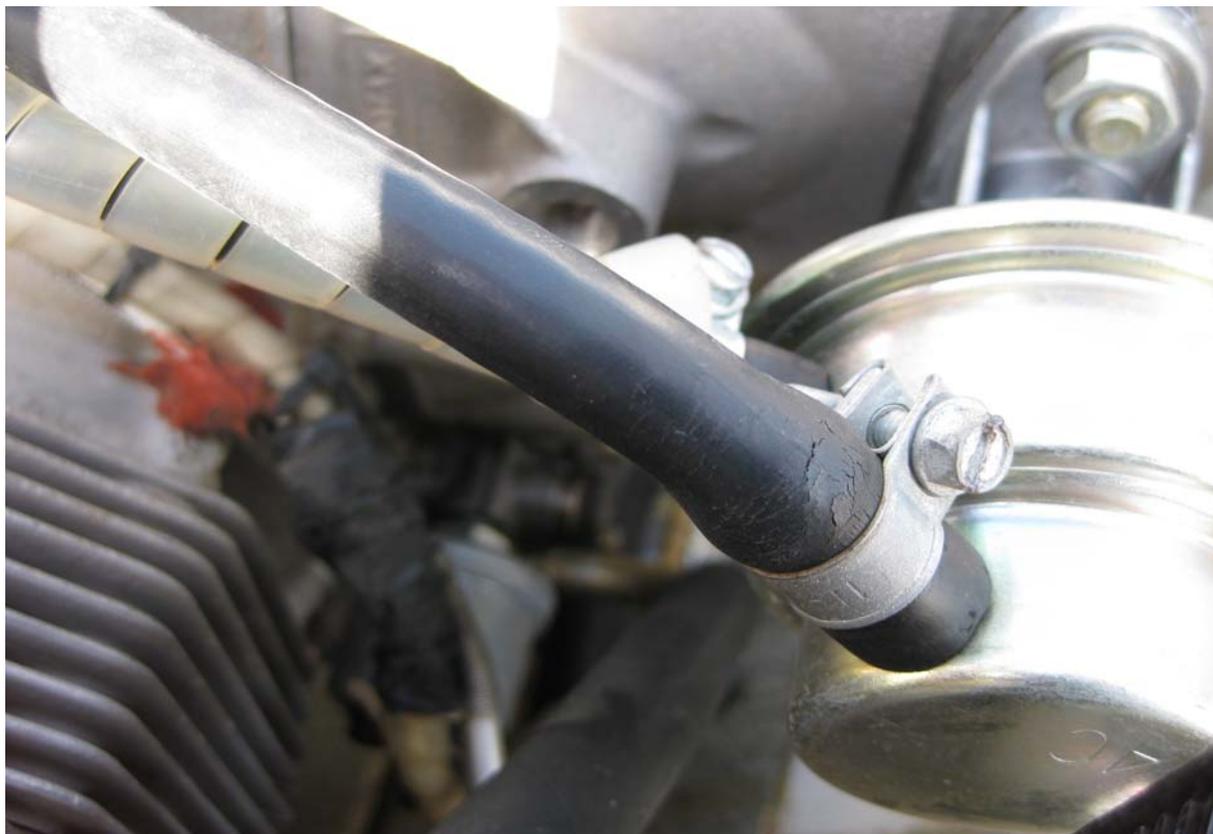
**Rotax: 912ULS; Cracked Fuel Hose; ATA 2820**

"The engine surged like it was starved for fuel, and then quit," says this submitter. "The engine was restarted in flight, but with the same result. This aircraft was manufactured without fire sleeves on any of the fuel hoses in the engine compartment. The Rotax 912 installation manual cautions to prevent vapor lock, all fuel lines on the suction side of the fuel pump have to be insulated from fire and heat. These fuel hoses (*P/N FUB386*) were over four years old and were becoming stiff and cracked."
