Environmental Exposure Report

Depleted Uranium in the Gulf

1998190-0000-036

Last Update: July 31, 1998

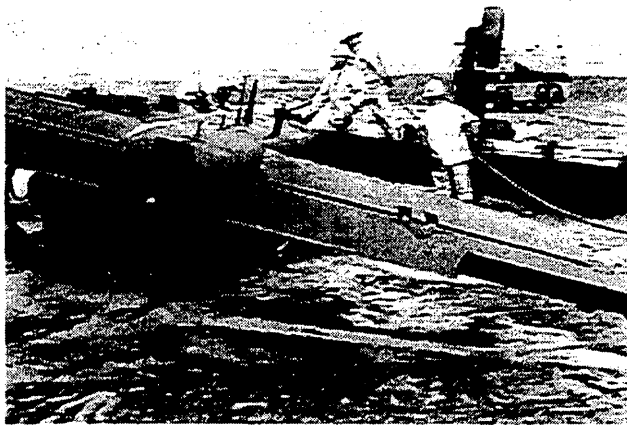
Figure 23 – Crashed A-10 at KKMC

An A-10 aircraft reportedly crashed and burned while trying to recover at KKMC.¹³⁸ The crash could have exposed emergency response personnel (firefighters; security policemen, rescue personnel) to smoke and DU oxides from burning 30mm DU rounds carried as part of the A-10's combat ammunition load. In addition, cleanup crews might have been exposed as well, if they did not wear proper personal protective equipment. This case is under investigation.

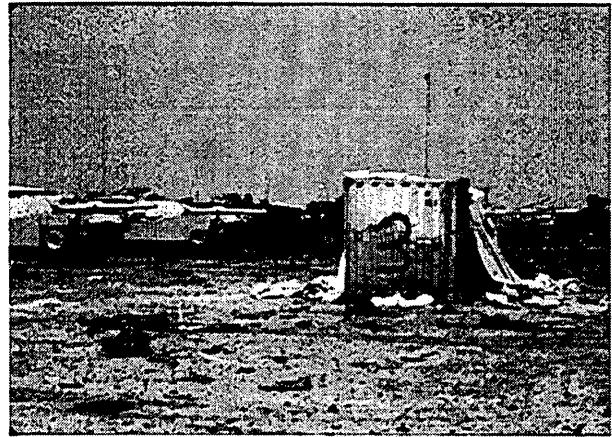
Figure 34 - Surviving Munitions Conex

Post-blast photos show many intact conexes among the burned-out wreckage (figure 34). The commander of the 146th Ordnance Detachment (EOD) stated that stored ammunition is more stable than is generally believed, and is fairly survivable except when directly exposed to fires, extreme heat, or explosions. Even in the conexes that blew up, typically only a few shells would detonate, scattering the other rounds rather than touching off a massive "sympathetic" detonation. This explains the huge quantity of unexploded ordnance (UXOs) littering the motor pool area.²²³ Large numbers of the lightweight FASCAM submunitions had been flung into the South Compound, but the heavier rounds, such as TOW anti-tank missiles (and all of the DU penetrators, evidently) remained in the North Compound.

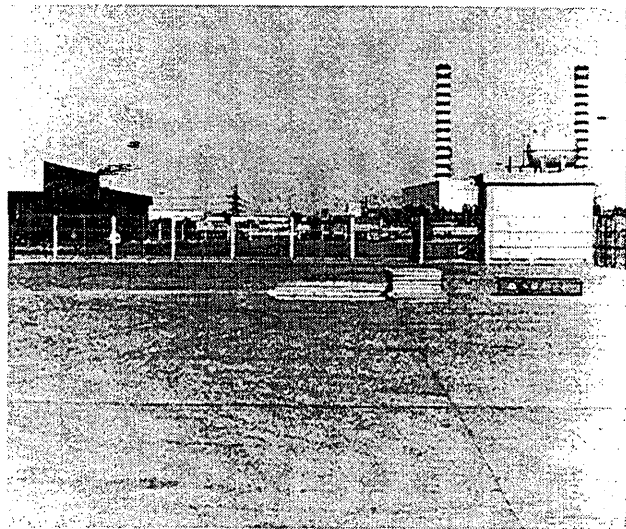
Figure 43 - Doha motor pool pad after cleanup

The ECC team brought their own radiation detection and measurement equipment and performed survey activities in the North Compound. Upon entering the 2nd Squadron motor pool, they found large quantities of DU scattered around the vicinity of the MILVAN containers (used for ammo storage) that had detonated in the fire. Many of these DU penetrators were intact, but others had fragmented or burned down to varying degrees, with some almost completely reduced. Some had been ejected into the open by the "kick-out" effect of individual rounds exploding among the stacked ammunition. Others, burned or unexploded, remained within the shells of the conexes. Using an AN/PDR-56 fitted with the small alpha probe, the SFC measured the DU cores and, after they were picked up, monitored the surface underneath them. Most of
