**AIRCRAFT
ACCIDENT INVESTIGATION BOARD
REPORT**

**US ARMY UH-60
BLACK HAWK HELICOPTERS
87-26000 AND 88-26060**

TECHNICAL REPORT F-15 MAINTENANCE

Aircraft Evaluated: F-15C, Tail Number 79-0025

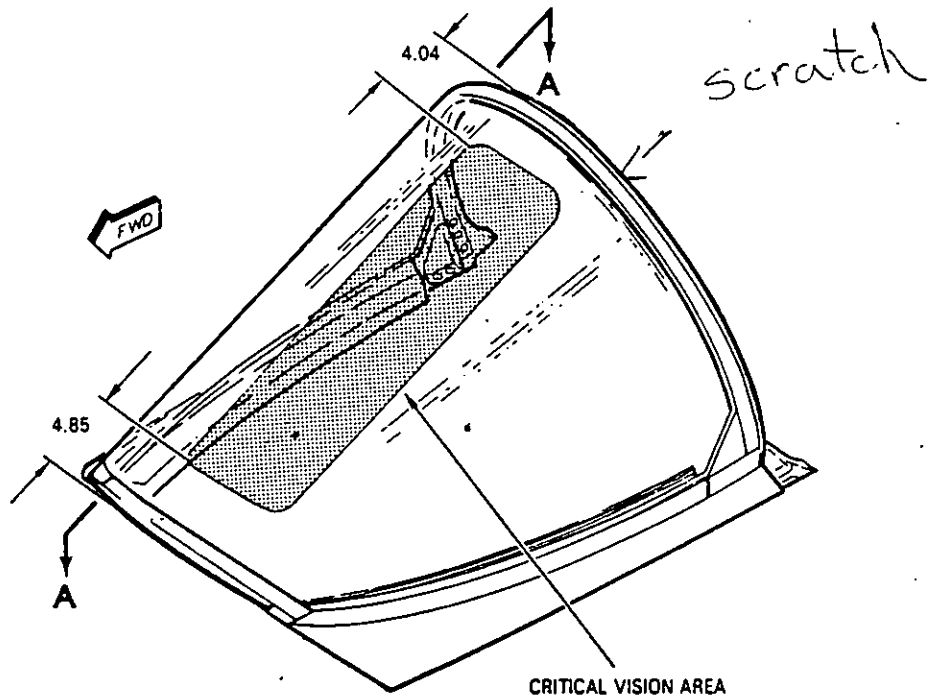
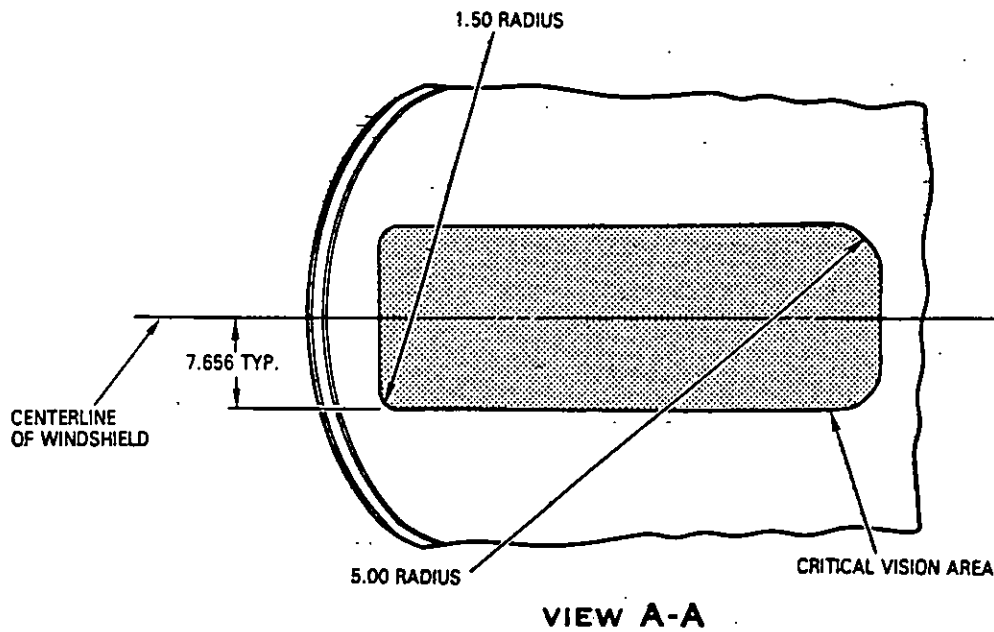
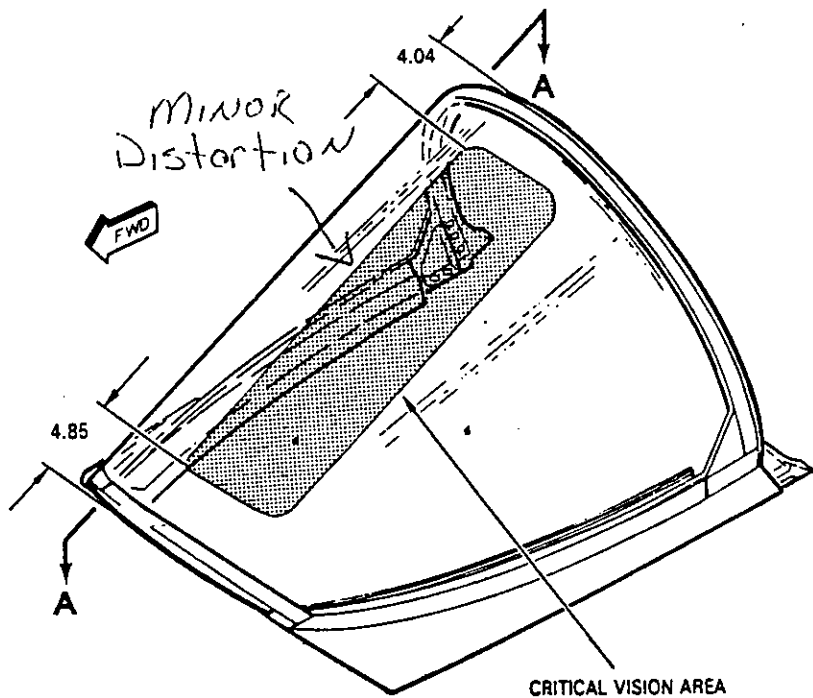
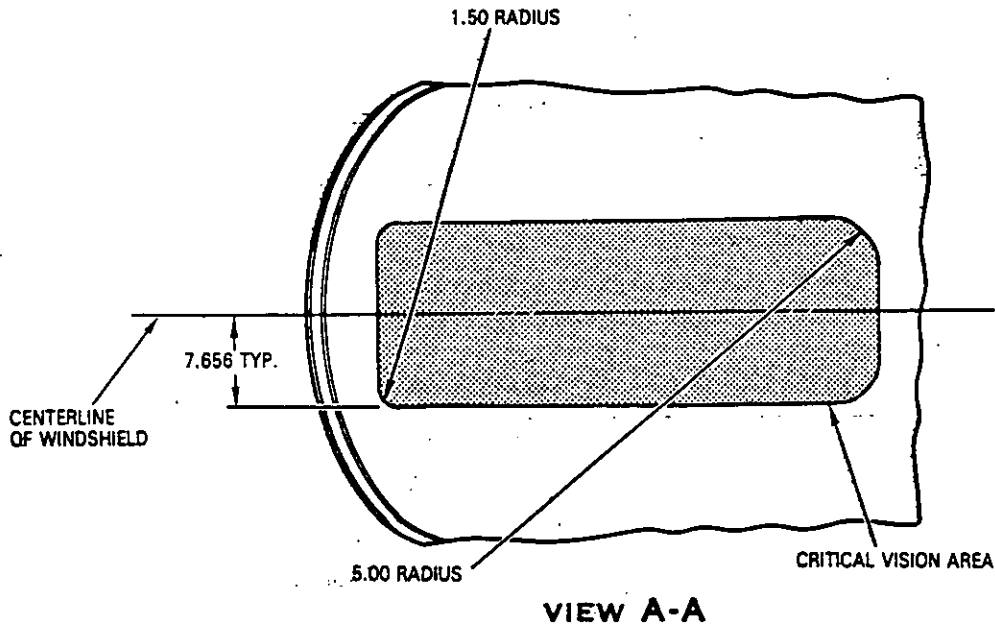
On my evaluation of A/C 9025 I found a scratch approximately 4 inches long at the 11 o'clock position on the windshield, near the windshield arch (Atch 3). Through visual inspection I found no distortion, and therefore there is no visual distortions. I then inspected the canopy, I found a few scratches that look like they may have come from a pilots helmet, but determined that they would be out of the pilots view area, and there was not any distortion.

Overall I found that both A/C's canopy's and windshield's were in very good condition. The canopy and windscreen are within limits IAW T.O. 1F-15C-3-4 on both aircraft.

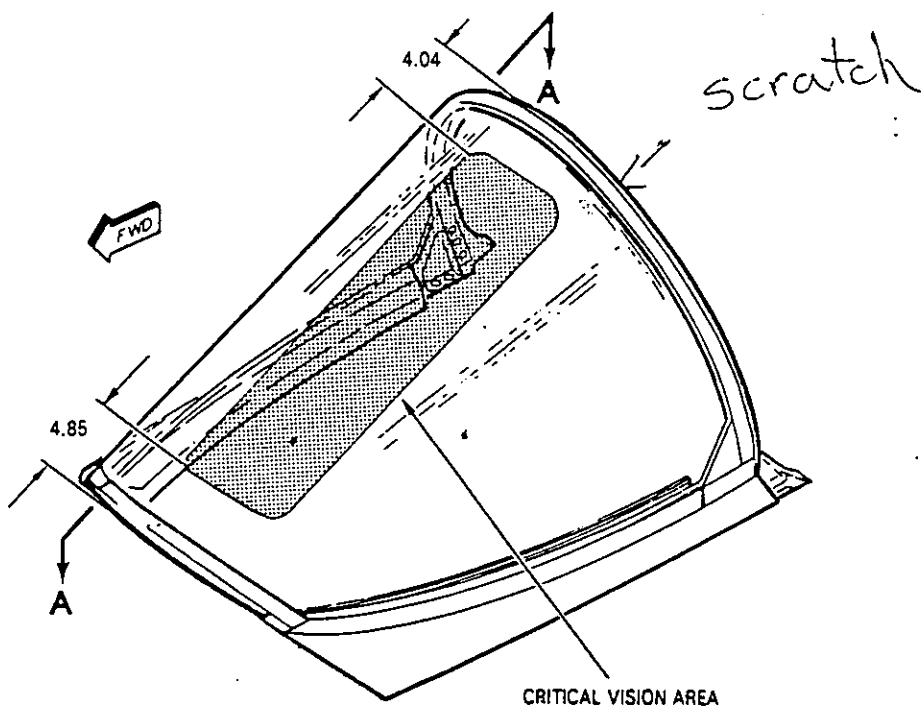
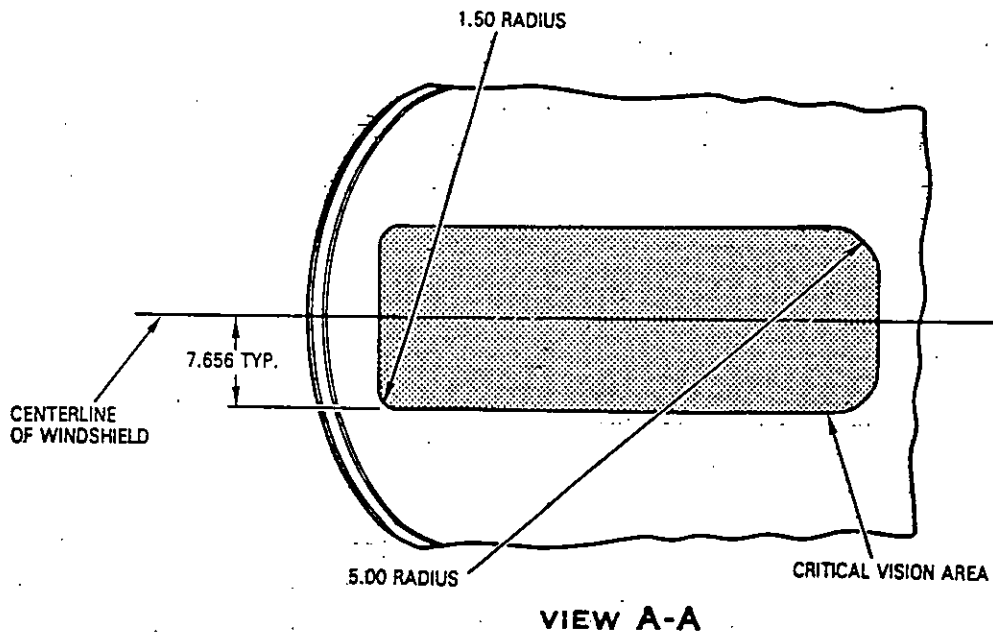
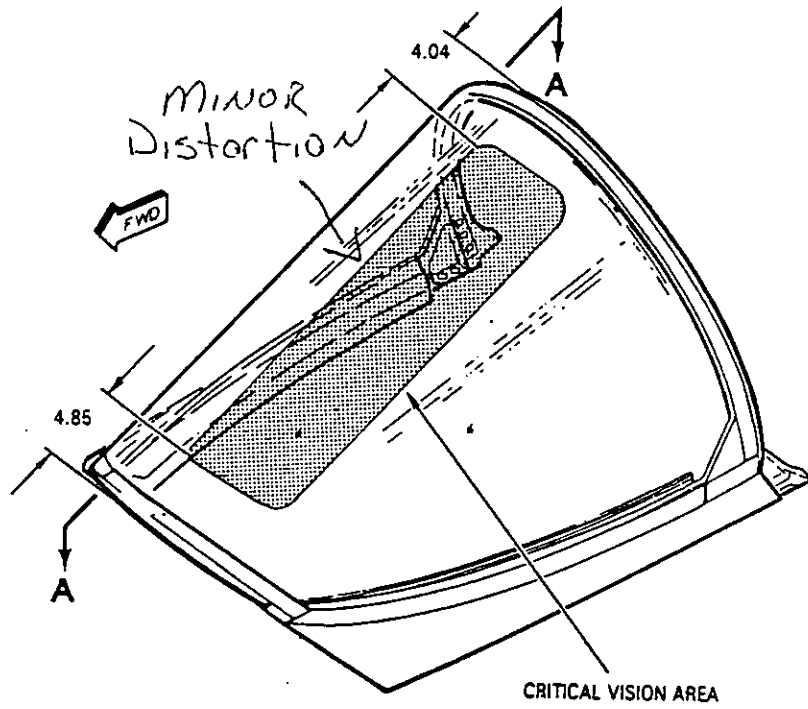
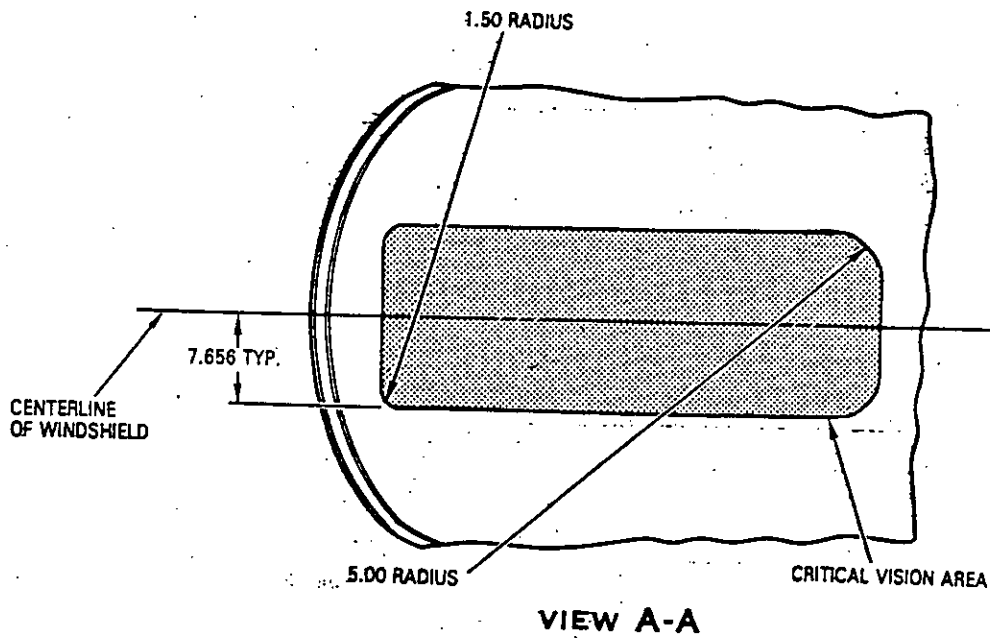
On my evaluation of A/C 9025 I found a scratch approximately 4 inches long at the 11 o'clock position on the windshield, near the windshield arch (Atch 3). Through visual inspection I found no distortion, and therefore there is no visual distortions. I then inspected the canopy, I found a few scratches that look like they may have come from a pilots helmet, but determined that they would be out of the pilots view area, and there was not any distortion.

Overall I found that both A/C's canopy's and windshield's were in very good condition. The canopy and windscreen are within limits IAW T.O. 1F-15C-3-4 on both aircraft.

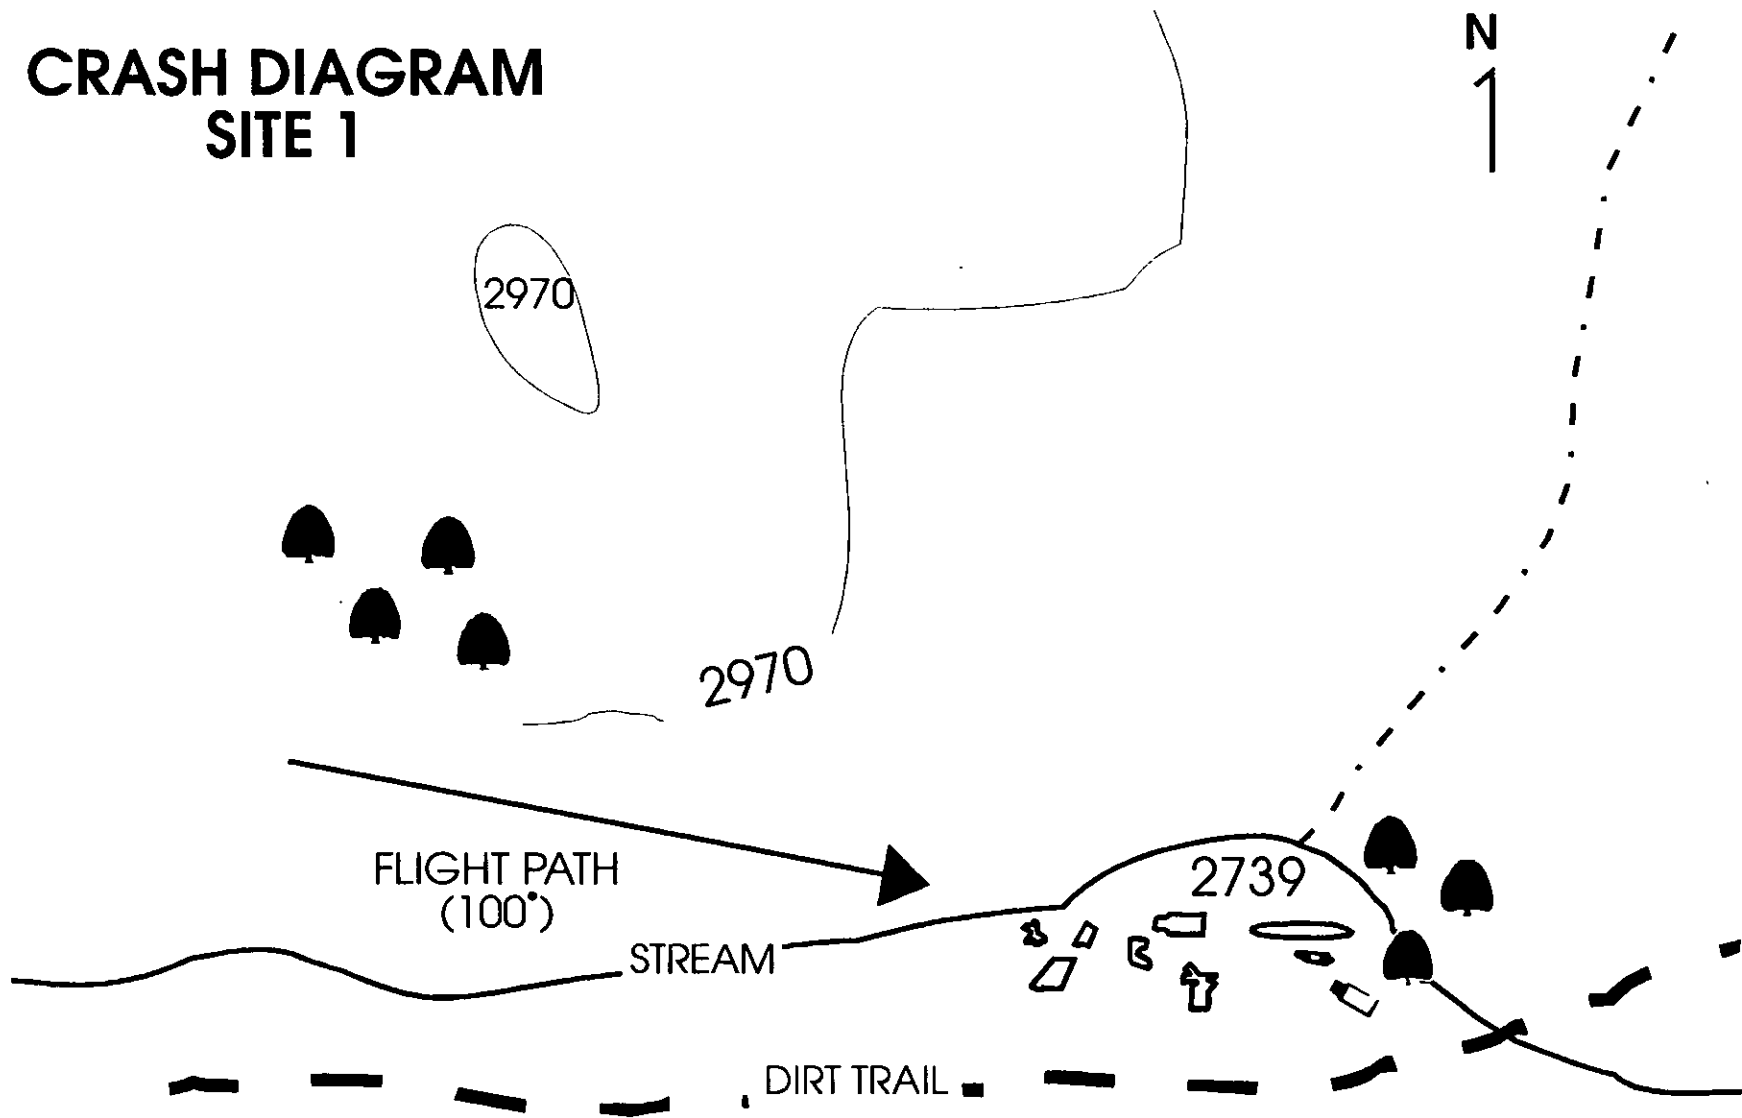
DIAGRAM 2

GROUND IMPACT POINT
SITE 1
N 36° 46' 04"
E 044° 05' 33"

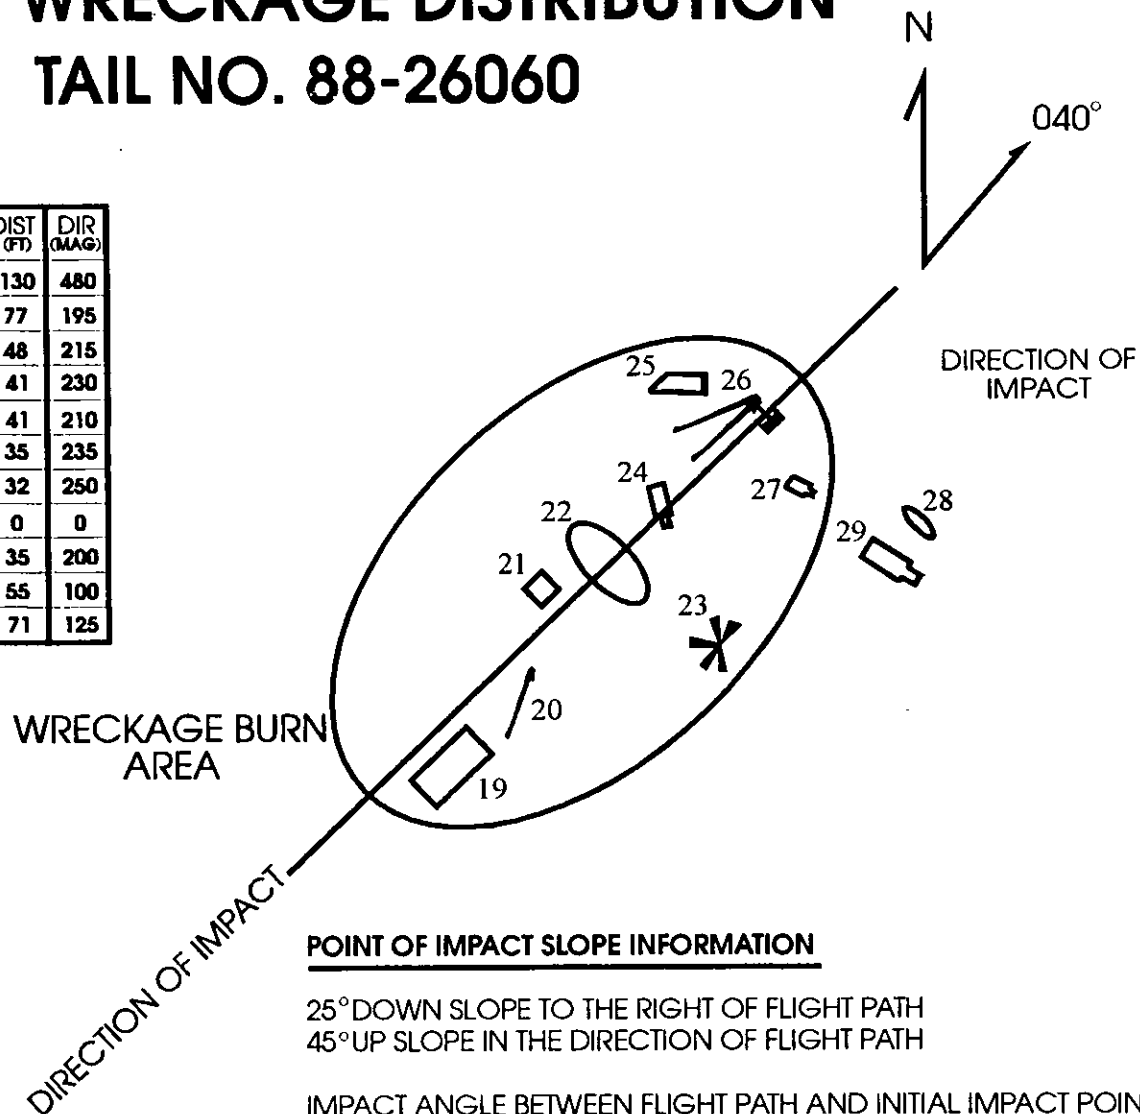
DIAGRAM 8

POINT OF IMPACT SLOPE INFORMATION

25° DOWN SLOPE TO THE RIGHT OF FLIGHT PATH
 45° UP SLOPE IN THE DIRECTION OF FLIGHT PATH

IMPACT ANGLE BETWEEN FLIGHT PATH AND INITIAL IMPACT POINT: 56°
 DISTANCES ARE MEASURED IN FEET
 DIRECTIONS ARE MEASURED IN DEGREES MAGNETIC
 DISTANCES AND DIRECTIONS ARE MEASURED FROM MAIN TRANSMISSION (26)
