From: Debra.Rosen@dot.gov
Sent: Friday, October 09, 2009 3:31 PM
To: Gorman, Karen
Cc: McMullen, Catherine; Wilson, Kevin; Judy.Kaleta@dot.gov; Thomas.Black@dot.gov
Subject: FW: FW: OSC File Nos. DI-08-0497; DI-08-0550; DI-08-0494
Attachments: DTW ATCT SOW.doc; DTW ATCT Microbiological 080808.pdf; ES_tripreport.pdf; Health Survey Intro.pdf; mold_responses_osc.doc

DETROIT, MICHIGAN

June 13, 2008

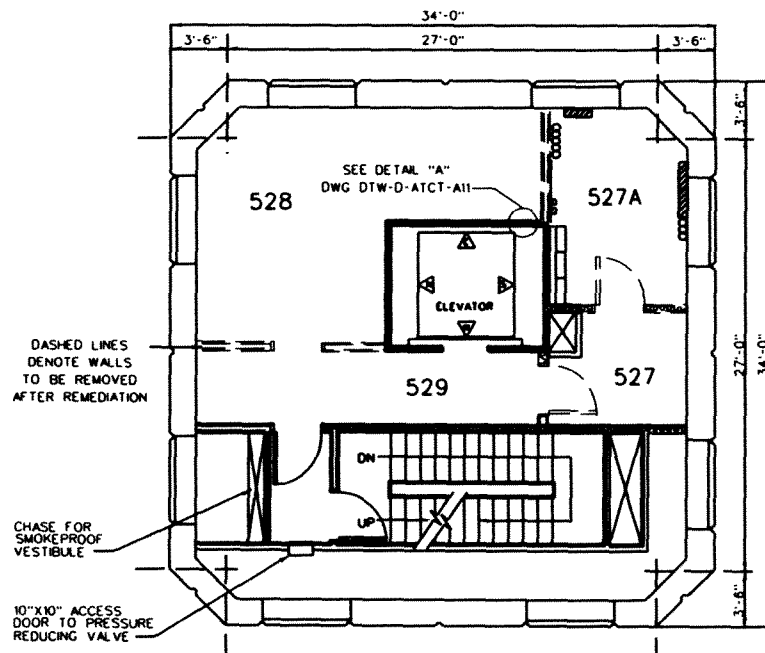
FIFTH FLOOR SHAFT PLAN

Room 527 North wall - mold was found in the northeast corner of the room. Approx. 3 square feet.

Room 527A South wall - mold was found in the southeast corner of the room. Approx. 2 square feet.

Room 529 East wall - suspect staining was found on the outer layer.

4. Remove and replace gypsum board and insulation totaling approximately 15 square feet, on the north wall, between the east wall and door to Room 527A, 2' wide to a height of 4' (surface layer) and 2' wide to a height of 3'6" (concealed layer).

1. A MINICONTAINMENT SHALL BE ESTABLISHED CONSISTING OF A SINGLE LAYER OF 6-MIL POLYETHYLENE SHEETING. A NEGATIVE PRESSURE ENCLOSURE SYSTEM SHALL BE ESTABLISHED AS DESCRIBED IN SECTION 8.05 REMEDIATION AREA.
2. THE PORTION OF THE EAST WALL, BETWEEN THE SOUTH WALL AND STAIRWELL DOORFRAME, 2" WIDE TO A HEIGHT OF 8", SHALL BE HEPA VACUUMED AND THEN WET WIPED WITH AN APPROVED CLEANING SOLUTION.

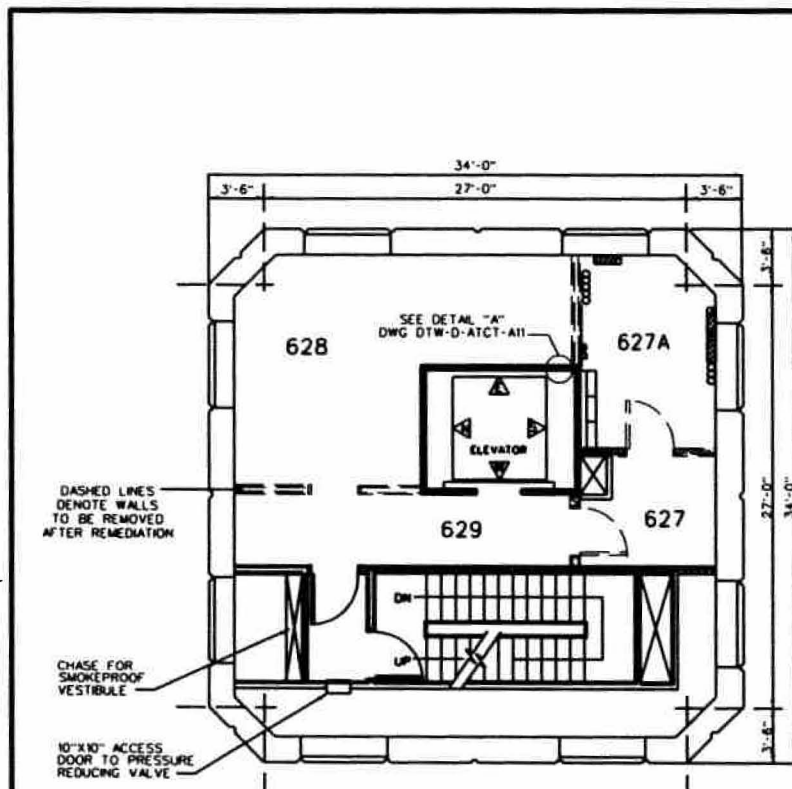
SIXTH FLOOR SHAFT PLAN

628 South and East elevator shaft walls - suspect staining was found on the outer layers.

1. The contractor shall provide additional cleaning procedures and pipe insulation removal/replacement.
2. Approximately 20 linear feet of 11" and 25 linear feet of 18" water stained and/or contaminated chilled and heating water pipe insulation shall be removed and replaced.

3. THE SOUTH (ELEVATOR SHAFT) WALL, UP TO A HEIGHT OF 4', SHALL BE HEPA VACUUMED AND THEN WET WIPED WITH AN APPROVED CLEANING SOLUTION.

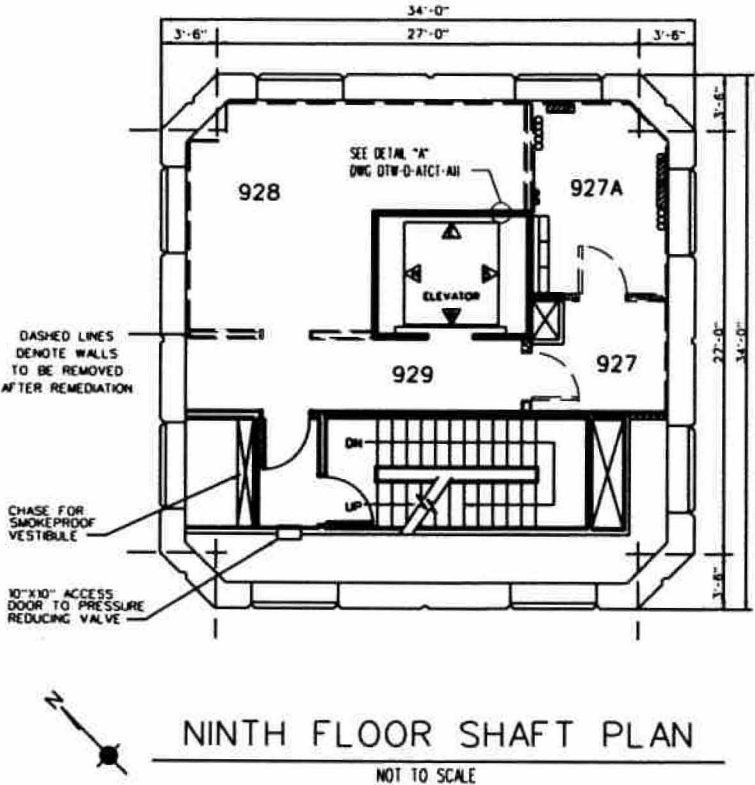
FLOOR 9:

928 North and West Walls in the northwest corner of the room - mold was found on the outer layer, middle layer, and shaft liner. Approx. 6 square feet.

928 South elevator shaft wall - mold was found on the middle layer and shaft liner. Approx. 6-8 square feet.

928 East elevator shaft wall - mold was found on the outer layer, middle layer and shaft liner. Approx. 6-8 square feet.

3. Remove and replace gypsum board, shaft liner, and insulation totaling approximately 311 square feet:
 - a. The east (elevator shaft) wall, 8' wide to a height of 5' (surface layer), 8' wide to a height of 4'6" (concealed layer), and 8' wide to a height of 4' (shaft liner).

1. PRIOR TO PERFORMING MICROBIOLOGICAL REMEDIATION PROCEDURES, THE CONTRACTOR SHALL SEAL ALL CRITICAL PENETRATIONS AND OPENINGS TO THE WORK AREA WITH A MINIMUM OF TWO LAYERS OF 6-MIL POLYETHYLENE, AND SHALL BE RESPONSIBLE FOR ENSURING ADJOINING AREAS ARE NOT EXPOSED TO THE MICROBIOLOGICAL CONTAMINATION DURING THE REMEDIATION.
