W O N D E R M A K E R S  
E N V I R O N M E N T A L

May 20, 2008

RE: Initial response to DOT investigation

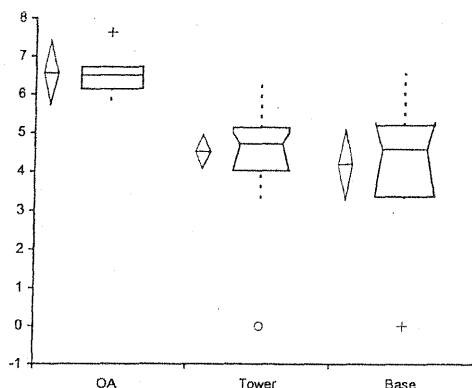
Test | Comparative descriptives  
 Variables | LN: OA, Tower, Base  
 Performed by | R

LN	n	Mean	SD	SE	95% CI of Mean	Median	IQR	95% CI of Median
OA	5	6.567	0.6805	0.3043	5.722 to 7.412	6.500	0.580	- to -
Tower	32	4.515	1.2073	0.2134	4.080 to 4.951	4.718	1.118	4.025 to 5.011
Base	18	4.200	1.8269	0.4306	3.292 to 5.109	4.583	1.839	3.367 to 5.278

n	GMean
OA	5	710.902
Tower	32	91.421
Base	18	66.720

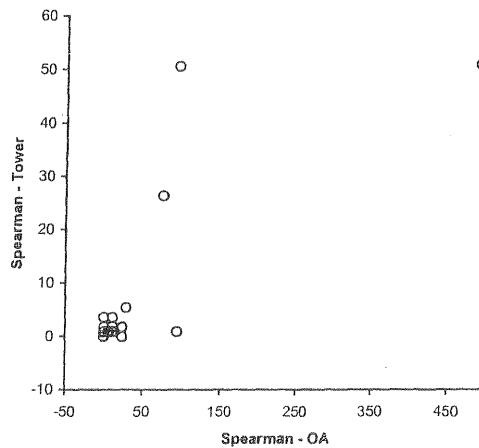
Test	Spearman rank correlation	
Alternative hypothesis	Spearman: OA $\neq$ Tower	
Performed by	R	Date   6 June 2007

n	17
rs statistic	0.54
95% CI	0.09 to 0.81
2-tailed p	0.0241 (t approximation, corrected for ties)

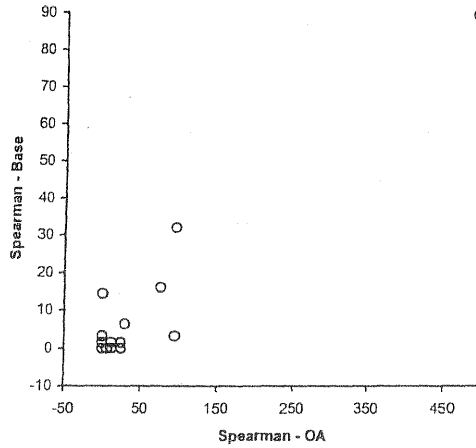
Test	Spearman rank correlation
Alternative hypothesis	Spearman: OA $\neq$ Base
Performed by	R
Date	6 June 2007

rs statistic | 0.54  
95% CI | 0.08 to 0.81

2-tailed p | 0.0251 (t approximation, corrected for ties)

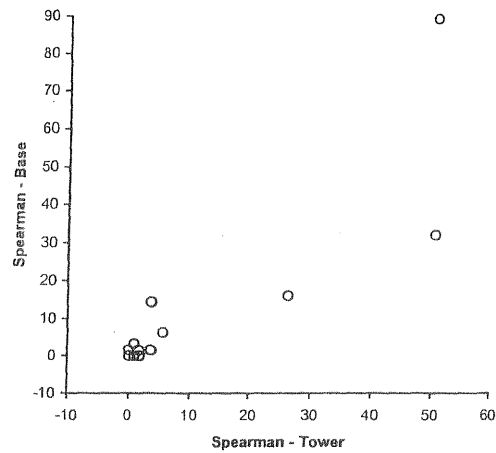
Test	Spearman rank correlation
Alternative hypothesis	Spearman: Tower $\neq$ Base
Performed by	R
Date	6 June 2007

rs statistic | 0.65  
95% CI | 0.24 to 0.86

2-tailed p | 0.0049 (t approximation, corrected for ties)
