Kansas City, Missouri Airport Traffic Control Tower (MCI ATCT)

Post Mold Remediation Clearance Report

Report on Mold and Moisture Inspection
Kansas City International Airport
Airport Traffic Control Tower

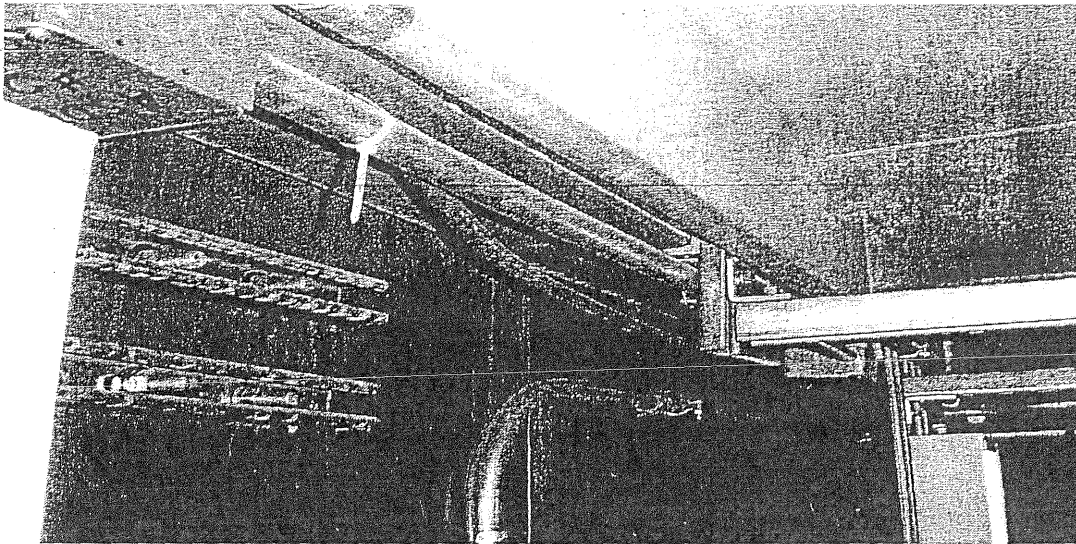
Photo 1: ASDE Penthouse, North Wall at Roof Beam.

There is no insulation on the bottom and backside of the beam or the $\frac{1}{4}$ " steel roof deck adjacent to the insulated panel wall. The gap between the beam and the wall allows warm air to contact the cold steel surfaces. The uninsulated steel is the likely point where condensation is occurring as shown by the heavy white residue visible on the wall near the bottom of the beam in the ASDE Penthouse.

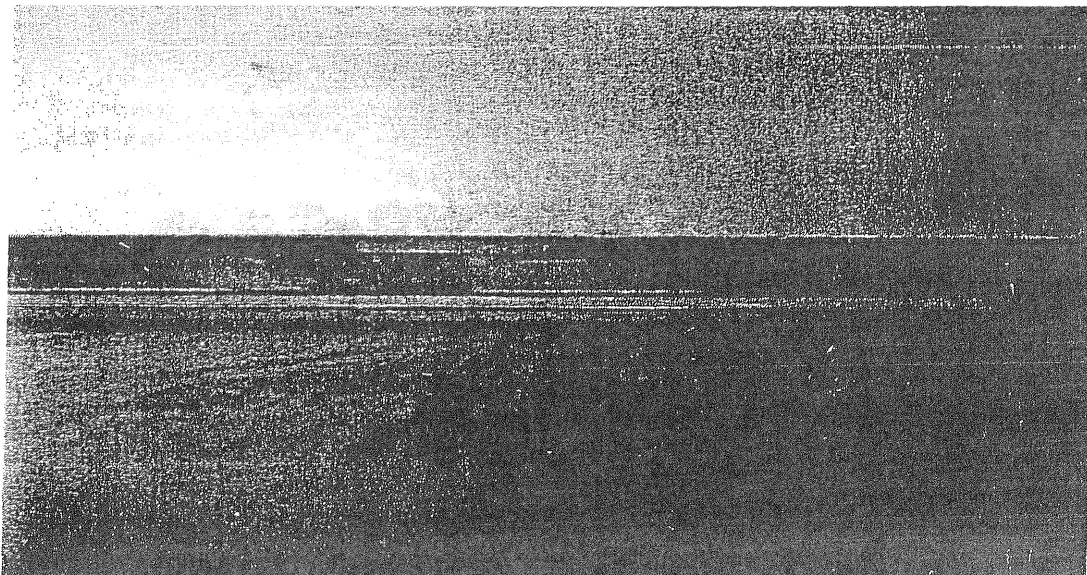
Photo 2: ASDE Penthouse, South Wall Between Beam and IMP.

This view is looking up at the $\frac{1}{4}$ " uninsulated steel roof deck between the insulated metal panel and steel beam. Rust, water stains, and white residue are visible on all surfaces from condensation and frosting.

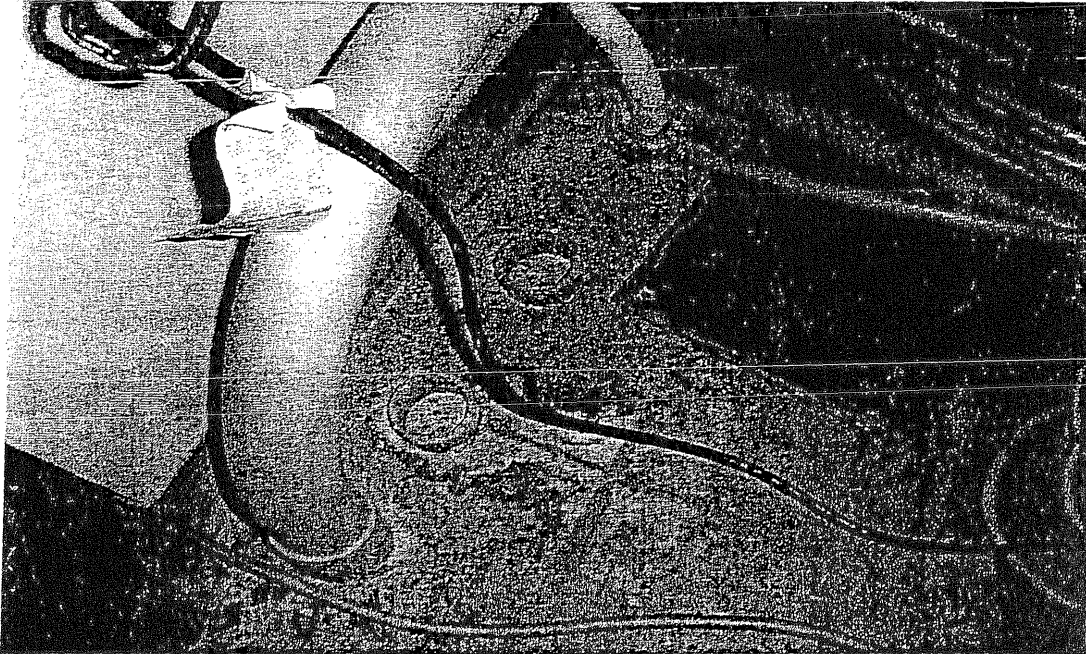
Photo 3: ASDE Penthouse, East Wall, South of Door.

The white residue shown on the floor of the ASDE Penthouse appears to be caused by condensation on the insulated metal panel and uninsulated steel beam and sections of roof deck.

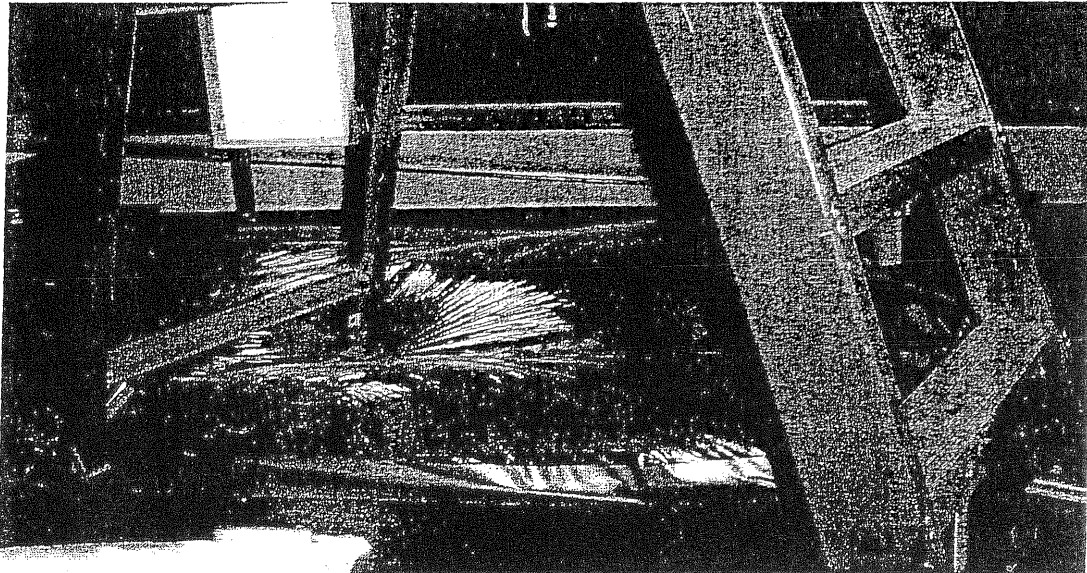
Photo 4: ASDE Penthouse, Floor Hatch.

The plastic covering the steel equipment floor hatch shows air infiltration from the Cab. In the winter months, this likely provides a source of warm humid air, which increases the potential for condensation on cold surfaces in the Penthouse.

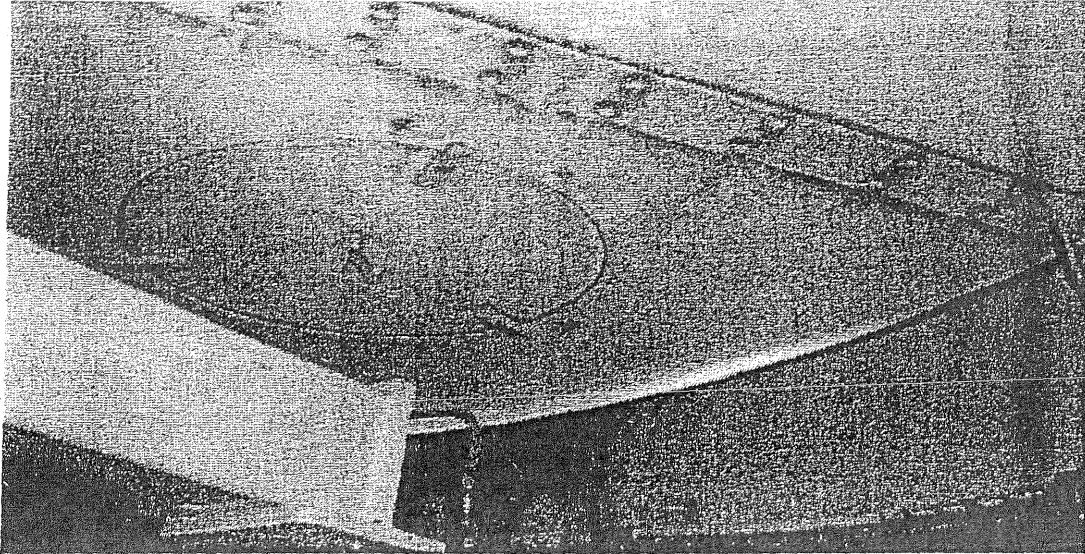
Photo 5: ASDE Penthouse, Antenna Opening.

The antenna opening is shown in the ceiling of the room. Rust and water stains are visible on the surrounding walls from condensation or frosting.

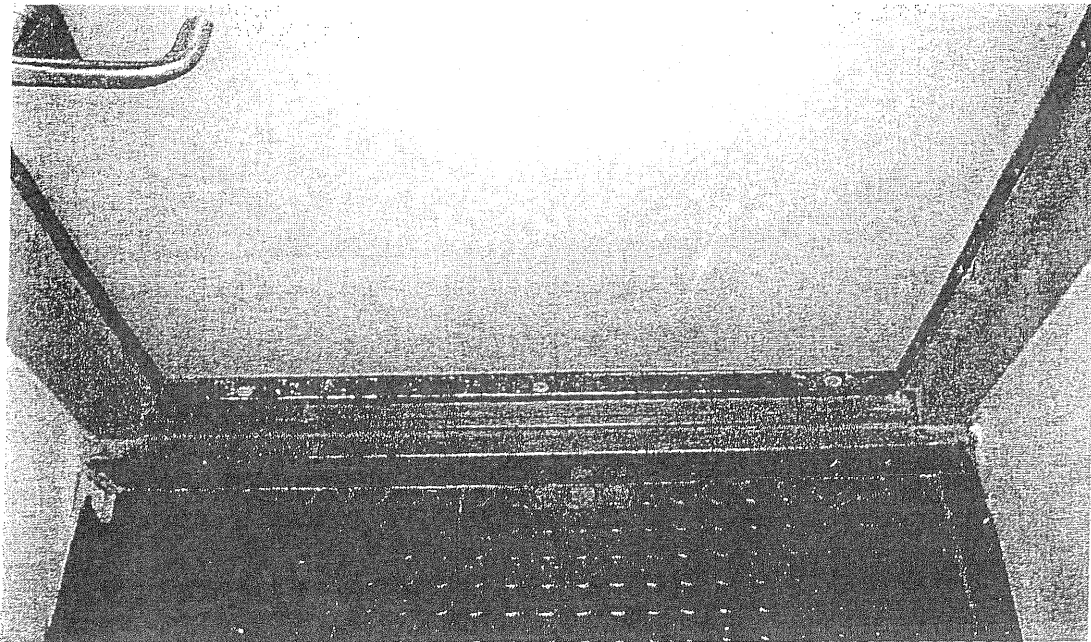
Photo 6: Cab Level, Interior of Door to Outside Walkway.

A gap in the doorframe weather-stripping and flashing that improperly slopes towards the door, have allowed water to enter the stairway near the door. The water has wicked up adjacent gypsum board causing it to deteriorate and has also resulted in mold growth behind the vinyl base.

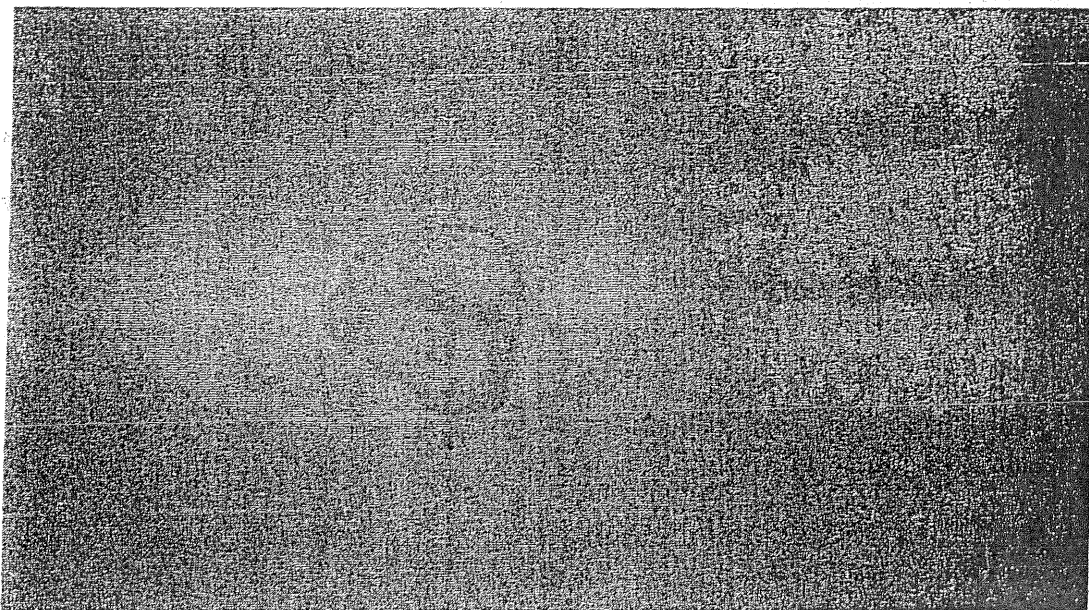
Photo 9: Cab Level Stairs, Water Stain on Sloped Ceiling.

Water stains are shown on the sloped ceiling under the Cab Level sink due to past water line or drain line leaks. Cleaning out a clogged drain line appears to be a major source of the water damage.

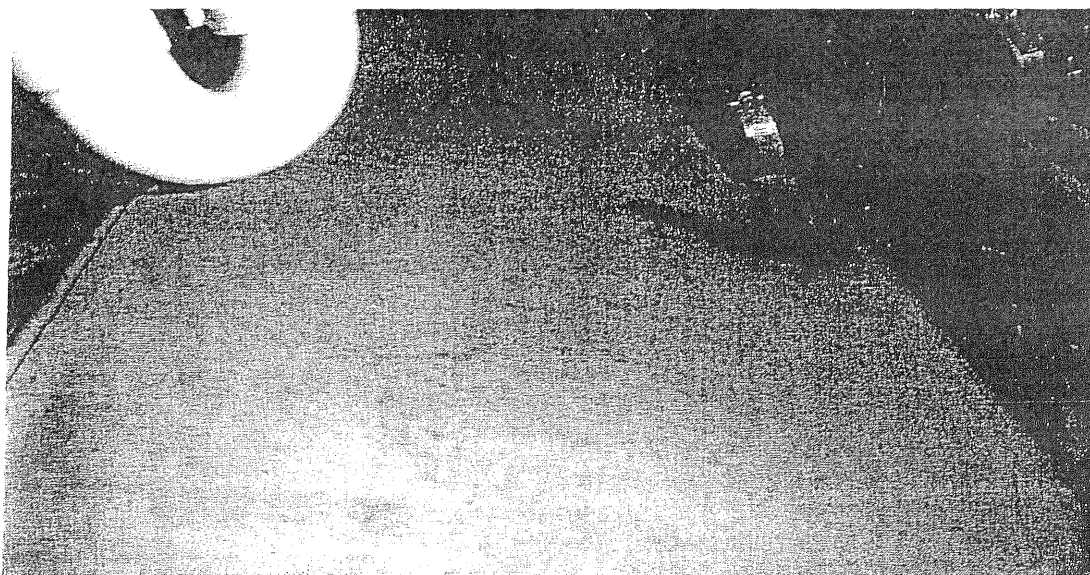
Photo 10: Cab Level, Back Side of Gypsum Board under Sink.

Mold is visible on the gypsum board under the sink due to past drain line leaks and possibly past water line leaks. Removal of the cap to clean out a clogged drain line also appears to have been the major source for water leaks/stains here and below in the Cab stairs.

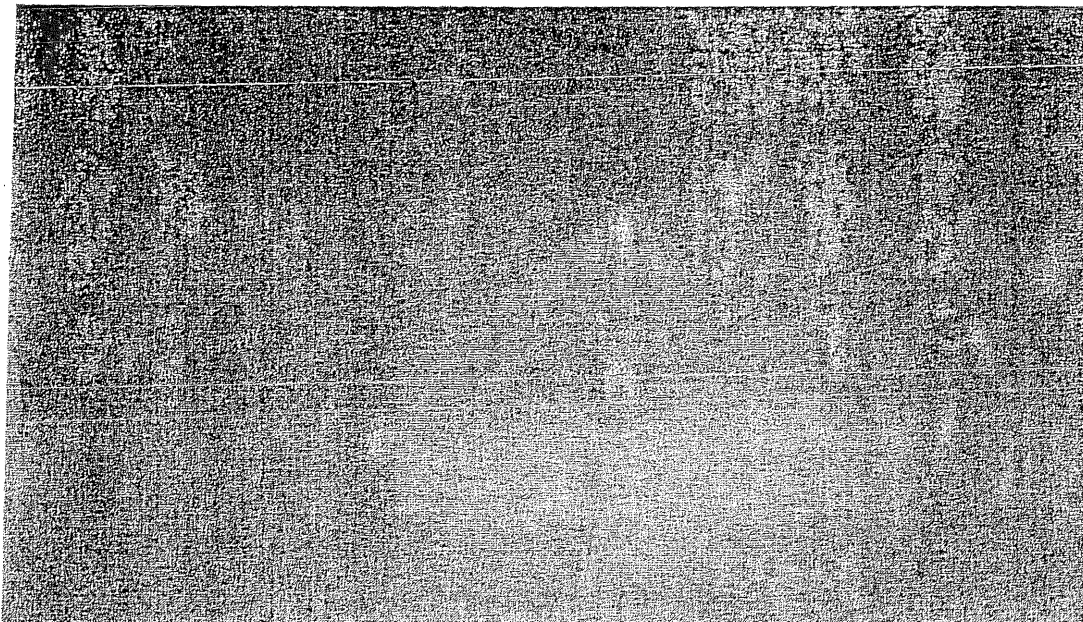
Photo 11: CA2 Landing, South Wall, Bottom of Soffit.

The water stain shown was likely caused by drain line leaks from the sink in the Cab Level.

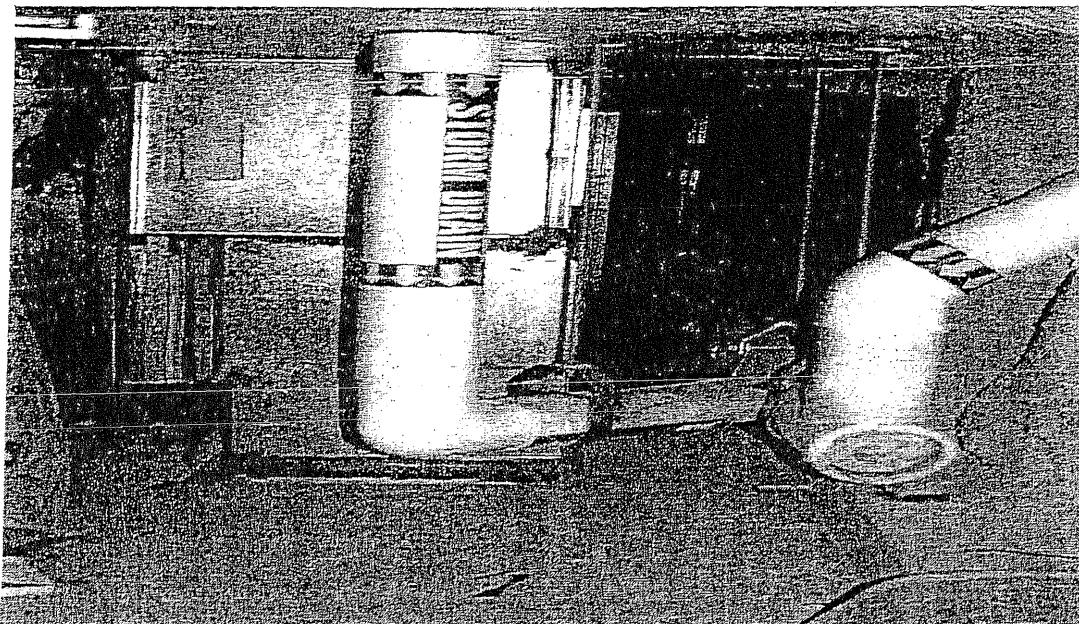
Photo 15: Cable Access Room (CA1).

One of the storm drain pipes in Room CA1, directly beneath the drain body, had water stained insulation as shown above. The stained insulation could be caused by a leak getting under the membrane and following the structural concrete slab to the opening around the drain body, a leak at the connection between the drain body and drain pipe, or possibly from condensation due to a damaged vapor barrier jacket on the insulation.

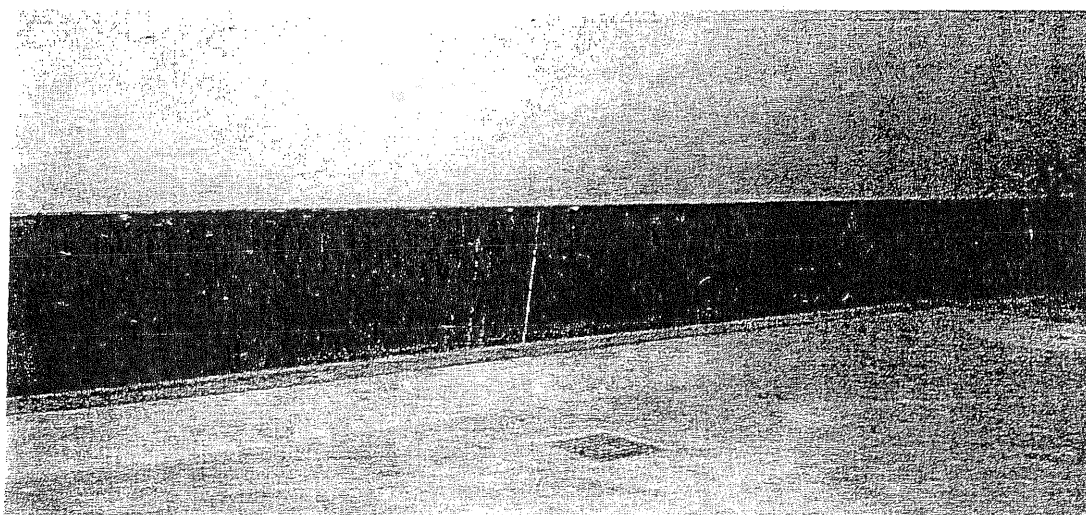
Photo 16: Cable Access Level, Northeast Wall.

Water stains are shown on the metal panel on the northeast wall, similar to that found on the IMP walls in the ASDE Penthouse. The potential sources of this water are condensation or building leaks.

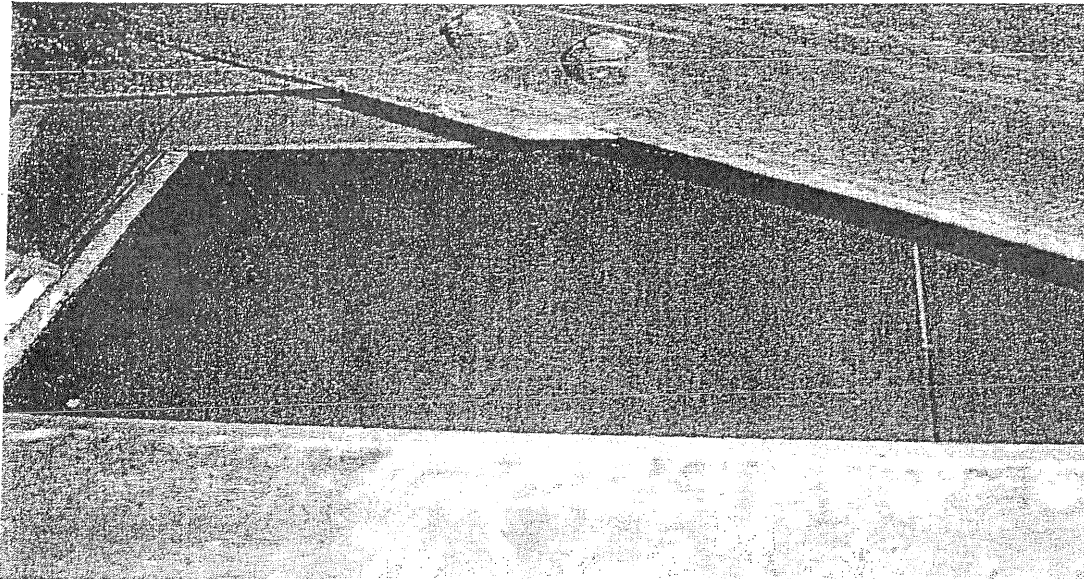
**Photo 17: Cable Access Level, Outer Portion,
Northeast Wall, Interior Face of IMP Siding.**

Water stains are shown on the metal panel, similar to that found on the IMP walls in the ASDE Penthouse. The potential sources of this water are condensation or building leaks.

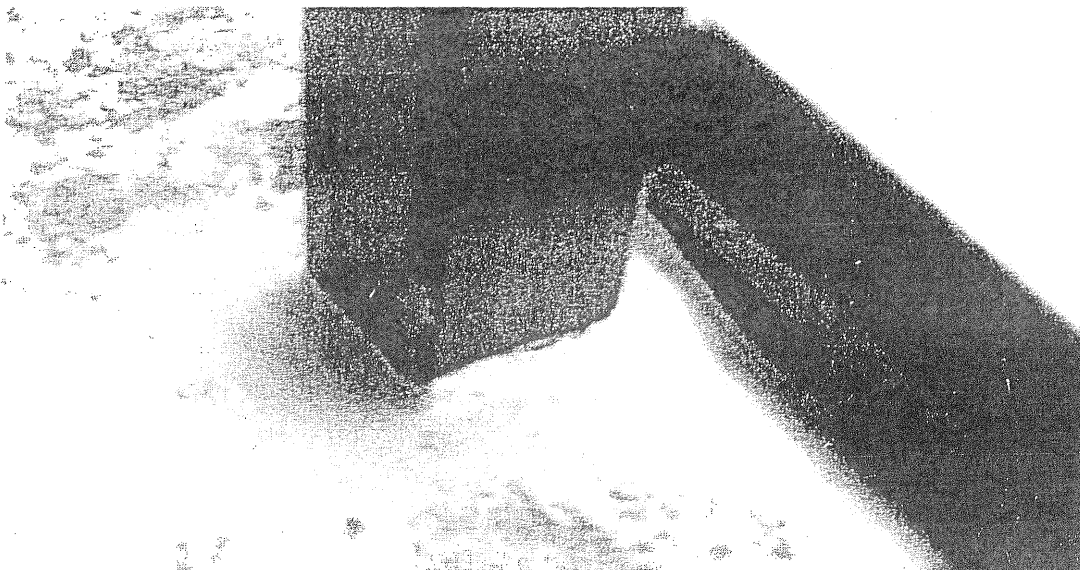
Photo 18: Junction Level, Bottom of Handrail Post.

The waterproofing on the Junction Level walkway is identical to the roofing system on the Cab Level walkway. There is some delamination of the waterproof coating on top of the concrete topping layer and some peeling at the handrail posts as shown above. No membrane flashing is evident around the handrail post and there appears to be a pliable caulk-like material under the waterproof coating around the post. This could be a source of leaks.

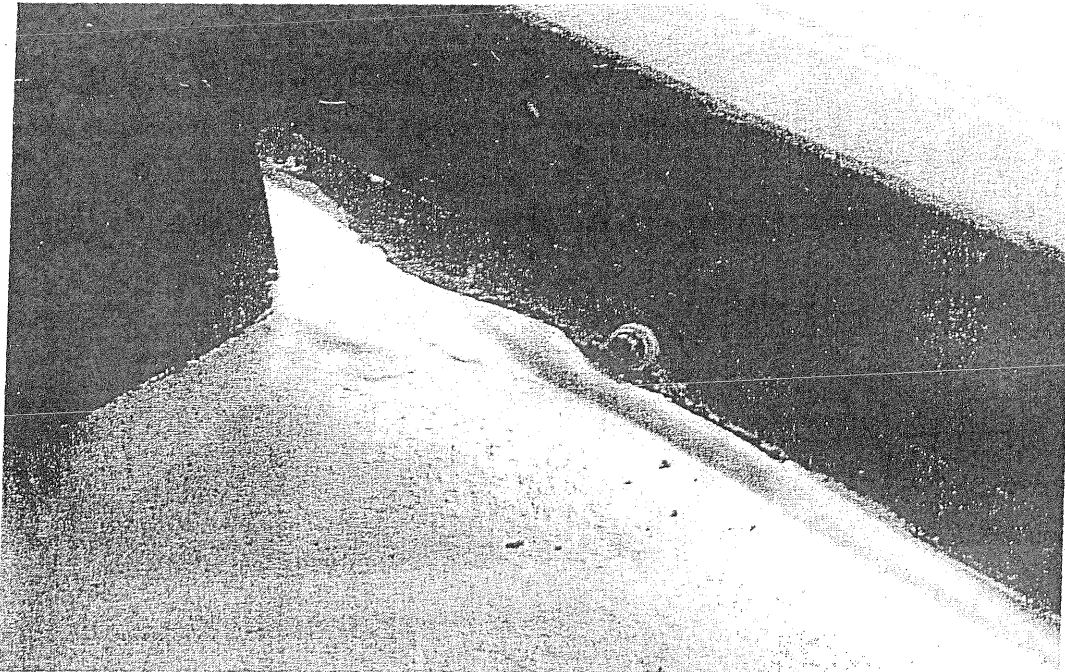
Photo 21: Junction Level, Northwest Corner of Walkway.

A rusty flashing is shown in the northwest corner of the walkway, indicating improper drainage of water in the area.

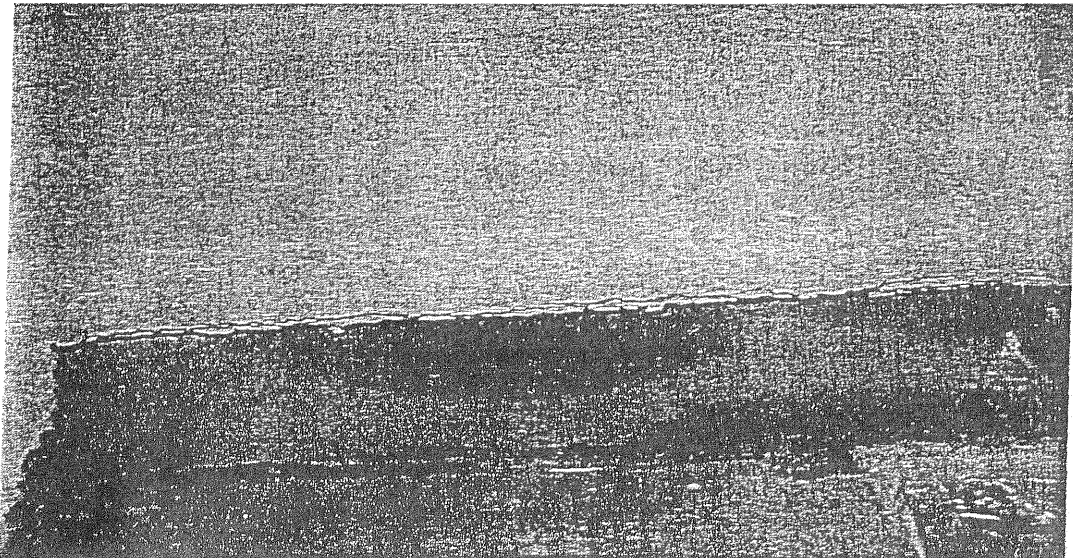
Photo 22: Junction Level, Water Stain on North Walkway.

A water stain is shown on the north walkway, indicating improper drainage of water in the area.

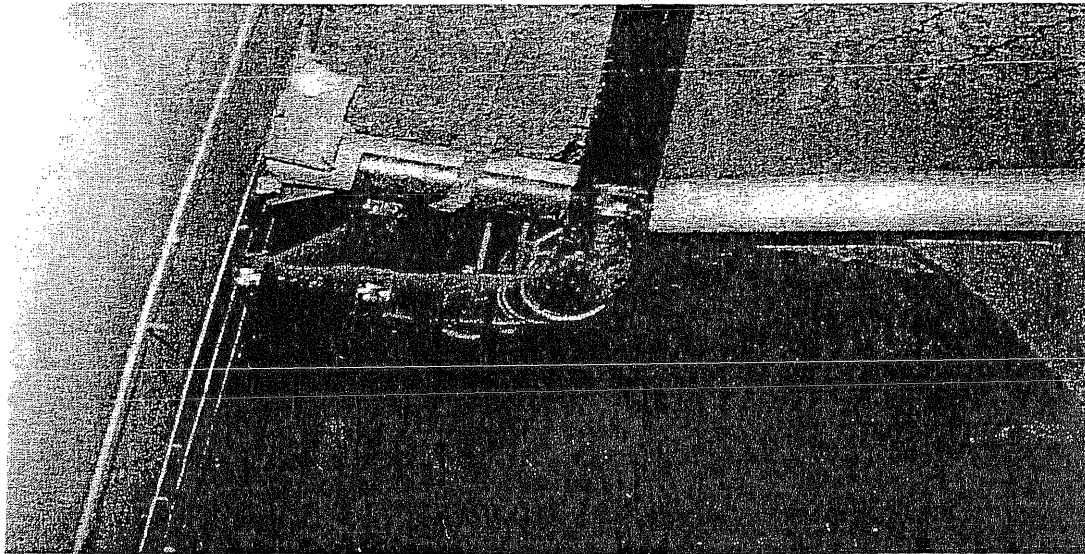
Photo 23: Sub Junction Level, Concealed Space between East 2-hour Shaft Wall of Room SJ1, looking North.

This area was evaluated in order to verify the storm drains were not leaking as well as determine the presence of mold.

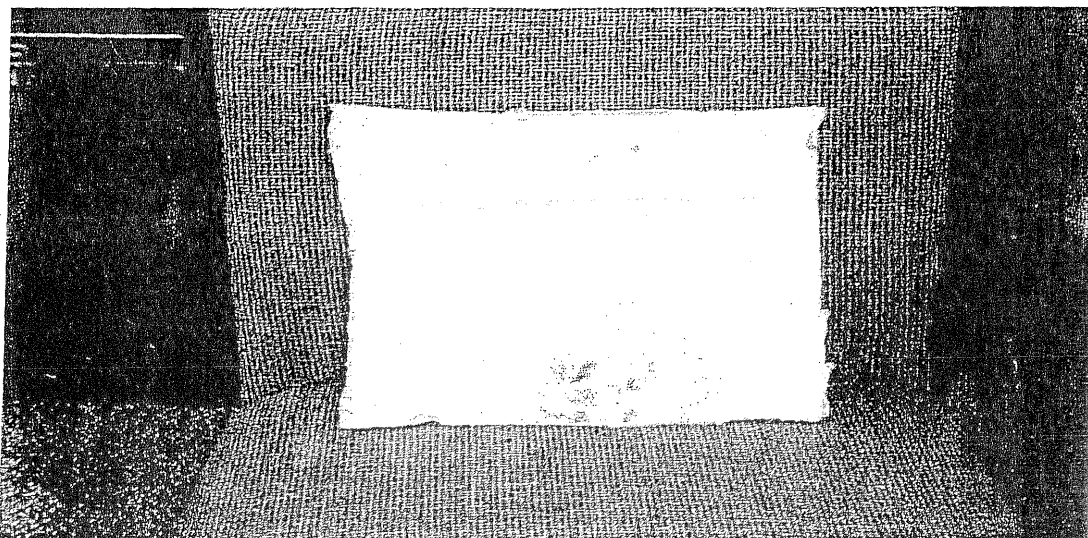
Photo 24: Sub Junction Level, Mold on Room SJ1 side of 1" GWB cut from the West Wall, South end.

Four openings approximately 12" square were cut through the perimeter 2-hour rated shaft wall above the suspended ceiling on the east, north, and west walls to inspect the concealed spaces located underneath the Junction Level walkways and between the sloped architectural precast concrete panels and the perimeter gypsum board walls. A mold-contaminated section of the shaft liner shown above was cut from the west wall, south end.

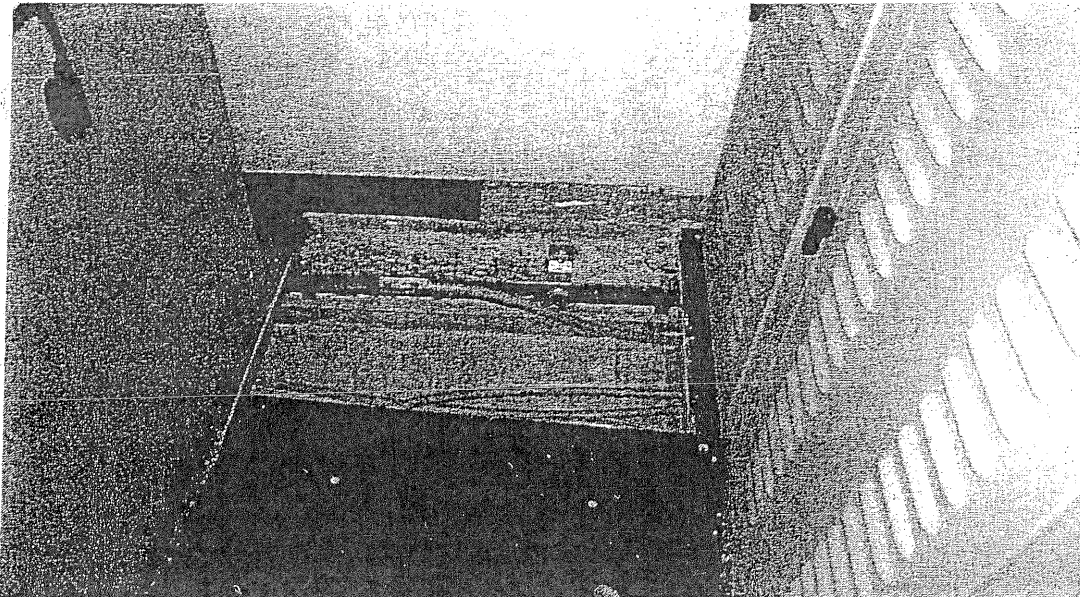
Photo 25: Sub Junction Level, Room SJ1, West Wall.

Inspection of the gypsum board walls below the raised access floor in the Equipment Room SJ1 revealed heavy concentrations of black mold as shown above. It can be attributed to the water from the humidifier and plugged floor drain in the southwest corner of this room.

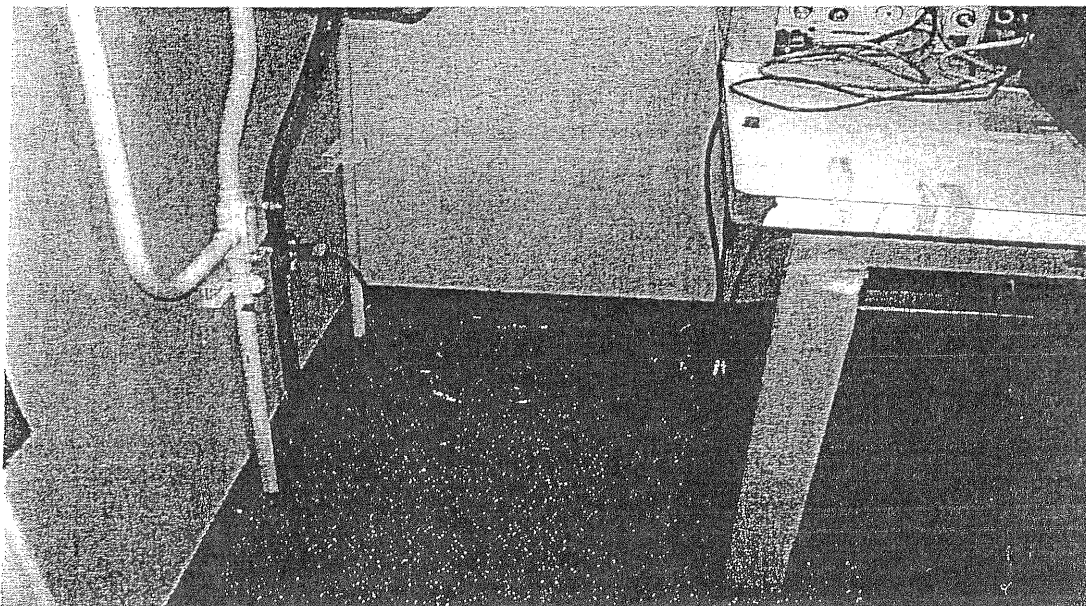
Photo 26: Sub Junction Level, Room SJ1, Southwest Corner.

Areas of yellow discoloration in the painted finish as shown above and visible mold were found up to three feet above the raised access floor.

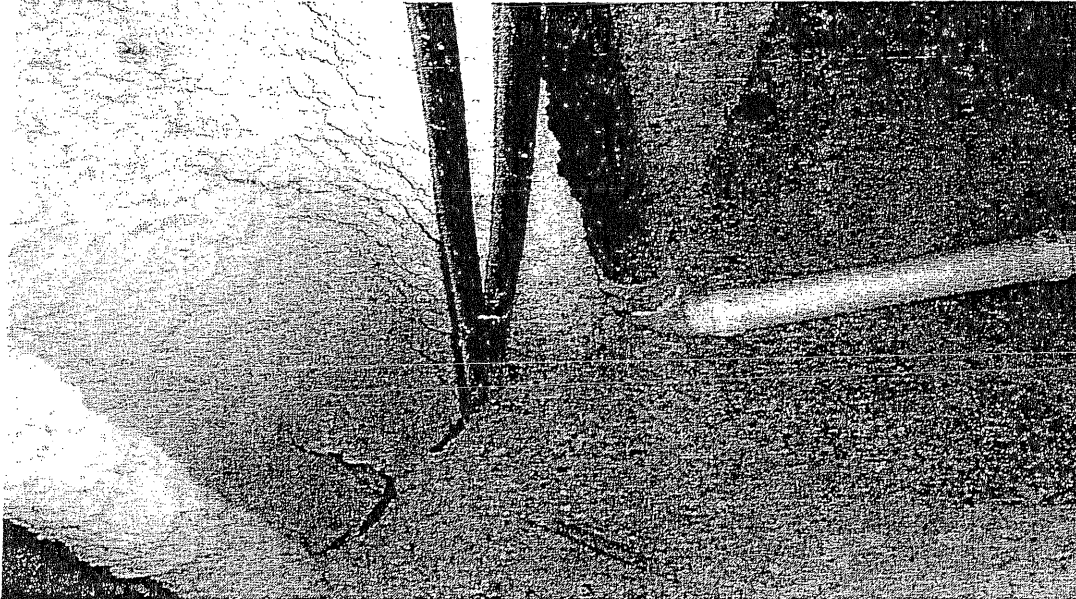
Photo 27: Sub Junction Level, Room SJ6.

Air shaft SJ6 has an area floor drain pipe, serving the concrete slab adjacent to the microwave fabric on the Junction Level, which discharges over the top of each floor drain as shown above.

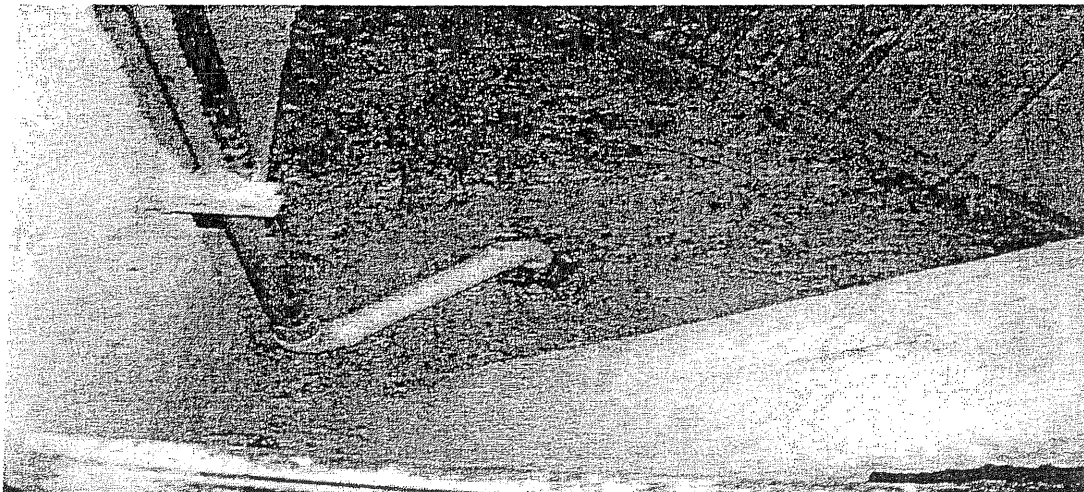
Photo 28: Sub Junction Level, Room SJ8.

Air shaft SJ8 is the outside air intake for the air-handling unit in the SubJunction Level Mechanical Room. The fireproofing debris present may block the drain line. Pigeon staining and droppings were also observed in the bottom of the shaft. The mold *Aspergillus* grows in damp bird debris, as well as possibly harboring other infectious agents such as *Chlamydophila psittaci*, *Cryptococcus neoformans*, and *Histoplasma capsulatum*. No pathogenic compounds were detected from the sample collected from this location.

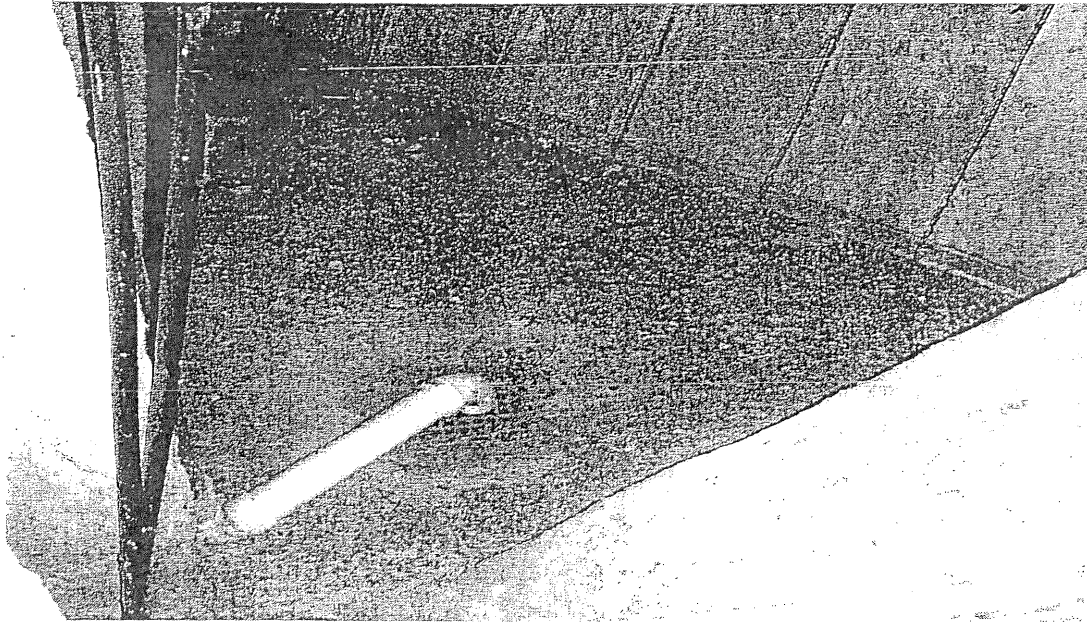
Photo 29: Sub Junction Level, Room SJ6.

Fireproofing debris and pigeon staining and droppings were observed in the bottom of air shaft SJ6. No pathogenic compounds were detected from the sample collected from this location.

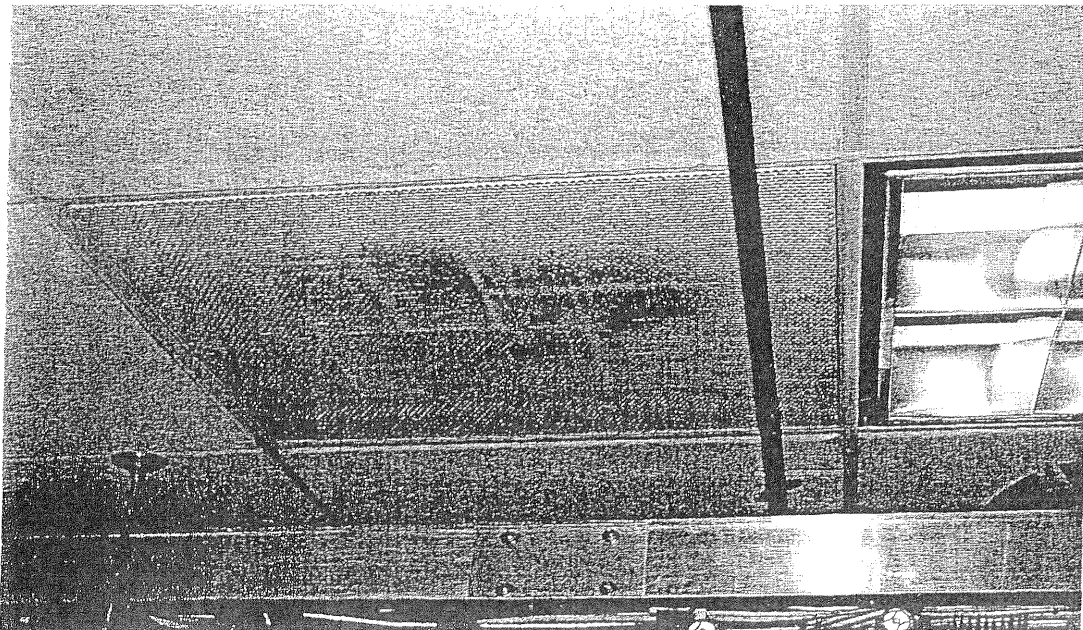
Photo 30: Sub Junction Level, Room SJ1, Dirty Diffuser.

A dirty diffuser is shown in Room SJ1. Diffusers and grilles must be cleaned as the dust provides a food source for mold.

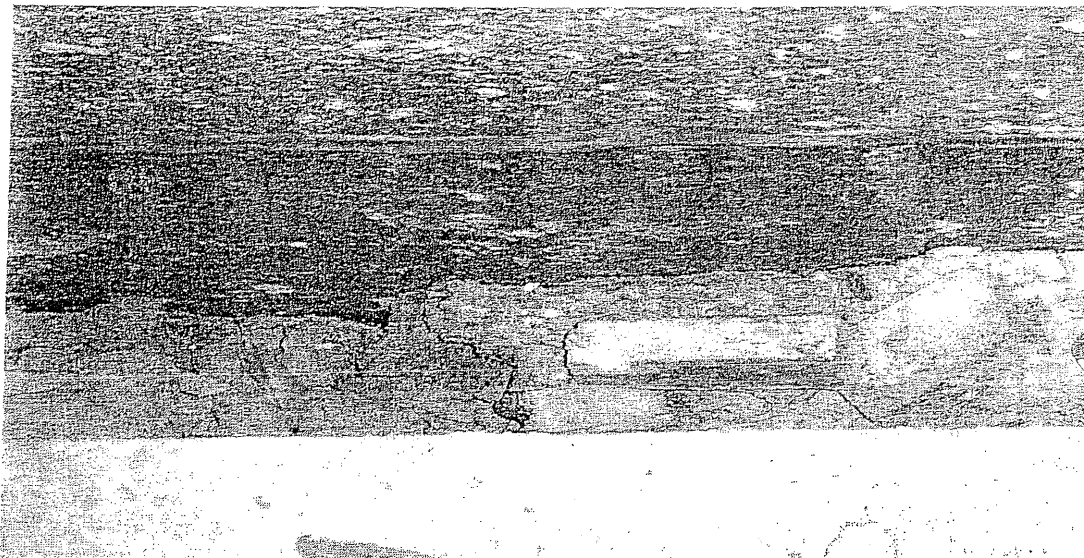
Photo 31: Debris found in 11th Floor Outer Ring.

A large quantity of scrap gypsum board was found in the void between the edge of the floor slab, precast exterior walls, and perimeter fire rated gypsum board walls as shown above.

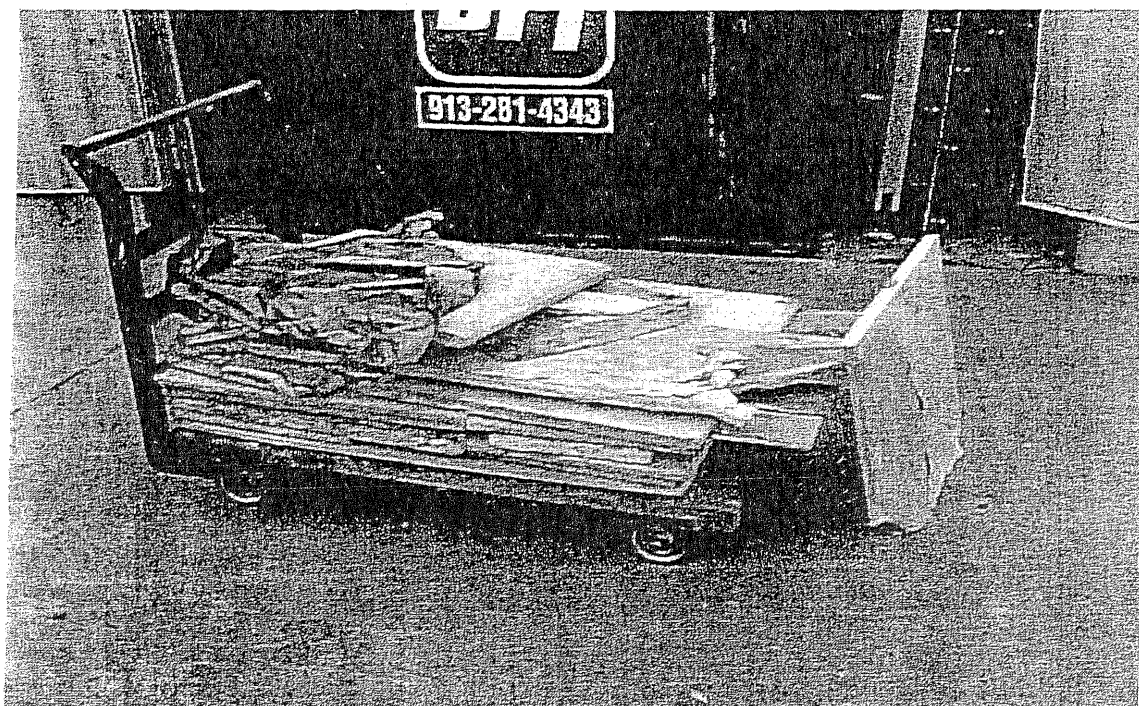
**Photo 32: Construction Debris found in 11th Floor Outer Ring,
Back of the West wall of 11TS5.**

This debris was found in the same location as the material shown in Photo 31. Much of this material appears to be left from the building's initial construction.

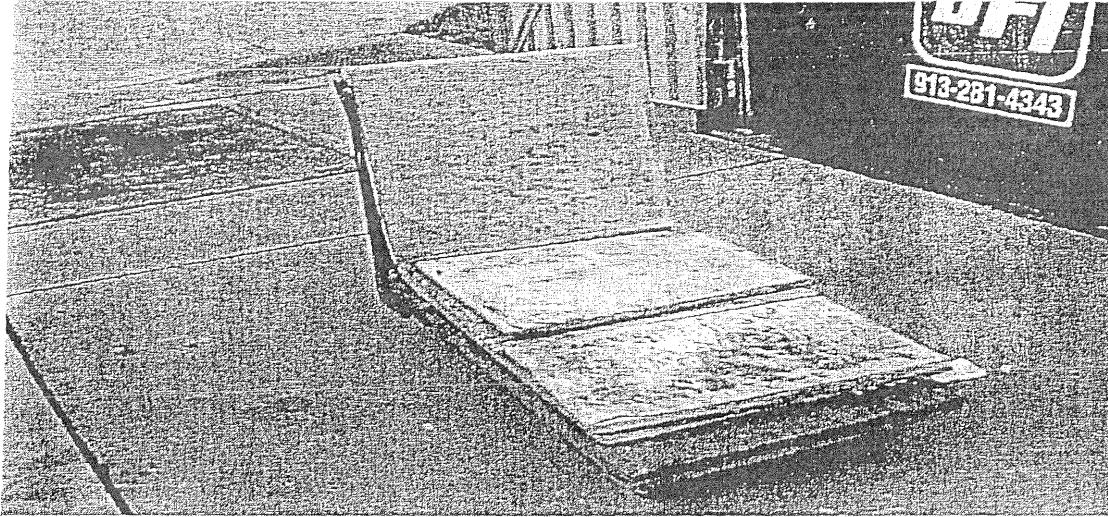
**Photo 33: Moldy Construction Debris found in
11th Floor Outer Ring, Back of the West wall of 11TS5.**

This construction debris was found in the same location as the material shown in Photos 31 and 32. Much of the scrap had large quantities of mold.

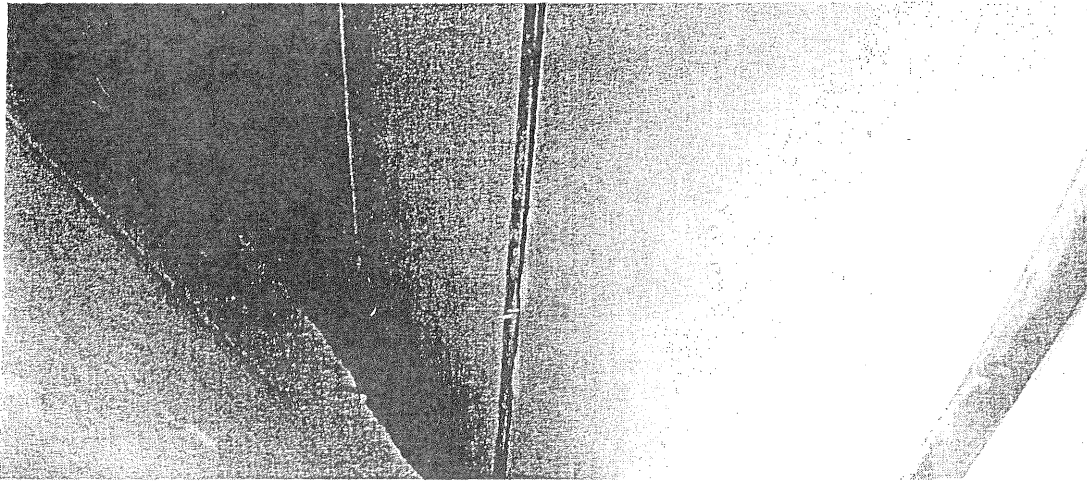
Photo 34: 11th Floor Outer Ring, Back of the West wall of 11TS5.

The debris shown in Photos 31, 32, and 33 were pulled from this location. Moisture from building and humidifier leaks lead to the growth of mold on the debris, which contaminated this area. *Ulocladium* (154 counts/cm²) was detected on the 5th panel from the South, in an area that had been biocide treated prior to sampling. After subsequent re-cleaning, *Pithomyces* (31 counts/cm²) was detected in the same area. After a 3rd biocide cleaning, however, all mold spore concentrations were below the limit of detection.

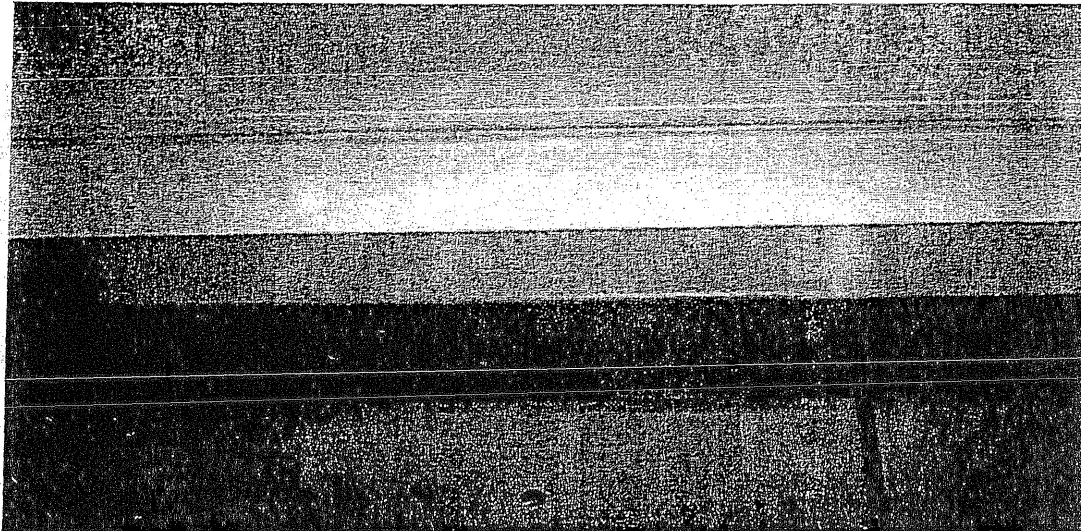
Photo 35: 11TS1, Mold-Containing Dust on Wall of Elevator Door.

Alternaria (77 counts/cm²), *Ascospores* (15 counts/cm²), *Cladosporium* (31 counts/cm²), *Epicoccum* (15 counts/cm²), *Pithomyces* (31 counts/cm²), and *Smuts* (31 counts/cm²) were detected above the elevator door. Biocide cleaning measures will be required in the area represented by this sample location.

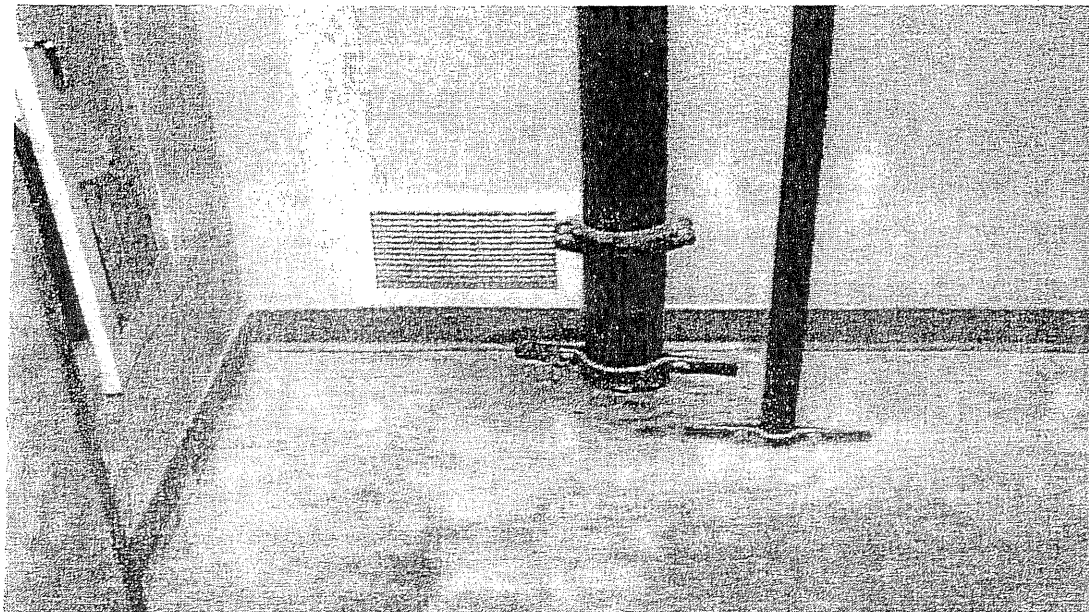
Photo 36: 11TS6, Southwest corner.

Water stains and discoloration were found on the concrete floor and gypsum board wall of stair vestibule 11TS6. A union and short section of pipe in the fire sprinkler line was unpainted and had been replaced after the tower was constructed. It was confirmed that this pipe had leaked and as repaired. Peeling back the vinyl base revealed visible mold.

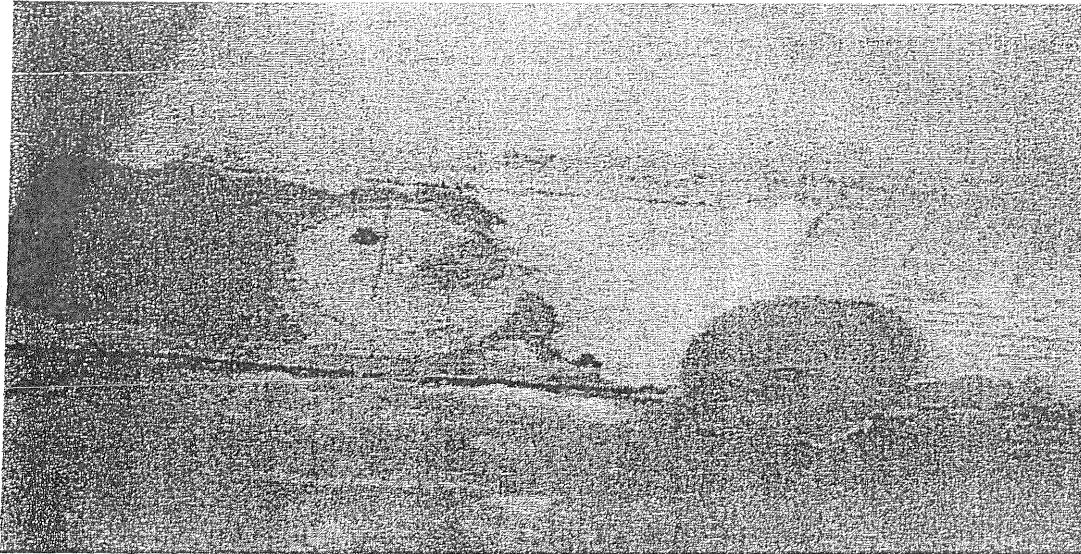
Photo 37: 11TS5, West Wall, Drilled Core South of Door.

Mold is shown on the back of the 1st layer of sheetrock and on the front of the concealed layer in Room 11TS5. This area was known to have had water leaks, therefore the base was pulled and cores were drilled in order to evaluate the possible presence of mold.

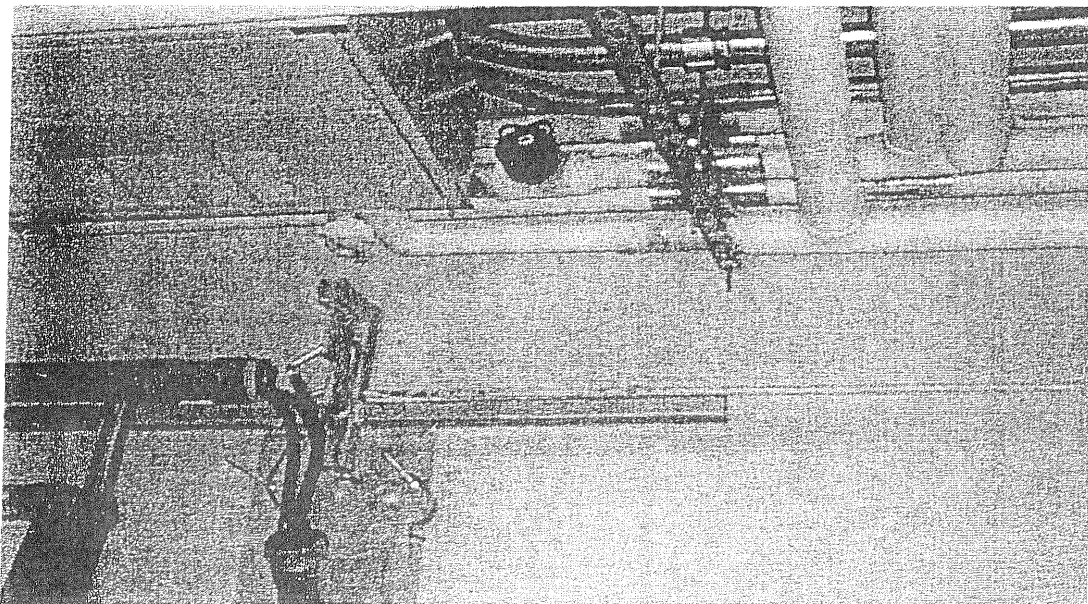
Photo 38: 11TS5, East Wall Fan Coil Unit.

Pipe insulation is shown with visible water stains in Room 11TS5. Water stained insulation should be checked regularly if in close proximity to sheetrock.

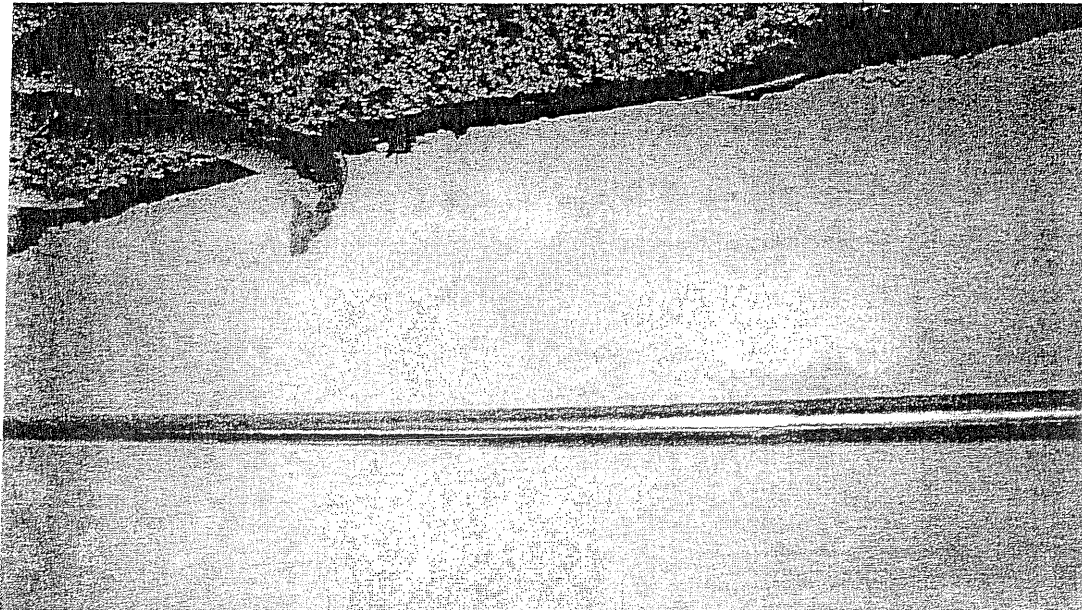
Photo 40: Yellow stained South Wall (Elevator Shaft) of 10TS5.

The yellowed areas shown on the sheetrock in Room 10TS5 often indicate the initial stage of underlying mold growth. In this case, however, the core sample obtained was negative.
