Kansas City, Missouri Airport Traffic Control Tower (MCI ATCT)

Post Mold Remediation Clearance Report

Report on Mold and Moisture Inspection
Kansas City International Airport
Airport Traffic Control Tower

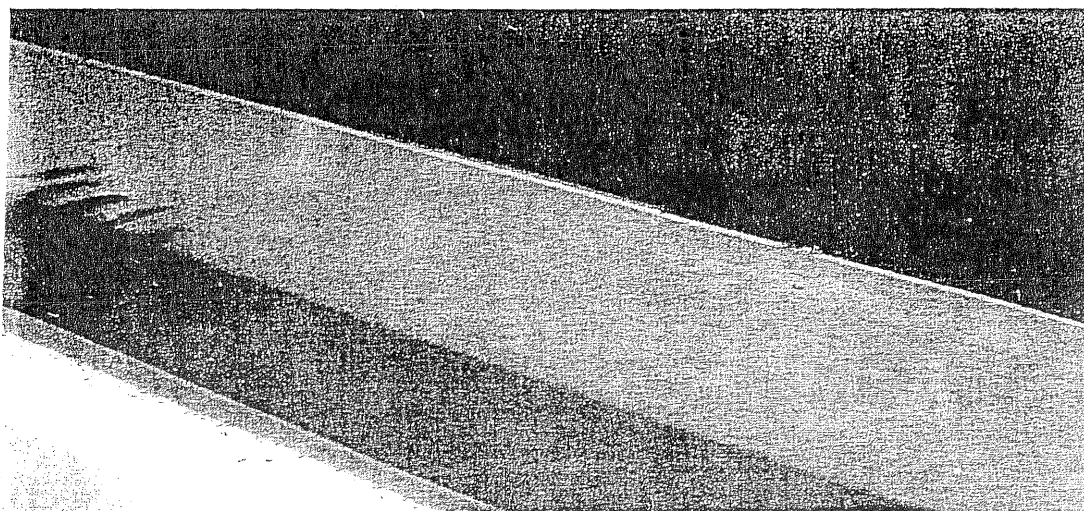
Photo 60: Stairway, Between Junction and Sub Junction Levels, Window Ledge. *Alternaria* (123 counts/cm²), *Ascospores* (31 counts/cm²), *Basidiospores* (31 counts/cm²), *Cladosporium* (108 counts/cm²), *Epicoccum* (62 counts/cm²), *Nigrospora* (15 counts/cm²), and *Smuts* (31 counts/cm²) were detected on the horizontal aluminum ledge of the window. HEPA-vacuuming, followed by biocide cleaning measures, will be required in the areas represented by these sample locations.

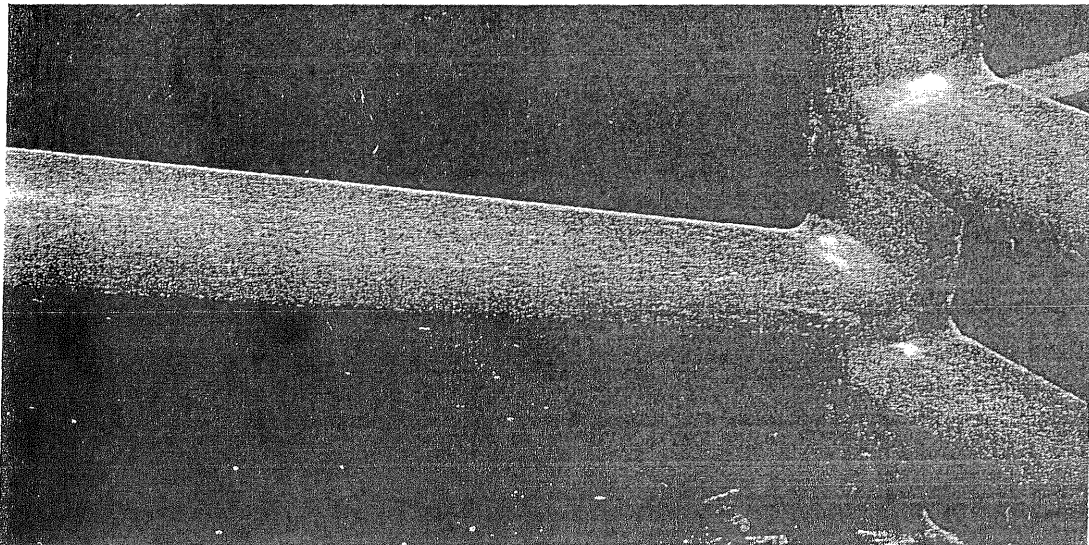
Photo 62: Stairway, Between Junction and Sub Junction Levels, Dusty Handrail.
A dusty handrail is shown above the gypsum board cover in Photo 61.
