Better Contract Oversight Could Have Prevented  
Deficiencies in the Detention Facility in  
Parwan, Afghanistan

SUBJECT: Better Contract Oversight Could Have Prevented Deficiencies in the Detention Facility in Parwan, Afghanistan (Report No. DODIG-2012-089)

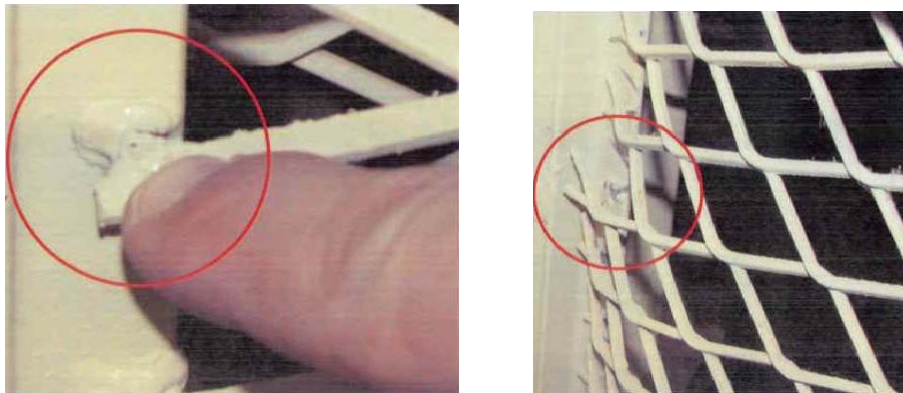
**Figure 1. Examples of Poorly Welded Cell Grates**

In a Construction Quality Presentation in July 2010, Task Force Rocky Mountain officials stated that the construction quality was not up to the standard suitable for a detention facility, and that the quality of construction of greatest interest was the areas where the detainees spent most of their time such as detention cells and the recreation yard. The presentation went on to say that the poorly constructed cell doors allowed detainees to damage the doors easily by repeated kicking. Figure 1 shows examples of the poor welding and Figure 2 shows the damage to the cell doors caused by the detainees because of the poor construction.

*The poorly constructed cell doors allowed detainees to damage the doors easily by repeated kicking.*

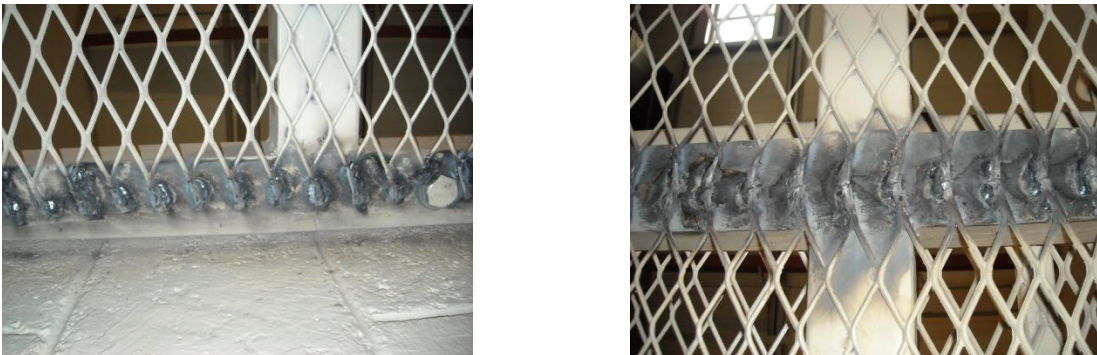
**Figure 3. Re-Welded Cell Doors**

According to the Task Force Rocky Mountain presentation, the quality of welding required the facility engineers to do extensive rework. Figure 3 shows the rework that DoD OIG engineers inspected in July 2010.

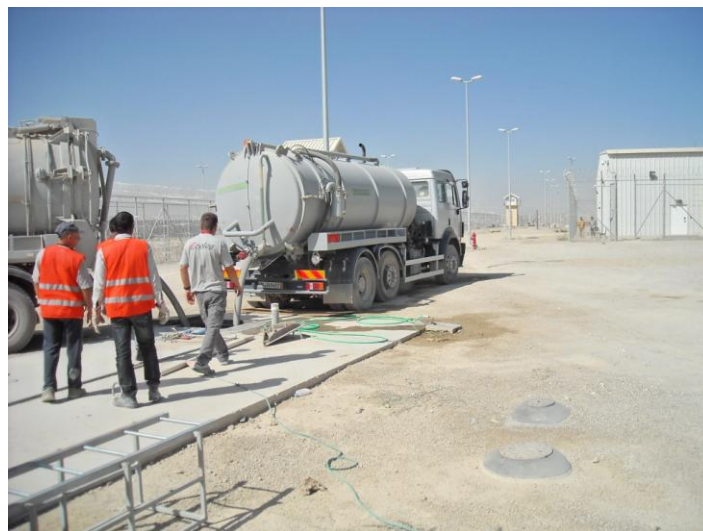
**Figure 6. Trucks Collect Sewage**

The contractor built the sewage system with two lift stations designed to allow sewage to pass from the detention facility to the two lift stations located in the DFIP secure courtyard. The two lift stations located in the courtyard would then pump the sewage uphill through transfer lines to a collection point located outside the detention facility. Once at the collection point, sewage trucks collect the sewage for disposal, as shown Figure 6.

According to DoD OIG engineers, who inspected the sewage system in July 2010, the two lift station pumps located in the DFIP courtyard were not built with grinders and were not operational. The lack of grinders caused the sewage to solidify because of the non-organic materials, such as uniforms, being flushed down the toilets by the detainees. Once the sewage hardened inside the lift station, the waste level began to rise above the sewage lines

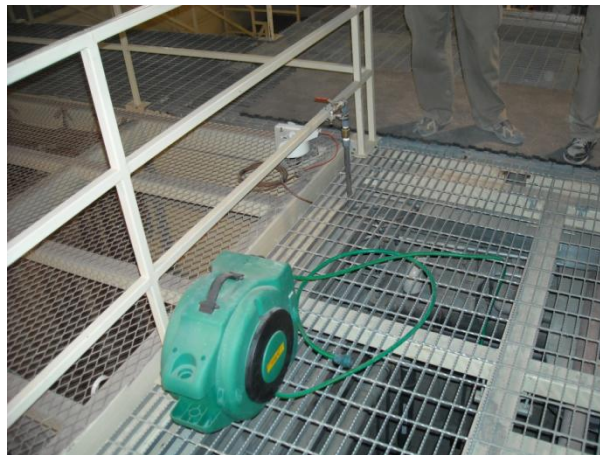
**Figure 8. Interim Fix to Fire Suppression System**

garden hoses above some of the detainee cells to help fight a fire should one occur. Figure 8 shows a garden hose located above the detainee cells.

However, the garden hose was not attached to a water source and would be useless in the event of a fire. The lack of a fire suppression system not only puts the detainees at risk, but also the soldiers who guard them.

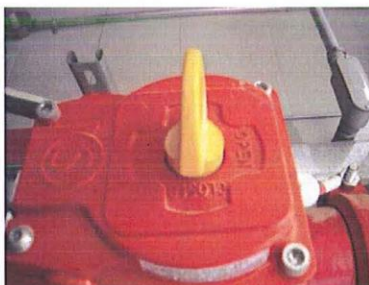
**Figure 1. Fire suppression valve turned off in Medical Holding Unit at DFIP**

USACE AED-N personnel provided documentation showing that on March 14, 2010, the fire suppression system was disabled. On March 14, 2010, PPI in an email to JTF-435<sup>th</sup> personnel outlined their process to identify and correct the issues with the sprinkler lines. However, during a walk through of the DFIP on July 19, 2010, we determined that the fire suppression system was still disabled in all buildings on the compound. For example, Figure 1 shows the fire suppression valve in the Medical Holding Unit turned to the closed position.

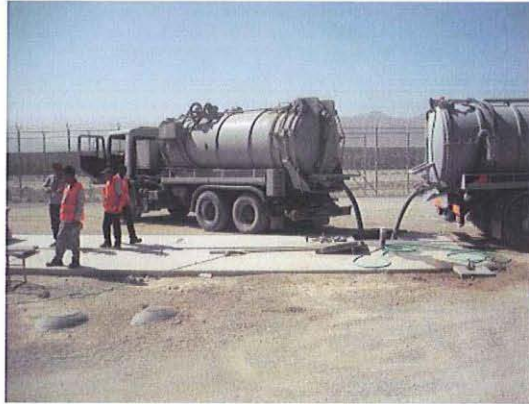
**Figure 4. Contractor trucks removing sewage from DFIP lift stations.**

To prevent the two sewage lift stations from overflowing, Fluor must bring four sewage removal trucks (see Figure 4) a day into the compound. Because the DFIP is a secure location, every time the trucks have to enter the facility the risk of a security incident increases.

To maintain the health and security of the individuals working and housed at the DFIP, USACE AED-N should require the contractor to immediately repair the lift stations in accordance with the warranty provisions in the contract and ensure the lift stations meet the requirements set forth in the contract.
