INPO 11-005
November 2011

Special Report on the Nuclear Accident at the Fukushima Daichi Nuclear Power Station

Revision 0

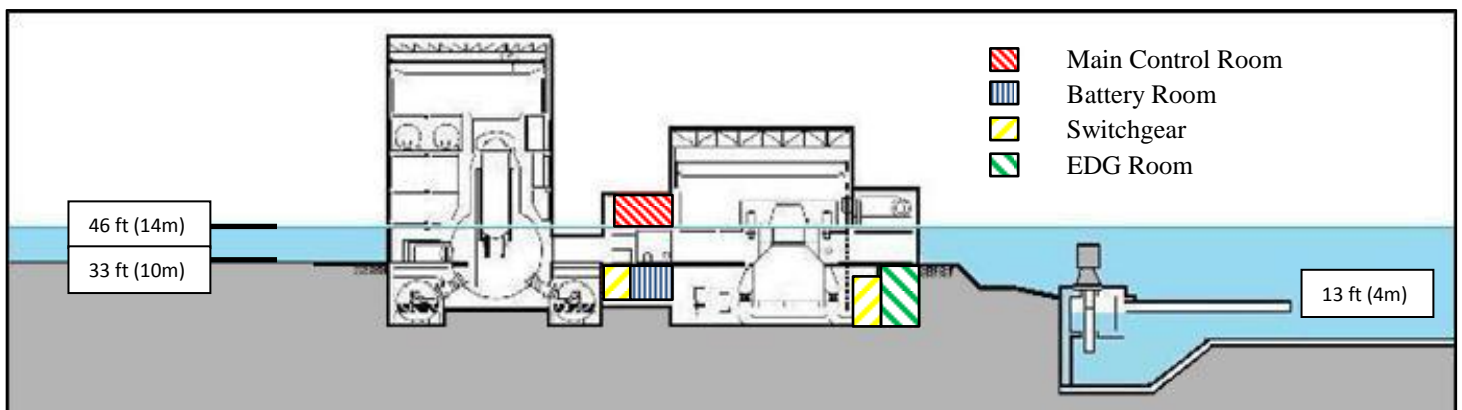
Figure 3.3-1 General Elevations and Inundation Level

The tsunami inundated the area surrounding units 1–4 to a depth of 13 to 16 feet above grade (4 to 5 meters), causing extensive damage to site buildings and flooding of the turbine and reactor buildings. Intake structures at all six units were unavailable because the tsunamis and debris heavily damaged the pumps, strainers, and equipment, and the flooding caused electrical faults. The damage resulted in a loss of the ultimate heat sink for all units. The diesel generators operated for a short time; but by 1541, the combination of a loss of cooling water, flooding of electrical switchgear, and flooding of some of the diesel generator rooms (located in the basement of the turbine buildings and not designed to withstand flooding) caused a loss of all AC power on site for units 1–5. (Refer to Figure 7.4-7.)

Figure 3.3-1 shows the general elevations (typical for units 1–4) and the approximate inundation level. The grade level of units 1–4 is 32.8 feet (10 meters) and is 42.7 feet (13 meters) at units 5 and 6 above mean sea level (commonly referred to as OP, for the level in the Onahama Port). The intake structures were at an elevation of 13.1 feet (4 meters) for all units.

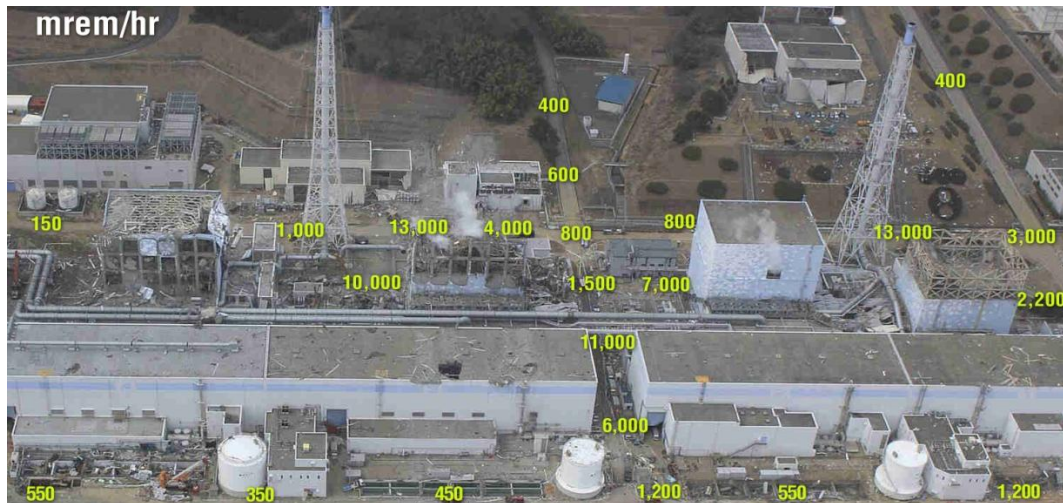
Figure 5.3-1 Site Dose Rates

On March 22 and 23, surveys of the airborne radioactivity and dose rates around the site began to be collected and documented. The dose rates are documented on Figure 5.3-1. Localized dose rates as high as 1,000 rem/hr (10 Sv/hr) were later discovered.

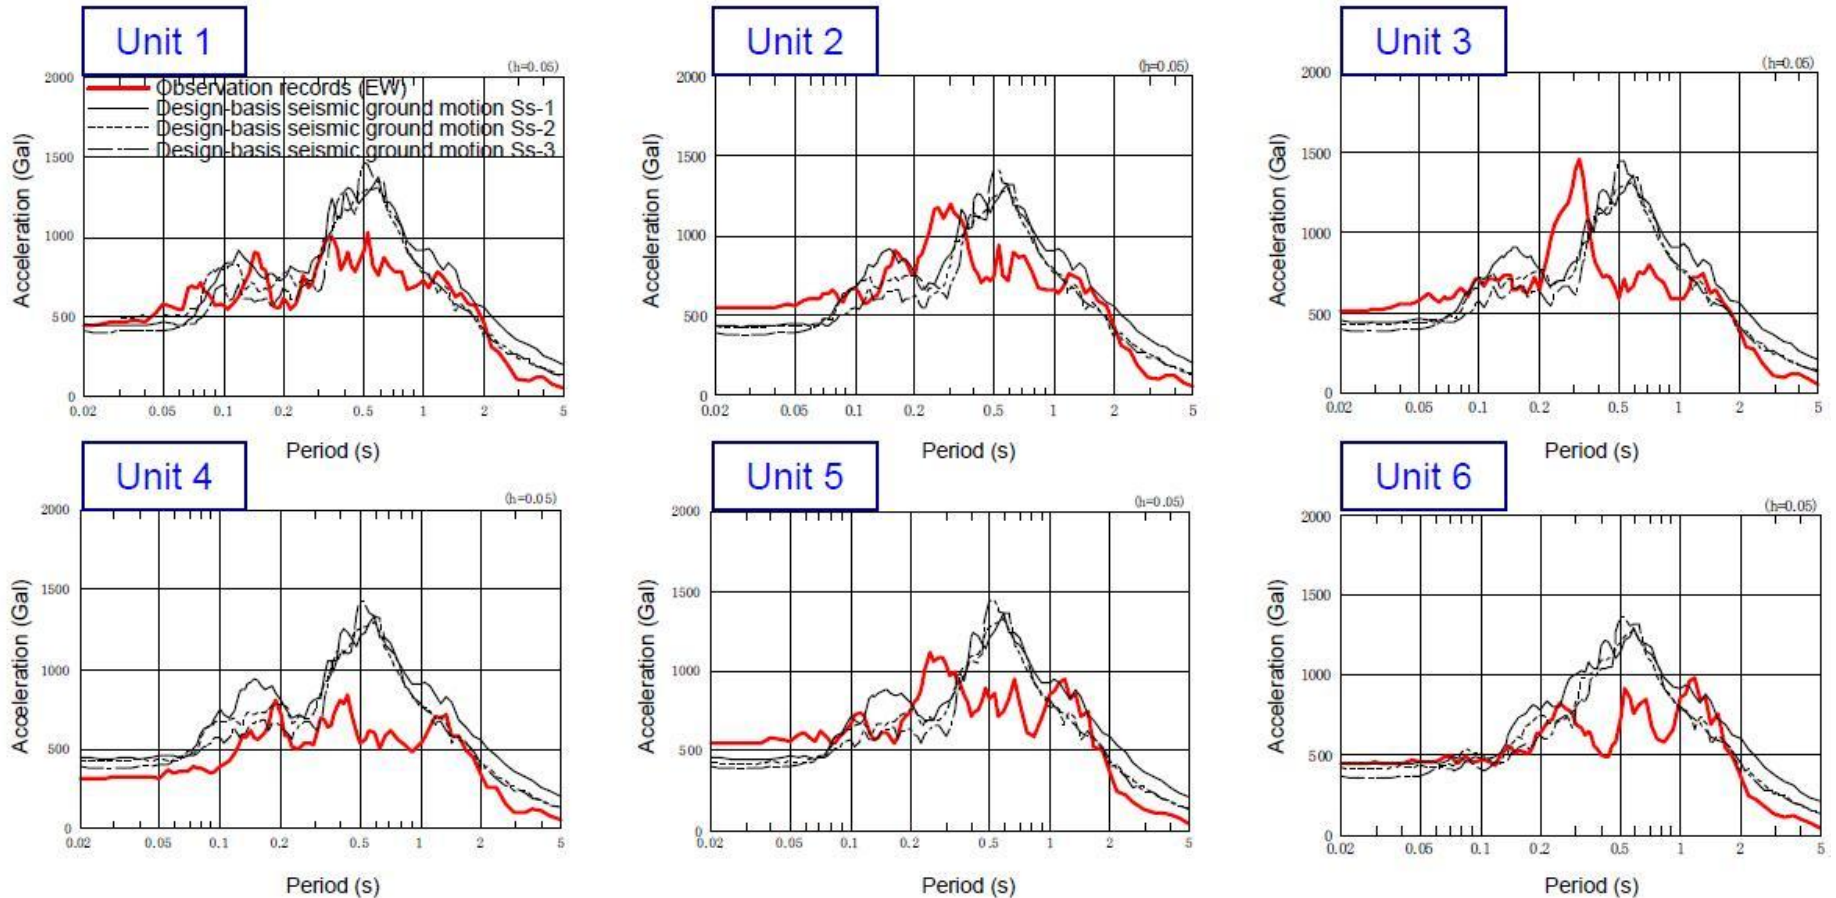
Figure 7.1-1 Preliminary Seismic Data

While no formal seismic walkdowns have been performed, a review of plant indications and operator logs does not indicate any seismic damage that affected the operator response to the earthquake. Before the tsunami, all emergency diesel generators that were operable started and loaded as expected, and each emergency core cooling system the operators used appeared to function as designed. Reactor pressure, reactor water level, and containment pressure indications for units 1, 2, and 3 appeared as expected following a scram and did not indicate any potential breach of the reactor coolant system from the earthquake.

Graphs indicate the observed values as compared to the design basis seismic criteria.
