Hanford BY-Farm Leak Assessments Report

Washington River Protection Solutions LLC

January 2011

Prepared for the U.S. Department of Energy
Office of River Protection

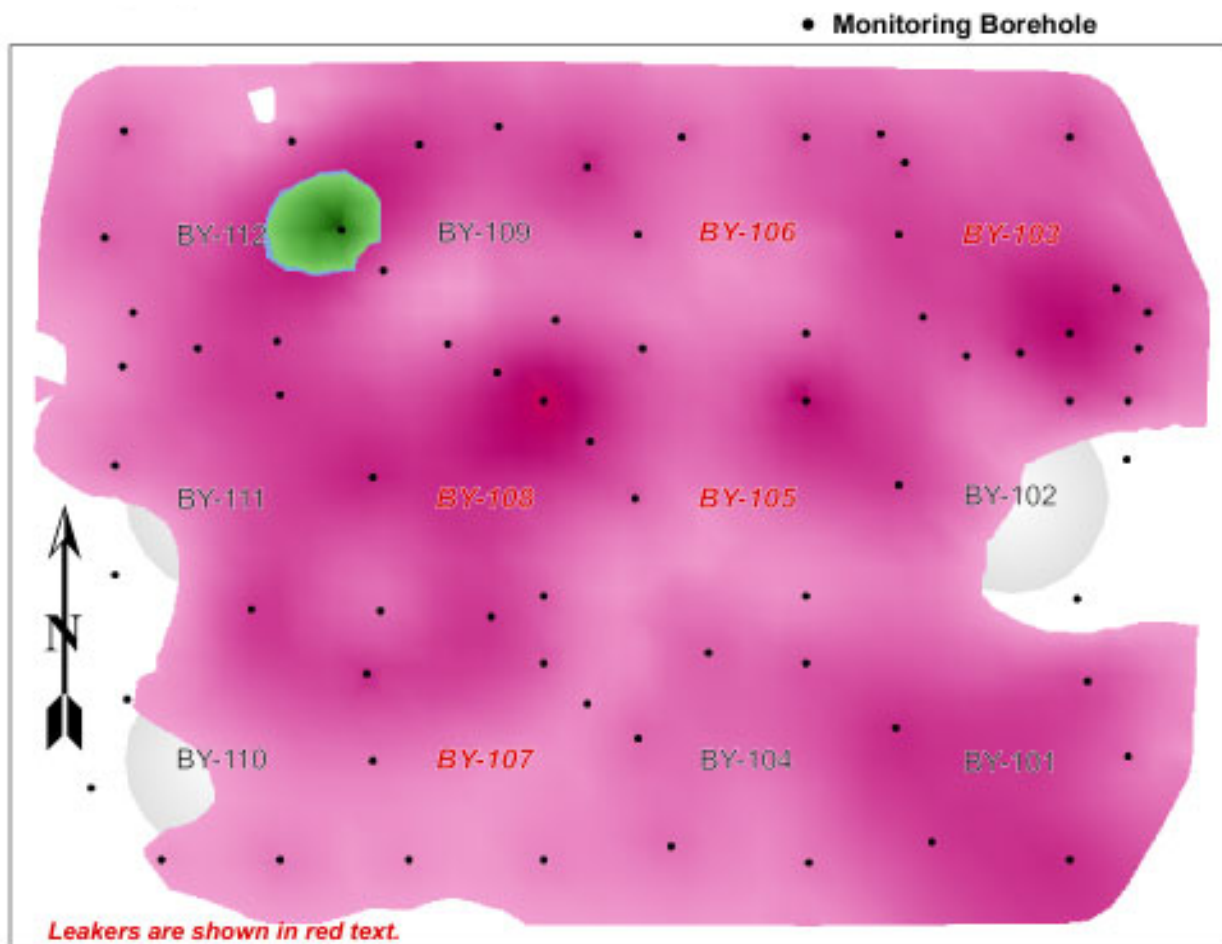
Figure 4-3. Visual Based on Drywell Logging Activity at 4 feet in 241-BY Tank Farm

Due to uncertainty of the liner integrity for ITS and ITS bottoms tanks, the leak assessment panel recommended that formal leak integrity assessments be conducted for all BY-Farm tanks including tanks currently classified as “sound” in HNF-EP-0182, except BY-103 (confirmed to have leaked in the past), per TFC-ENG-CHEM-D-42. The assessments are needed to support determination of technologies to retrieve waste and to determine a basis for inventory calculations from BY-Farm tanks in the future. Additional information for BY-Farm tanks currently classified as “sound” is included in Appendix C.

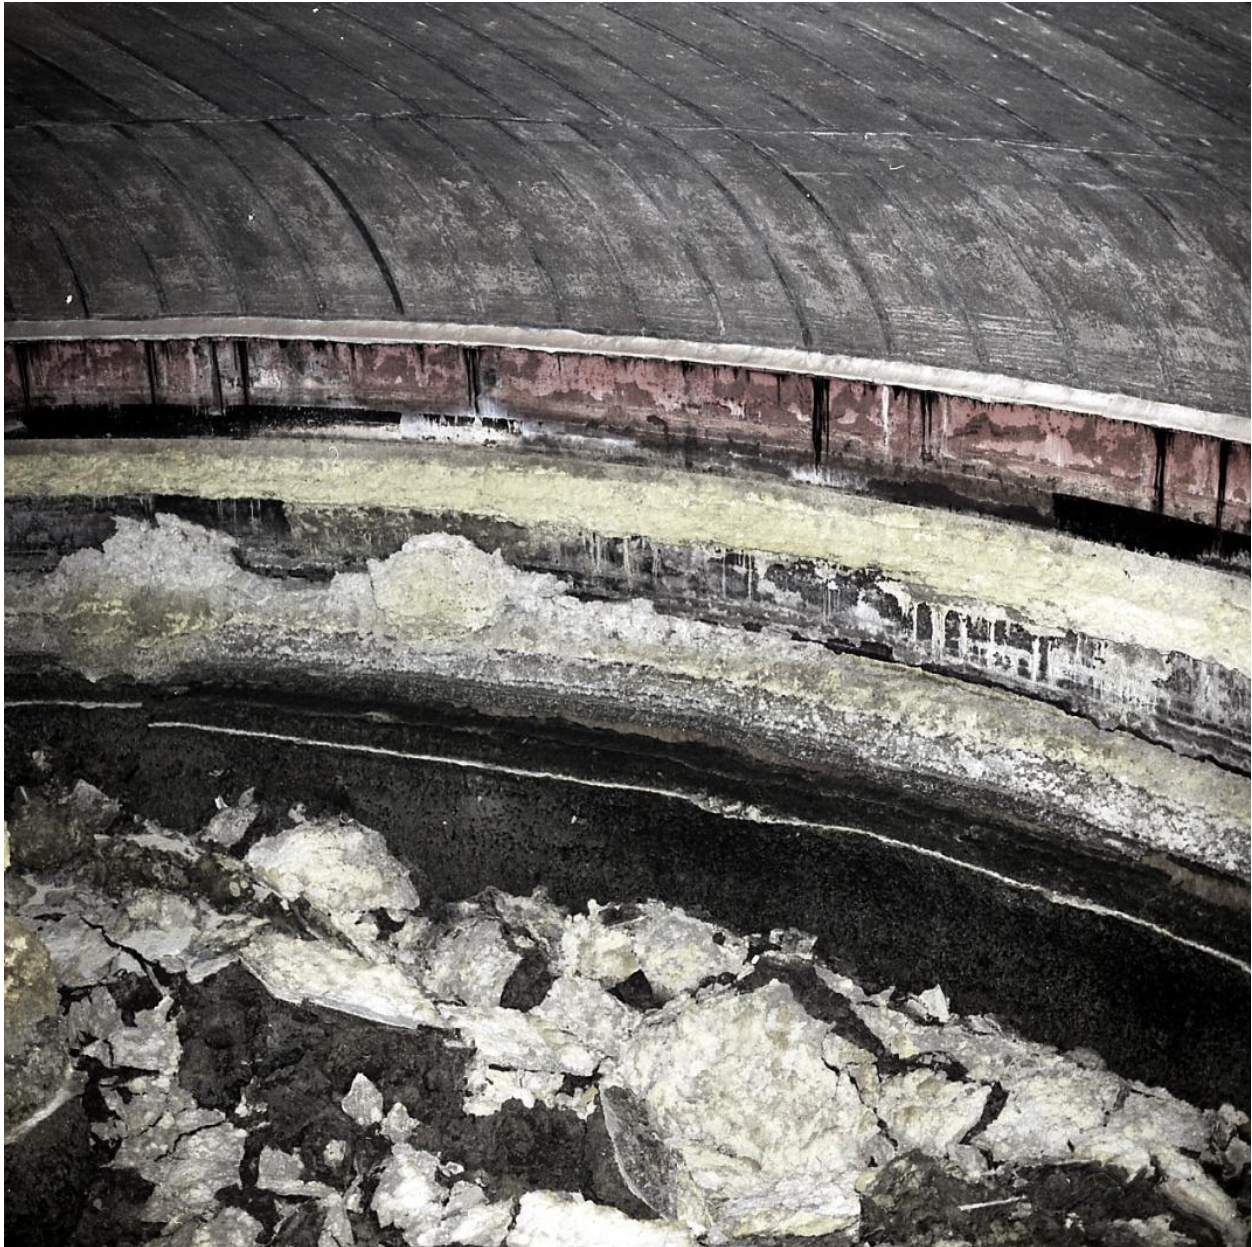
Figure 4-6. Tar Rings Photos for Tank 241-BY-108

Except as noted for tank BY-103, there was no basis to assign a leak inventory estimate for BY-Farm tanks at this time. Leak volume estimates are provided for some of the UPRs shown in Table 4-1. The SIM inventory estimates were determined to be reasonable for these releases.

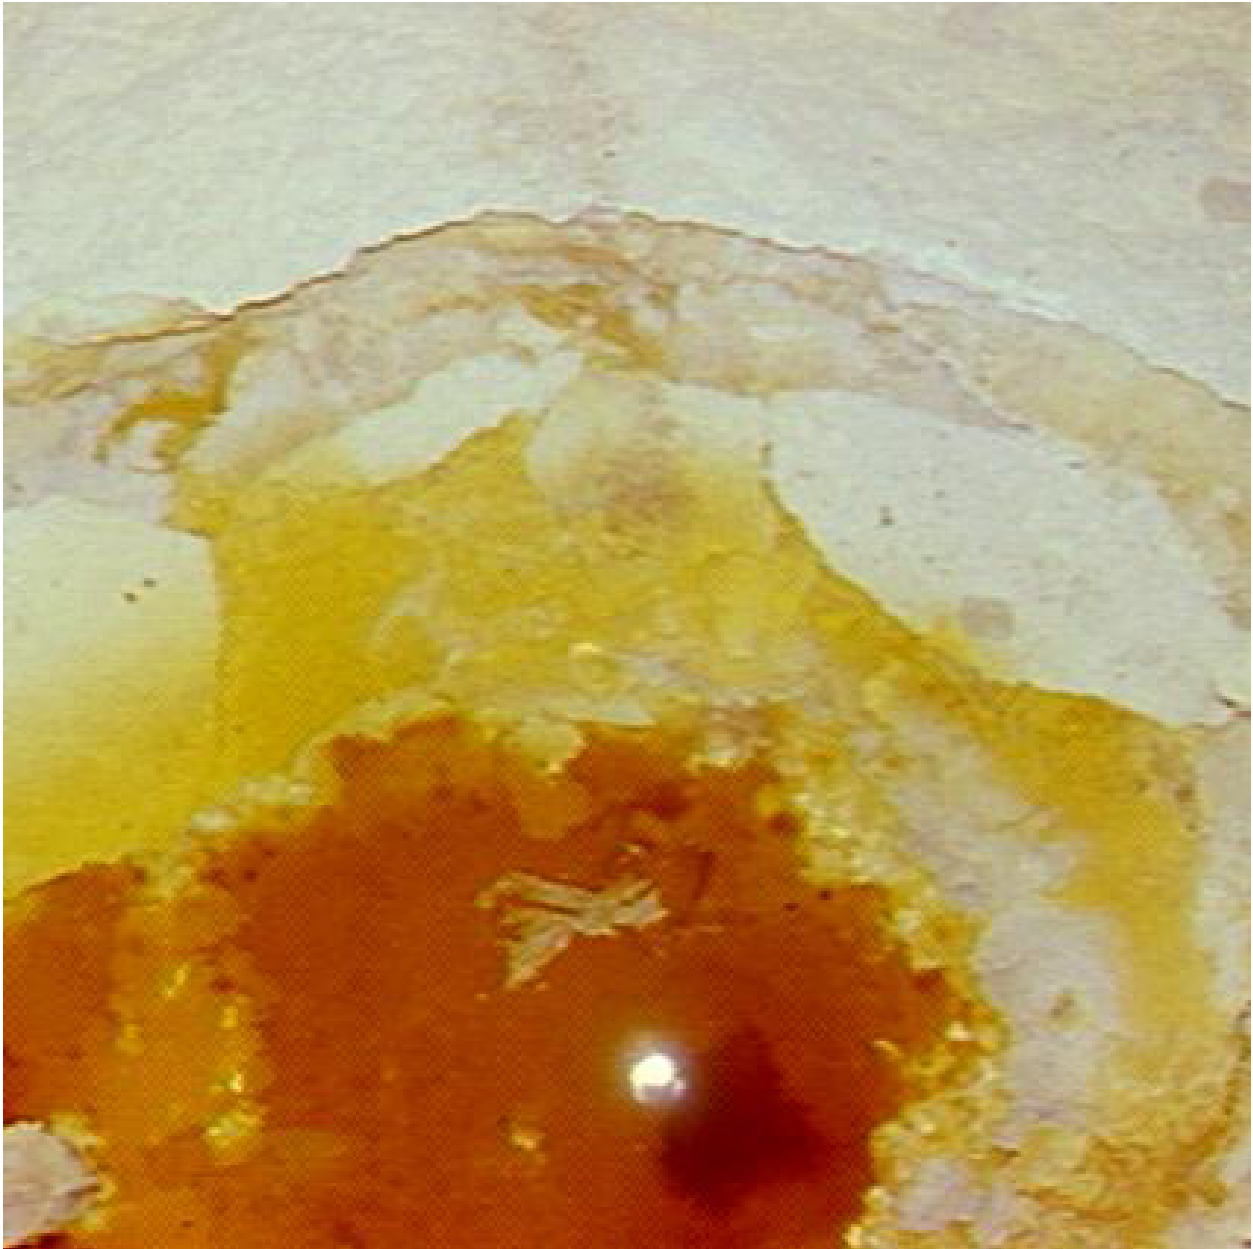
Figure B.2-6. Tank 241-BY-105 In-Tank Waste Surface Photo (July 1, 1986)

The 1966 cement additions may have contributed to “erratic” surface level measurements, as well as the shelves shown in Figure B.2-6 and observed in the video taken when the tank was interim stabilized. The SACS includes the following comments regarding tank BY-105 manual tape surface level measurements:

Note: Figure shows saltcake surface crust and multiple levels of shelves near the tank center.
