U.S. Department of Energy
Office of River Protection

P.O. Box 450, MSIN H6-60
Richland, Washington 99352

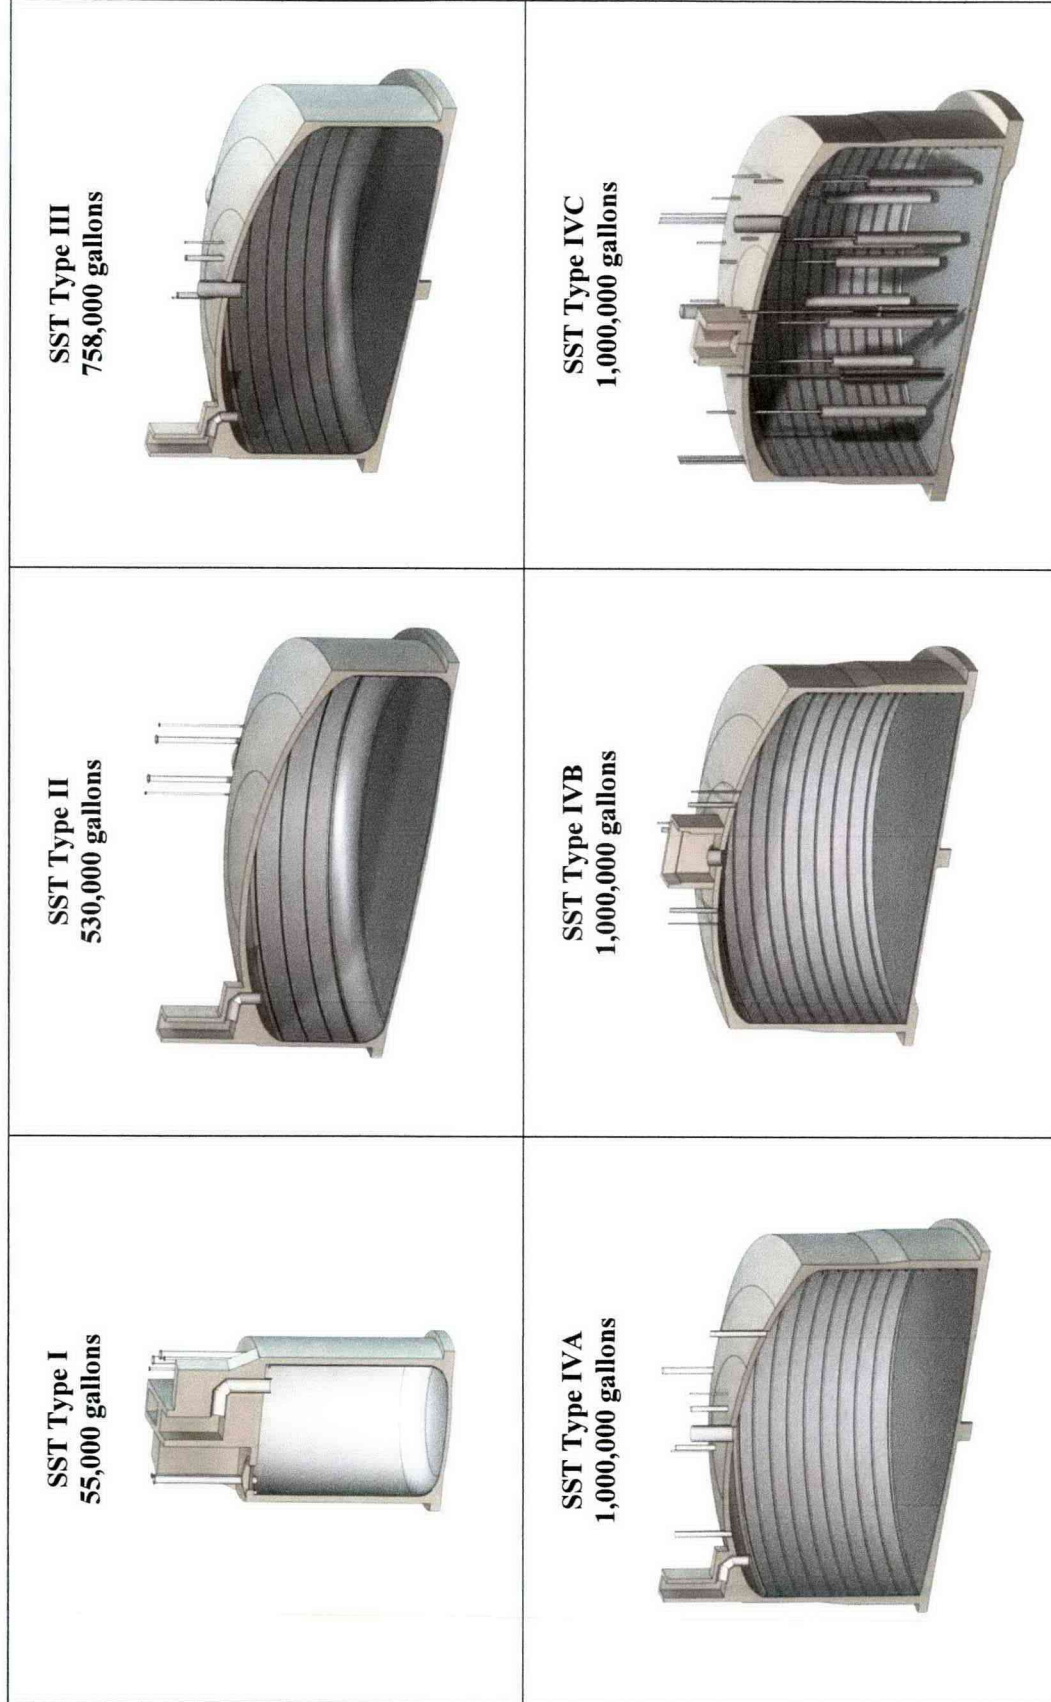
3.0 SCOPE OF SINGLE-SHELL TANK VISUAL INSPECTION

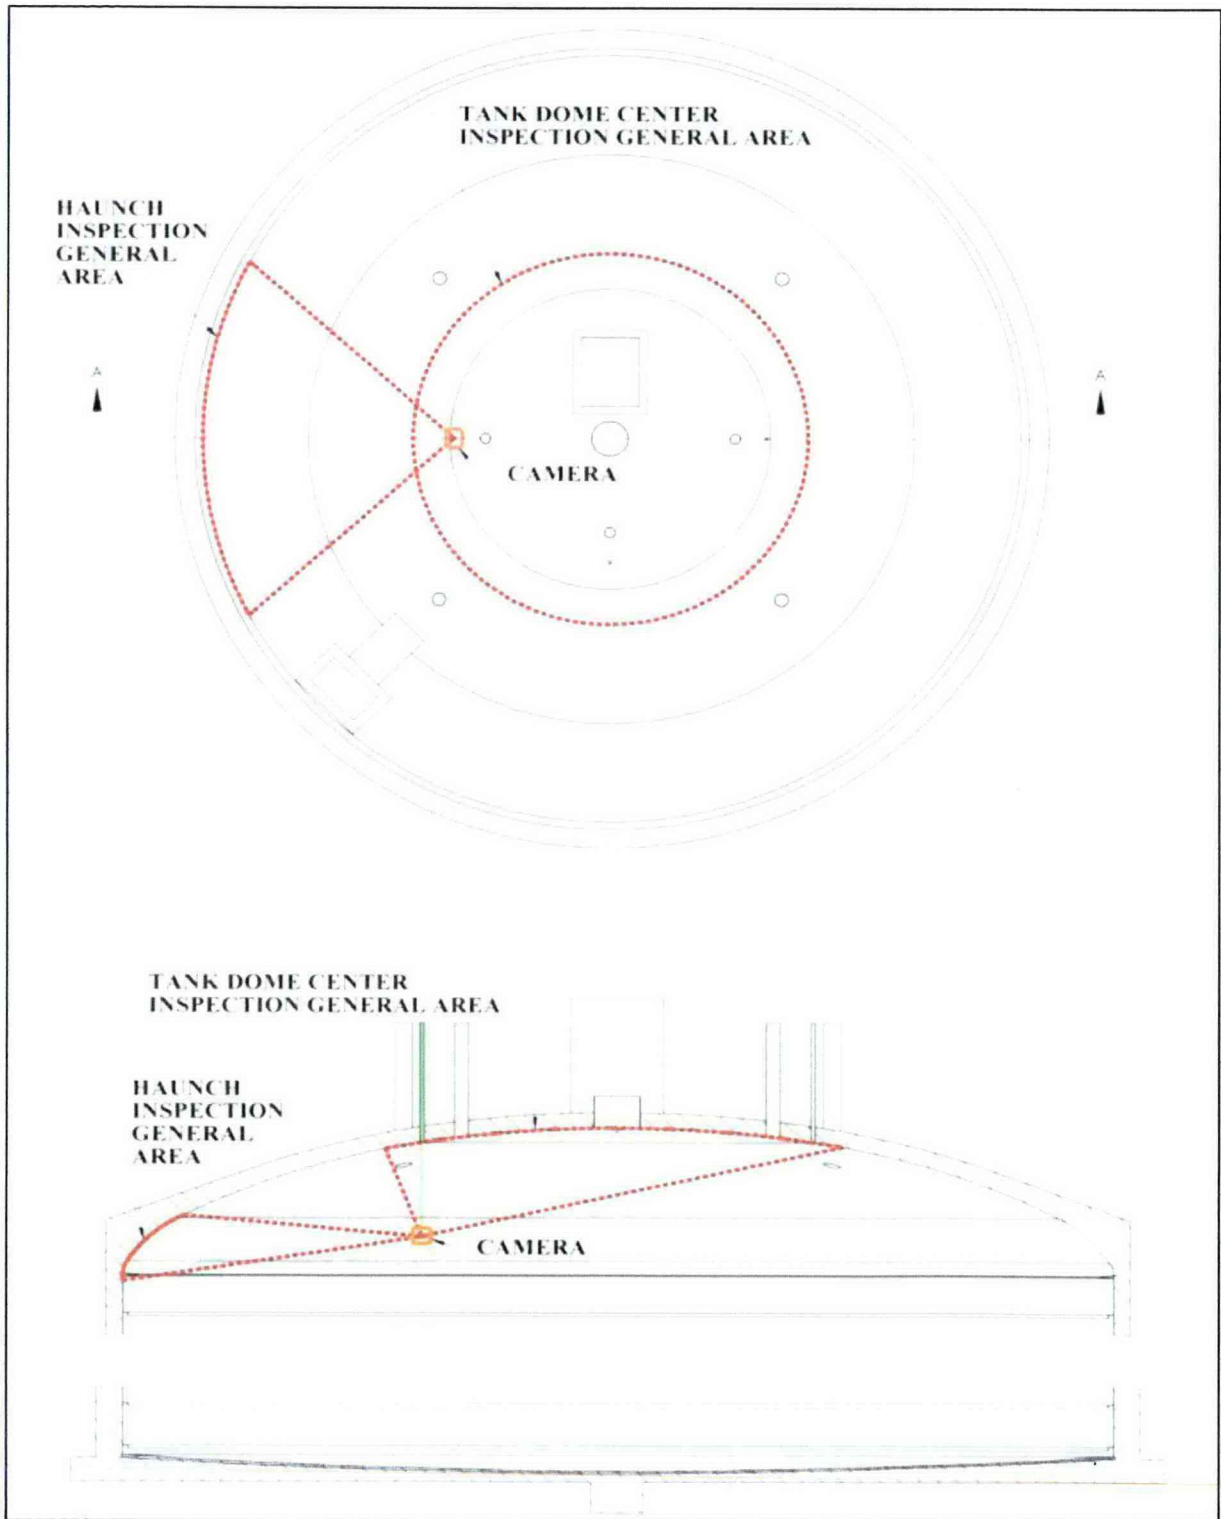
3.1 SINGLE-SHELL TANK VISUAL INSPECTION CRITERIA

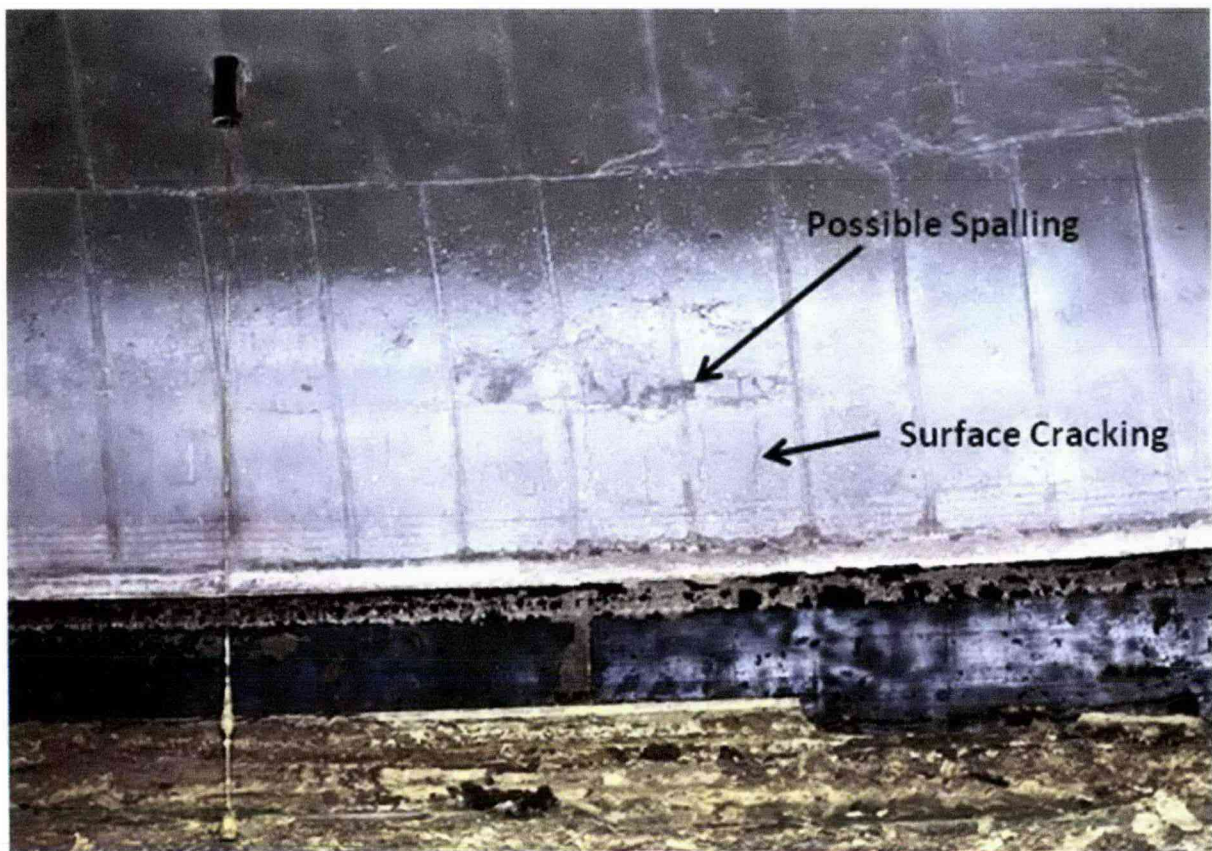
Figure 3-2: Possible Concrete Cracking and Spalling (Tank 241-S-112)¹

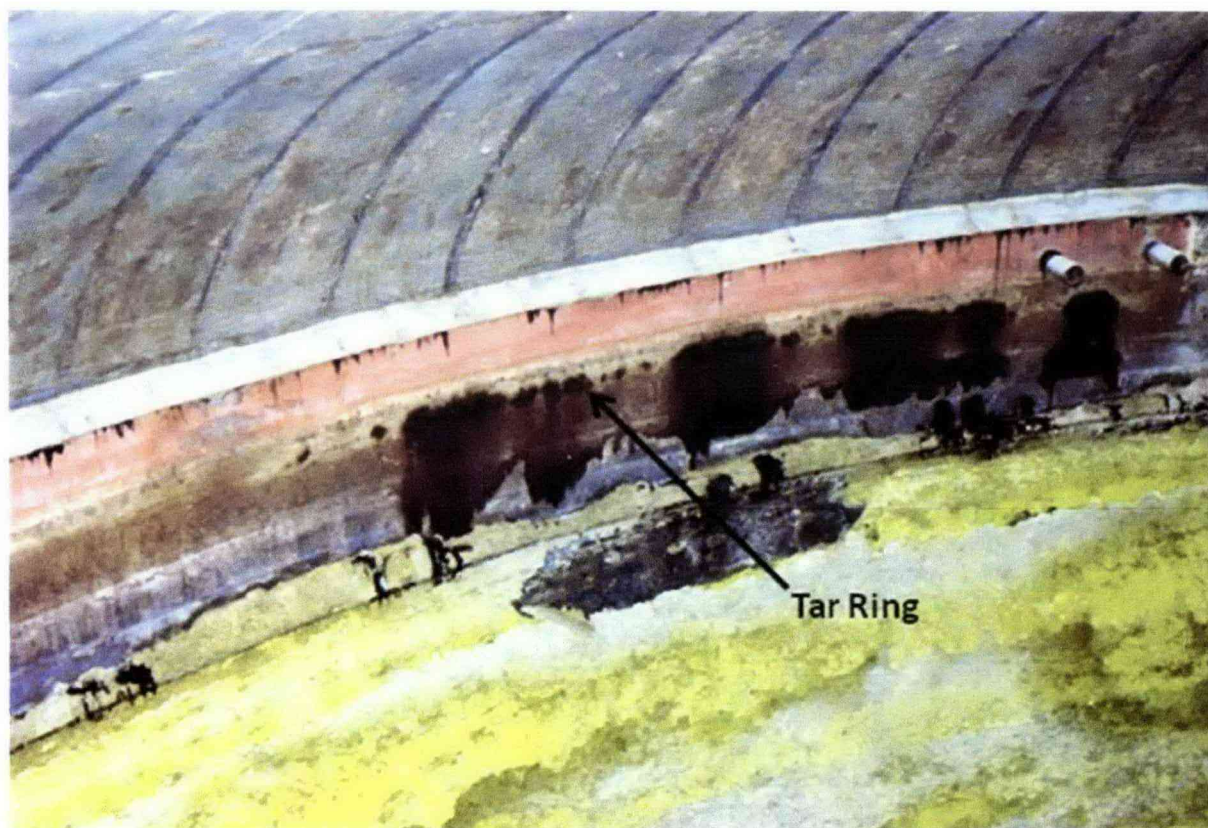
Figure 3-3: Tar Rings (Tank 241-BY-107)²

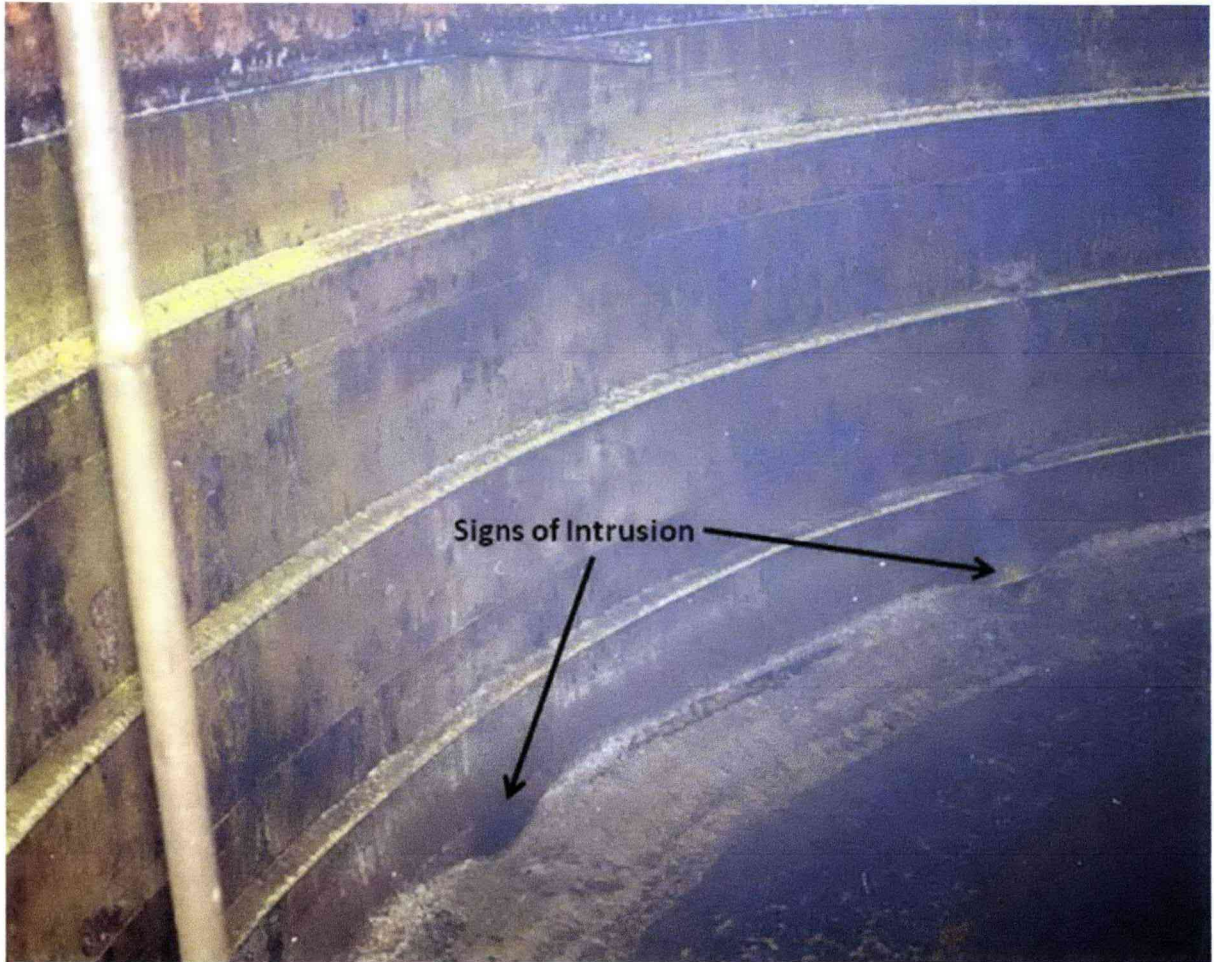
Figure 3-4: Signs of Liquid Intrusion (Tank 241-T-102)³

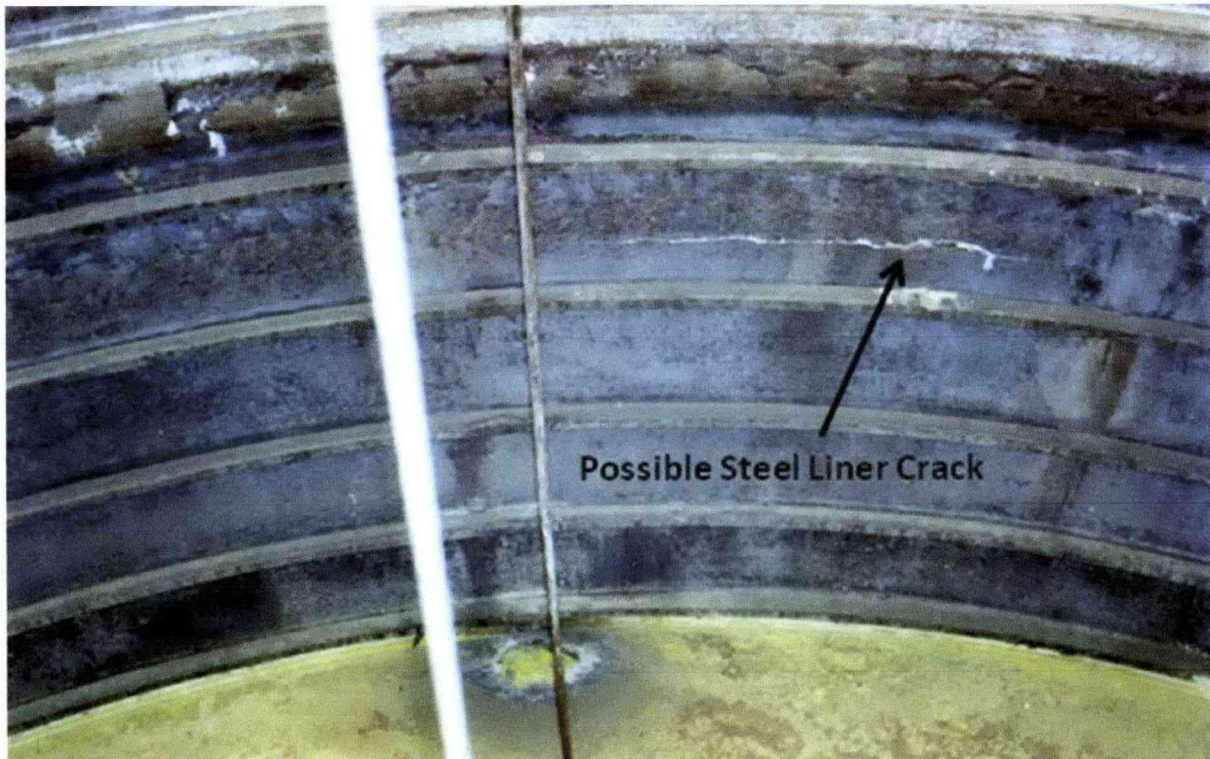
Figure 3-5: Possible Steel Liner Crack (Tank 241-SX-112)⁴

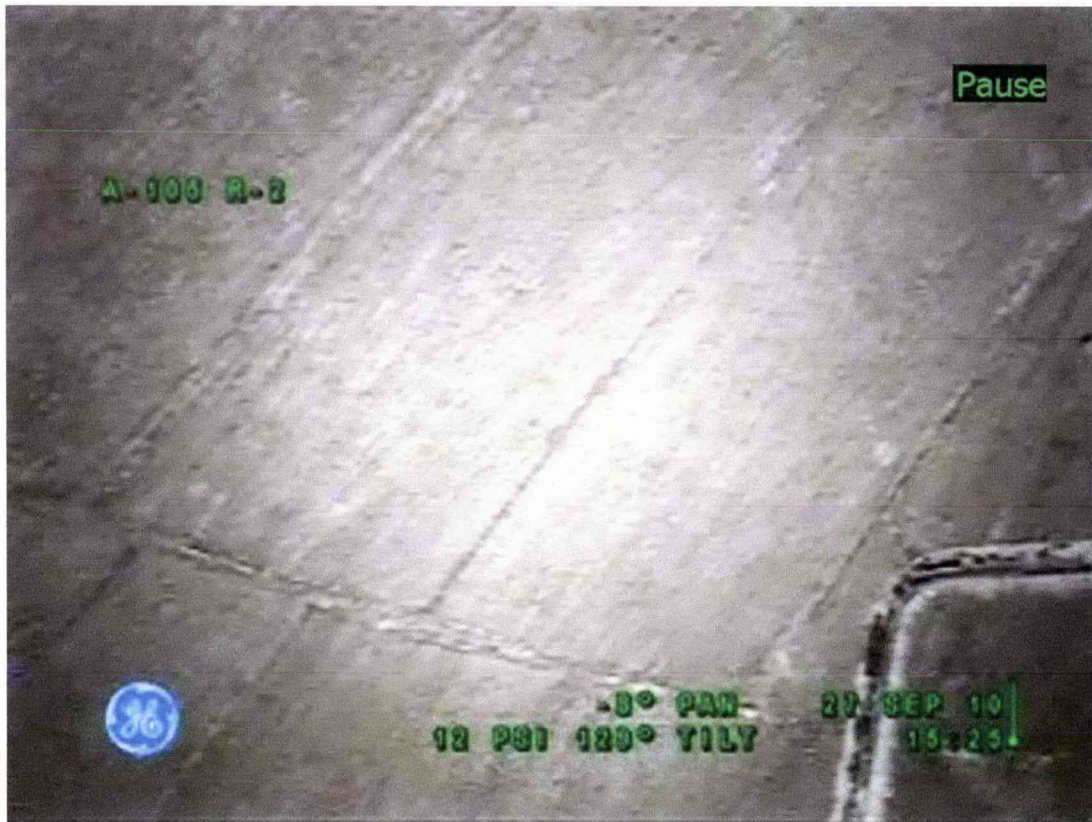
Several close-up pictures of the concrete dome have been compiled into one photograph to see the condition of the concrete as a panorama. This can be seen in Figure 5-2. This figure shows

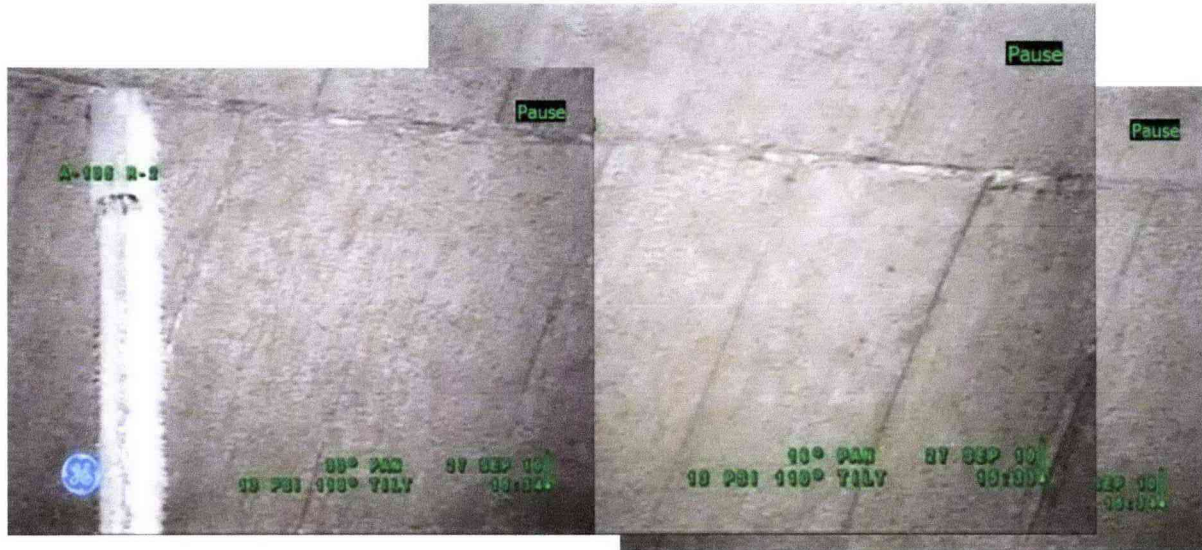
Figure 5-3 shows a horizontal linear anomaly in the tank's dome. Because it has a shape that does not appear random and stops at a fairly defined line, the most likely cause of this anomaly is a construction patch. Upon review of the complete footage, no critical visual anomalies were observed in the concrete that structures the dome of tank 241-A-105.

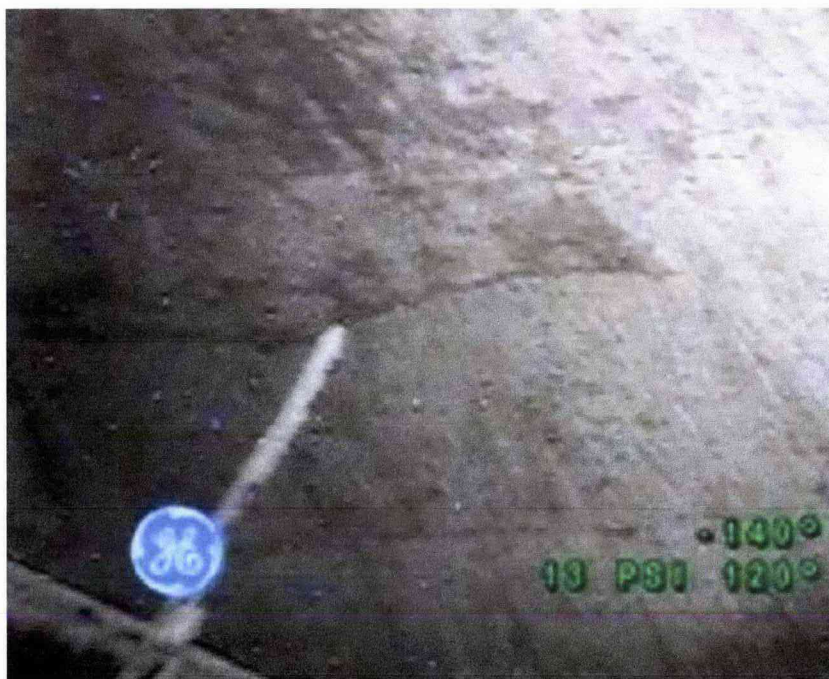
Figure 5-3: Concrete Anomaly

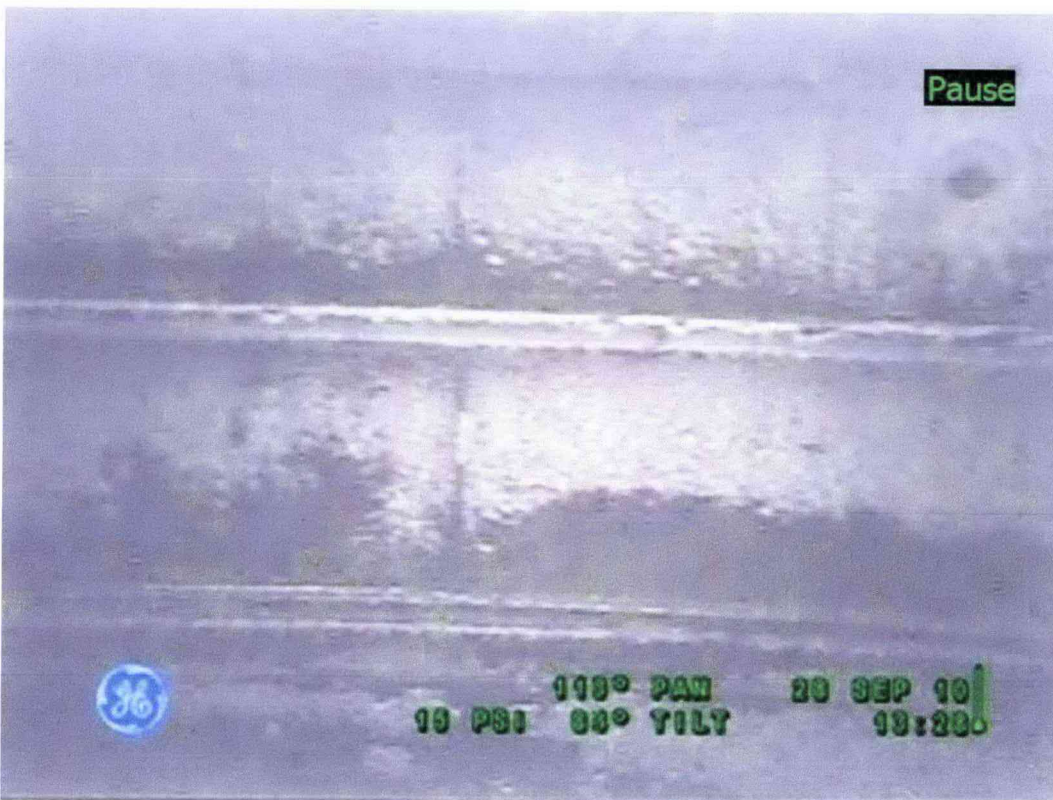
Several close-up pictures of the steel liner have been compiled into one photograph to see the condition of the steel liner and surrounding concrete as a panorama. This can be seen in Figure 5-5. This figure shows steel that appeared to be without any visual anomalies. Upon review of the complete footage, no critical visual anomalies were observed in the upper portion of the steel that lines tank 241-A-105. When compared to prior photos of the tank taken in the 1970s and

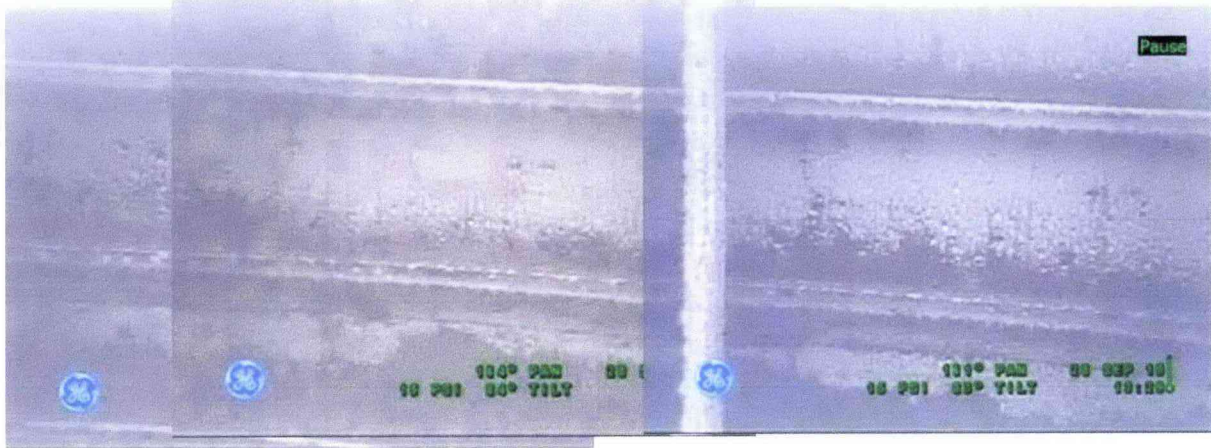
Figure 5-6: Tank 241-A-105⁵ in 1981

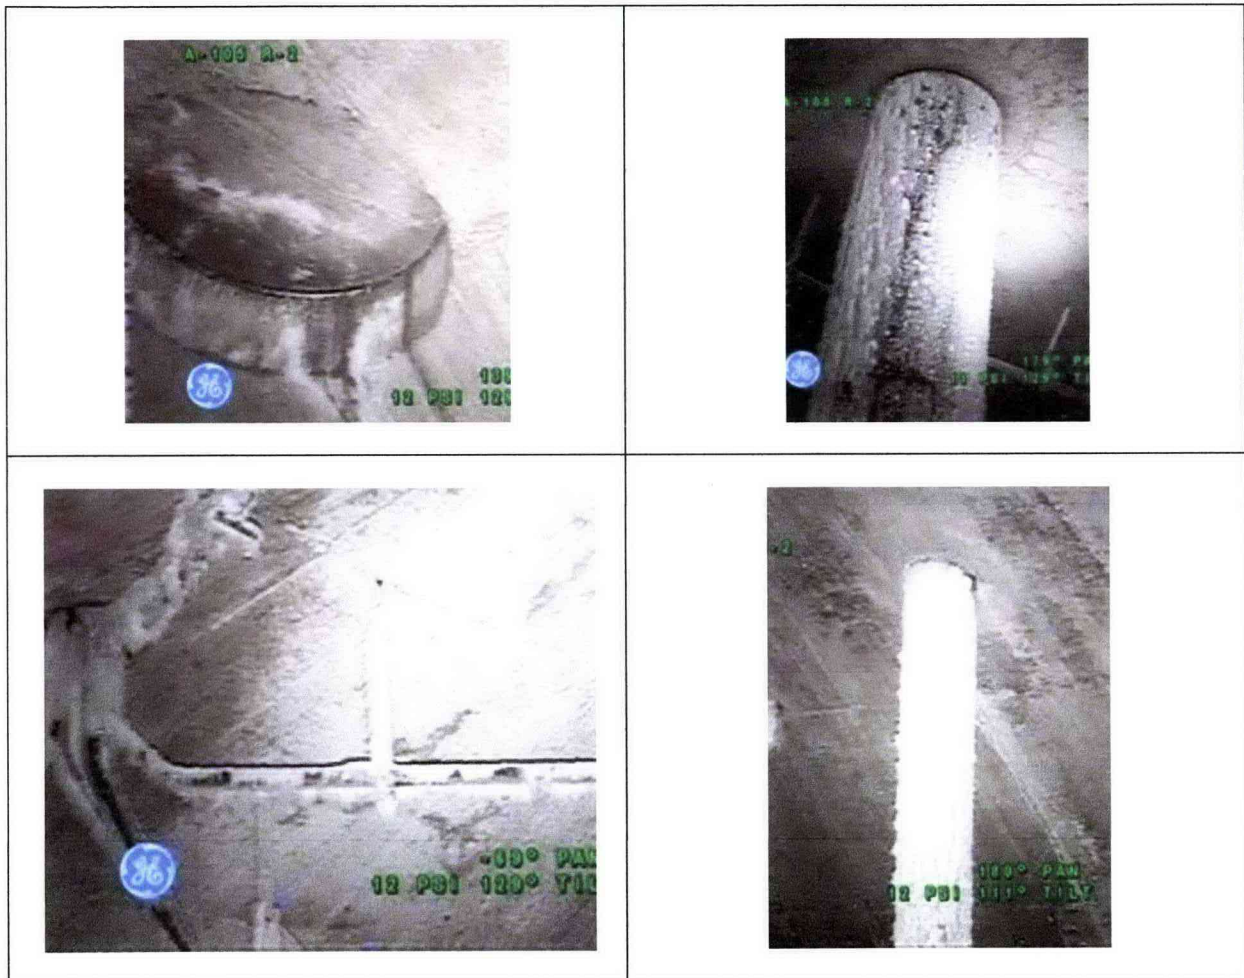
When compared to photos taken in 1981 such as Figure 5-8, it can be determined that the salt build up in the tank is more recent than the steam eruption. The likely source is a reaction in the vapor space of the tank.

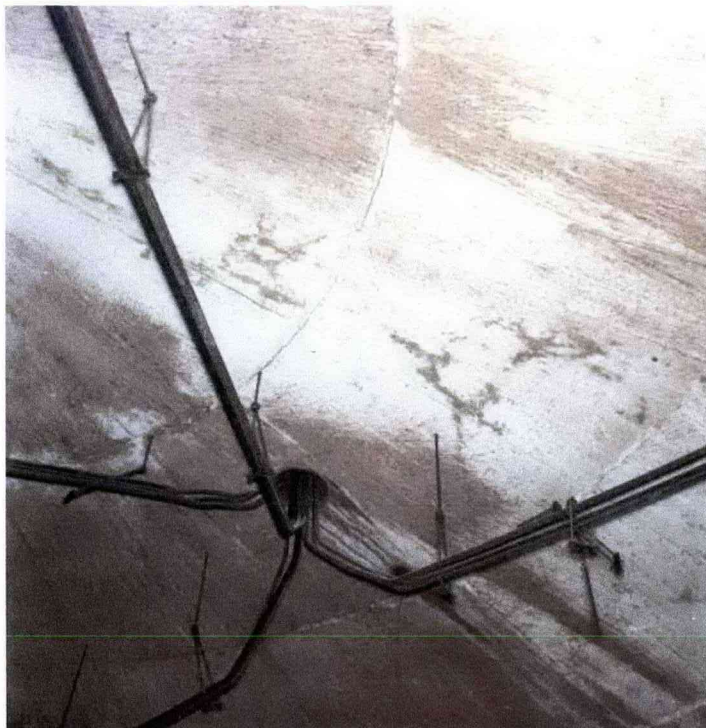
Figure 5-8: Tank 241-A-105 in 1981⁶

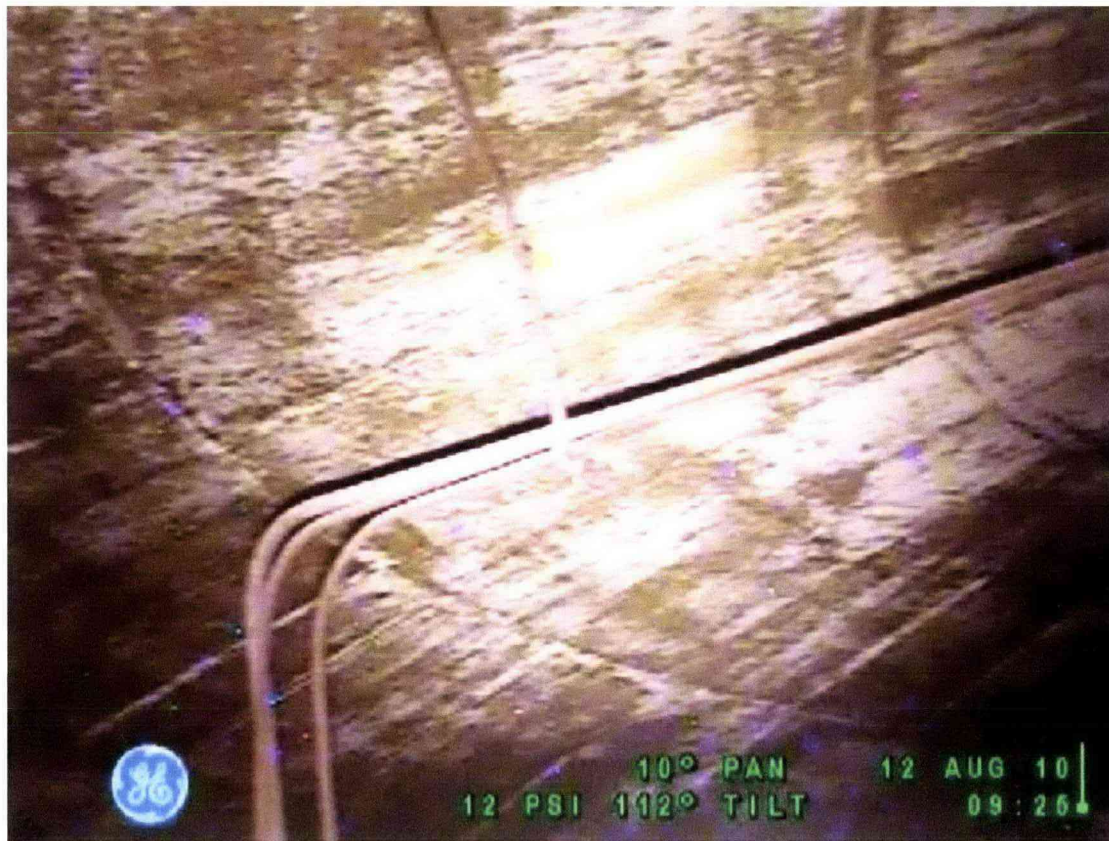
There were some difficulties with the available lighting and the amount of the tank's dome that could clearly be visually inspected. However, areas that could clearly be seen appeared to be in satisfactory condition.

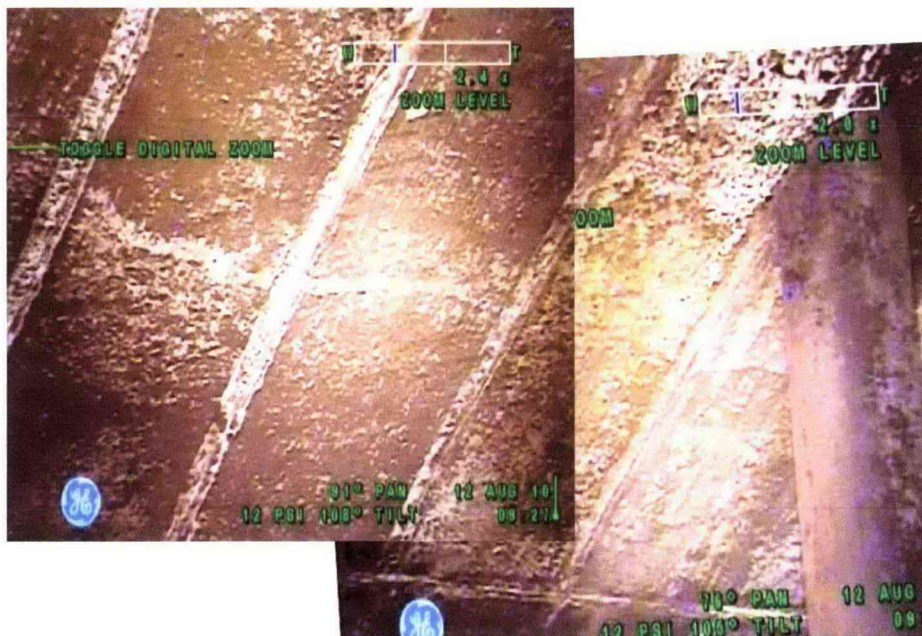
Figure 6-2: Compilation of Photographs of Tank 241-A-106 Dome

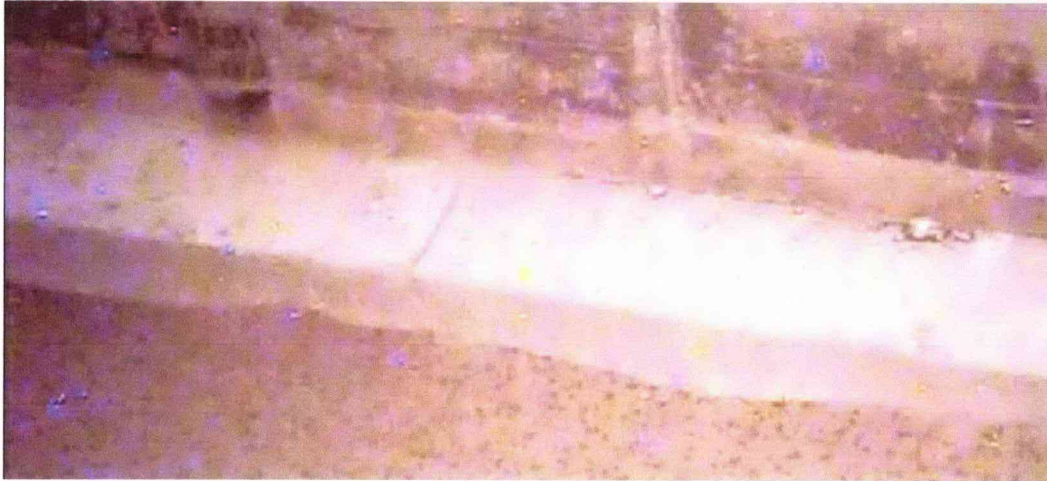
Several close-up pictures of the steel liner have been compiled to make one photograph to easier see the condition of the steel liner and surrounding concrete. This can be seen in Figure 6-4. This figure shows concrete with no visible cracks, spalling or other anomalies that might jeopardize the integrity of the tank. The steel also appeared to be without any visual structural anomalies. Upon review of the complete footage, no critical visual structural anomalies were observed in the concrete or the steel that lines tank 241-A-106.

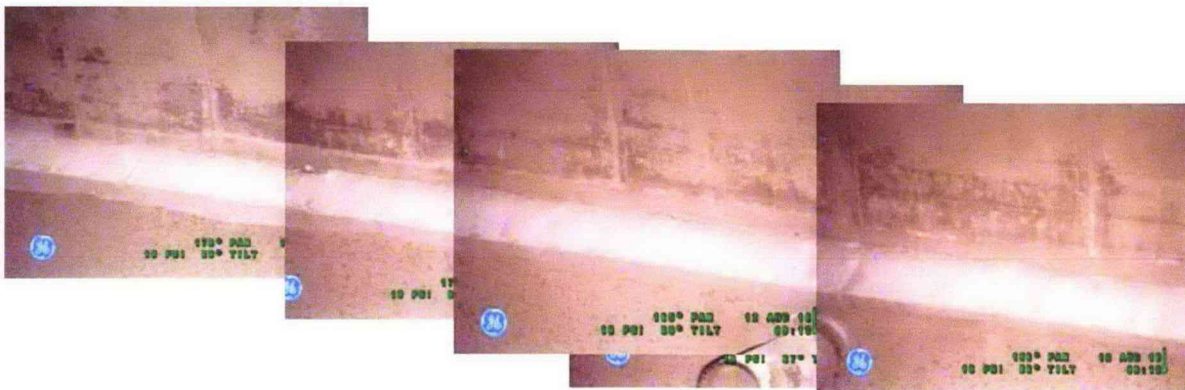
6.1.3 In-tank Equipment/Risers

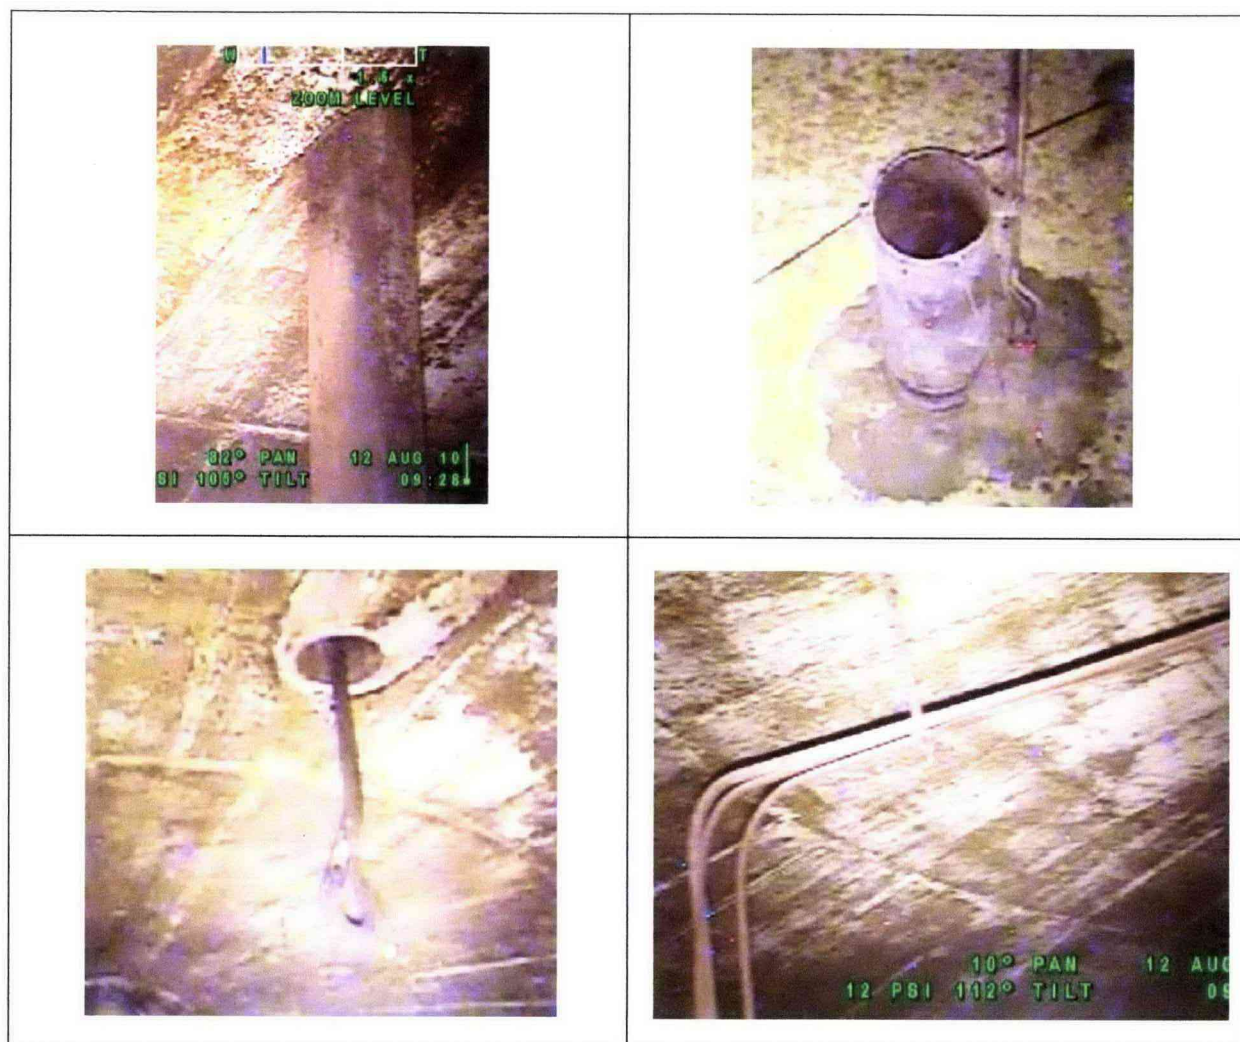
Figure 6-5: Tank 241-A-106 In-Tank Equipment/Risers

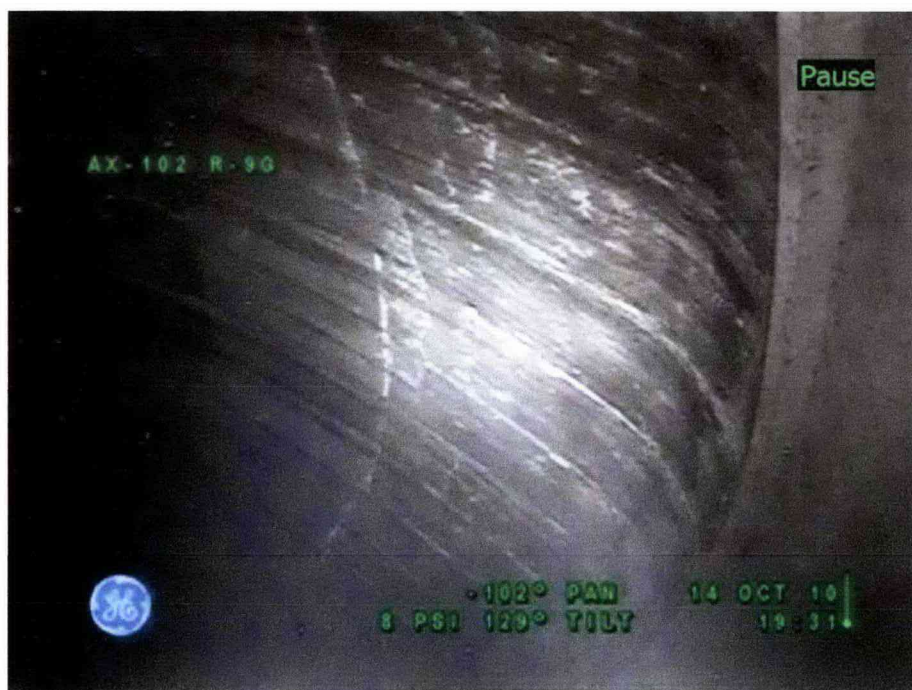
There were some difficulties with the available lighting and the amount of the tank's dome that could clearly be visually inspected. However, areas that could clearly be seen appeared to be in satisfactory condition.

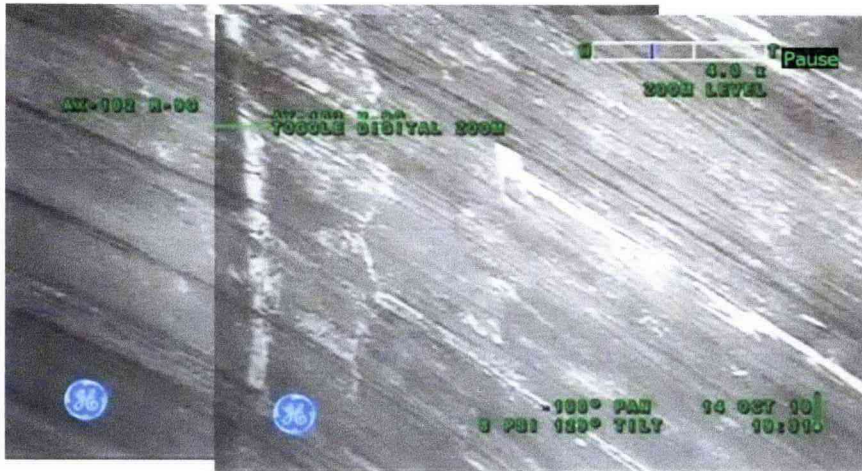
Upon visual inspection of the tank, some dissimilar areas were observed on the concrete dome. Figure 7-3 shows an area on the dome of the tank with irregular lines that do not appear to be cold joints. These linear anomalies run vertically and horizontally, which is not typical of a cold joint line. While this figure shows anomalies in the appearance of the tank's dome, they do not appear to be rust stains from rebar, spalling, cracking, or any other abnormality that might affect the integrity of the stability of the tank and therefore not considered to be structurally significant.

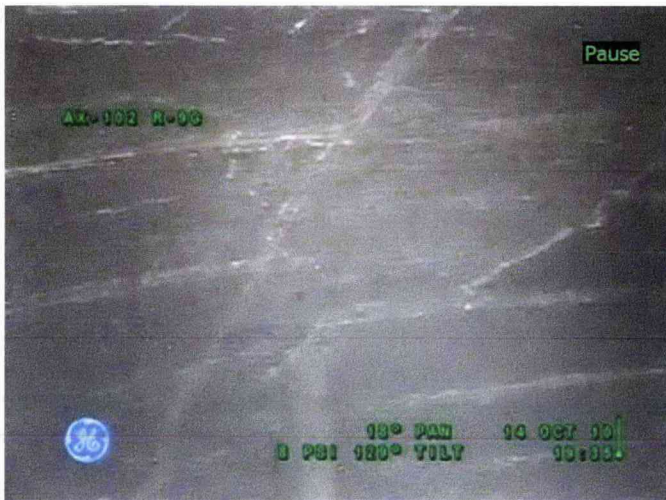
Figure 7-3: Concrete Anomaly

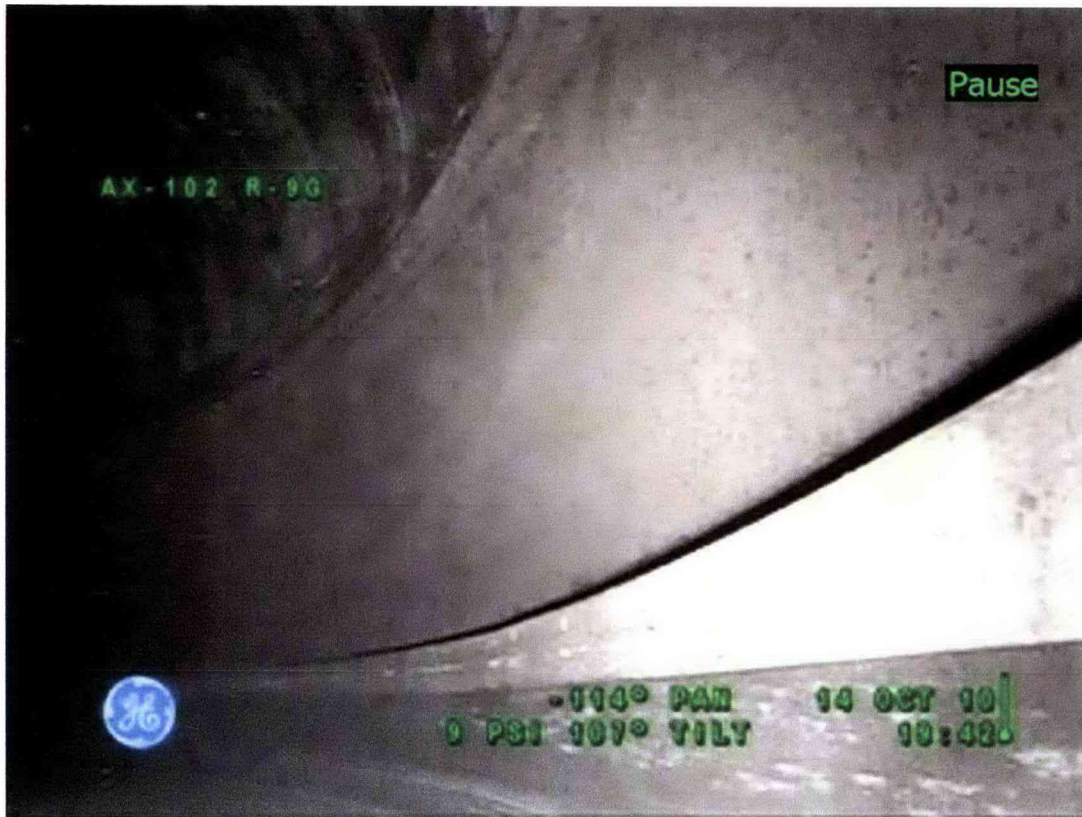
7.1.3 In-tank Equipment/Risers

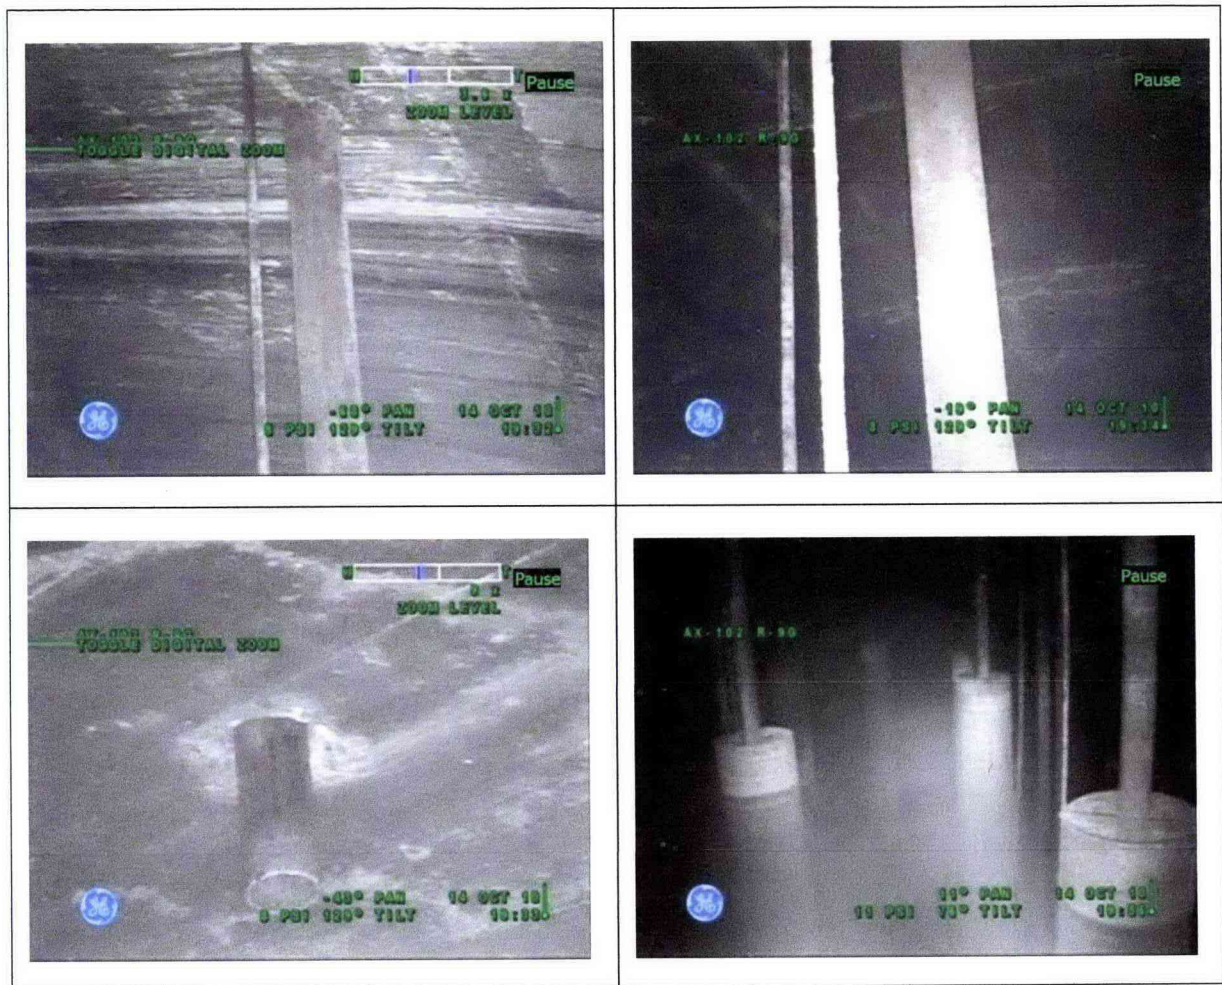
Figure 7-5: Tank 241-AX-102 In-Tank Equipment/Risers

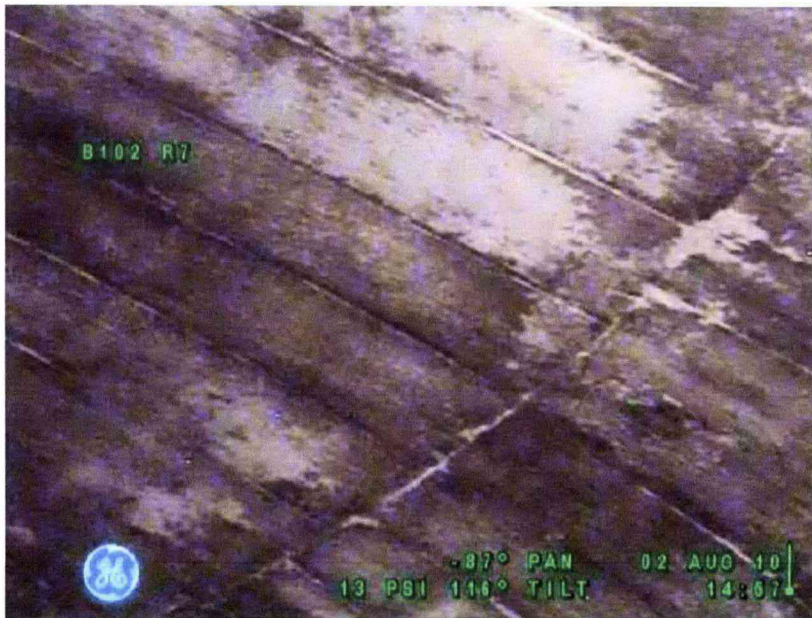
Several close-up pictures of the concrete dome have been compiled into one photograph to see the condition of the concrete as a panorama. This can be seen in Figure 8-2. This figure shows concrete with no visible cracks, spalling or other anomalies that might jeopardize the integrity of the tank. Upon review of the complete footage, no critical visual anomalies were observed in the concrete that structures the dome of tank 241-B-102.

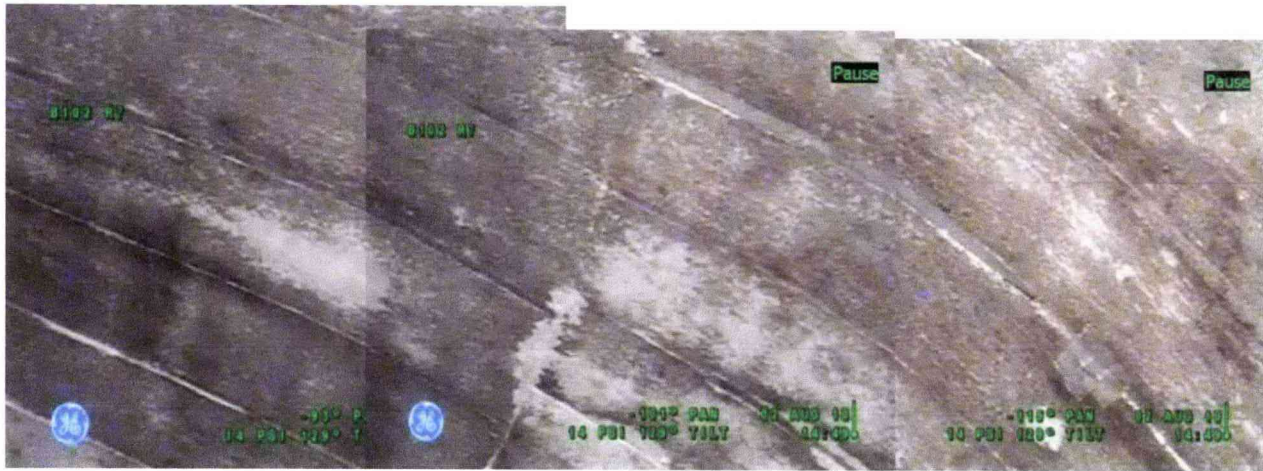
Figure 8-2: Compilation of Photographs of Tank 241-B-102 Dome
