U.S. Department of Energy
Office of River Protection

P.O. Box 450, MSIN H6-60
Richland, Washington 99352

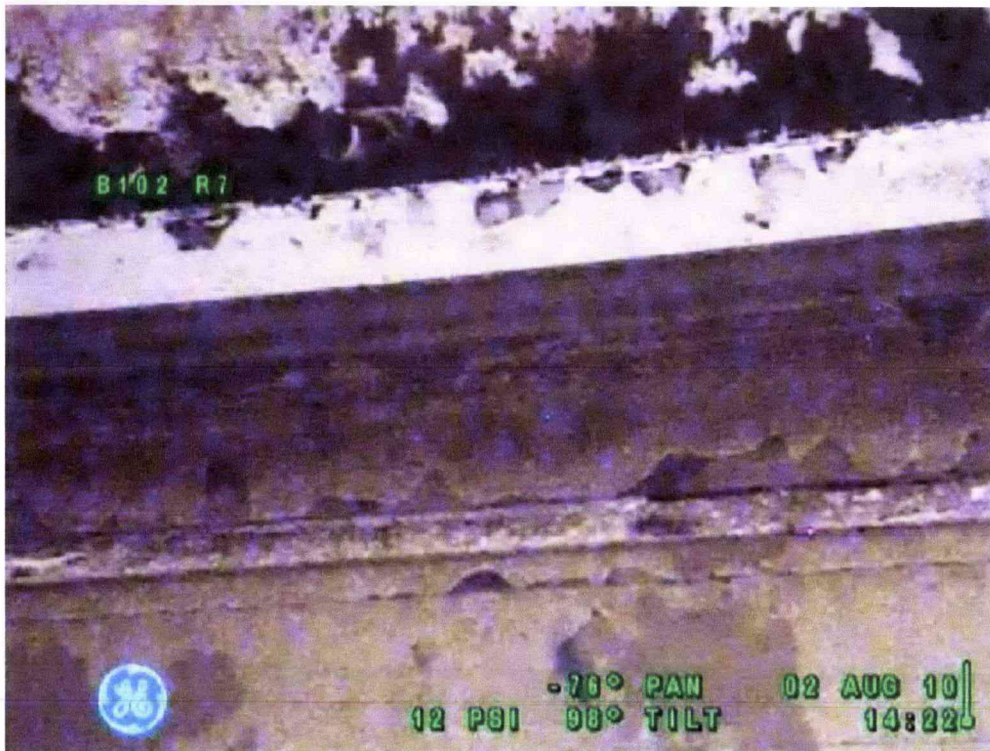
Several close-up pictures of the steel liner have been compiled into one photograph to see the condition of the steel liner and surrounding concrete as a panorama. This can be seen in Figure 8-4. This figure shows concrete with no visible cracks, spalling or other anomalies that might jeopardize the integrity of the tank. The steel also appeared to be without any visual anomalies. Upon review of the complete footage, no critical visual anomalies were observed in the concrete or the steel that lines tank 241-B-102. When compared to photographs of this tank from 1985 such as in Figure 8-5, it can be seen that the condition of the liner looks as if it has not changed significantly.

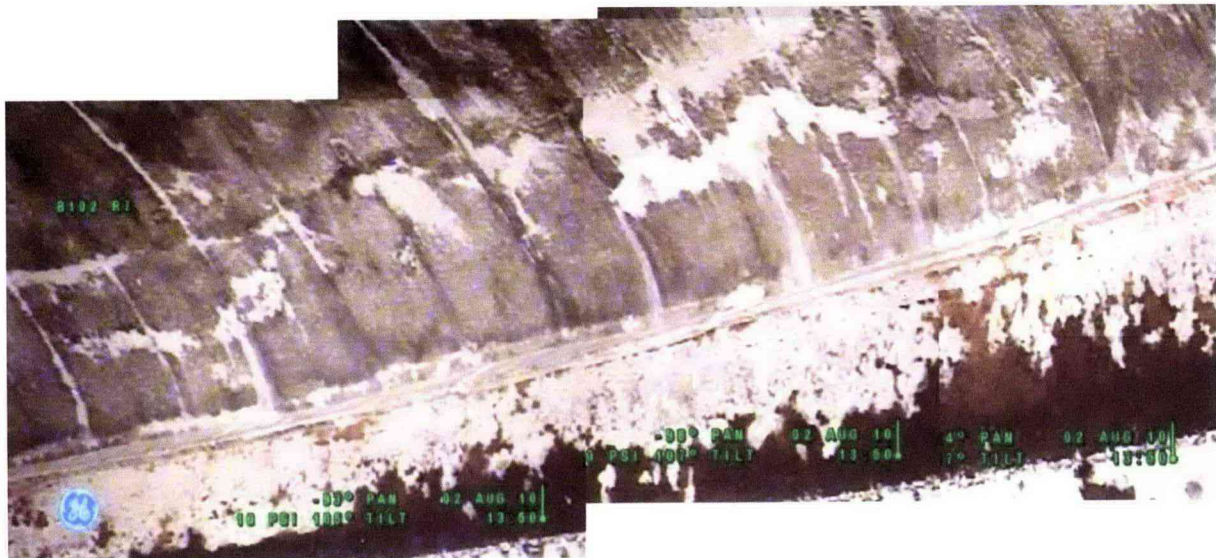
Figure 8-5: Tank 241-B-102⁷

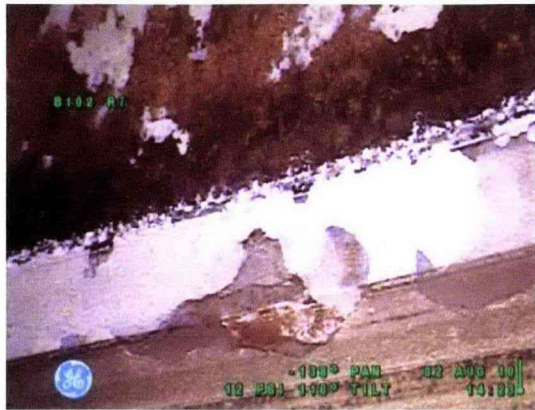
Figure 8-7: Steel Anomaly

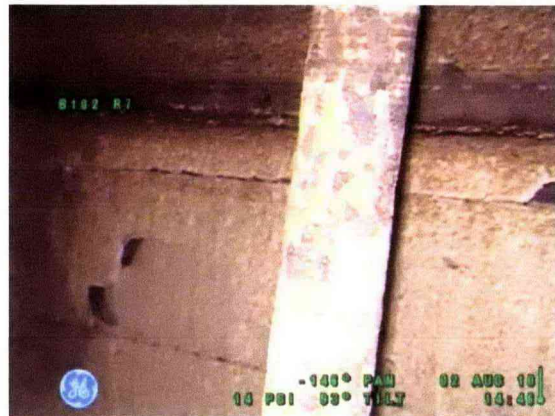
8.1.3 In-tank Equipment/Risers

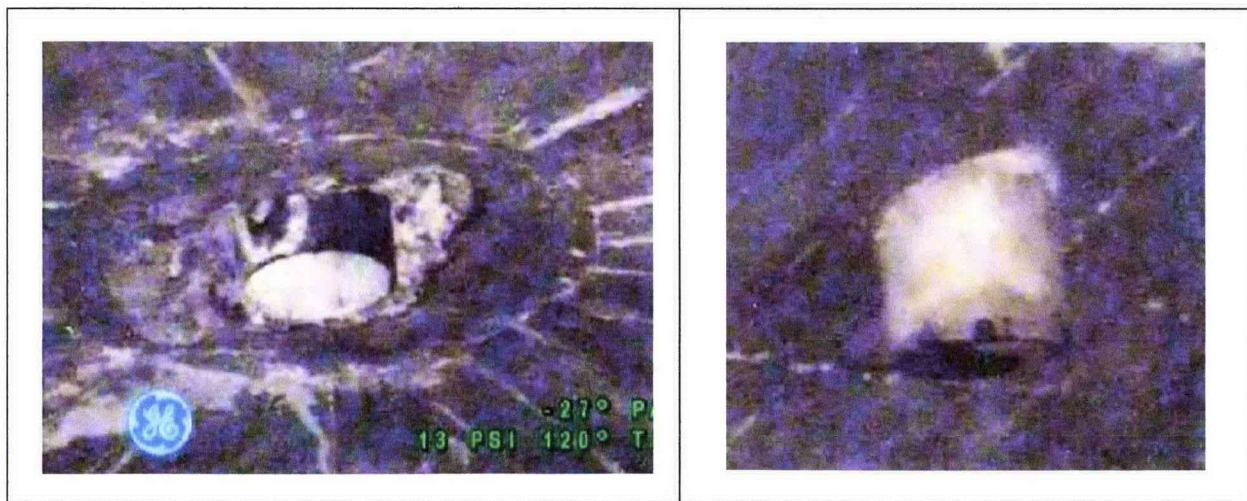
Figure 8-8: Tank 241-B-102 In-Tank Equipment/Risers

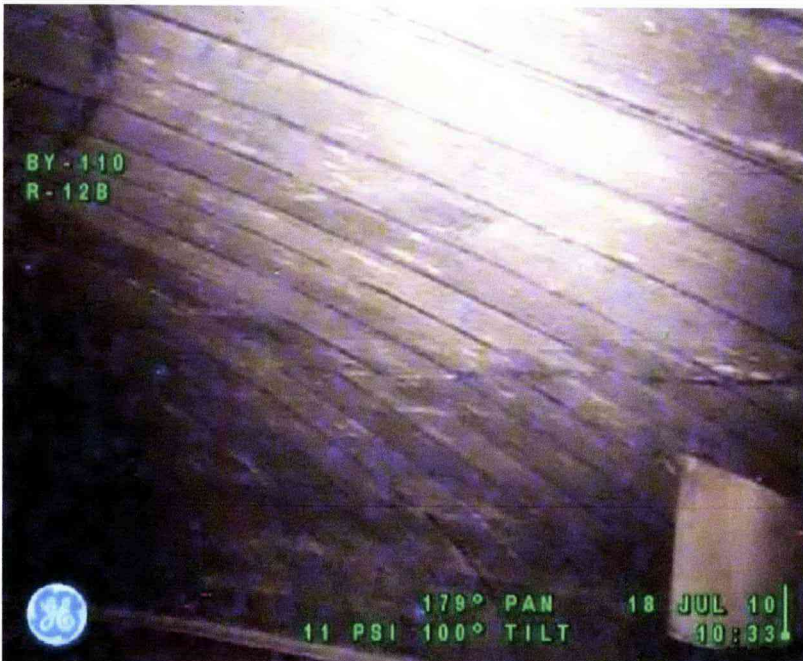
Several close-up pictures of the concrete dome have been compiled into one photograph to see the condition of the concrete as a panorama. This can be seen in Figure 9-2. This figure shows concrete with no visible cracks, spalling or other anomalies that might jeopardize the integrity of the tank. Upon review of the complete footage, no critical visual anomalies were observed in the concrete that structures the dome of tank 241-BY-110.

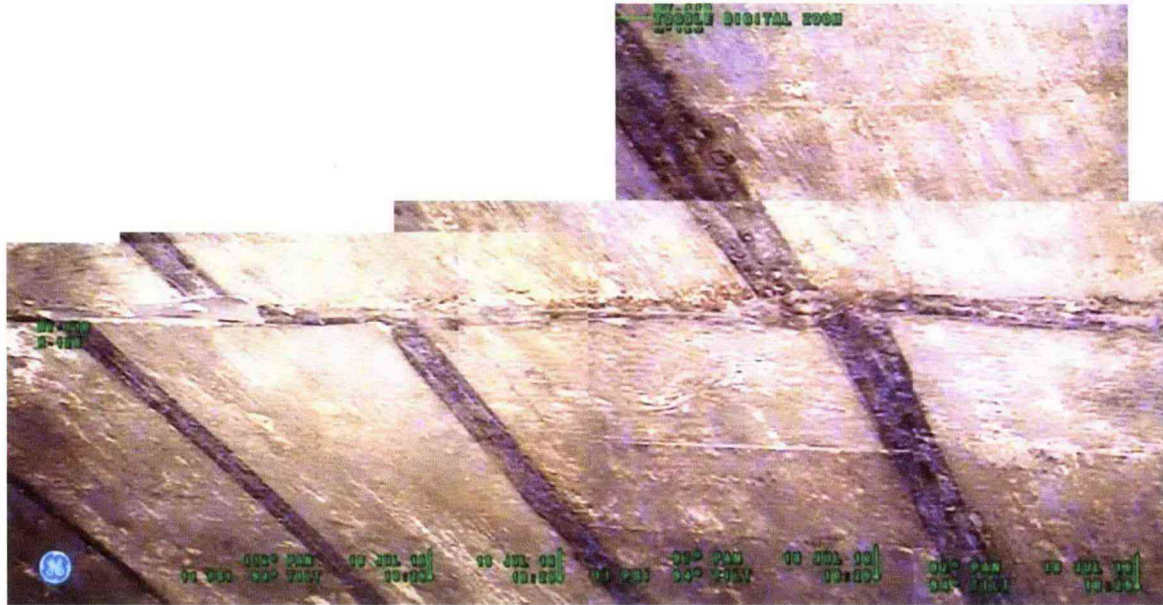
Upon visual inspection of the tank, some dissimilar areas were observed on the concrete dome. Figure 9-3 shows an area near the center of the tank's dome. There appears to be some sort of a build up on the concrete. Figure 9-4 shows the development of a checkered pattern close to the center on the dome's east side. While these two figures show anomalies in the appearance of the tank's dome, they do not appear to be rust stains from rebar, spalling, cracking, or any other abnormality that might affect the integrity of the stability of the tank and therefore not considered to be structurally significant.

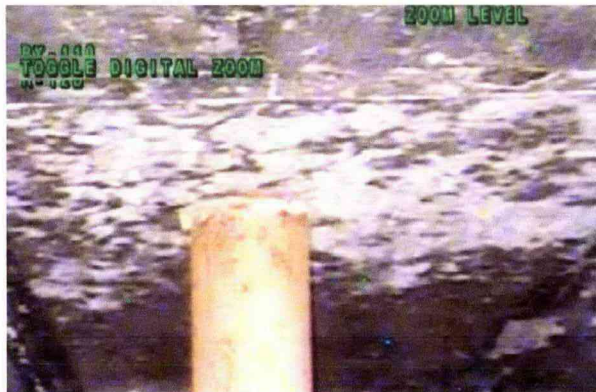
Figure 9-4: Concrete Anomaly

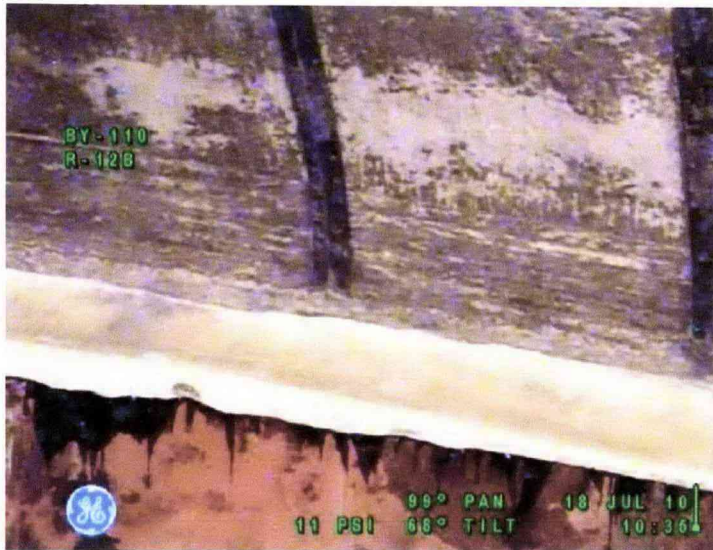
Several close-up pictures of the steel liner have been compiled into one photograph to see the condition of the steel liner and surrounding concrete as a panorama. This can be seen in Figure 9-6. This figure shows concrete with no visible cracks, spalling or other anomalies that might jeopardize the integrity of the tank. The steel also appeared to be without any visual anomalies. Upon review of the complete footage, no critical visual anomalies were observed in the concrete or the steel that lines tank 241-BY-110. When compared to photographs of this tank from 1984 such as in Figure 9-7, it can be seen that the condition of the liner looks as if it has not changed significantly.

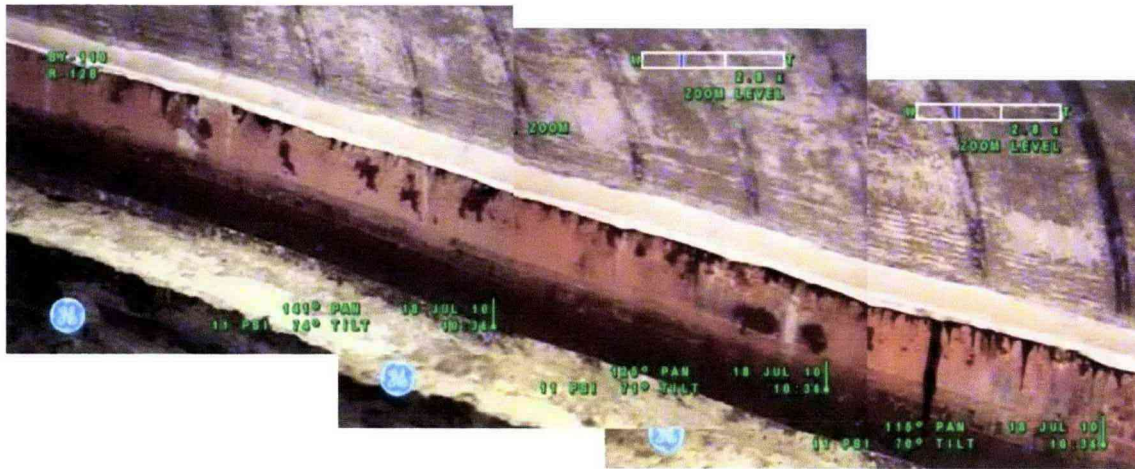
**Figure 9-7: Tank 241-BY-110⁸**

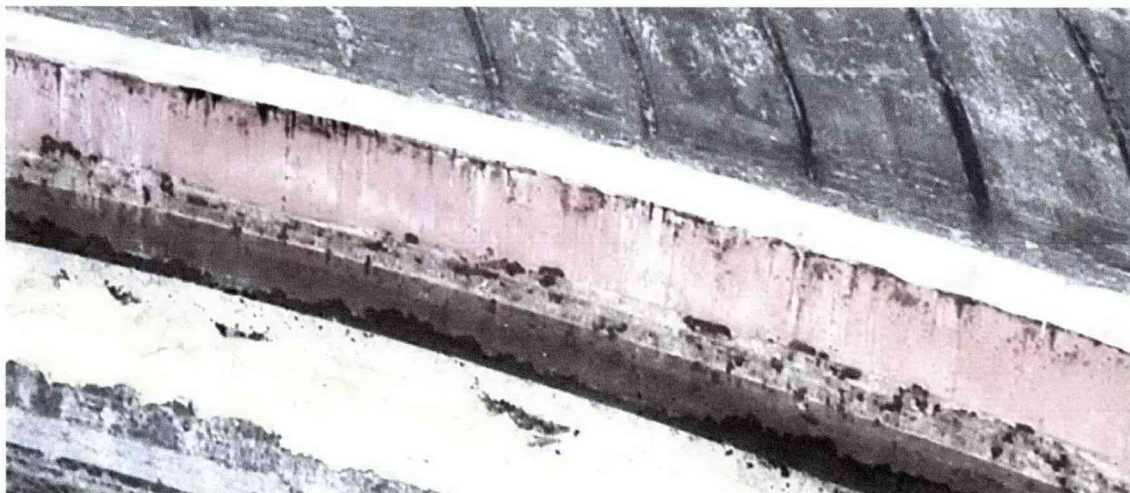
The lighting in the tank was not sufficient to observe the steel liner below the first stiffener ring. Because the images in the video were too dark to inspect it has been determined that the condition of the steel liner in the lower part of the tank is indeterminate.

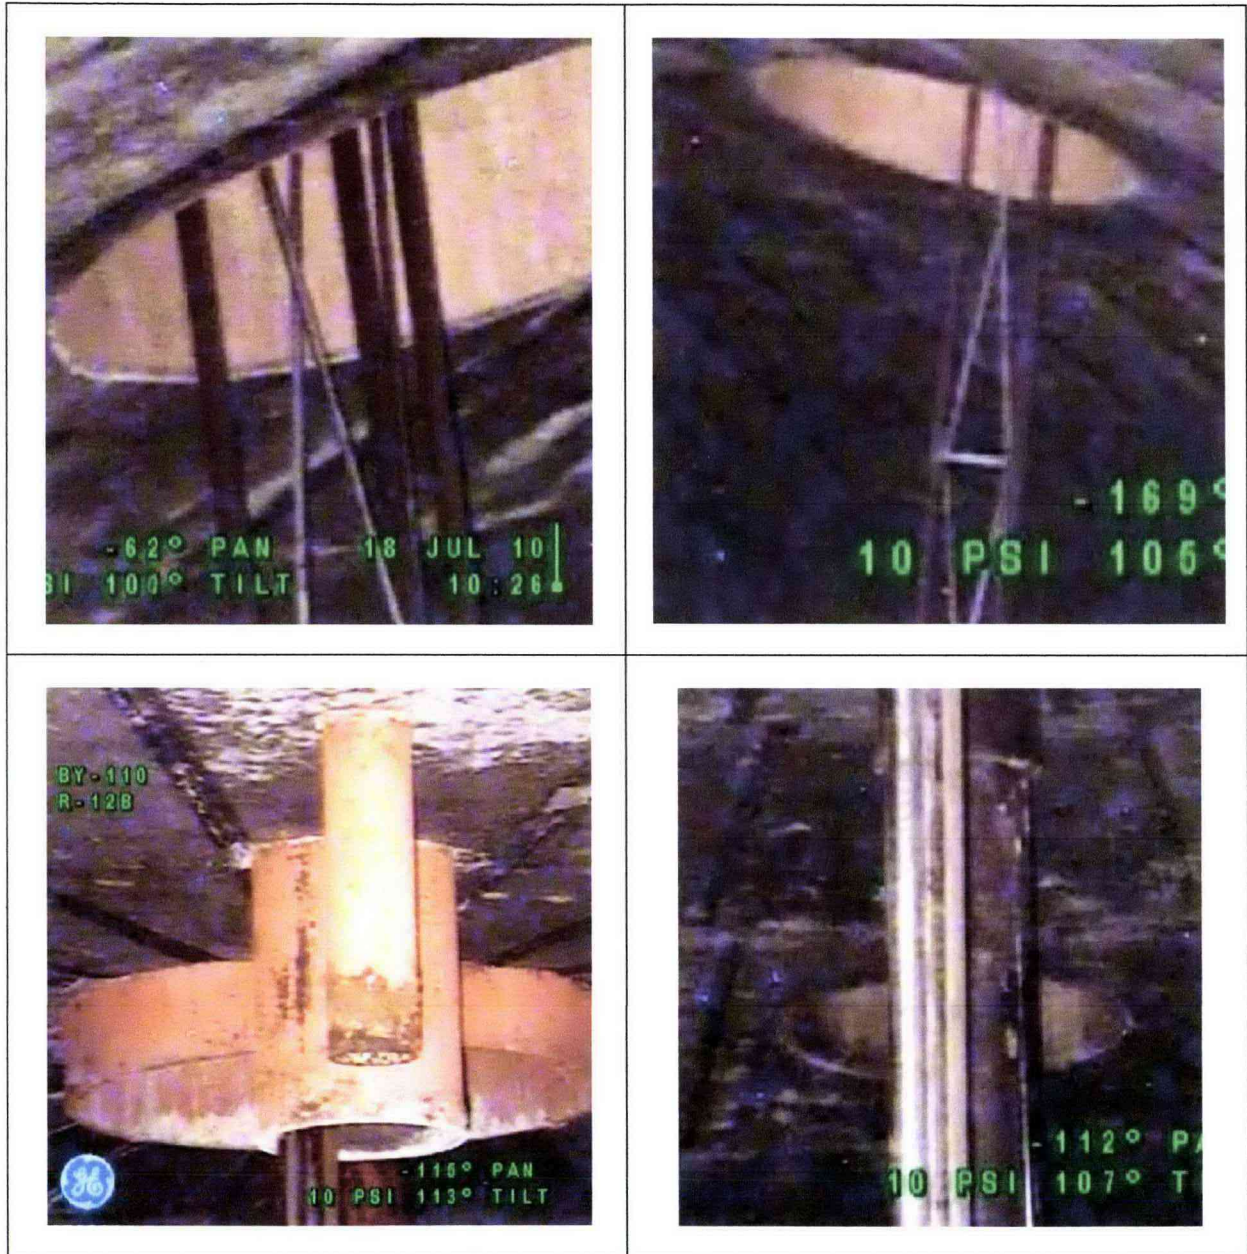
Figure 9-8: Tank 241-BY-110 In-Tank Equipment/Risers

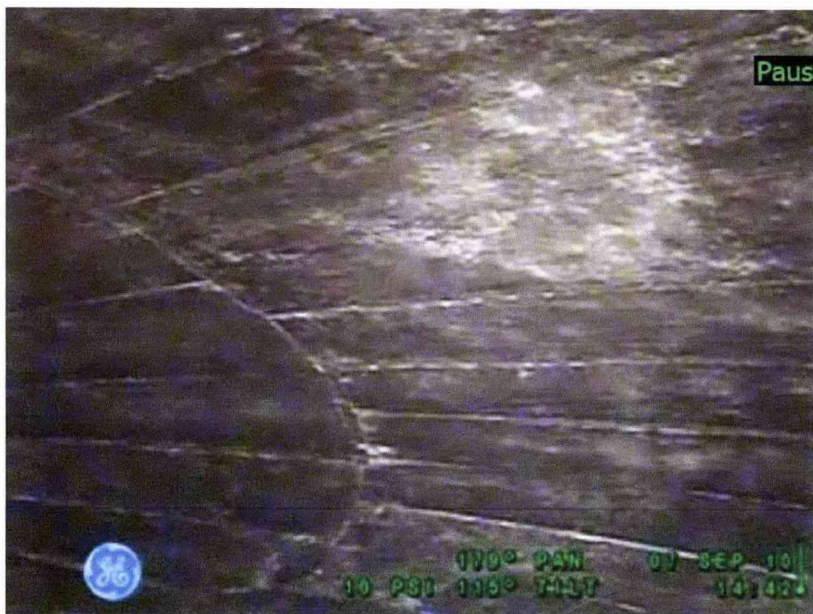
Several close-up pictures of the concrete dome have been compiled into one photograph to see the condition of the concrete as a panorama. This can be seen in Figure 10-2. This figure shows concrete with no visible cracks, spalling or other anomalies that might jeopardize the integrity of the tank. Upon review of the complete footage, no critical visual anomalies were observed in the concrete that structures the dome of tank 241-C-110.

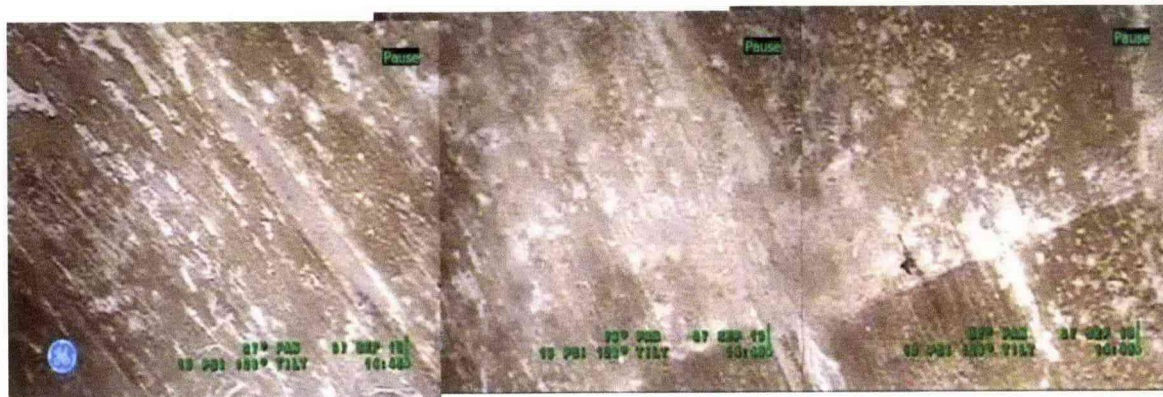
Figure 10-2: Compilation of Photographs of Tank 241-C-110 Dome

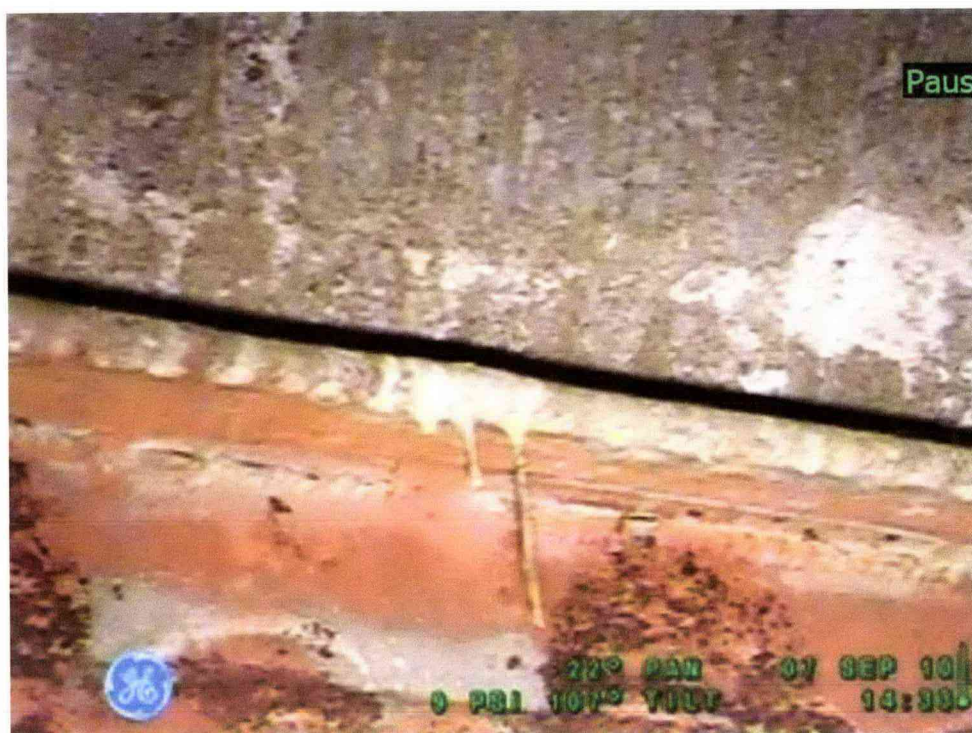
Several close-up pictures of the steel liner have been compiled into one photograph to see the condition of the steel liner and surrounding concrete as a panorama. This can be seen in Figure 10-4. This figure shows concrete with no visible cracks, spalling or other anomalies that might jeopardize the integrity of the tank. The steel also appeared to be without any visual anomalies. Upon review of the complete footage, no critical visual anomalies were observed in the concrete or the steel that lines tank 241-C-110. When compared to photographs of this tank from 1986 such as in Figure 10-5, it can be seen that the condition of the liner looks as if it has not changed significantly.

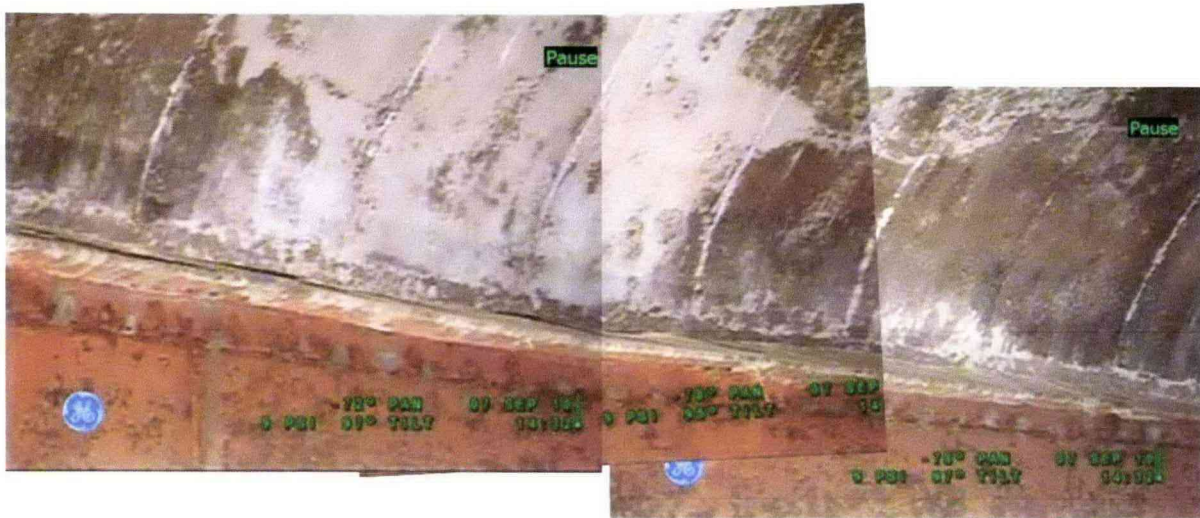
Figure 10-5: 241-C-110⁹

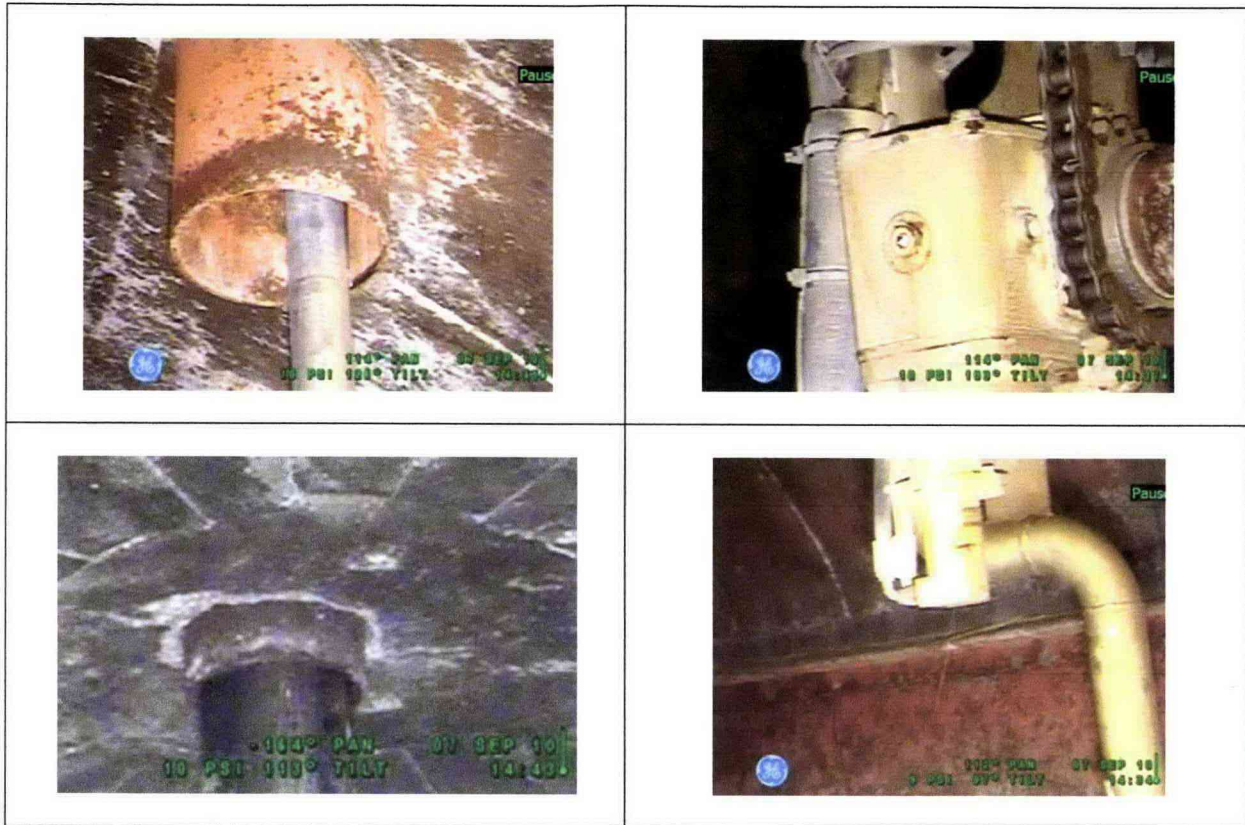
10.2 RECOMMENDATIONS

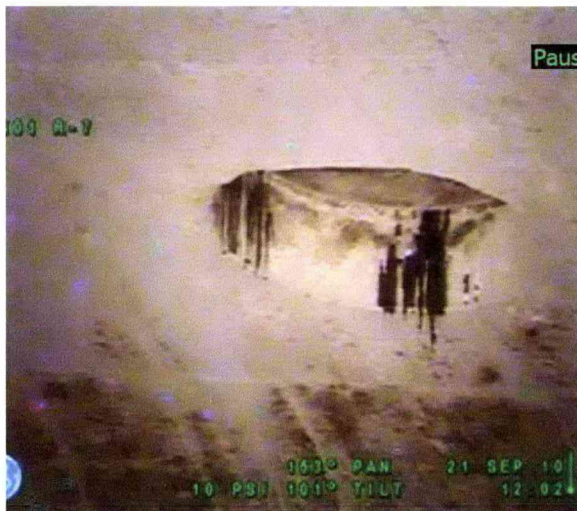
Figure 11-2: Prior photo of Tank 241-S-101¹⁰

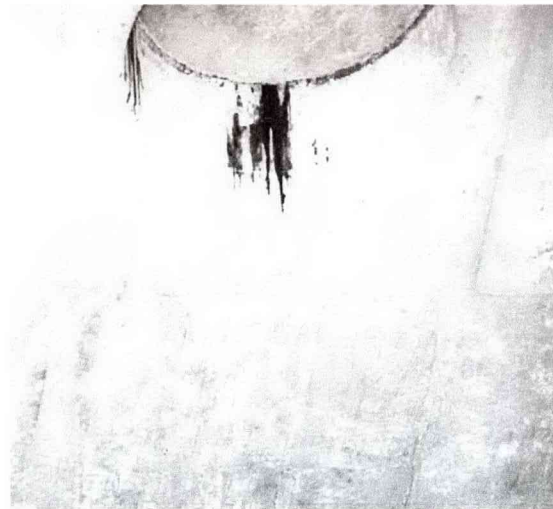
Upon visual inspection of the tank, some dissimilar areas were observed on the concrete dome. Figure 11-3 shows some spots on the tank's dome. These appear to be uniform on the concrete and can be seen throughout the video inspection. While this figure shows an anomaly in the appearance of the tank's dome, it does not appear to be rust stains from rebar, spalling, cracking or any other abnormality that might affect the integrity of the stability of the tank and therefore not considered to be structurally significant.

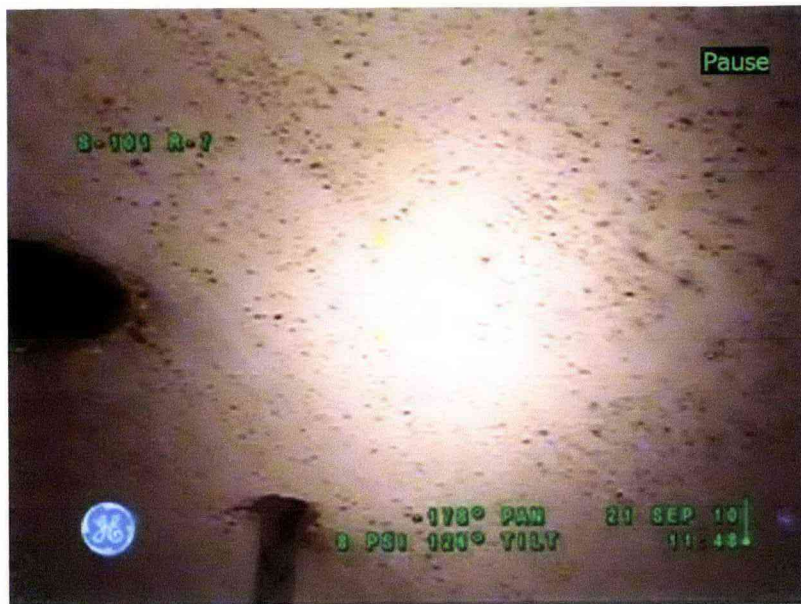
Figure 11-3: Concrete Anomaly

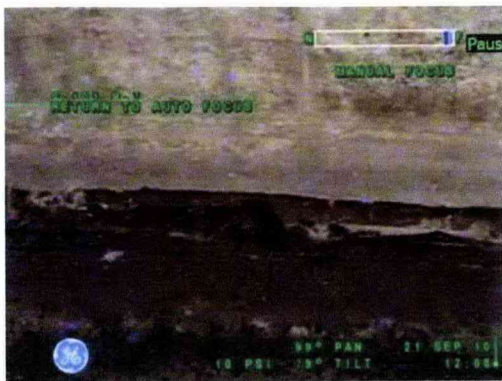
Figure 11-5: Tank 241-S-101 Steel Liner

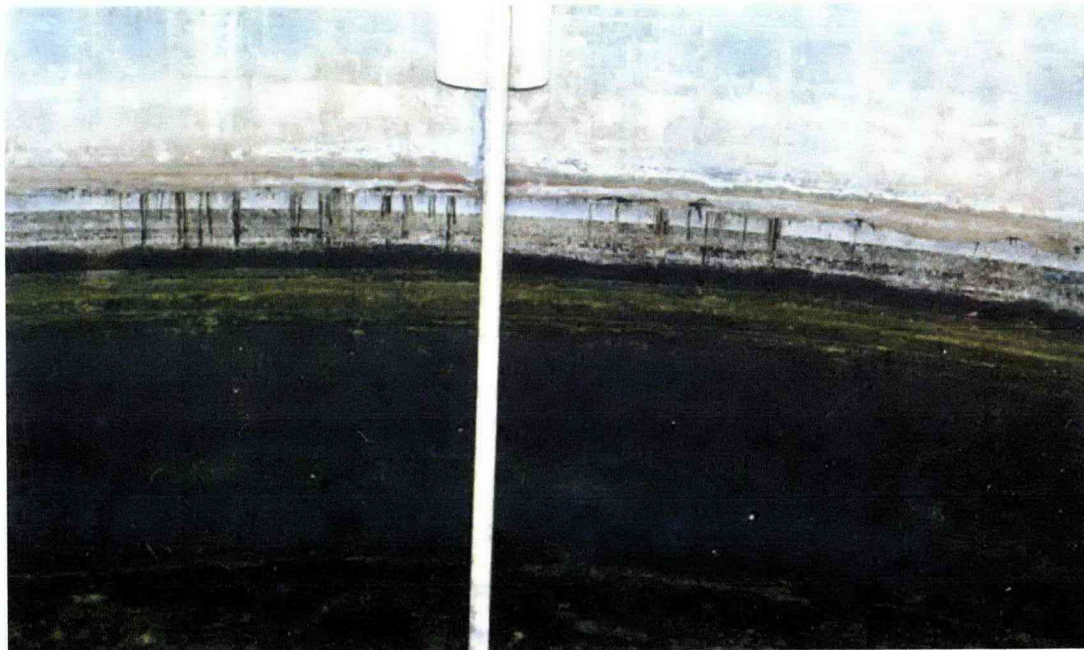
11.1.3 In-Tank Equipment/Risers

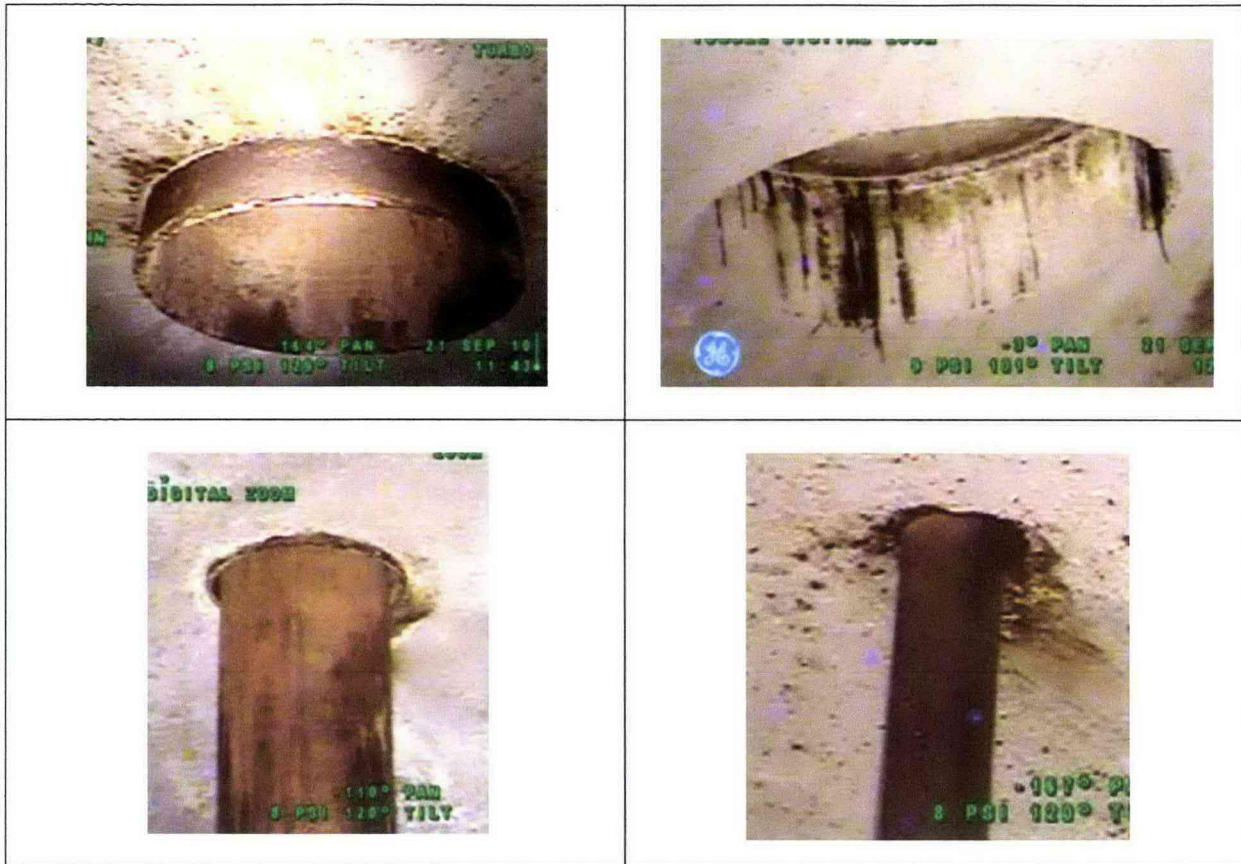
11.2 RECOMMENDATIONS

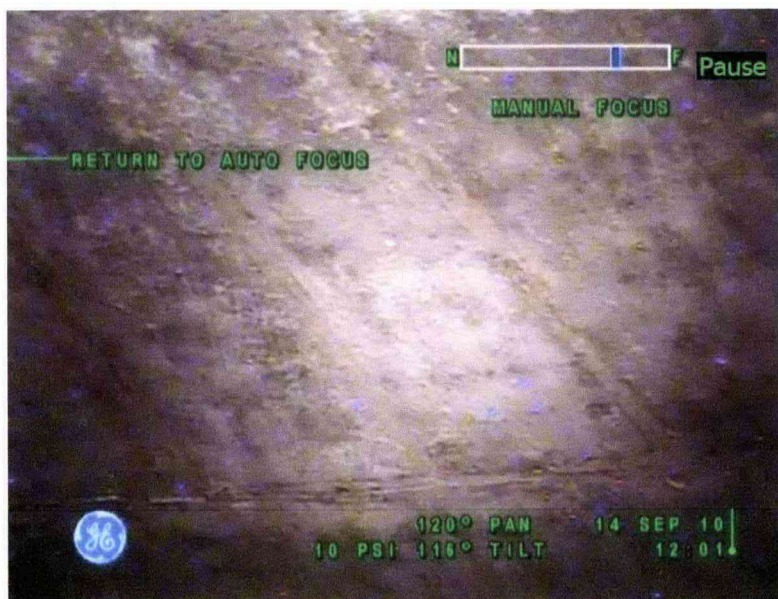
Several close-up pictures of the concrete dome have been compiled into one photograph to see the condition of the concrete as a panorama. This can be seen in Figure 12-2. This figure shows concrete with no visible cracks, spalling or other anomalies that might jeopardize the integrity of the tank. Upon review of the complete footage, no critical visual anomalies were observed in the concrete that structures the dome of tank 241-S-103.

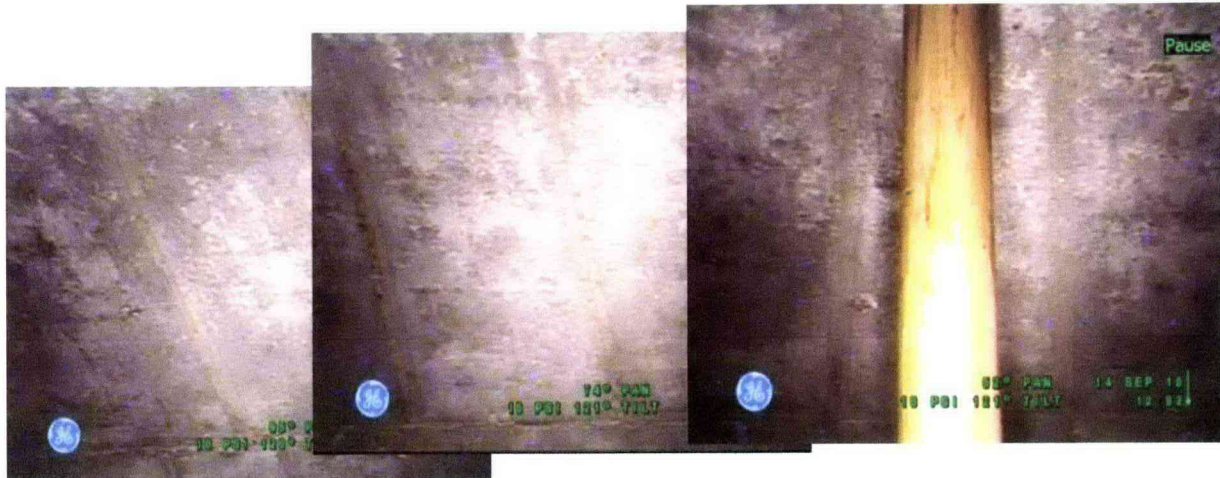
Upon visual inspection of the tank, some dissimilar areas were observed on the concrete dome. Figure 12-3 shows a section of the tanks dome. The concrete looks like it is streaked with something from outside the tank. This streak originates from the top of the tank and continues down the side. It appears that it might have been a liquid of some sort that came in through the top of the tank and ran down the dome. Figure 12-4 shows a small void in the dome's concrete. This could have been formed during the construction of this tank as it does not look fragmented or cracked. While these two figures show anomalies in the appearance of the tank's dome, they do not appear to be rust stains from rebar, spalling, cracking, or any other abnormality that might affect the integrity of the stability of the tank and therefore not considered to be structurally significant.

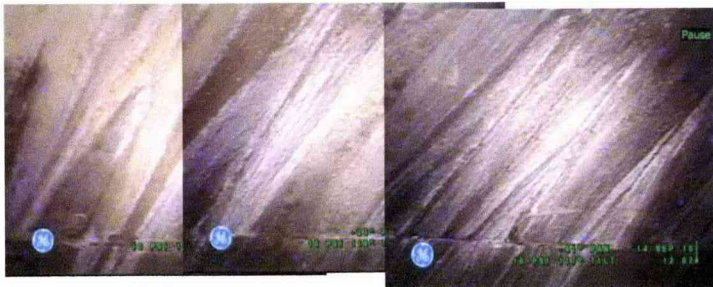
**Figure 12-4: Concrete Anomaly**

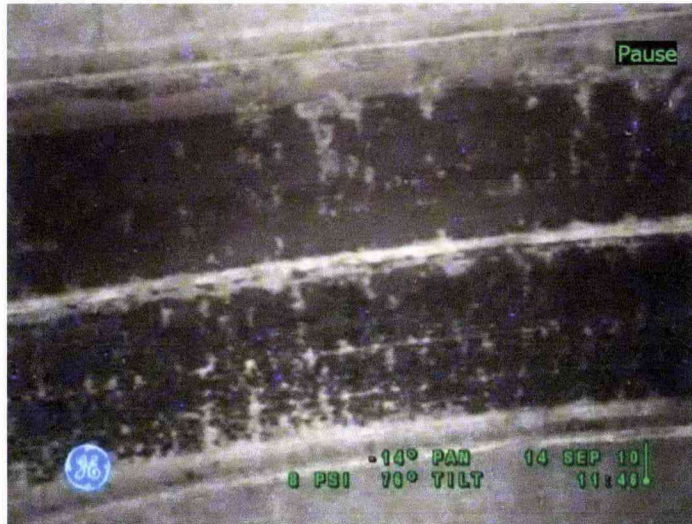
Several close-up pictures of the steel liner have been compiled into one photograph to see the condition of the steel liner and surrounding concrete as a panorama. This can be seen in Figure 12-6. This figure shows concrete with no visible cracks, spalling or other anomalies that might jeopardize the integrity of the tank. The steel also appeared to be without any visual anomalies. Upon review of the complete footage, no critical visual anomalies were observed in the concrete or the steel that lines tank 241-S-103. When compared to photographs of this tank from 1984 such as in Figure 12-7, it can be seen that the condition of the liner looks as if it has not changed significantly.

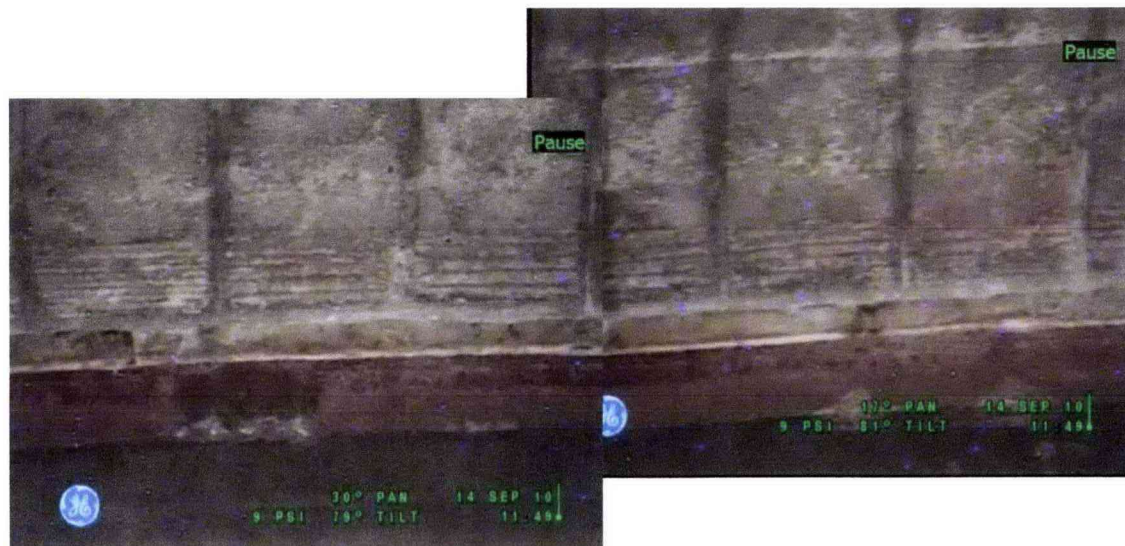
Figure 12-7: Tank 241-S-103¹² in 1984

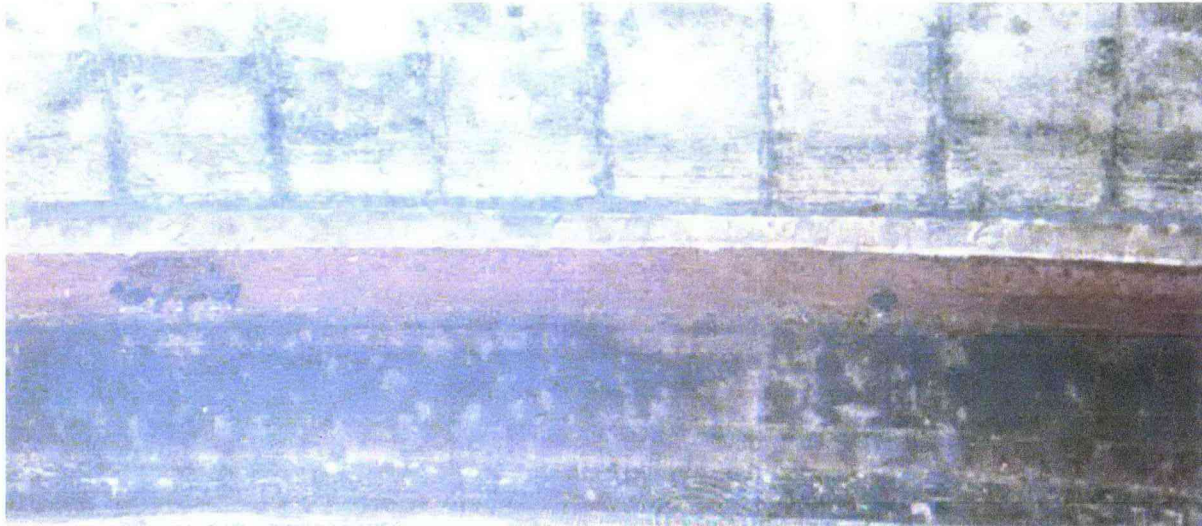
The lighting in the tank was not sufficient to observe the steel liner below the first stiffener ring. Because the images in the video were too dark to inspect it has been determined that the condition of the steel liner in the lower part of the tank is indeterminate.

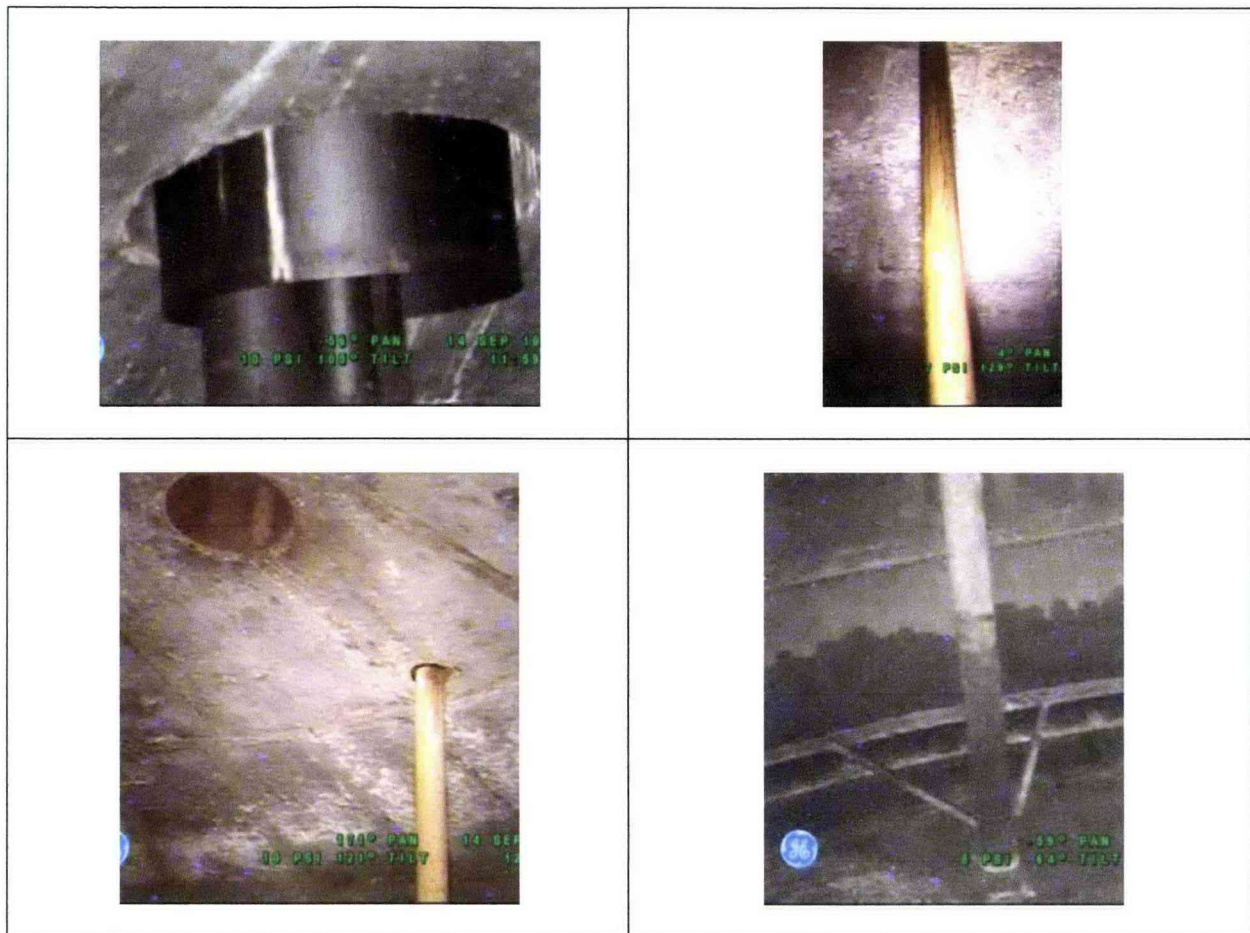
12.2 RECOMMENDATIONS

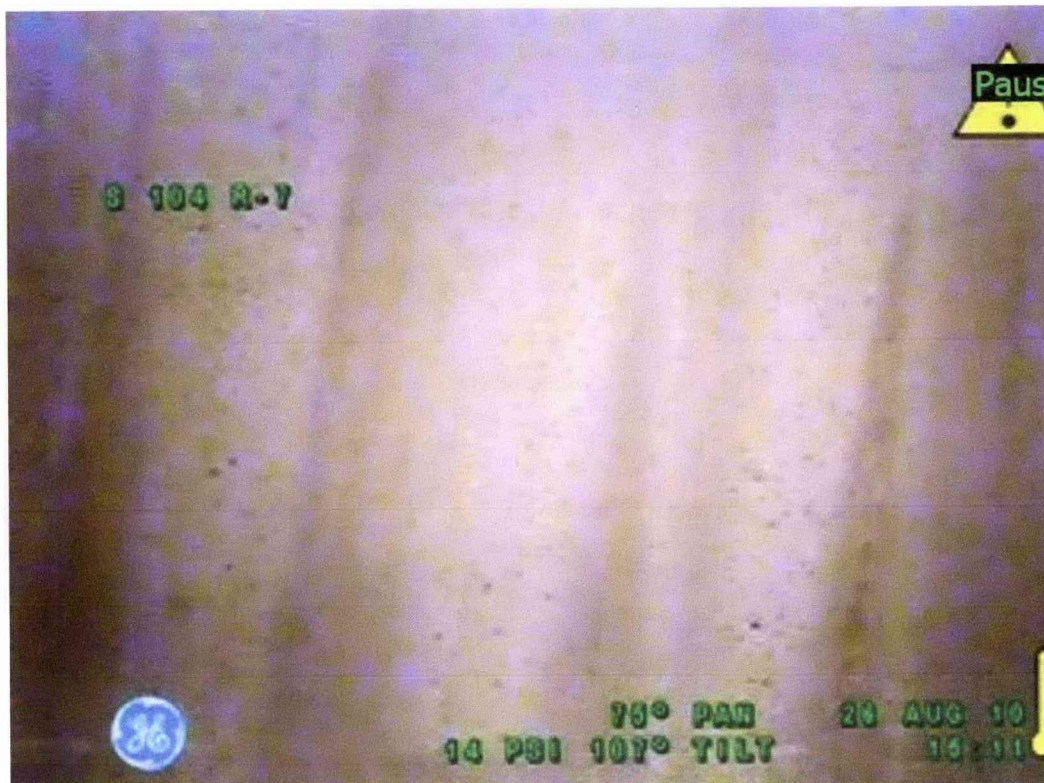
Upon visual inspection of the tank, some dissimilar areas were observed on the concrete dome. Figure 13-2 shows the tank's dome where there are some surface defects that look like they could be possible pitting. While this figure shows anomalies in the appearance of the tank's dome and steel liner, they do not appear to be rust stains from rebar, spalling, cracking, or any other abnormality that might affect the integrity of the stability of the tank and therefore not considered to be structurally significant.

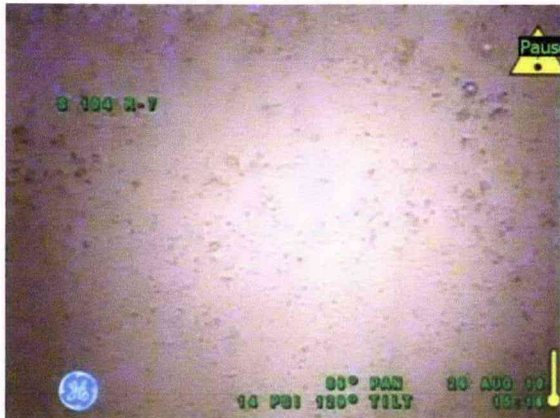
Figure 13-2: Concrete Anomaly

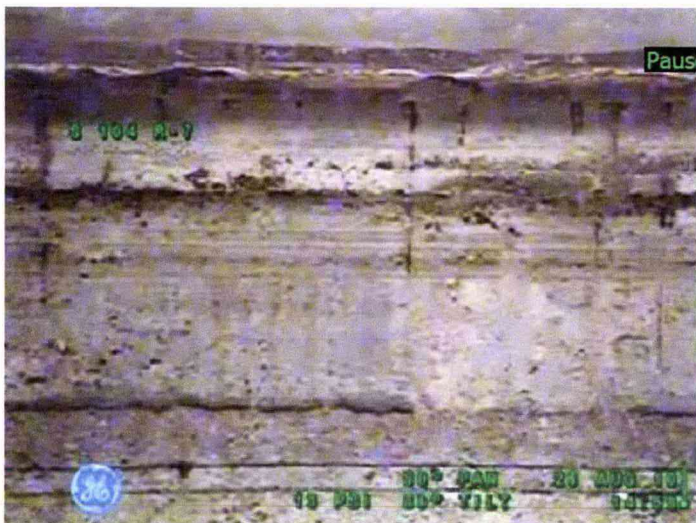
This figure shows steel that appeared to be without any visual anomalies. Upon review of the complete footage, no critical visual anomalies were observed in the concrete or the steel that lines tank 241-S-104. Upon review of the complete footage, no critical visual anomalies were observed in the concrete or the steel that lines tank 241-S-104. When compared to photographs of this tank from 1984 such as in Figure 13-4, it can be seen that the condition of the liner looks as if it has not changed significantly.

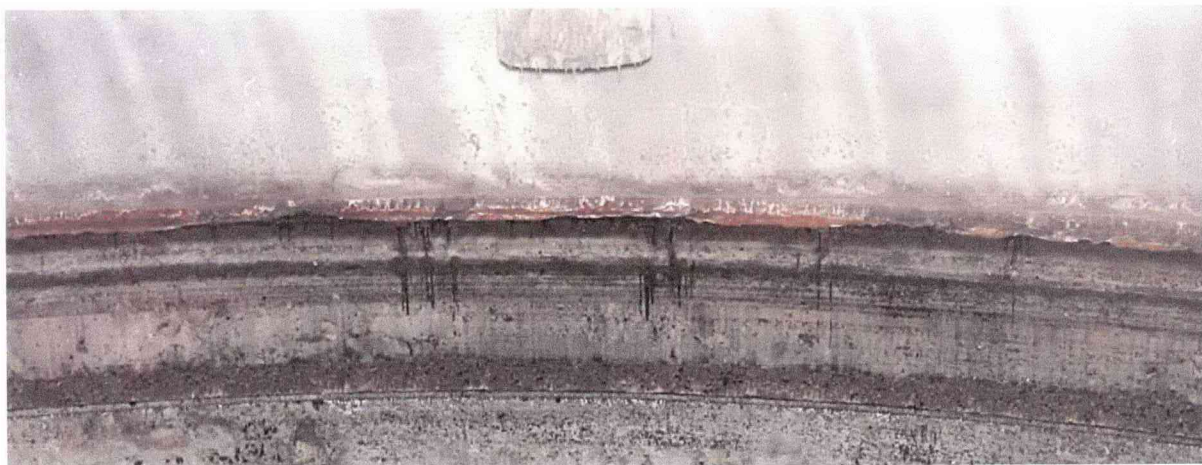
Figure 13-5 shows steel liner with some surface defect and possible pitting of the steel. This figure shows anomalies in the appearance of the tank's steel liner. Because these anomalies are in the steel liner of the tank, they are not considered to be structurally significant.

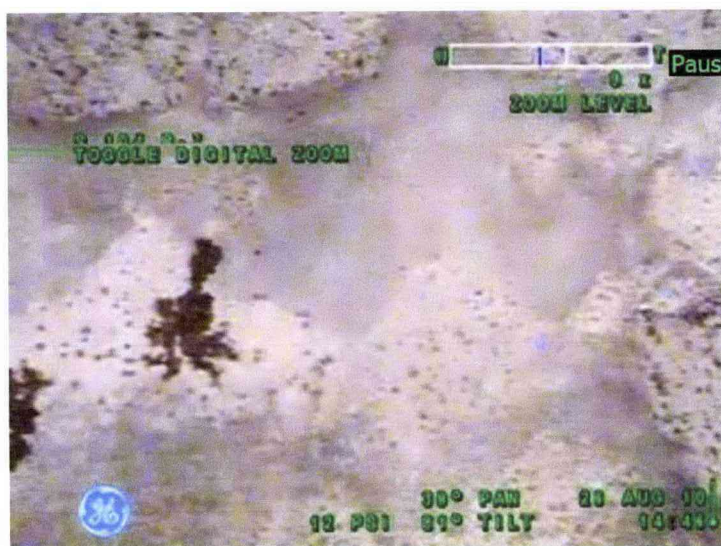
Figure 13-5: Steel Anomaly

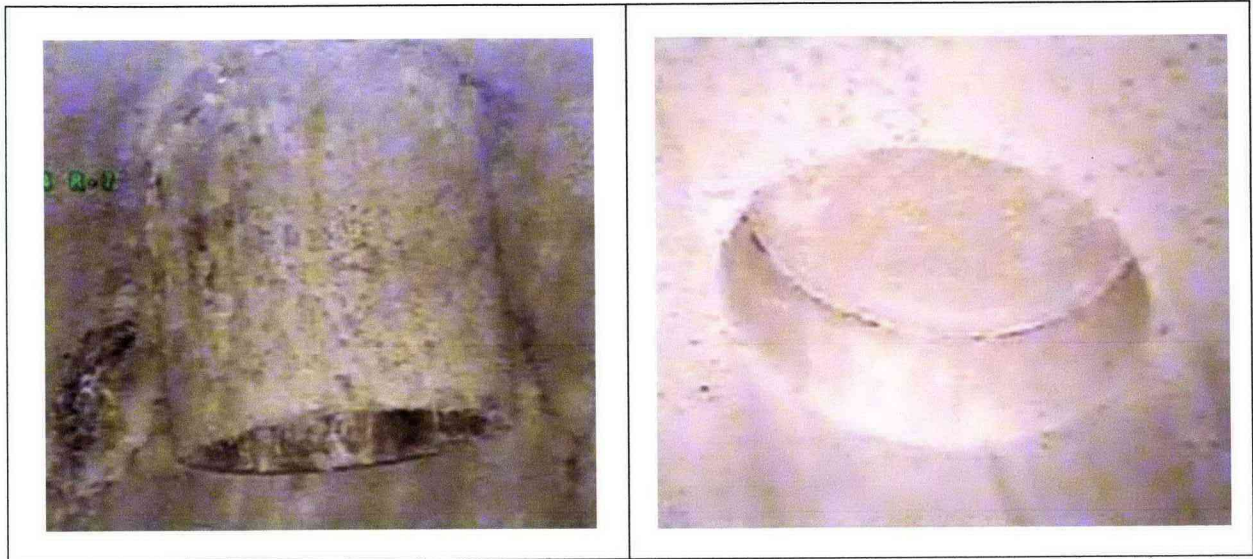
13.2 RECOMMENDATIONS
