U.S. Department of Energy
Office of River Protection

P.O. Box 450, MSIN H6-60
Richland, Washington 99352

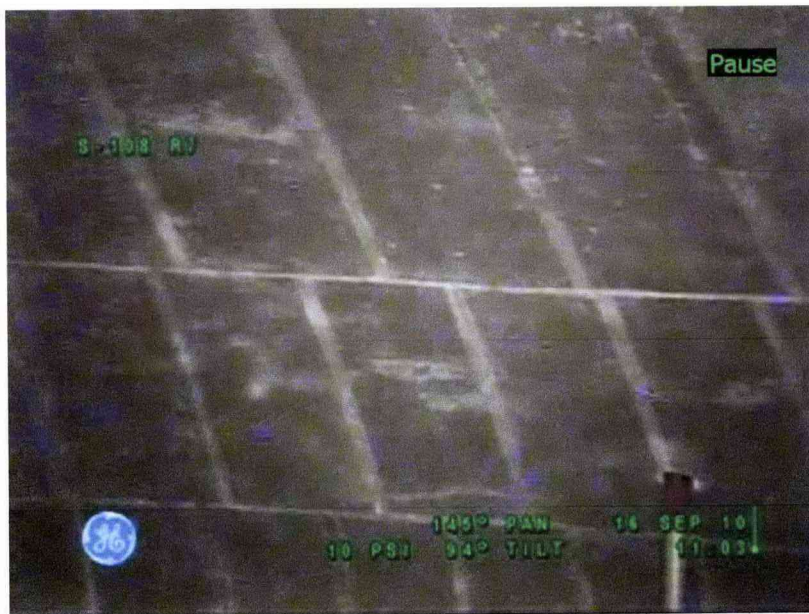
Several close-up pictures of the concrete dome have been compiled into one photograph to see the condition of the concrete as a panorama. This can be seen in Figure 14-2. This figure shows concrete with no visible cracks, spalling or other anomalies that might jeopardize the integrity of the tank. Upon review of the complete footage, no critical visual anomalies were observed in the concrete that structures the dome of tank 241-S-108.

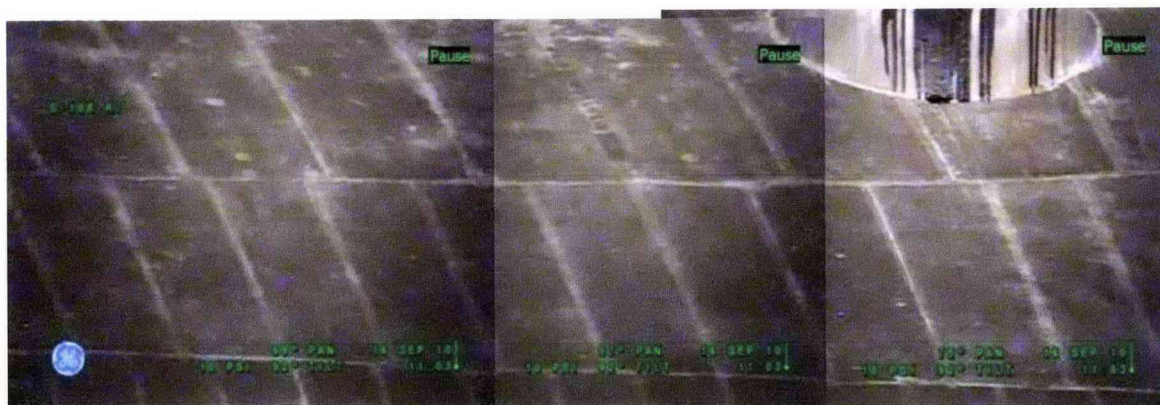
Upon visual inspection of the tank, some dissimilar areas were observed on the concrete dome. Figure 14-3 shows an area near the center of the tank's dome. There appears to be some sort of void where the concrete slabs come together. Figure 14-4 shows a raised section on the joint of the concrete. Most of the joints are flush with the concrete. This one appears to have some build up on it. This has not been seen in any other visual inspections of the single-shell tanks. While these two figures show anomalies in the appearance of the tank's dome, they do not appear to be rust stains from rebar, spalling, cracking, or any other abnormality that might affect the integrity of the stability of the tank and therefore not considered to be structurally significant.

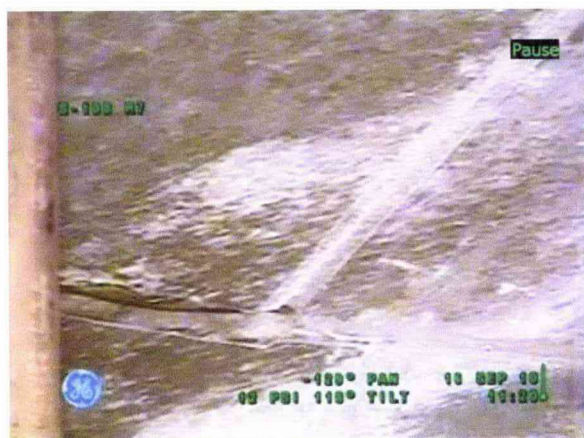
**Figure 14-4: Concrete Anomaly**

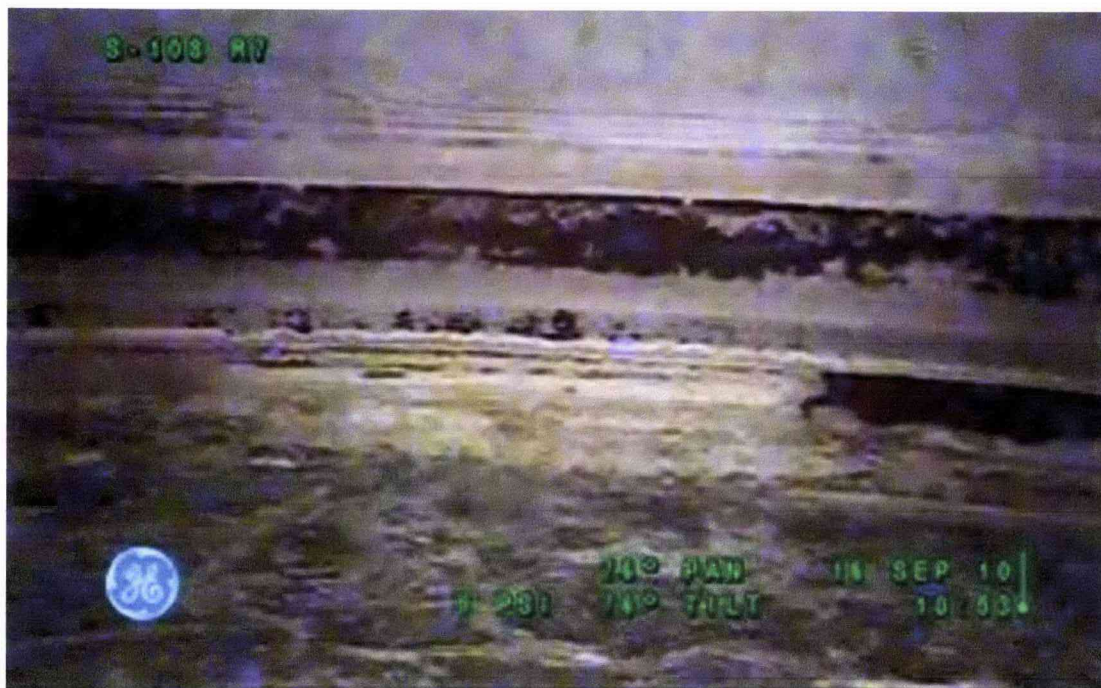
14.1.3 In-Tank Equipment/Risers

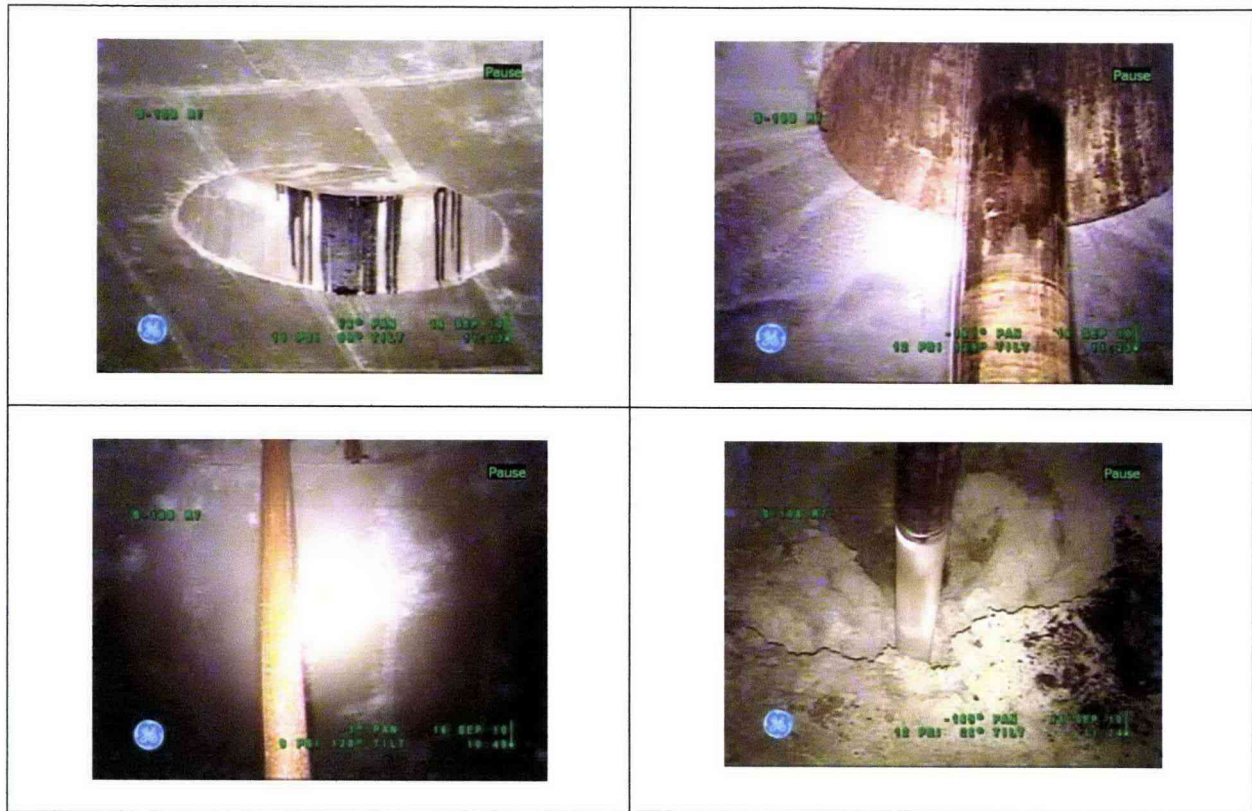
14.2 RECOMMENDATIONS

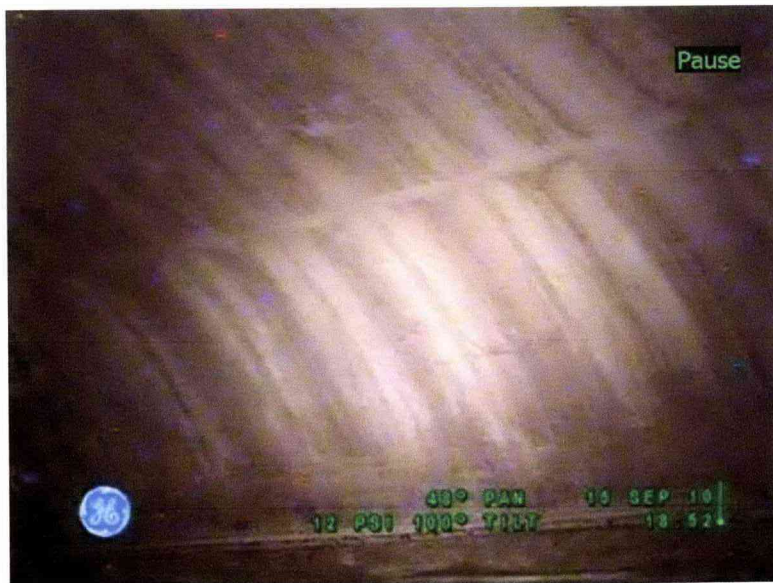
Figure 15-1: Tank 241-SX-101 Concrete Dome

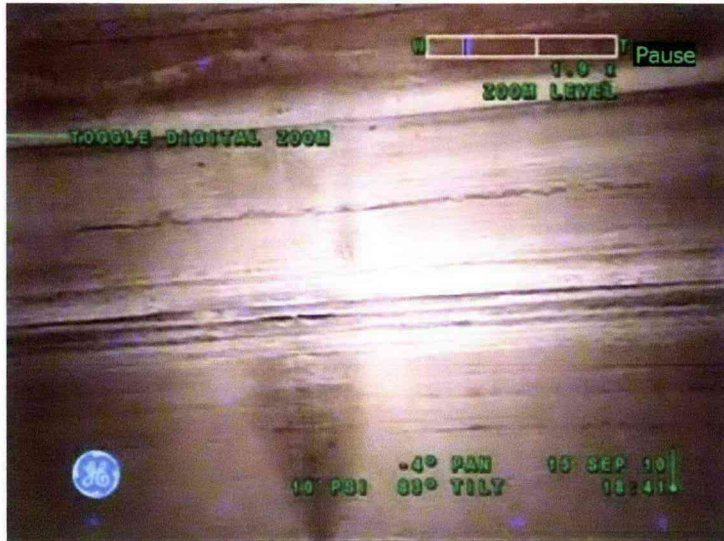
Figure 15-3: Tank 241-SX-101 in 1982¹⁴

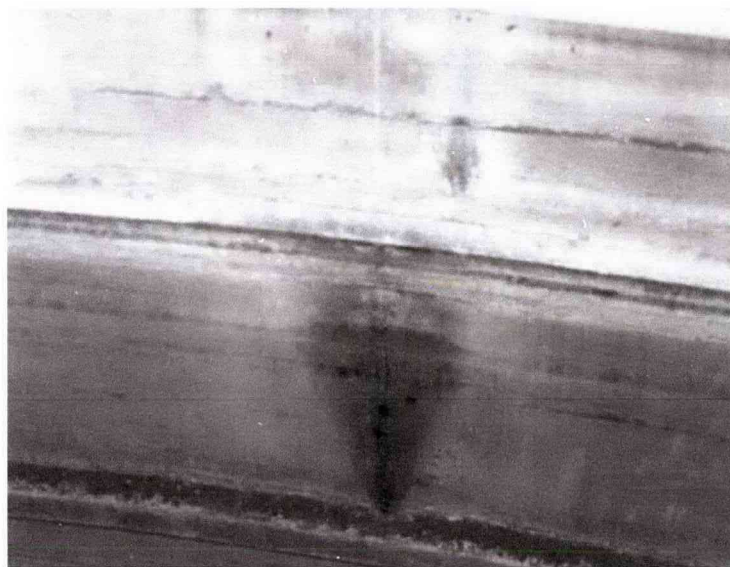
Figure 15-4 shows what appears to be either a crack or salt line in the steel liner. Below in the figure an inverse tar ring can also be seen. This is where the mastic is assumed to have seeped out of a perforation in the steel liner of the tank while there was still liquid waste in the tank. Because the mastic was less dense than the fluid in the tank at the time, it floated up the wall giving it the “V” like appearance in the figure.

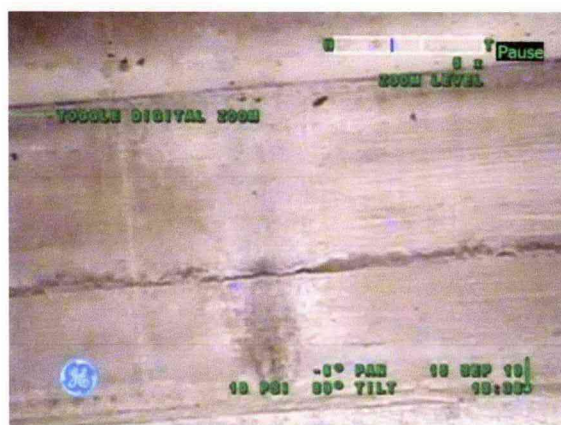
15.1.3 In-Tank Equipment/Risers

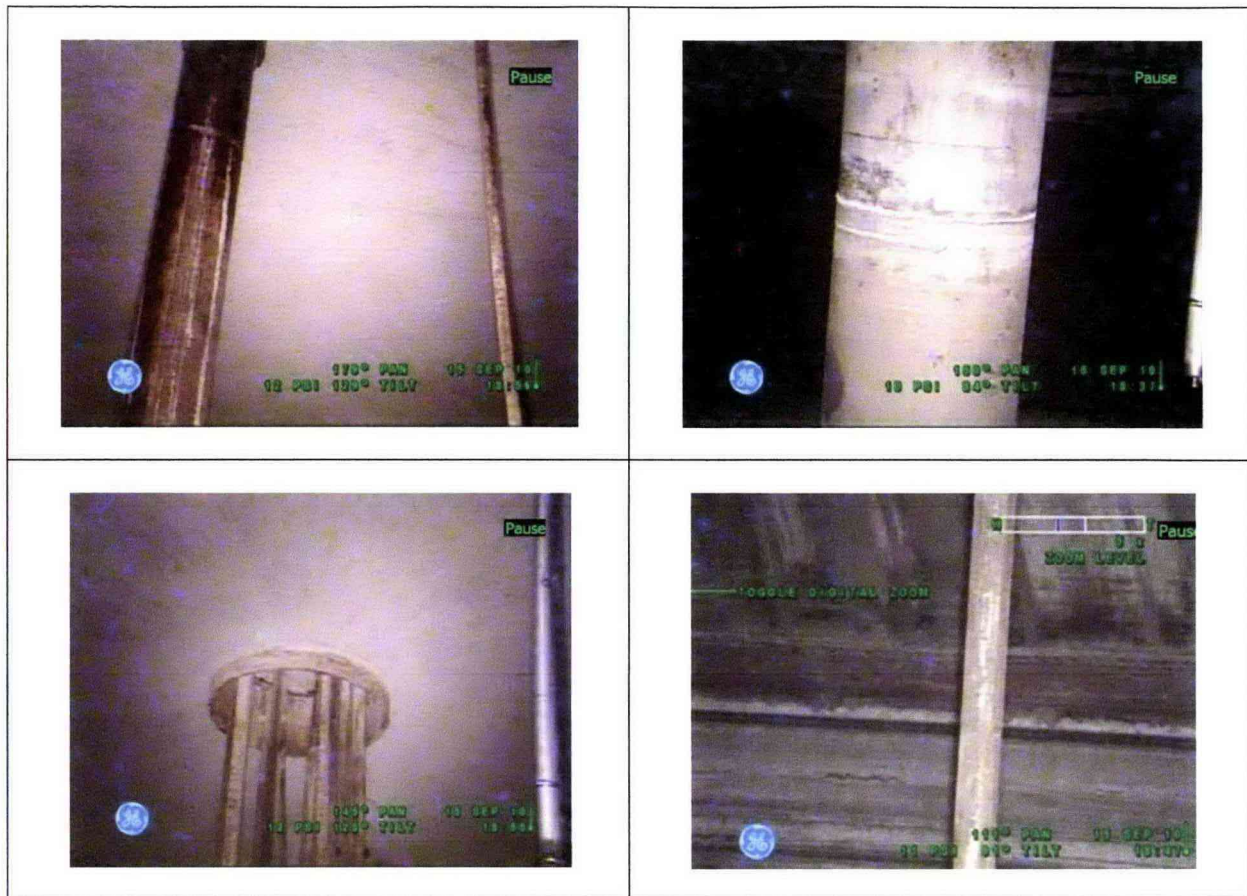
15.2 RECOMMENDATIONS

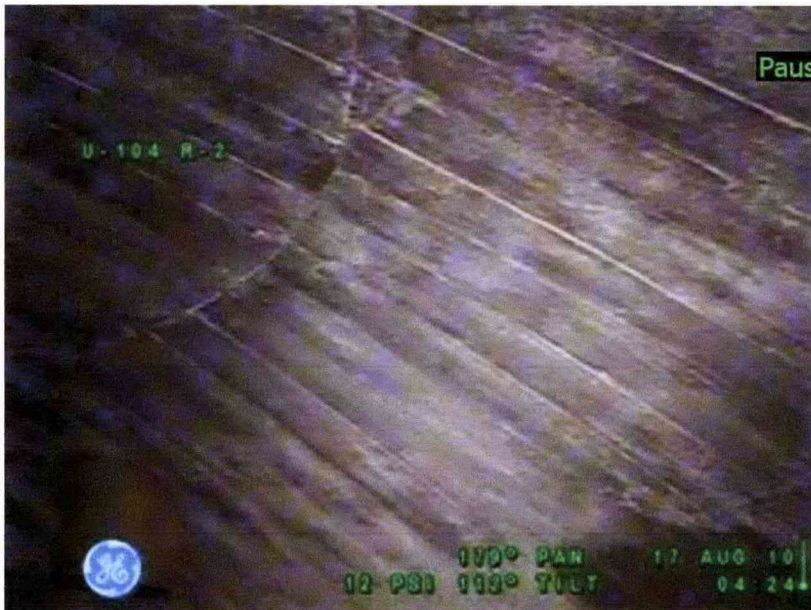
Several close-up pictures of the concrete dome have been compiled into one photograph to see the condition of the concrete as a panorama. This can be seen in Figure 16-2. This figure shows concrete with no visible cracks, spalling or other anomalies that might jeopardize the integrity of the tank. Upon review of the complete footage, no critical visual anomalies were observed in the concrete that structures the dome of tank 241-U-104.

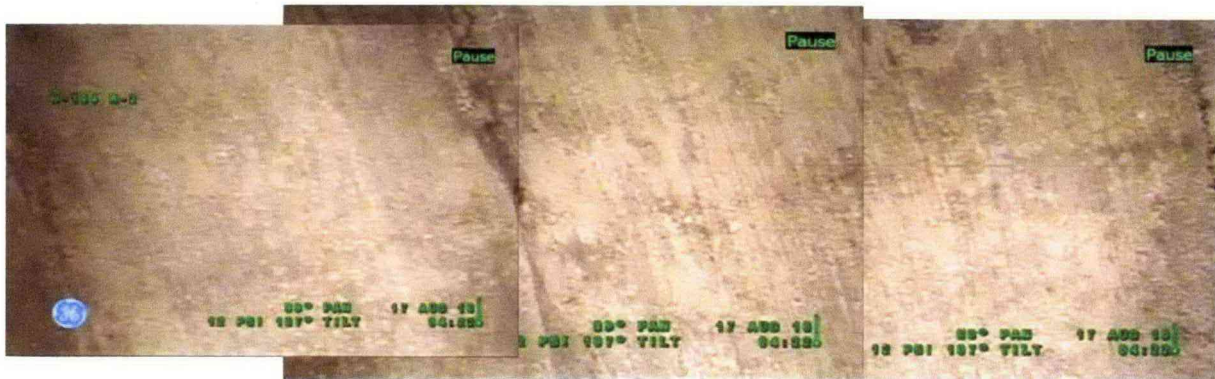
Upon visual inspection of the tank, some dissimilar areas were observed on the concrete dome. Figure 16-3 shows a concrete area near the steel liner of the tank. There appears to be an anomaly that runs parallel to the steel liner. Figure 16-4 shows what appears to be a cold joint or minor crack near the haunch of the tank's dome. While these two figures show anomalies in the appearance of the tank's dome, they do not appear to be rust stains from rebar, spalling, cracking, or any other abnormality that might affect the integrity of the stability of the tank and therefore not considered to be structurally significant.

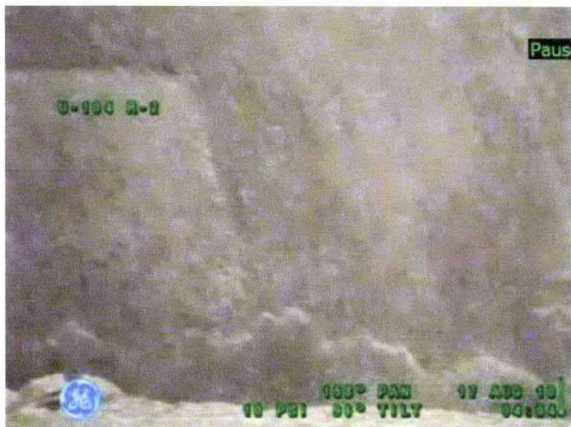
Figure 16-4: Concrete Anomaly

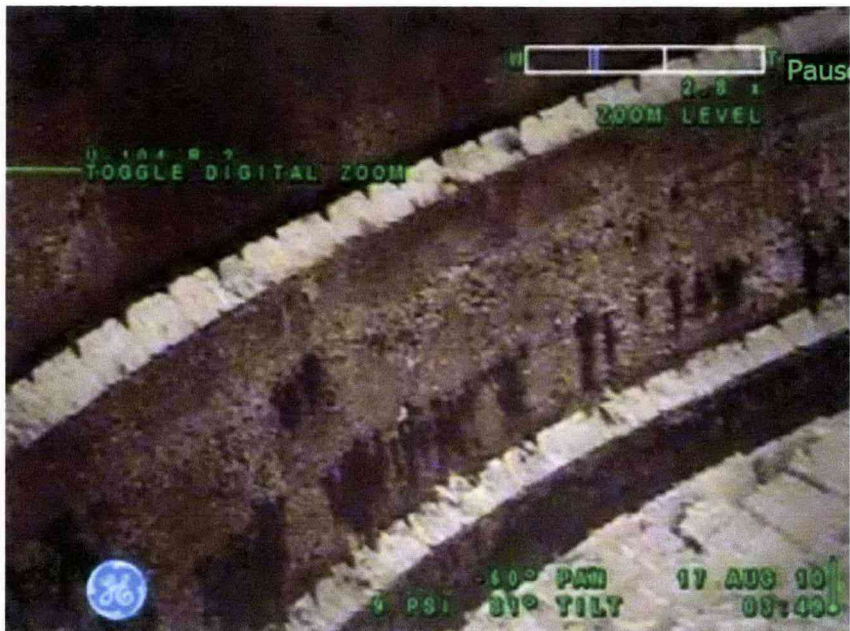
Several close-up pictures of the steel liner have been compiled into one photograph to see the condition of the steel liner as a panorama. This can be seen in Figure 16-6. This figure shows steel that appears to be without any visual anomalies. The surface of the steel liner appears to be dissimilar from other tanks inspected for FY 2010. This could possibly be a coating of waste on the steel liner or corrosion of the steel. Upon review of the complete footage, no critical visual anomalies were observed in the concrete or the steel that lines tank 241-U-104. When compared to prior photos of the tank such as in Figure 16-7, it can be seen that the condition of the tank has not changed significantly.

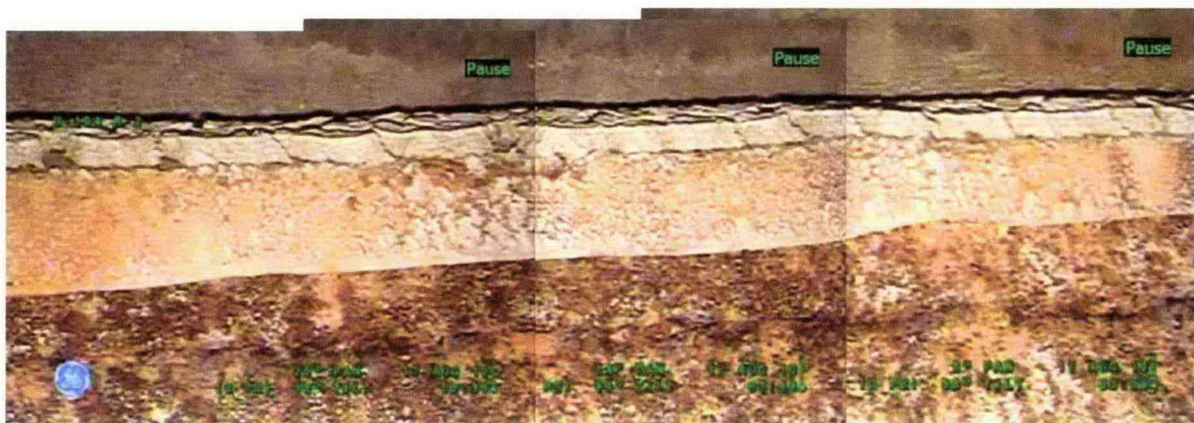
Figure 16-7: Tank 241-U-104¹⁵ in 1989

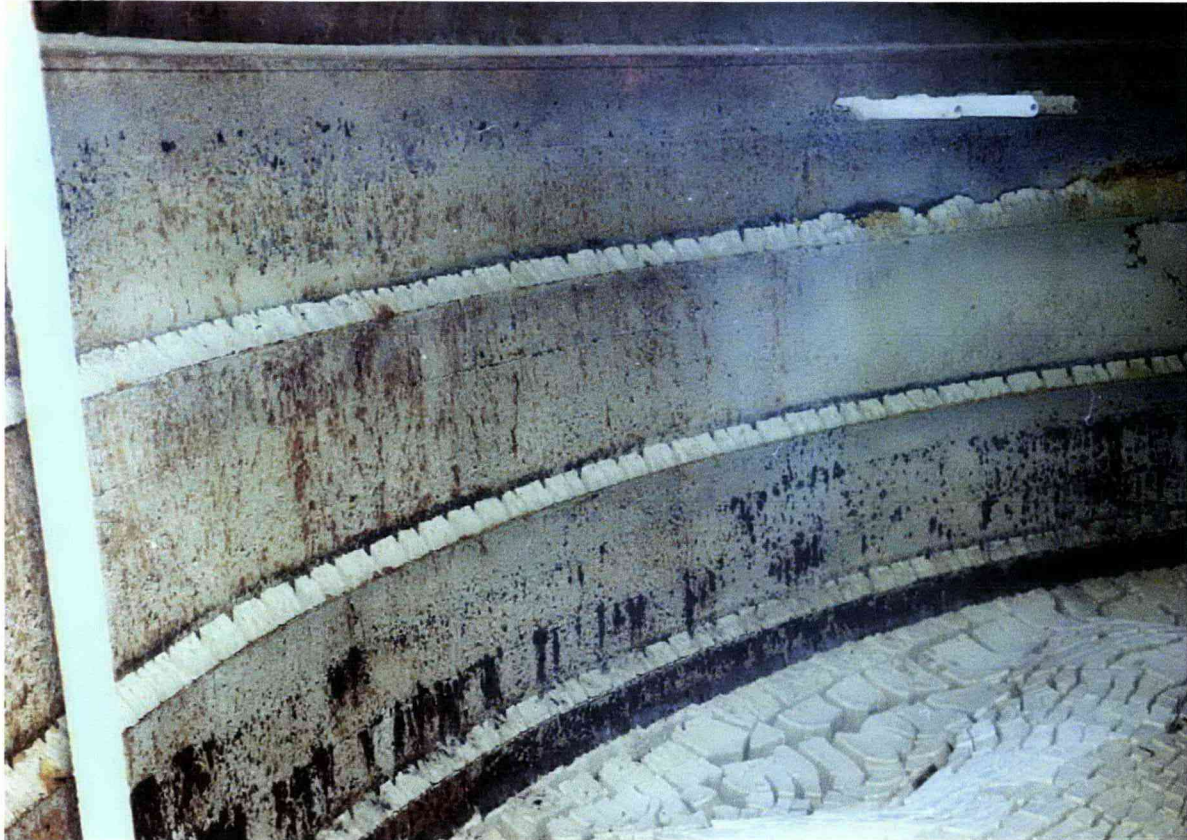
16.1.3 In-Tank Equipment/Risers

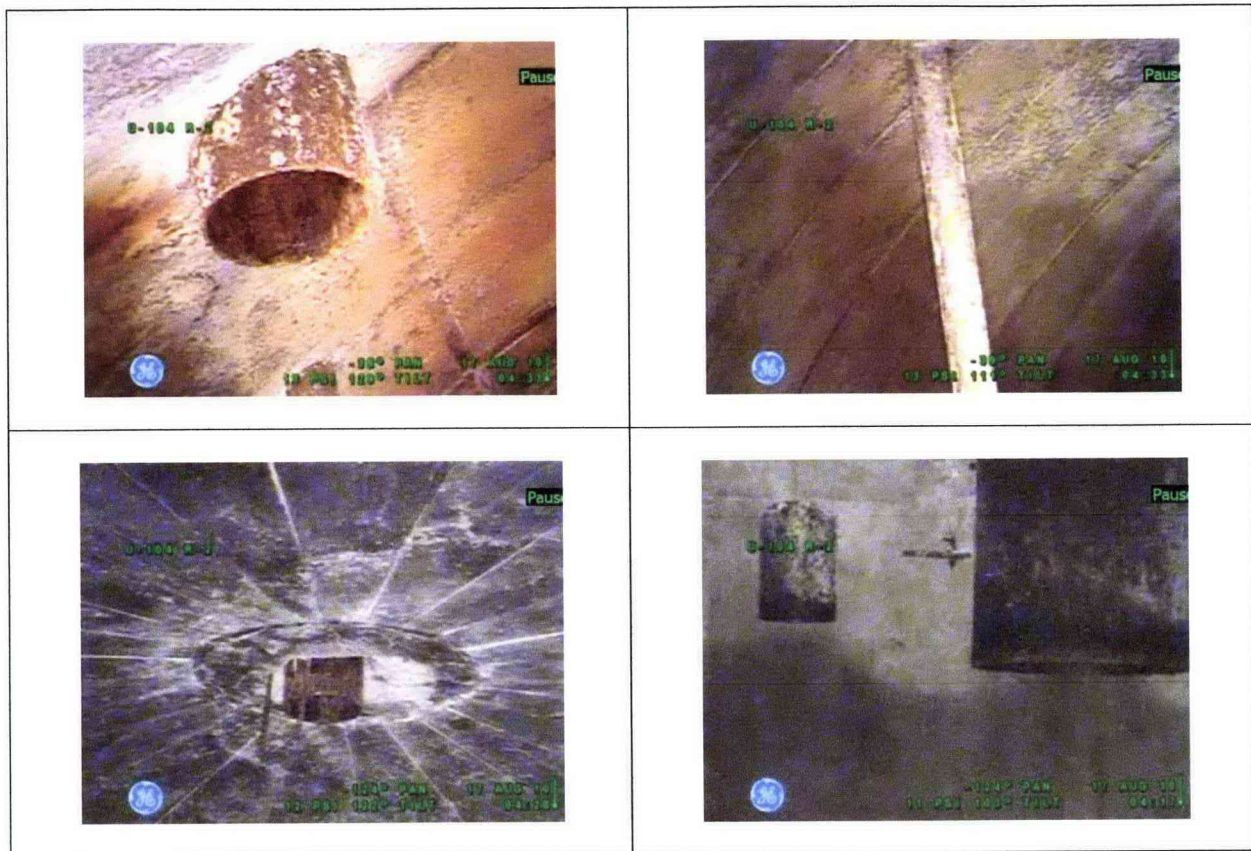
16.2 RECOMMENDATIONS
