Section 2 Project History

2.1 History of Construction of the Upper Reservoir Dam

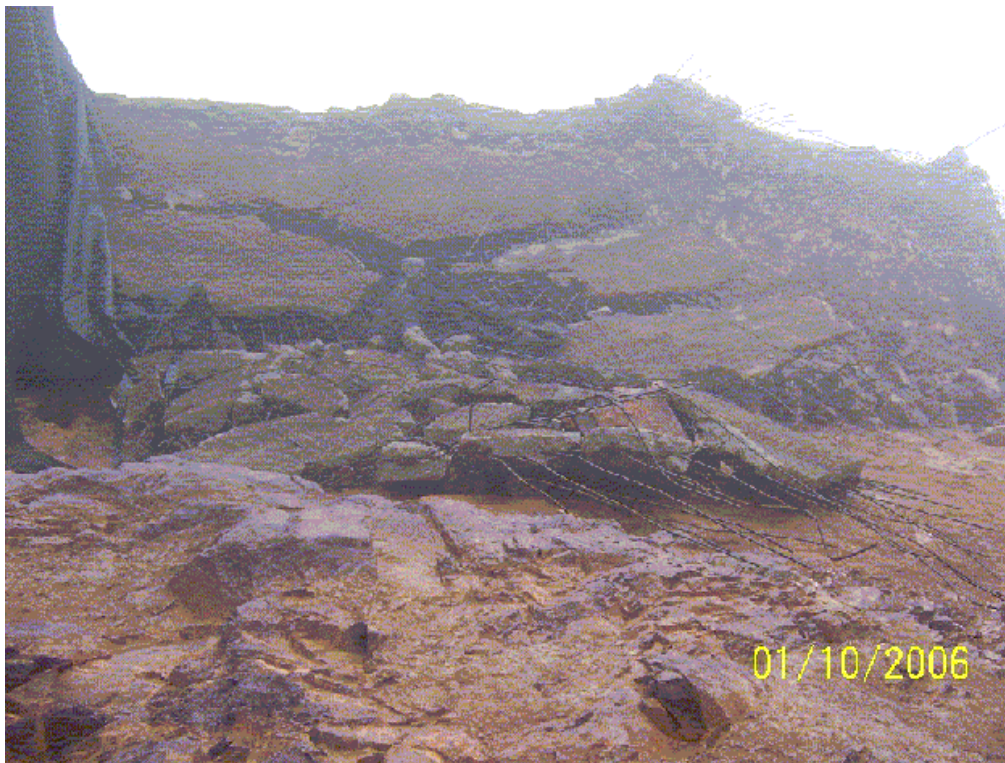
**Figure 2.4 - View of bedrock immediately below failed embankment section.
Note weathered clay in lower portions of the exposure.**

An area of the foundation in the breach section contained clay with low-moderate plasticity and weathered rock in the area just beneath the breach. The clay and weathered rock zone could have provided a failure surface for embankment sliding. The clay appears to be a residual weathering product of the bedrock (Figure 2.6), and in areas, relict bedrock structure can be observed in partially and completely decomposed clay remnants. No records were made available that indicate the extent of clay that was left in the breach area. However it could be conjectured that the settlement of the parapet wall in this area may have been accentuated due to consolidation of this clay deposit if it was of substantial thickness. The clay appeared saturated and contained groove marks from debris (Figures 2.7-2.9). This area was over-excavated in the footprint of the reservoir due to the clay foundation conditions, forming the “fish-pond” area of the

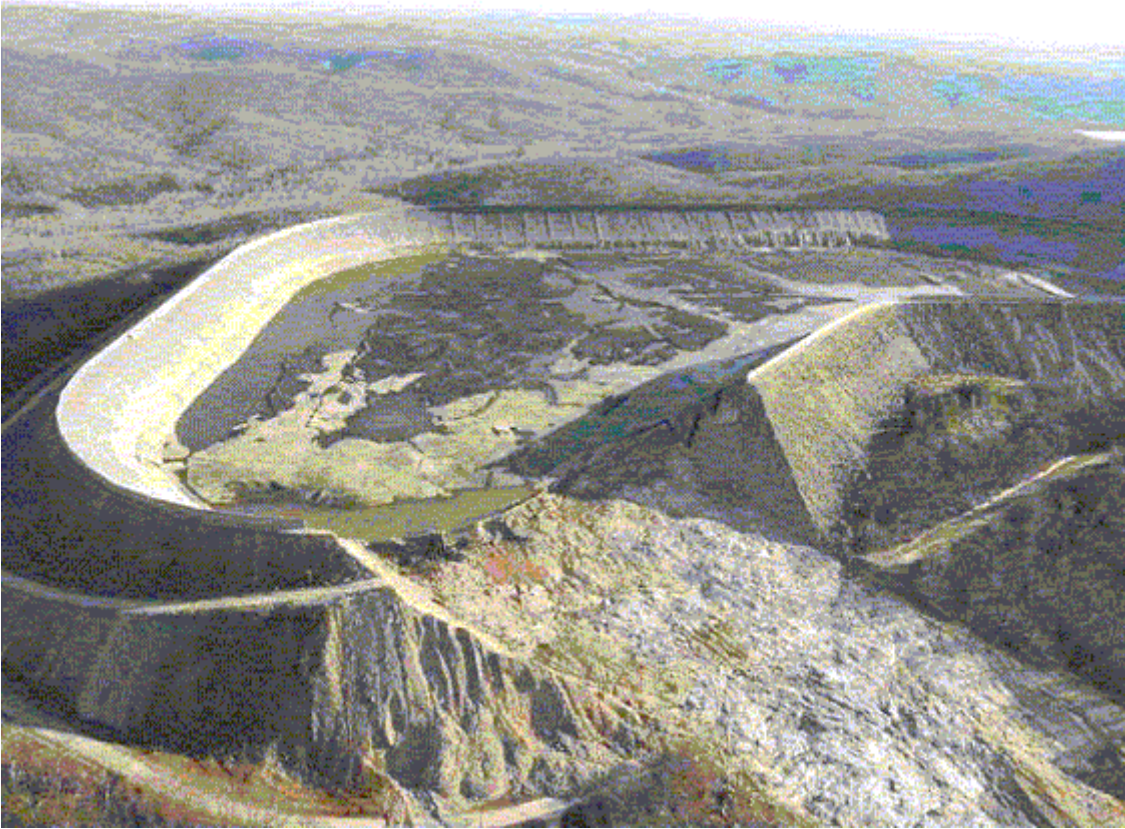
Figure 2.5 - View of bedrock within, and immediately below failed embankment section. Note distribution of weathered rock (red-brown color) and topsoil (green-brown color). The “fish-pond” area contains water and is immediately upstream of the breach.

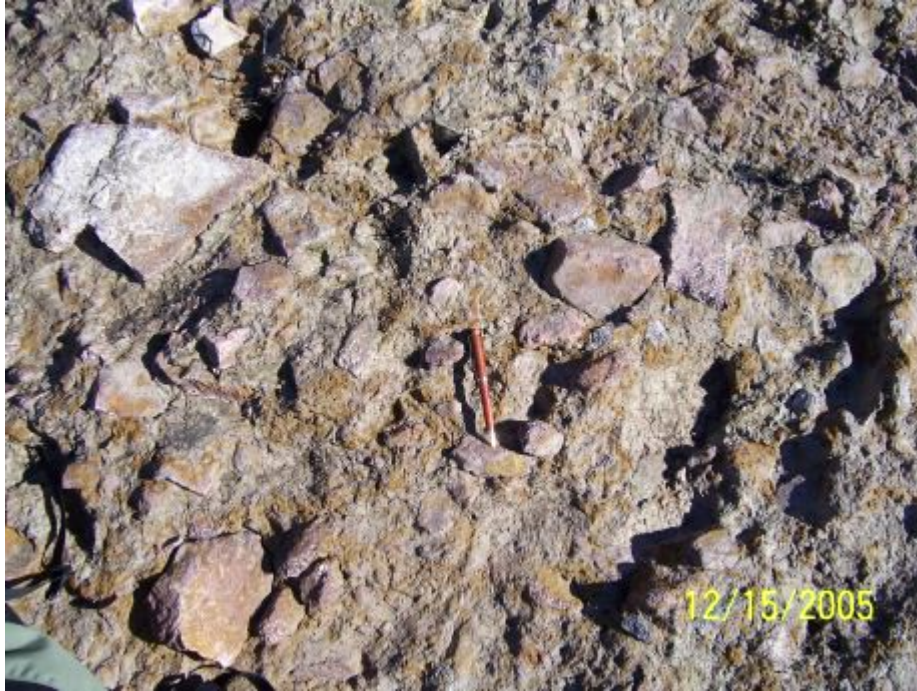
Figure 2.6 - Foundation area composed of weathered rhyolite with some clay, located in breach area.

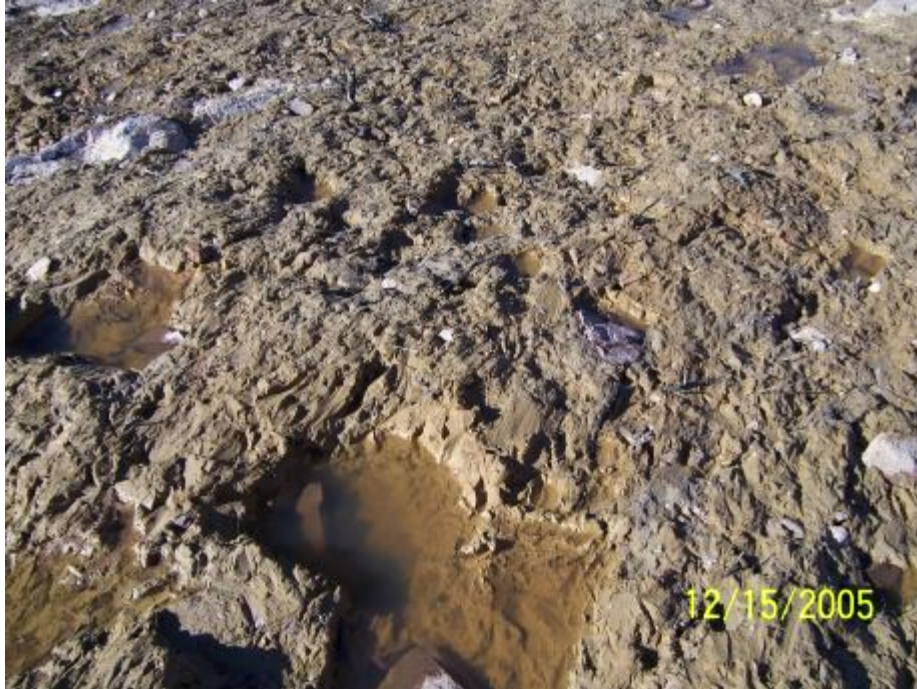
Figure 2.7 - Grooves cut into an area of clay-seam foundation by the floodwaters. This area is located immediately downstream and in the center of the breach.

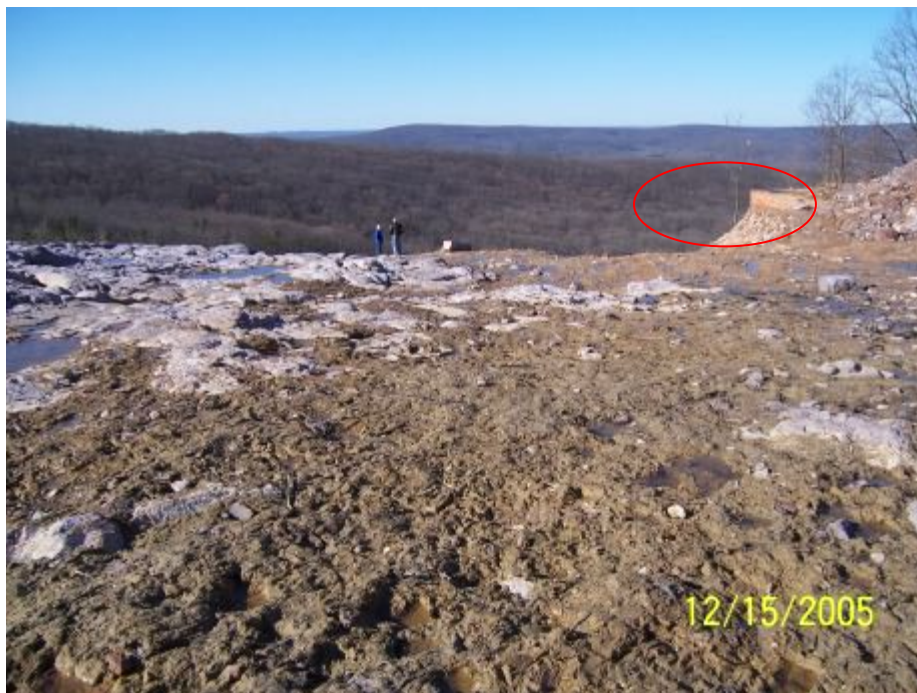
Figure 2.8 - Overview of area shown in previous photograph. Note washed out access road (circled).

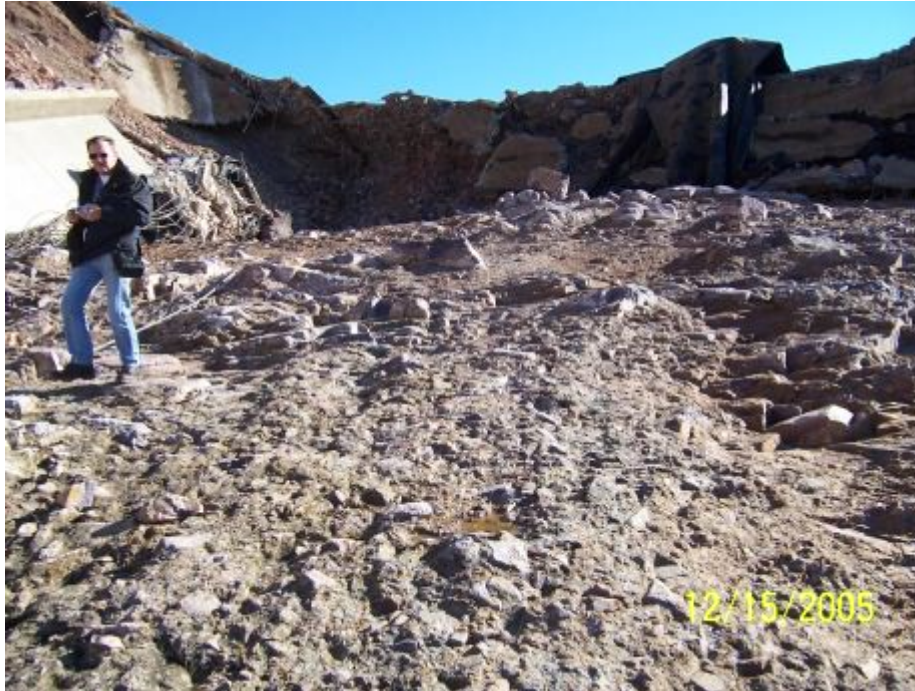
Figure 2.9 - Overview of area to the right of that shown in previous photograph. (See also Figure 2.4.) Note breach in background and toe of breach slope on left edge of photograph.

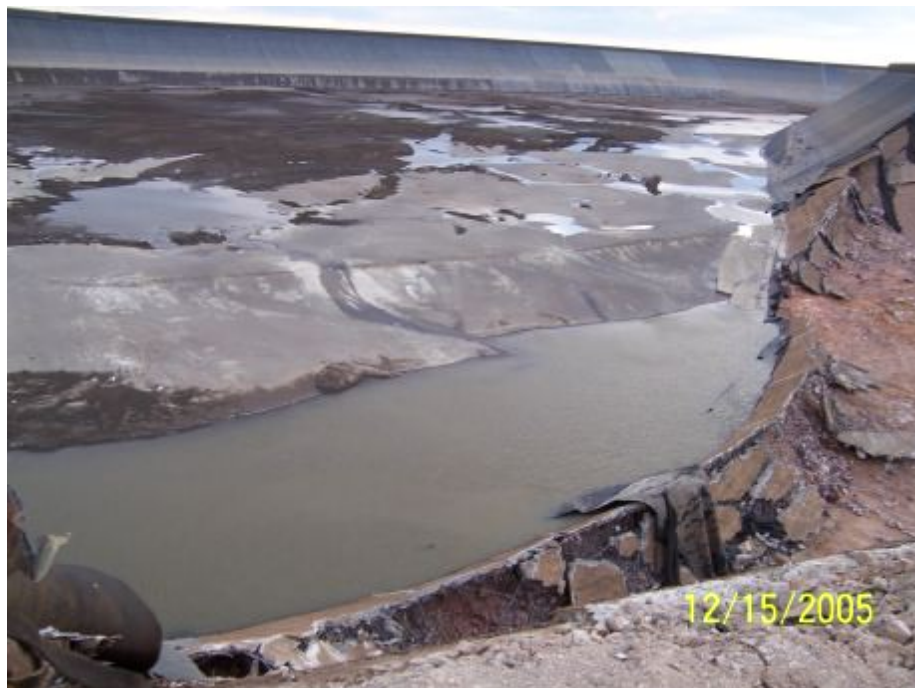
Figure 2.10 - Breached area. Note “fish pond” area immediately upstream of the breach. This area was over-excavated during original construction due to poor foundation conditions.

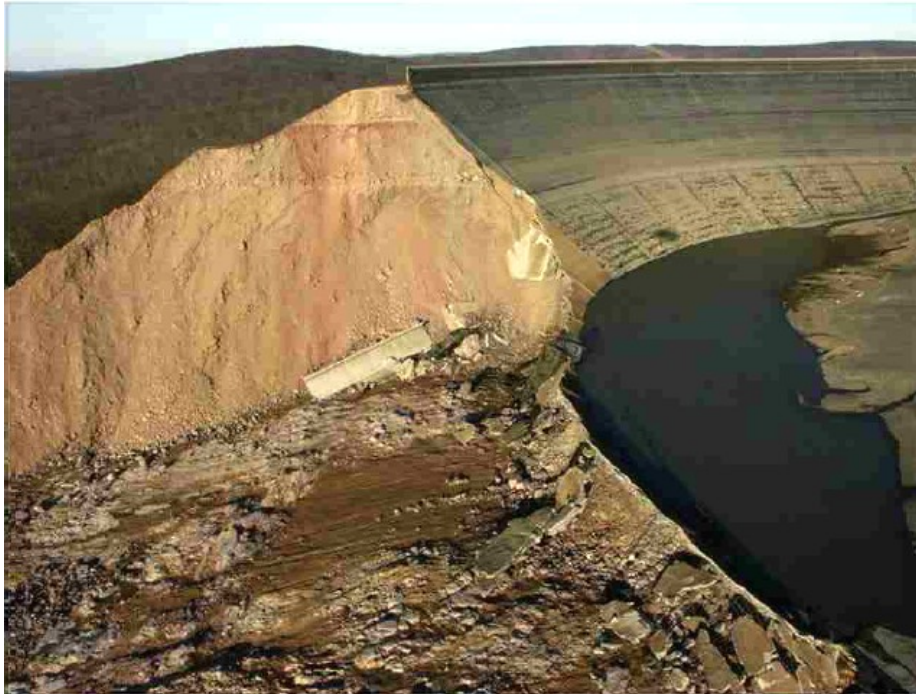
Figure 2.11 - Weathered rock and discontinuous clay seam foundation just downstream of fish-pond area.

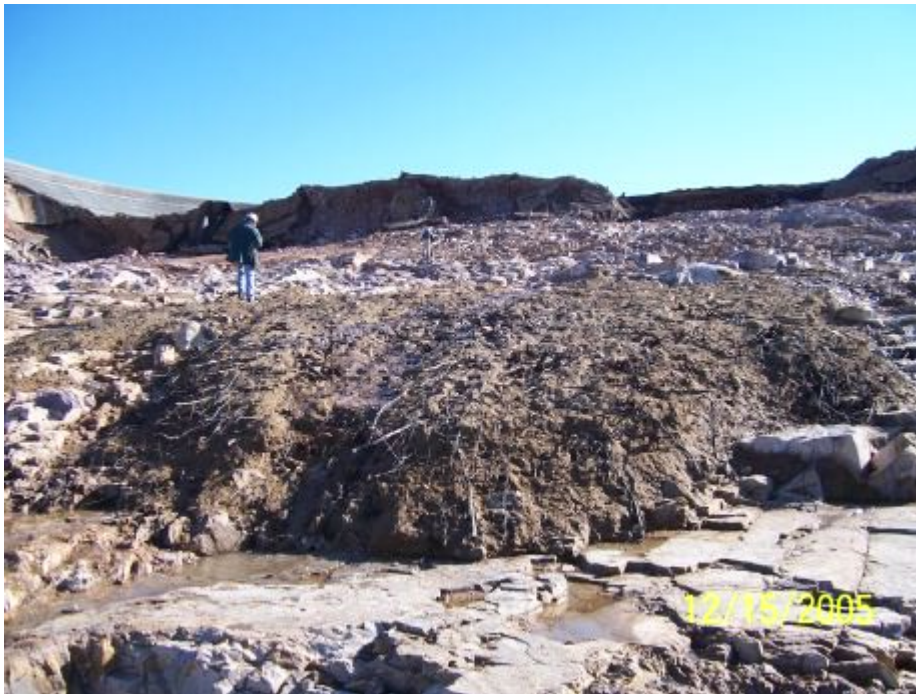
reservoir floor (Figure 2.10). There was also some remnant soils found in the breach area (Figure 2.11 and 2.12).

Figure 2.12 - Root-laden remnant native soil in breach area, resting on fresh rhyolite.

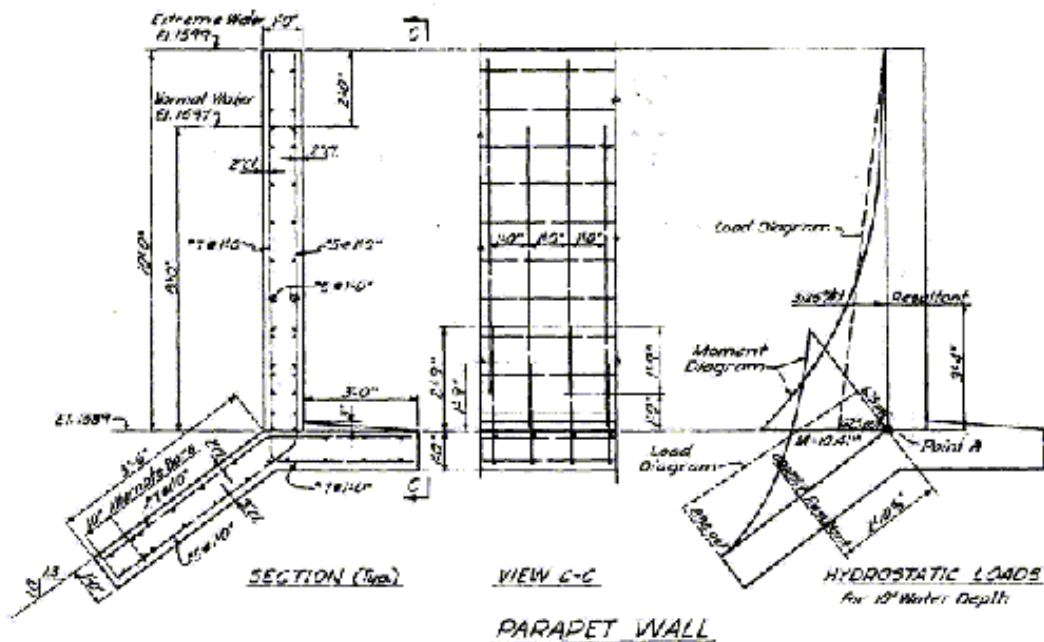
Figure 2.13

Design Drawing 8304-X-26157 (Figure 2.13) shows the following results from an overturning stability analysis, taken about the point where upstream vertical surface intersects the sloping base of the parapet wall:

Overturning Moment: 10,406 Kip-feet
 Stabilizing Moment: 11,155 Kip-feet

Taking moments about the downstream heel of the wall (Pt. A on Figure 2.15) yields an overturning factor of safety of 2.45. This calculations neglect uplift on the base of the wall, assuming a free draining foundation.

The table indicates the maximum unit tensile stresses in the reinforcement would meet the Alternate Design Method code for water levels two feet below the top of wall. For the extreme case of water levels at the top of the wall, the maximum unit tensile stress is higher than the allowable stress.

The wall design meets Load Factor Design code when water levels are two feet below the top of the parapet wall. For the extreme condition with water levels at the top of the wall, Mu exceeds $\Phi M_n/1.3$.

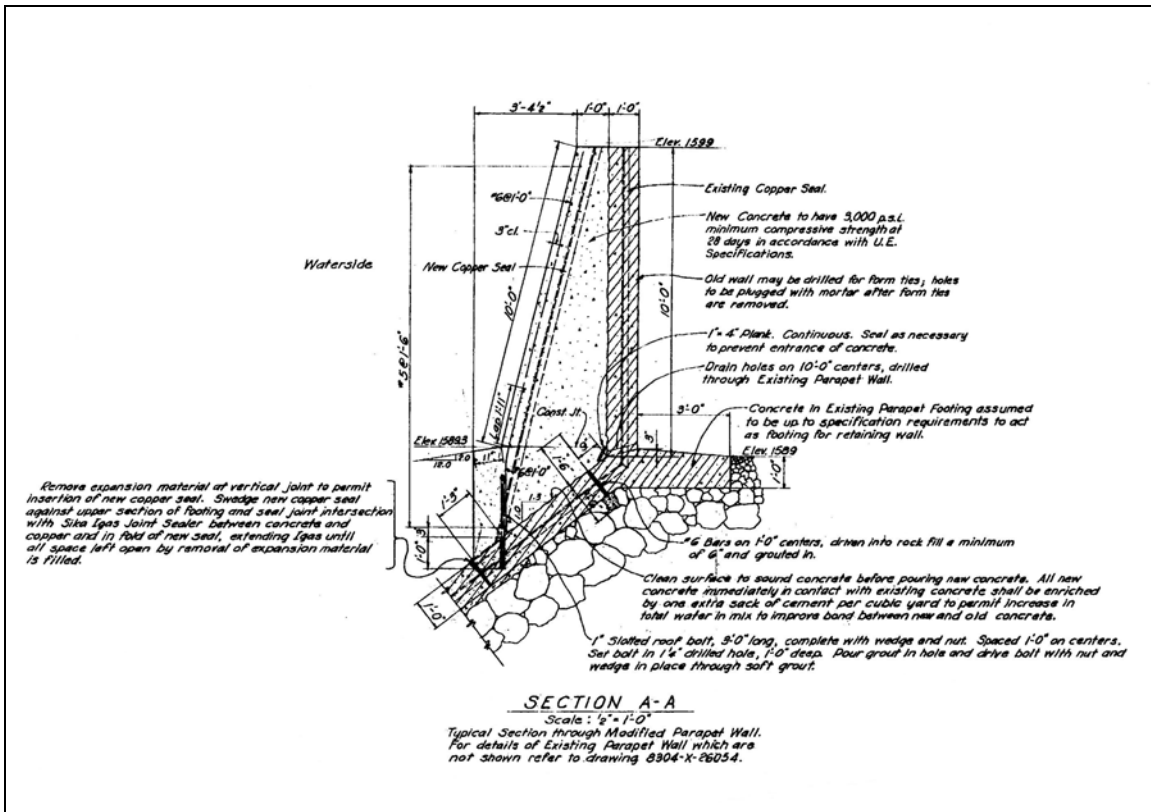
Figure 2.14

The initial portion of the concrete parapet wall, panels 3-20, were pneumatically placed concrete similar to the concrete face slab. However, this section was not accepted due to poor quality concrete. Based on a 1963 design drawing (8304-X-26122), parapet panels 3-20 were modified to have a sloping reinforced-concrete wall placed upstream of the parapet stem, with the area between the two walls filled with 3,000 psi concrete (see Figure 2.14).

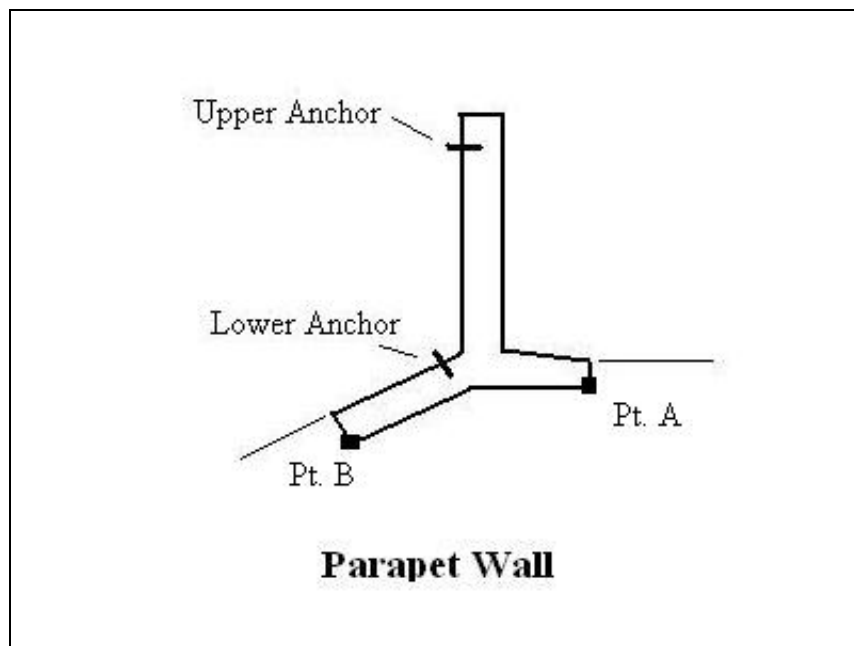
Figure 2.15

These forces result in a net increase in the stabilizing moment about the downstream heel of the wall (Pt. A on Figure 2.15). The Design Report includes calculations showing the effects of the anchor on overturning about the upstream toe of the sloping wall slab (Pt. B on Figure 2.15). This was done to determine if the anchors would pull the wall into the reservoir, especially when the water level was just below the parapet wall. The factor of safety for overturning about the upstream toe was determined to be 5.64.
