Section 4 Post Breach Survey and Estimates of Overtopping

4.1 Post Breach Survey and Estimate of Overtopping

4.2 Damage on Downstream Slope

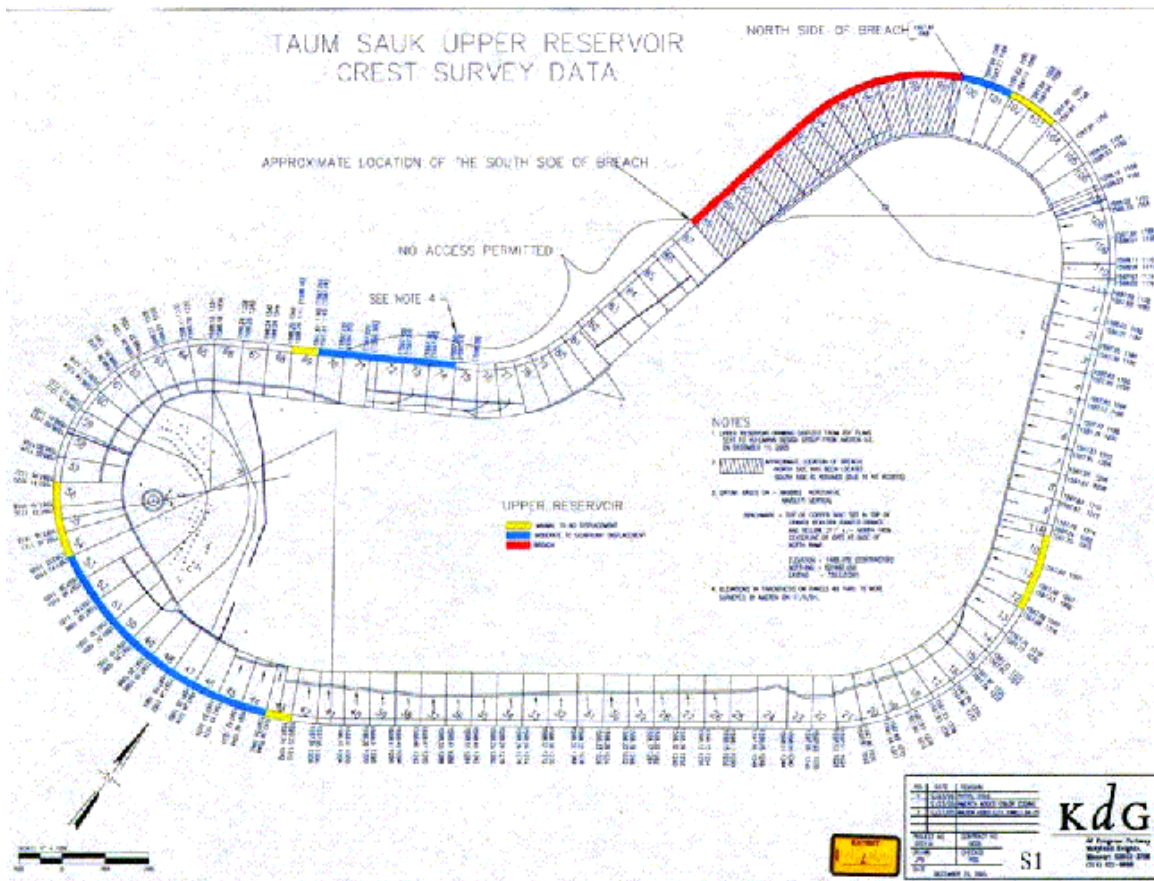
Figure 4.1 From KdG, Maryland Heights Missouri

Figure 4.1 shows the post breach survey and downstream damage assessment. The figure provides evident of where overtopping occurred:

<u>Parapet wall panel</u>	<u>Wall Elevations</u>	<u>Damage Survey</u>
• Panel 10 yellow	1597.60 -1597.70 ft	minimal to no damage
• Panel 12 yellow	1597.43 -1597.69 ft.	minimal to no damage
• Panel 103 yellow	1597.94 -1597.90 ft	minimal to no damage
• Panel 100 blue	1597.69 ft	moderate to significant
• Panel 43 yellow	1597.7 - 1597.58 ft	minimal to no damage
• Panel 49 blue	1597.2 -1597.33 ft	moderate to significant
• Panel 56 yellow	1597.79 -1597.91 ft	minimal to no damage
• Panel 69 yellow	1598.26 -1597.81 ft.	minimal to no damage
• Panel 72 blue	1596.99 -1597.15 ft	moderate to significant
• Panel 74 blue	1597.42 - 1597.80 ft	moderate to significant

From the above survey data the range of possible peak pool elevation appears to range between 1597.7 ft to 1597.9 ft.¹ (Note that the elevations referenced in this report from various surveys are assumed to be correct. No allowance for systematic error has been considered in the assessment of the overtopping event.)

The Overtopping in the breach area (blue zone on Figure 4.1) was estimated at two locations where the 2004 elevation data was available at the parapet wall footer survey pins. The elevations and estimate of overtopping in the breach area at the following locations:

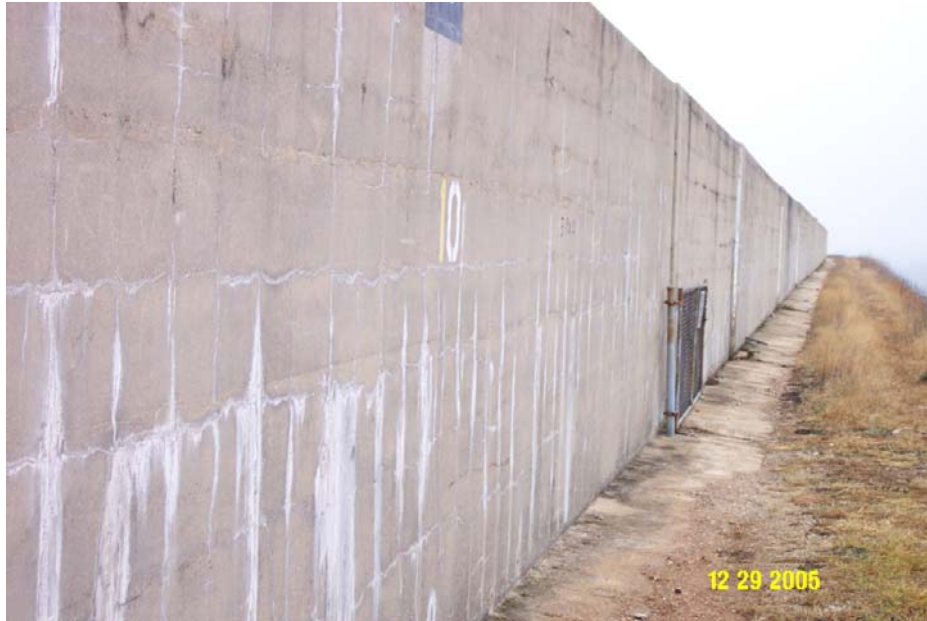
Assuming a peak pool elevation of 1597.7 ft the maximum overtopping was about 0.7 ft at Panel 72, 0.5 ft at Panel 49, and 0.1 ft at Panel 10. This neglects the wind-induced waves, which may have been on the order of 0.5 foot along the north side of the reservoir on December 14.

Figure 4.2 - Panel 10
Note grass is lain over near footing
Damage from overtopping was judged as Minimal
Estimate 0.1 ft. of overtopping

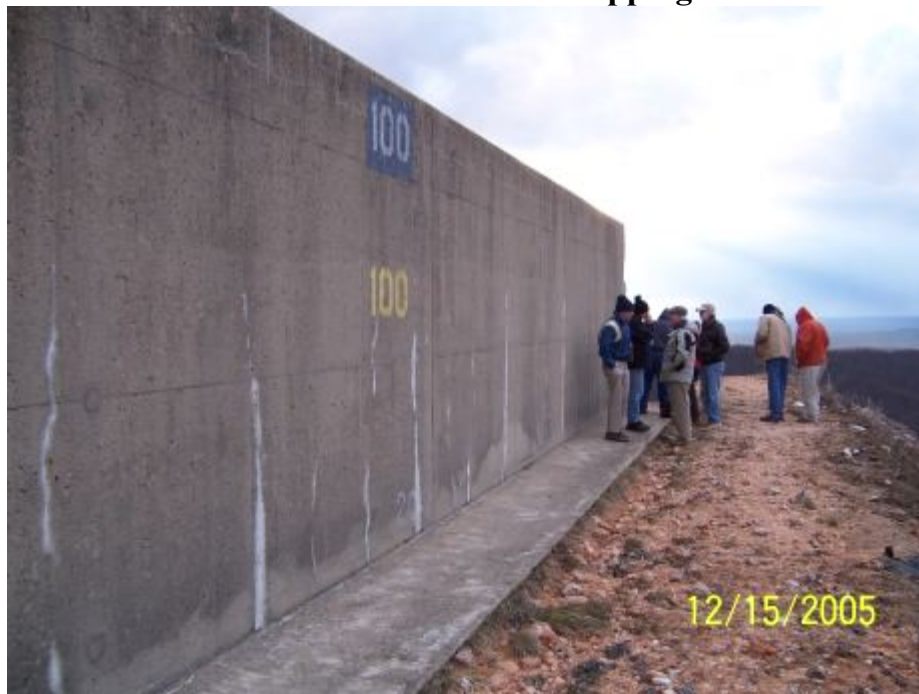
Figure 4.3 - Panel 100
Adjacent to the right side of the Breach
Note erosion at toe of parapet wall footing
Damage which was judged as moderate to significant

The elevations of Panels 100 and 101 were measured between elevations 1597.67 and 1597.82 ft (Figure 4.3). The damage at Panel 100 and 101, which was judged as moderate to severe, does not appear to agree with the estimates of the peak reservoir estimates occurring on December 14, 2005. However, wind-induced waves could have overtopped these walls by several inches on December 14, 2005. Damage may have been the result of the December 14, 2005 event and/or the September 25, 2005 wave overtopping event.

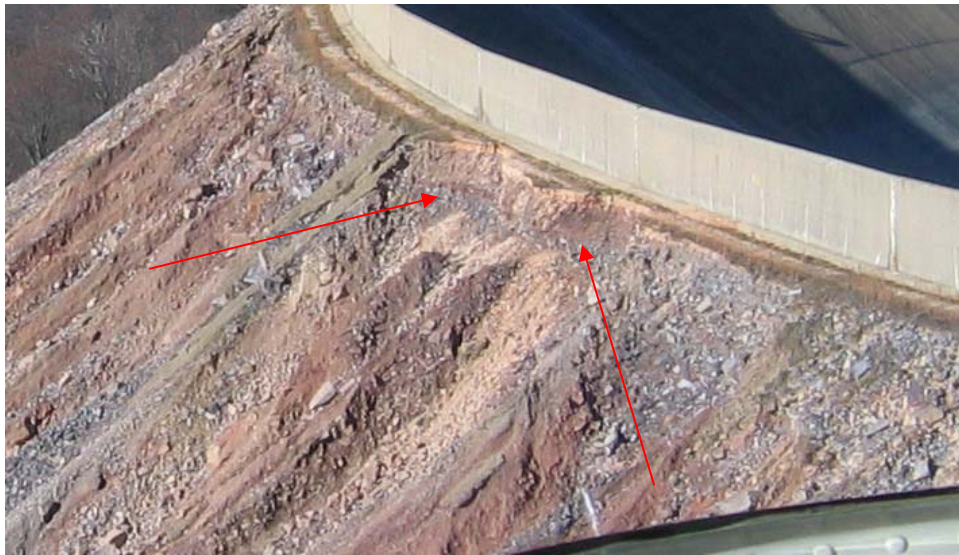
Figure 4.4 - Erosion Panel 48/49

Note scarps that may be the results of a localized slope failure

Damage judged as significant

Estimate 0.5 ft of overtopping

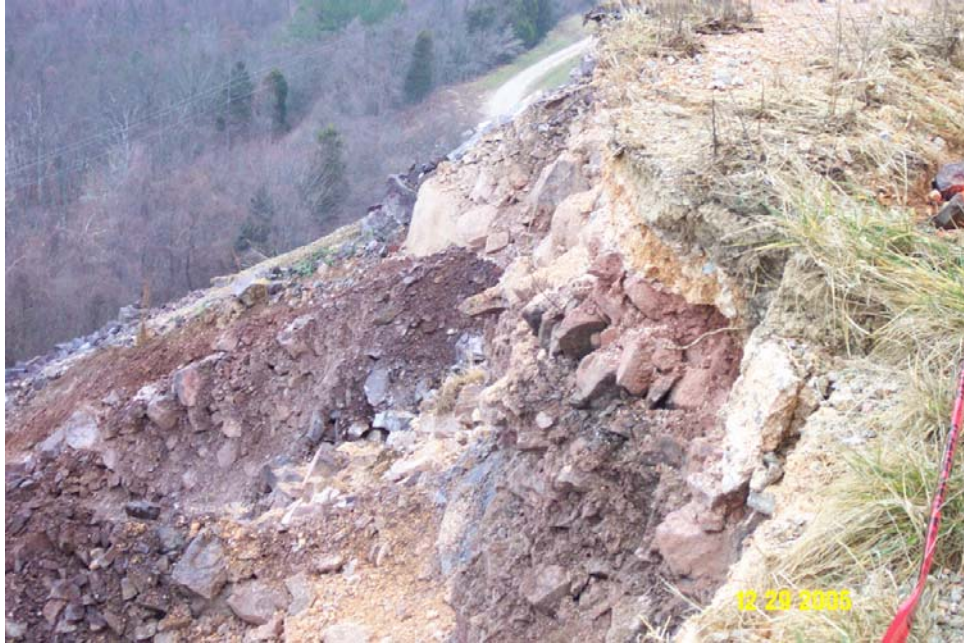
**Figure 4.5 - Panels 48 and 49
Scarp near toe of parapet wall footing**

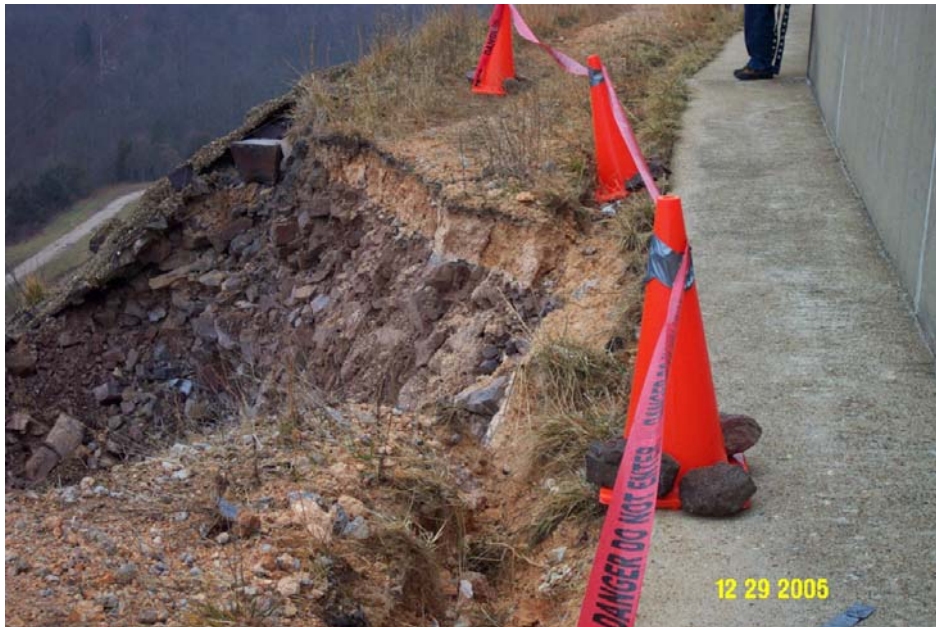
**Figure 4.6 - Panels 48 and 49
Scarp near toe of parapet wall footing
Note erosion rut adjacent to the footing**

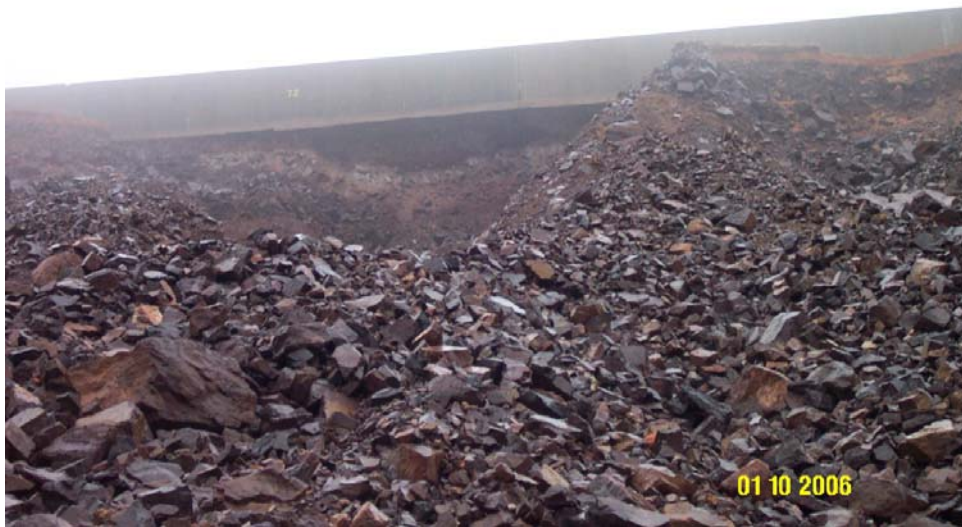
Figure 4.7 - Panel 72
Note erosion deep beneath the parapet wall
Damage judged as significant
Estimate 0.7 ft of overtopping

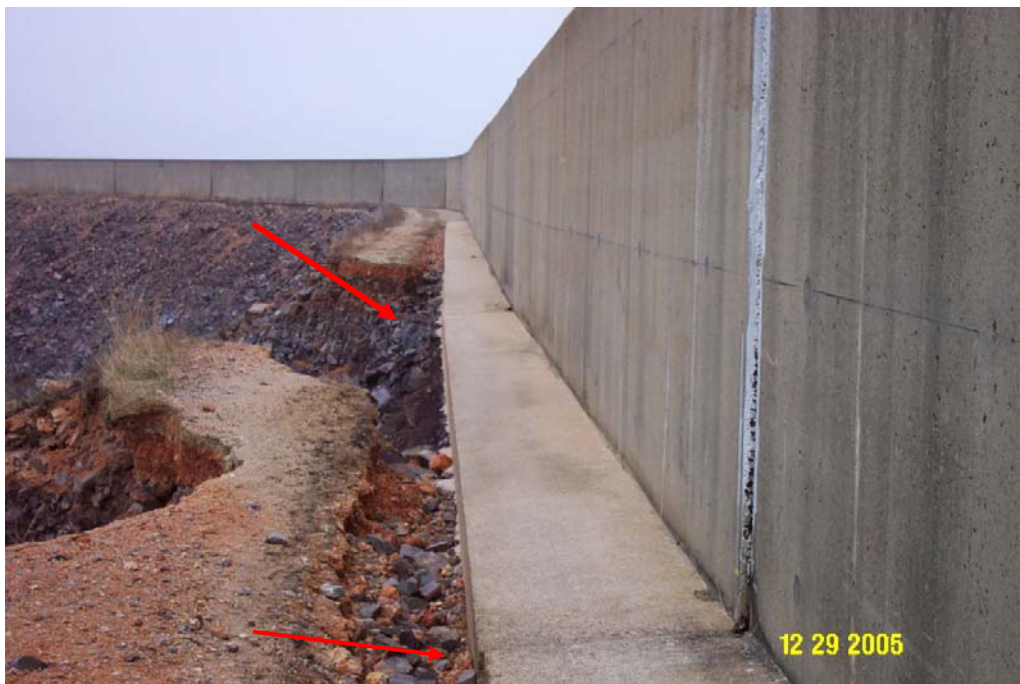
Figure 4.8 - Erosion at Panel 71 footing
Note the horizontal displacement between Panel 70 and 71 (foreground) and
bowing at the joint between Panels 71 and 72. Erosion at the footing is
similar to that described during the September 25, 2005 wave overtopping.

AmerenUE's personnel identified the damage that occurred on September 25, 2005 as "ruts and trenches" adjacent to panels 90-96. The operators reported depths of 6 inches to 1 foot. The operators subsequently repaired and regraded the damage using crushed rock, with most of the rock used to repair and improve the access road. No formal procedure was used to repair the trenches and the ruts.

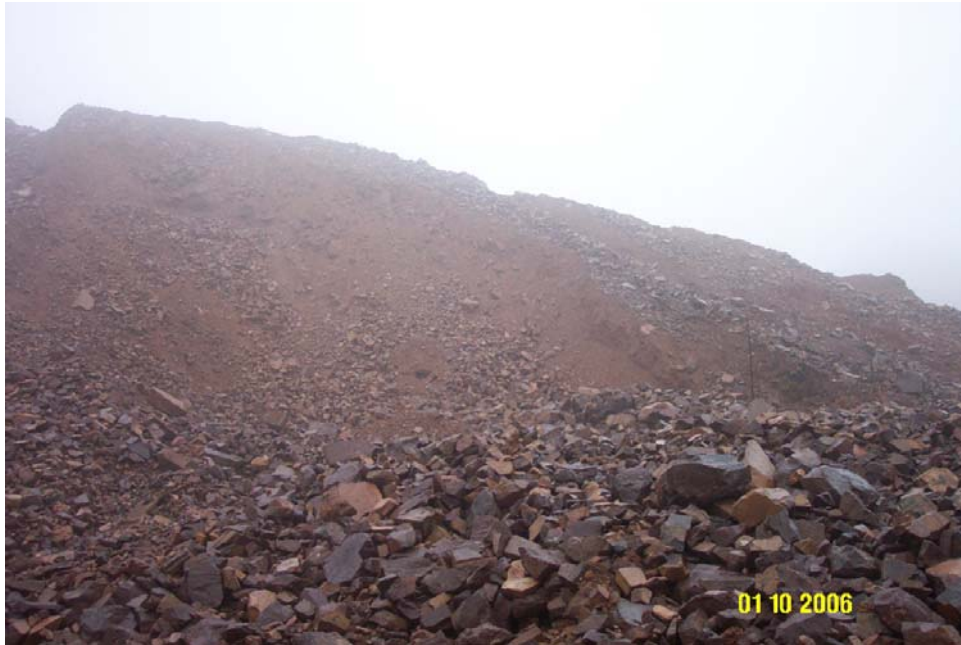
Figure 4.9 - Possible slope failure between Panel 100 and the full breach section

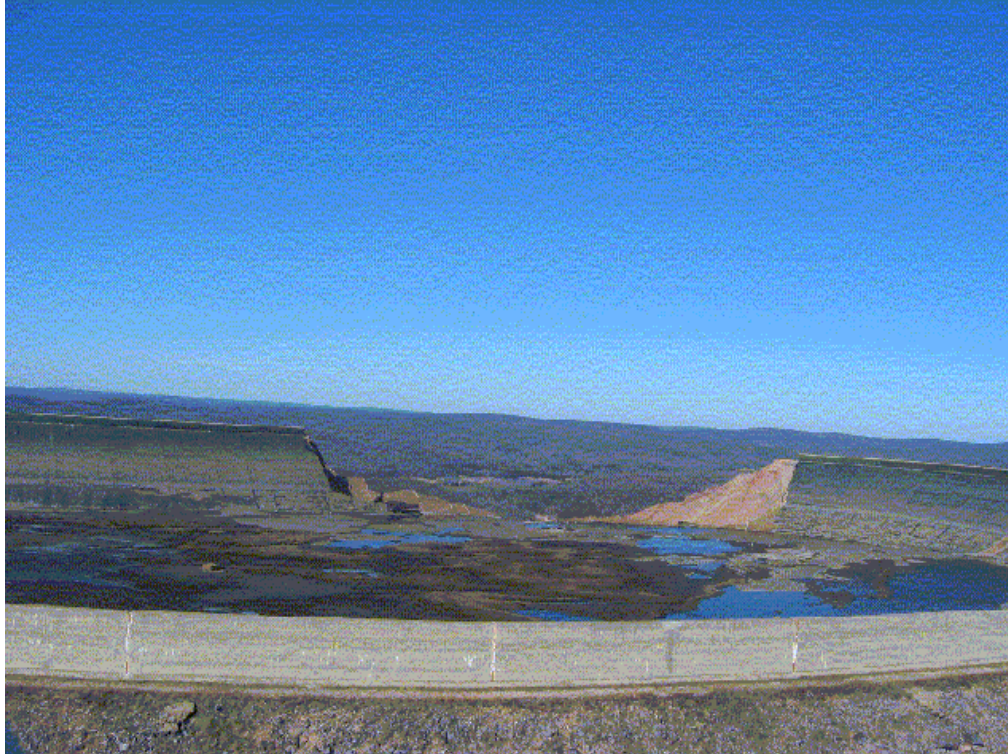
Footer Pin 18 (Panel 90) Elev.	1587.49 ft *
Top of wall Elev.	1597.49
Amount of Overtopping	0.2 ft

Footer Pin 19(Panel 95) elev.	1587.39 ft*
Top of wall elev.	1597.39
Amount of Overtopping	0.3 ft

**Figure 4.10 – Breach Panels 88 - 99 removed during the event
Estimate 0.2 -0.3 ft. of overtopping. (Missouri DNR Photo)**

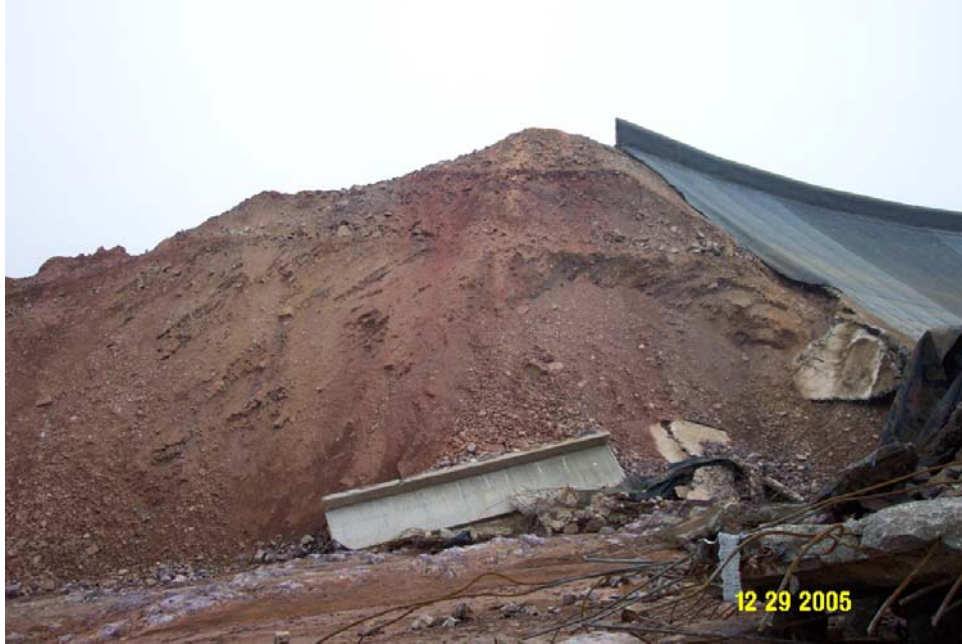
**Figure 4.12 - Right side of breach
Note layering of embankment**
