Taum Sauk Upper Reservoir Failure

Technical Reasons for the Breach

Presented by: Joseph L. Ehasz
Kermit Paul

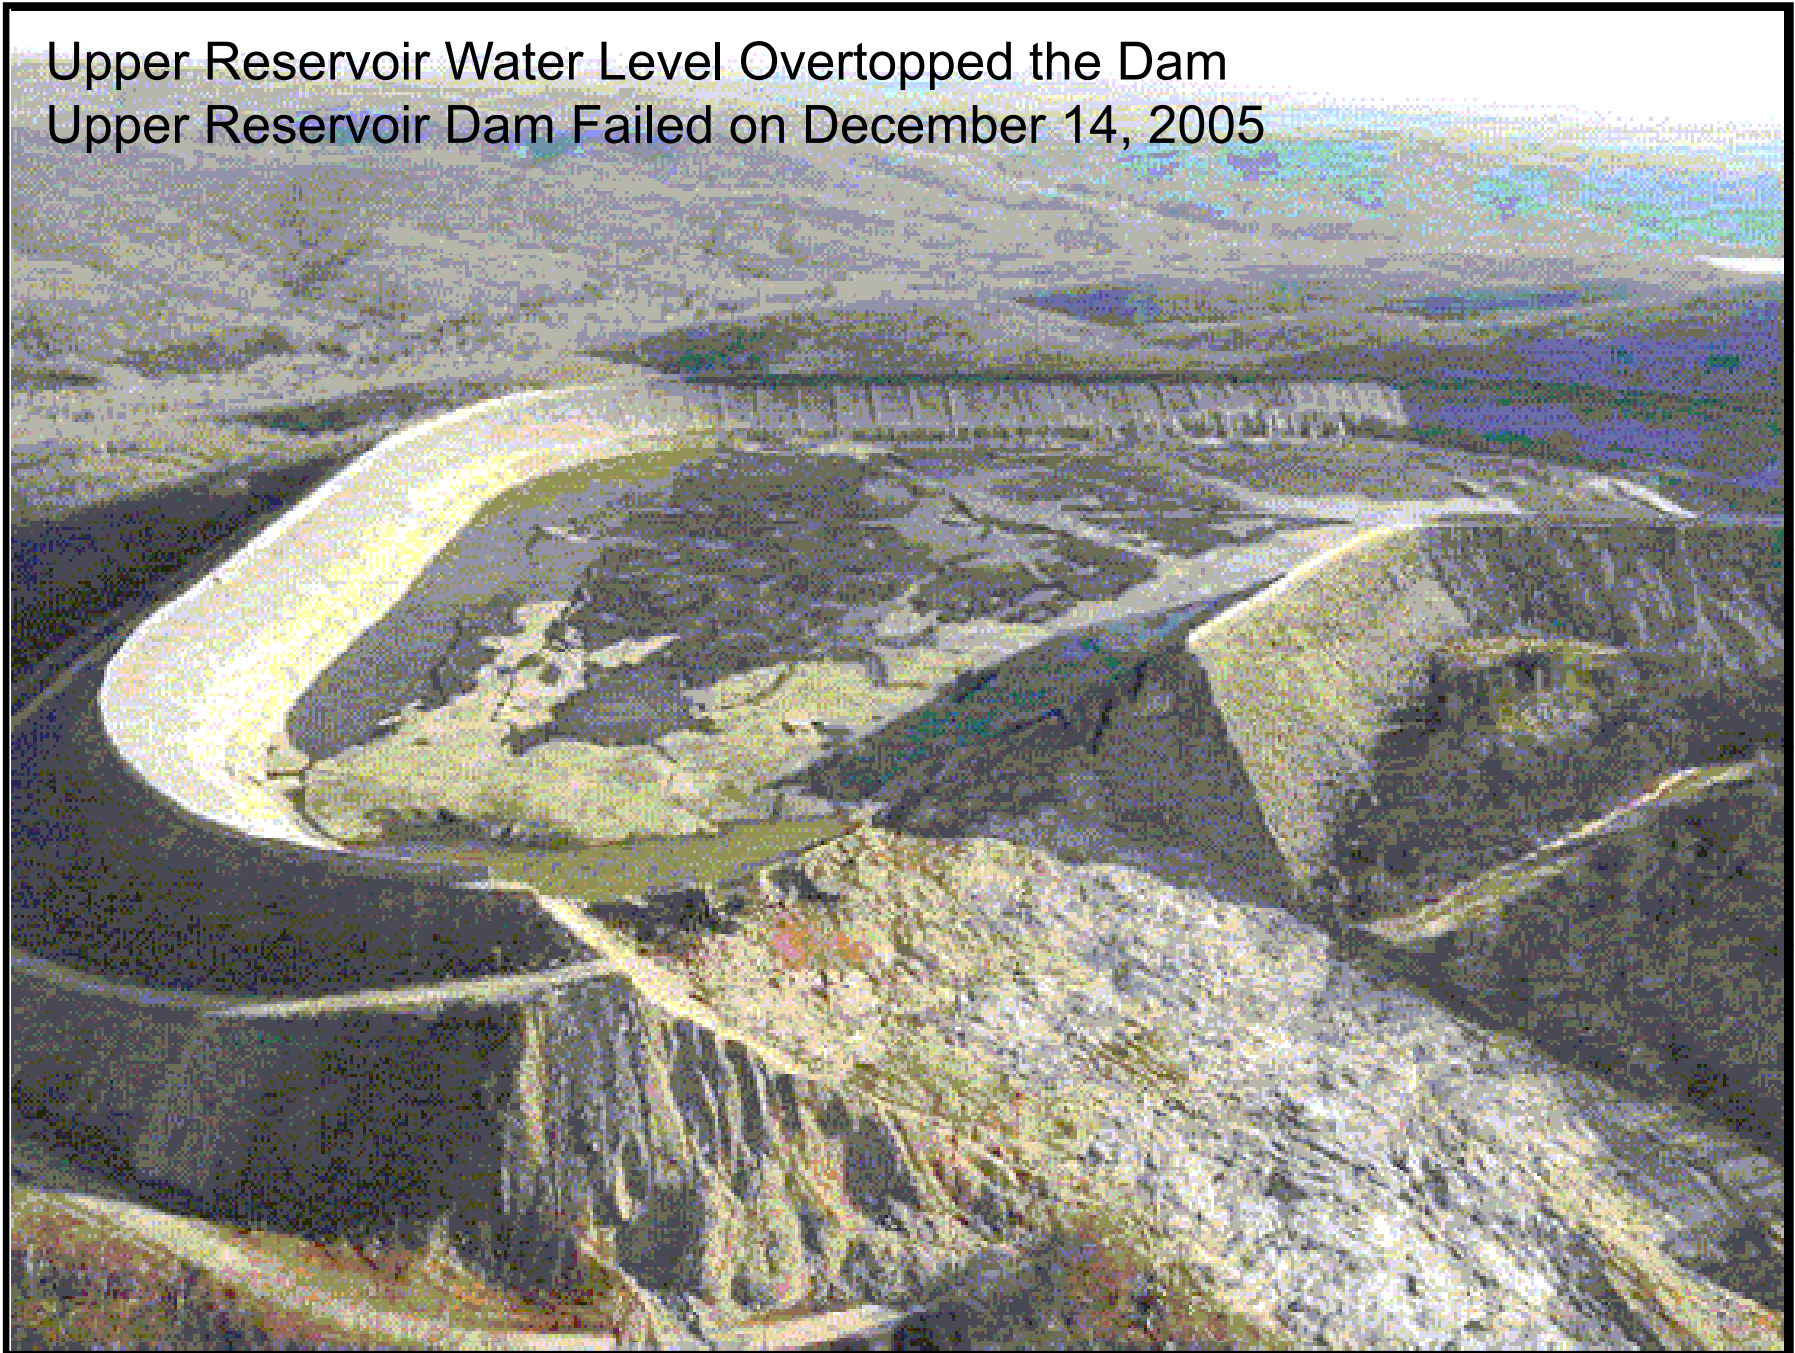
Taum Sauk Upper Reservoir Breached

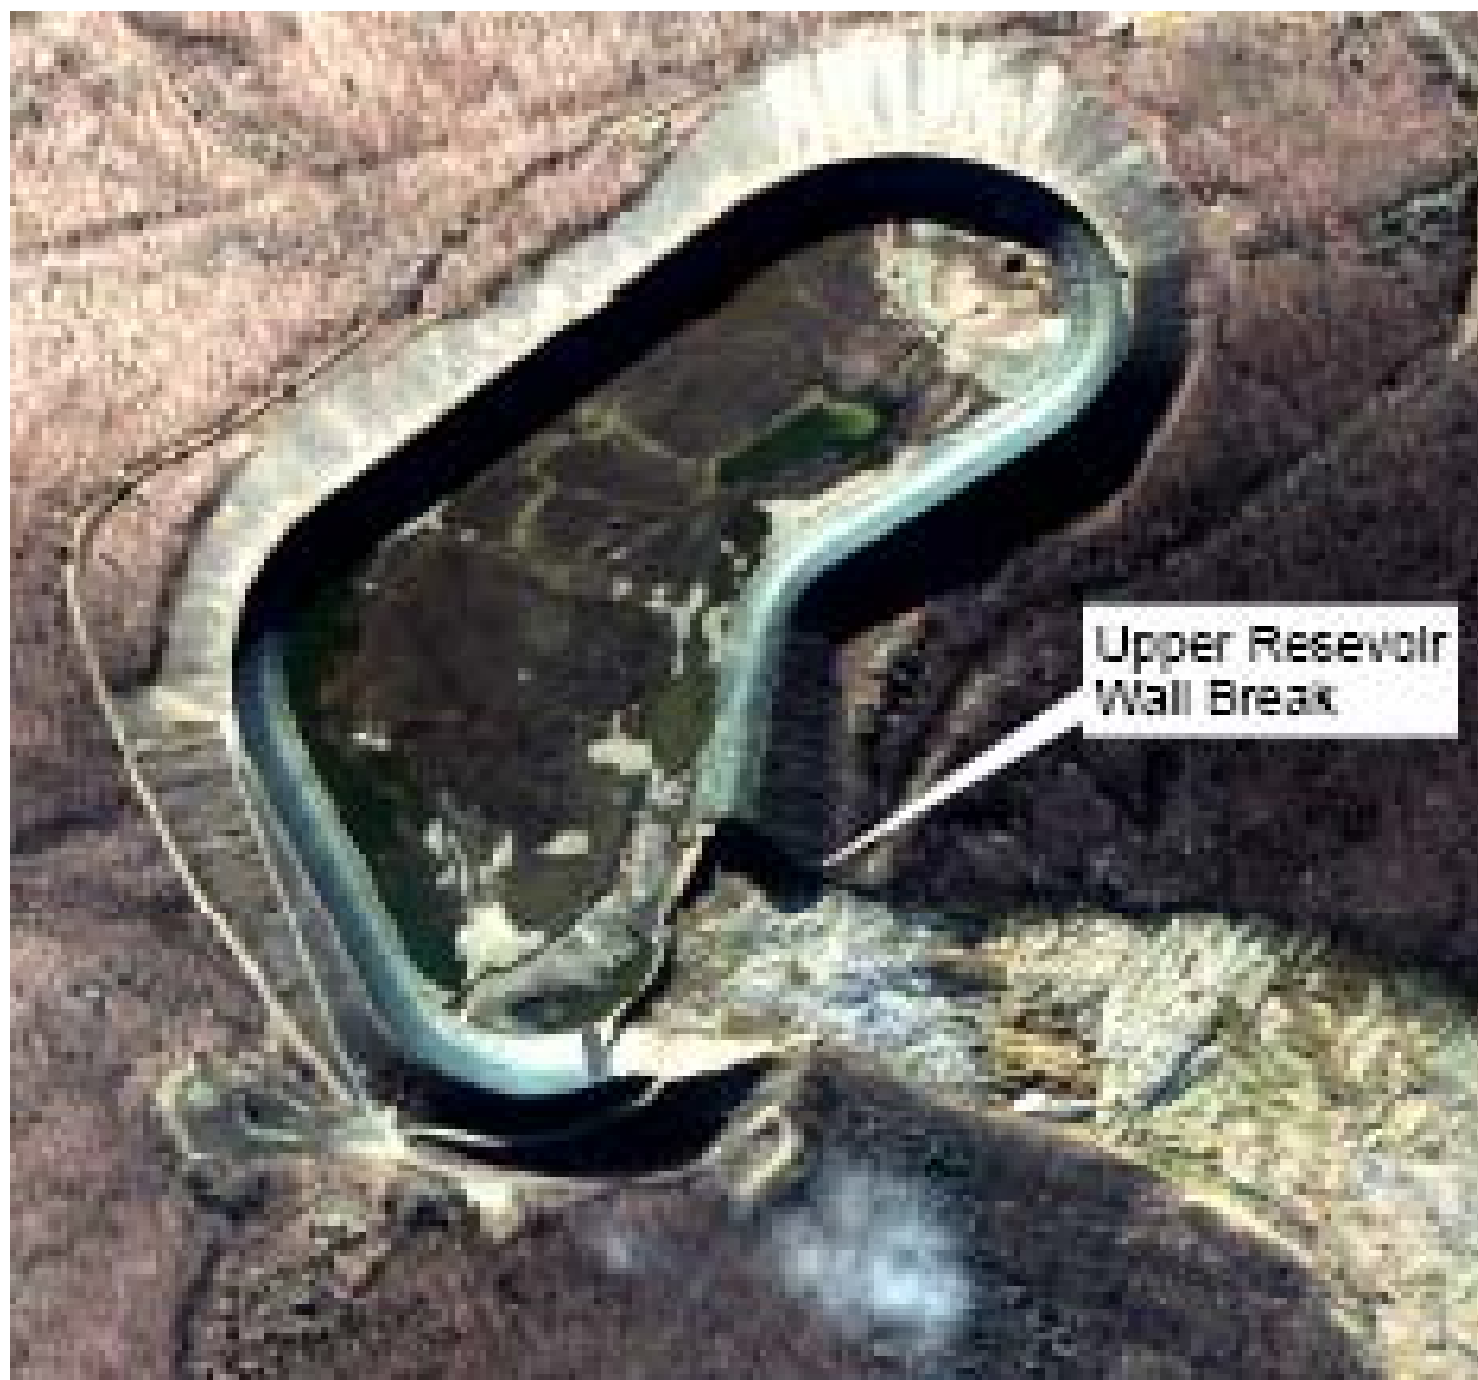
Upper Reservoir
Wall Break

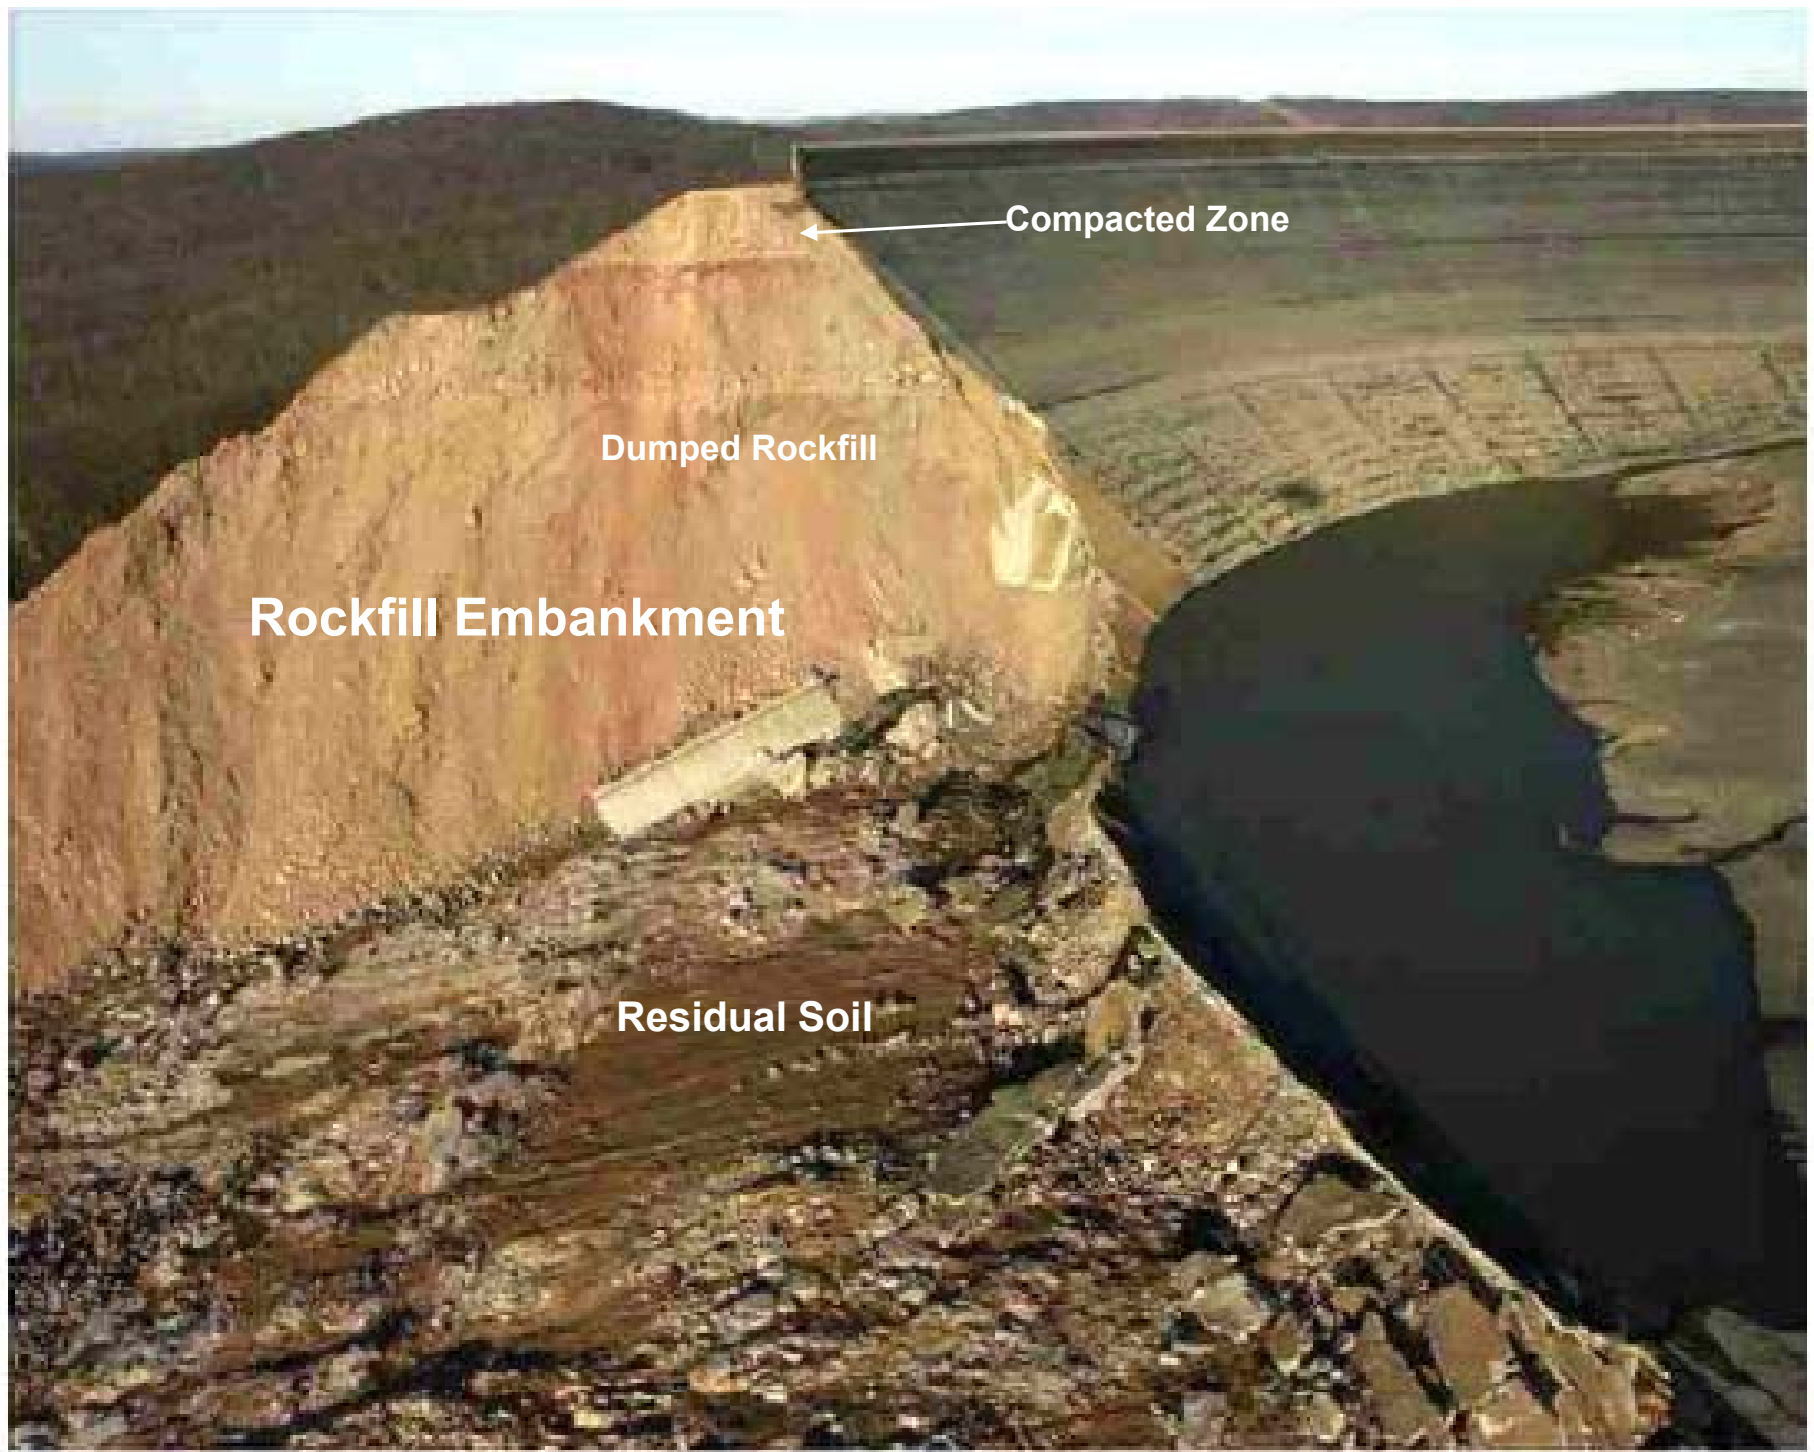
North Side of Breach Face

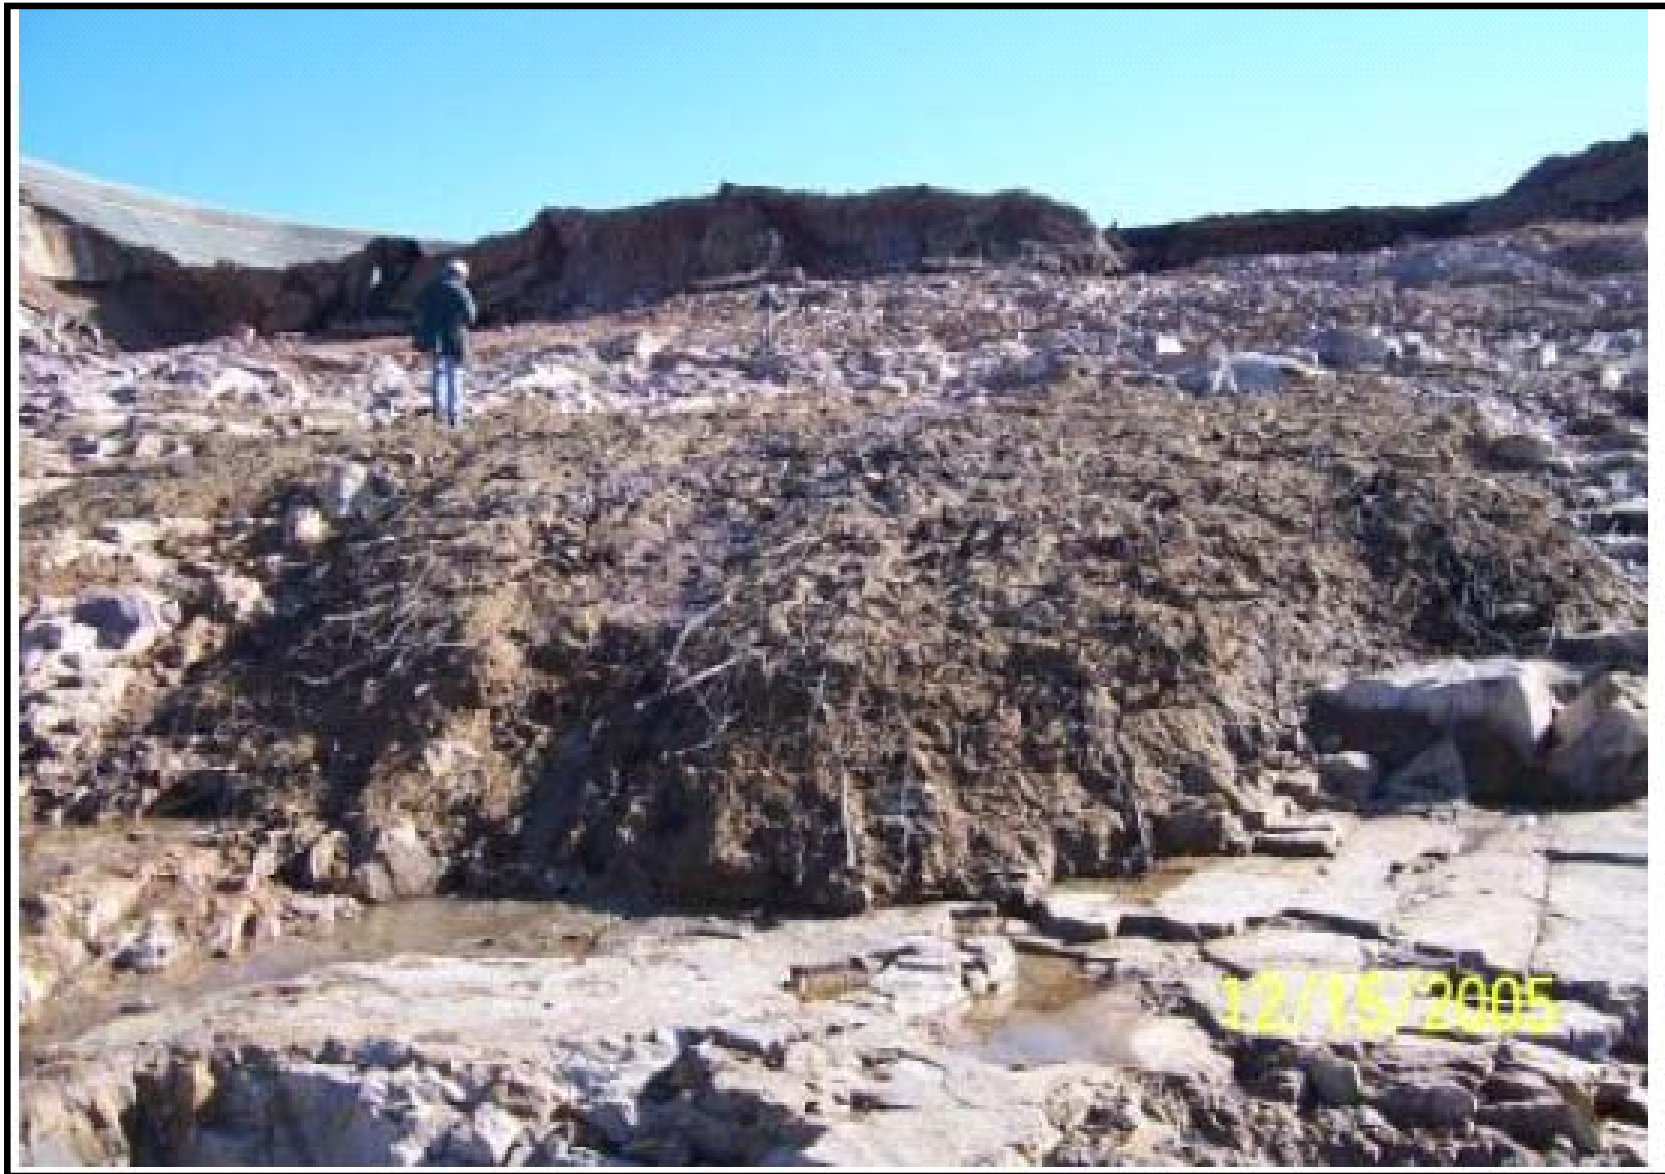
Eroded foundation, note rock jointing and overlying clay materials

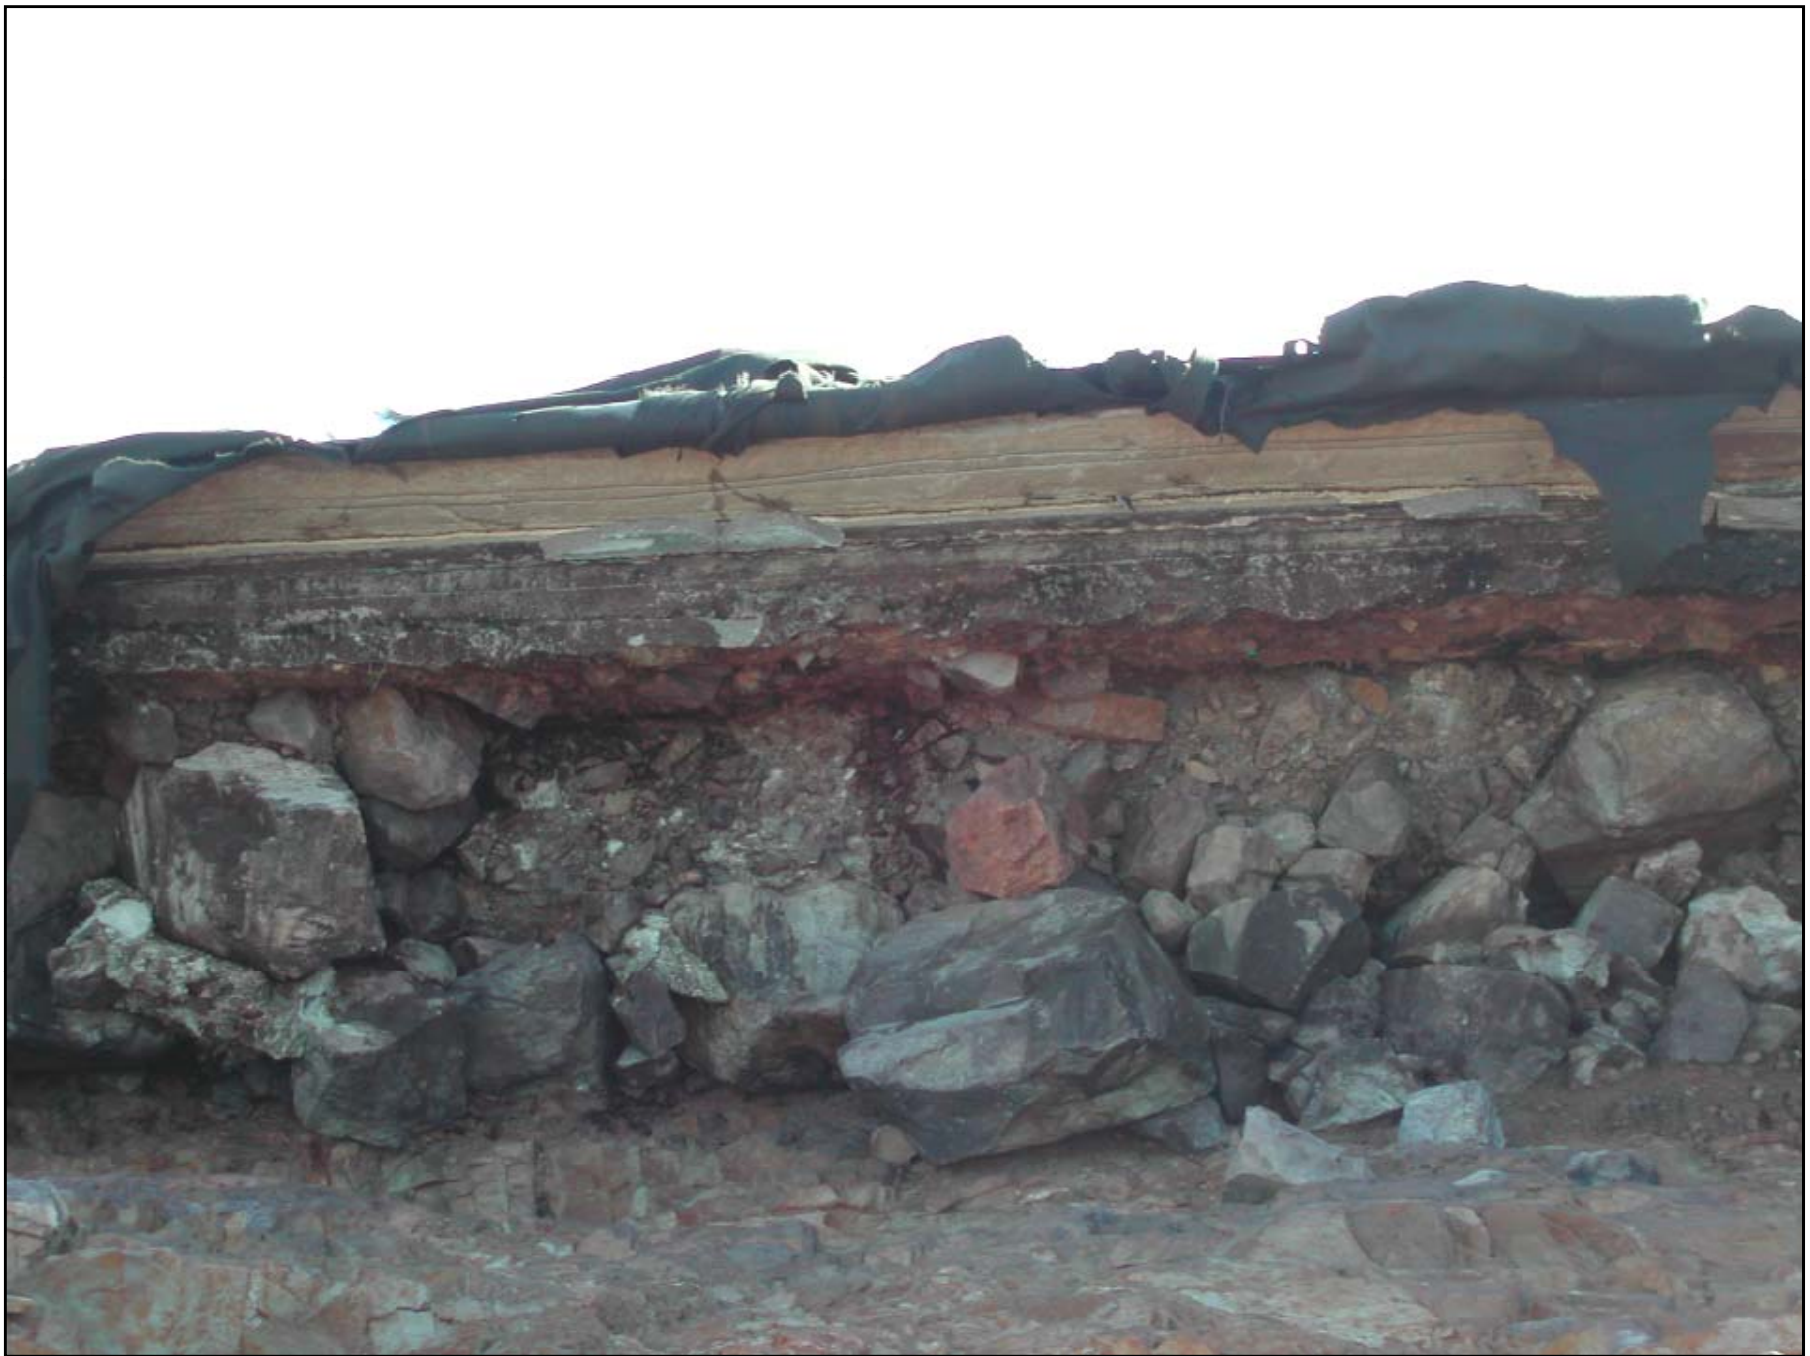
Rockfill between top of rock and base of plinth,
note reddish grout in rockfill beneath the plinth

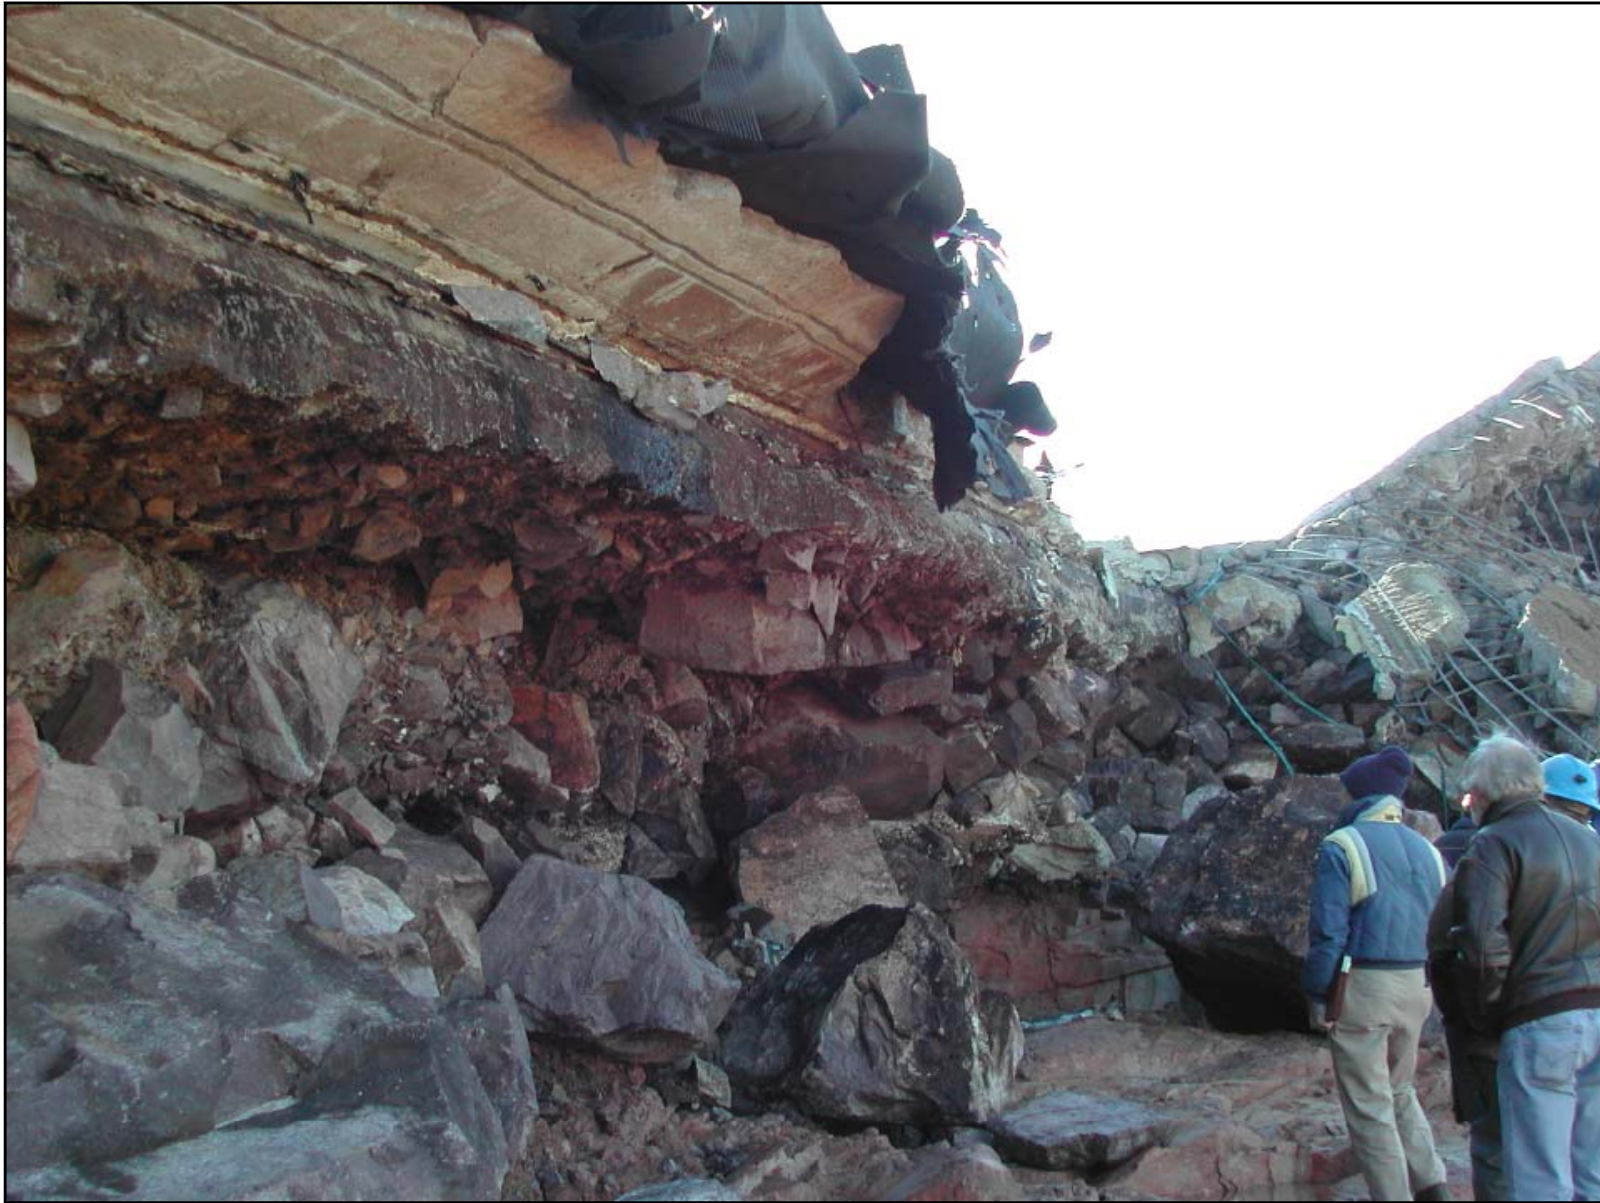
Rockfill between top of rock and base of plinth,
note reddish grout in rockfill beneath the plinth

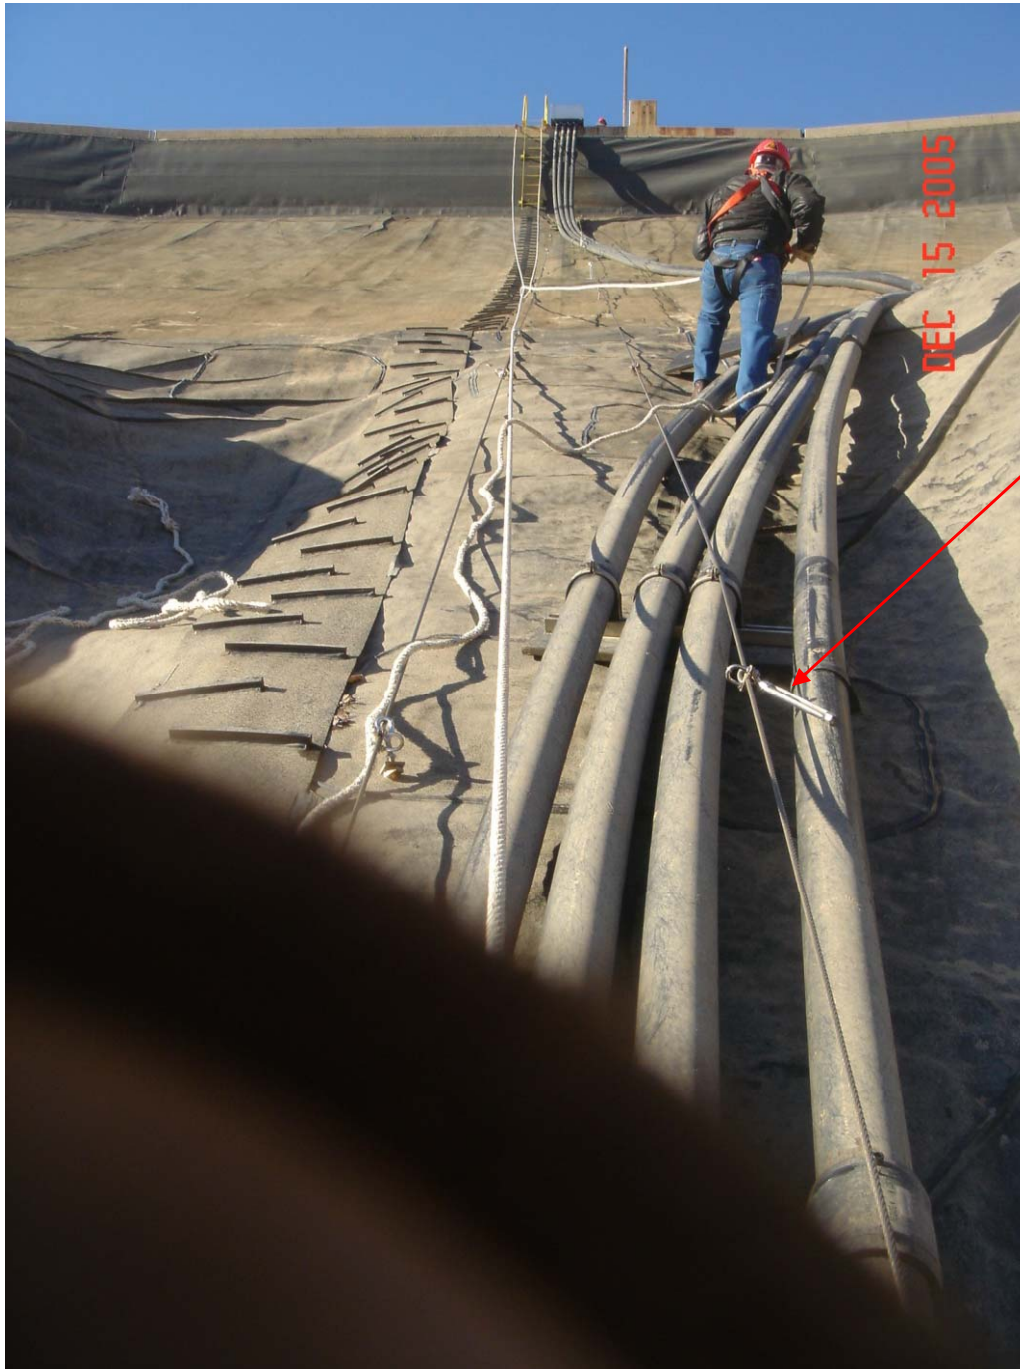
Note turnbuckle
unthreaded from
lower bolt.

- Level errors known as early as Sept, 2005.
- Physical evidence of protective pipe movement with transducers inside.
- Transducer movement produces level indications lower than actual level.
- Sept. 2005 removal of one transducer and adjustment of level indications downward by 0.4 ft.

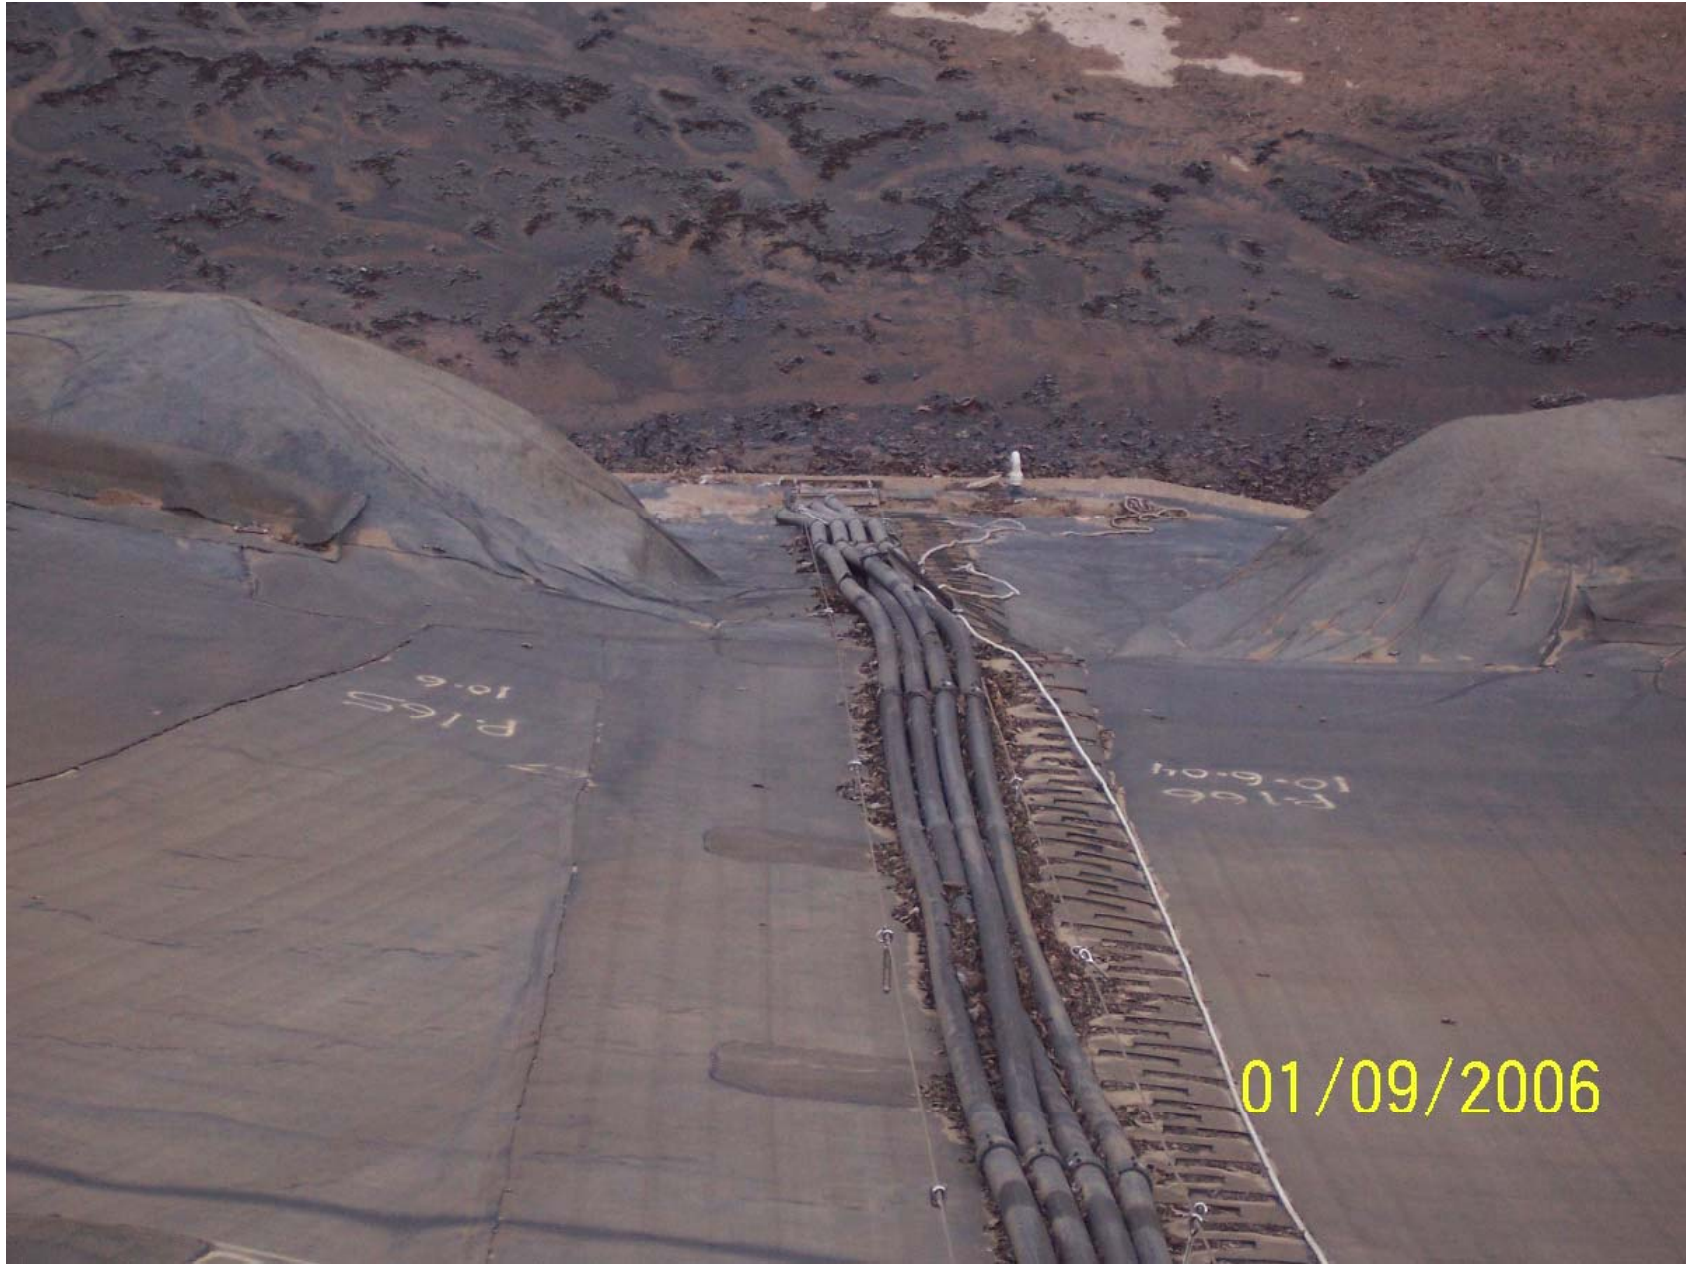
Note separation of guy cable eye bolts from base plates and movement of one pipe over another.

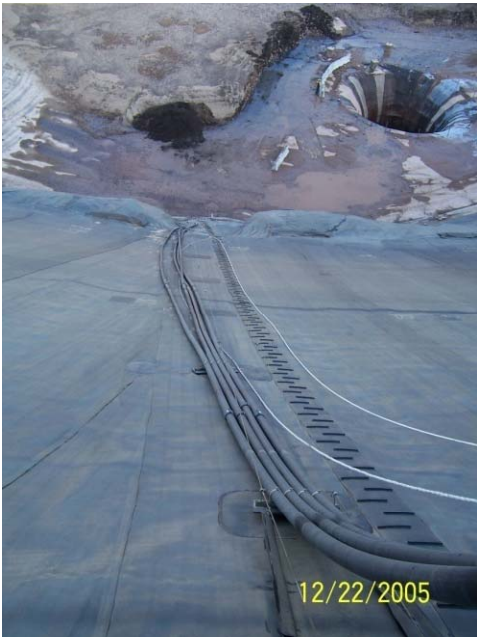
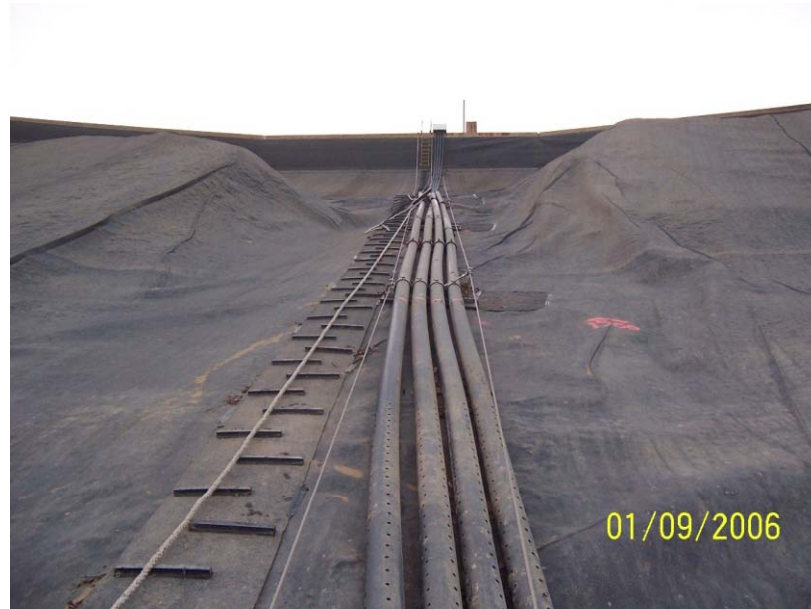
Note, straightening of protective pipes between dates of above photos.

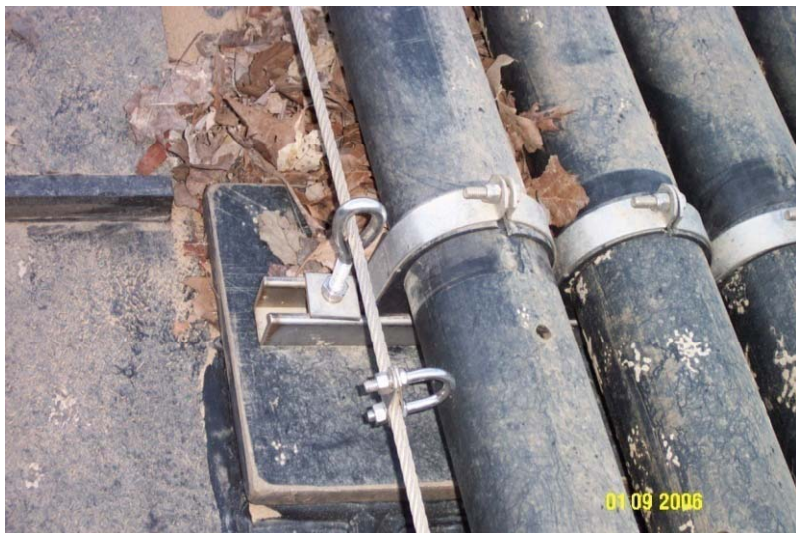
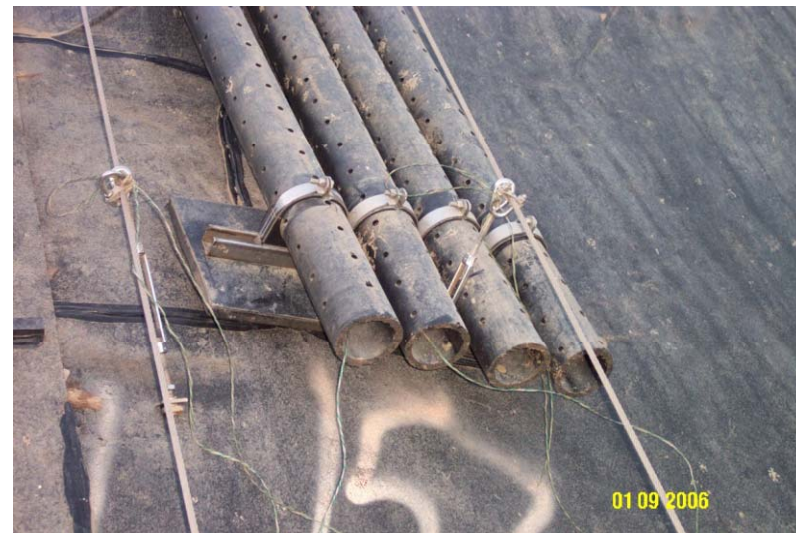
Protective pipe base plates are not anchored to reservoir. Left guy cable has come loose from base plate in right photo.

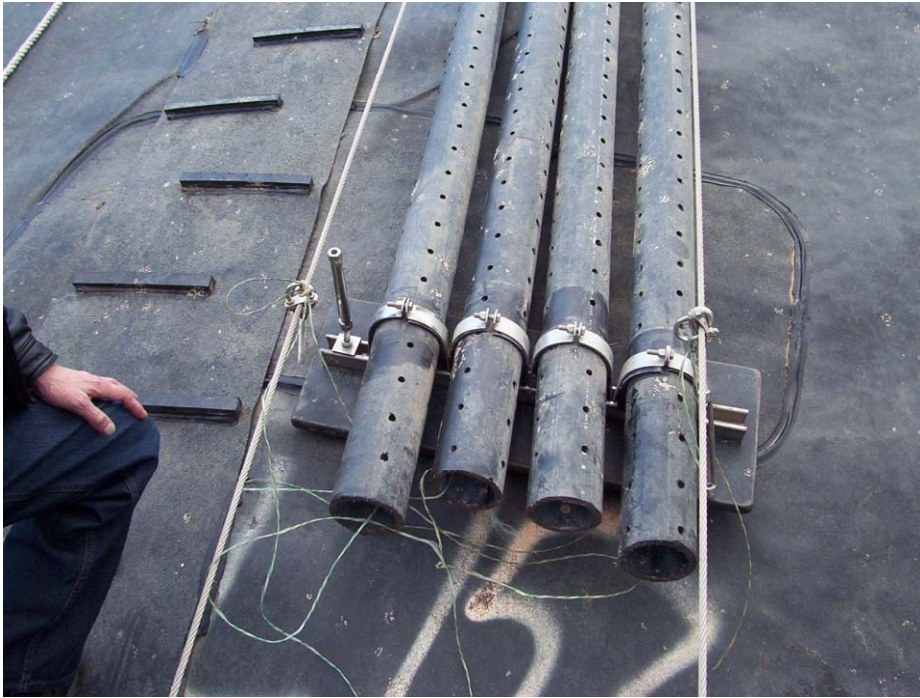
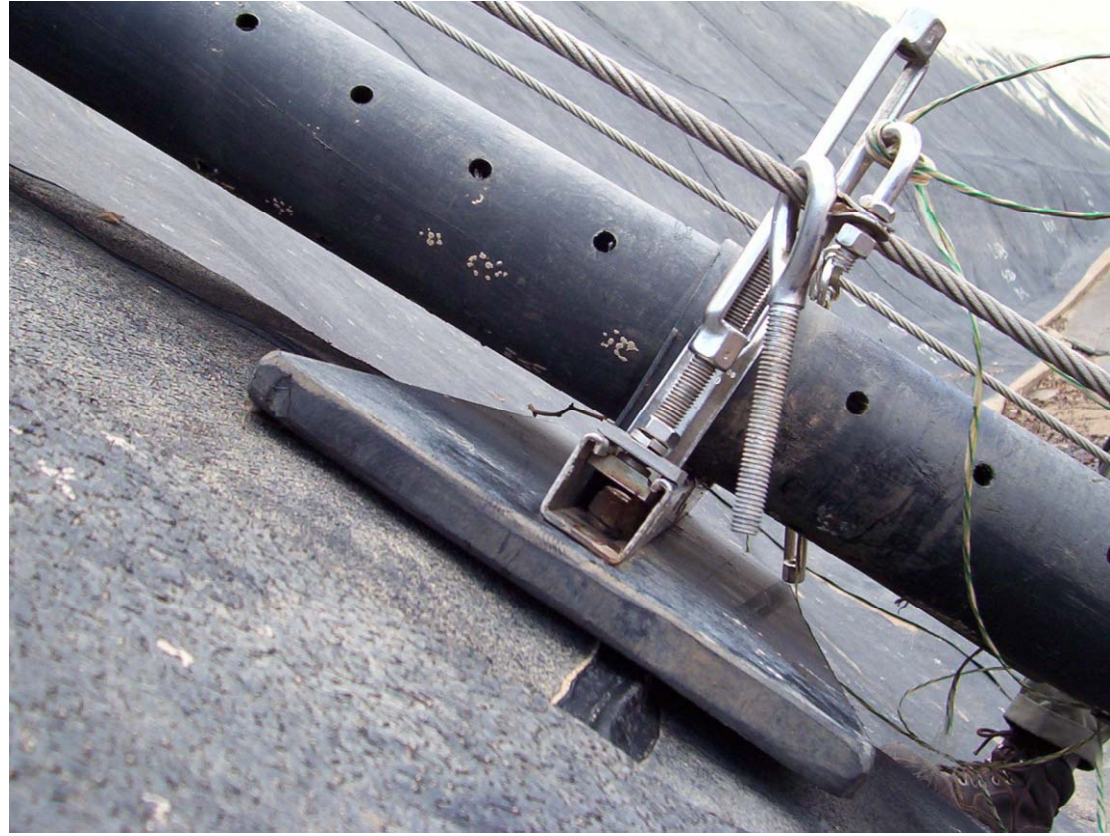
Protective pipe support system as found. Note eye bolt unthreaded from turnbuckle. Also note lock washer in place at connection to U channel but lack of lock washer at turnbuckle.

- Movement of protective pipes and cables may have resulted from flow turbulence, Von Karman vortices or both.
- New runner max. pump discharge is 3,000 cfs compared to 2,450 cfs for old runner.
- Exit losses into reservoir (turbulence) varies as flow squared (50% greater).

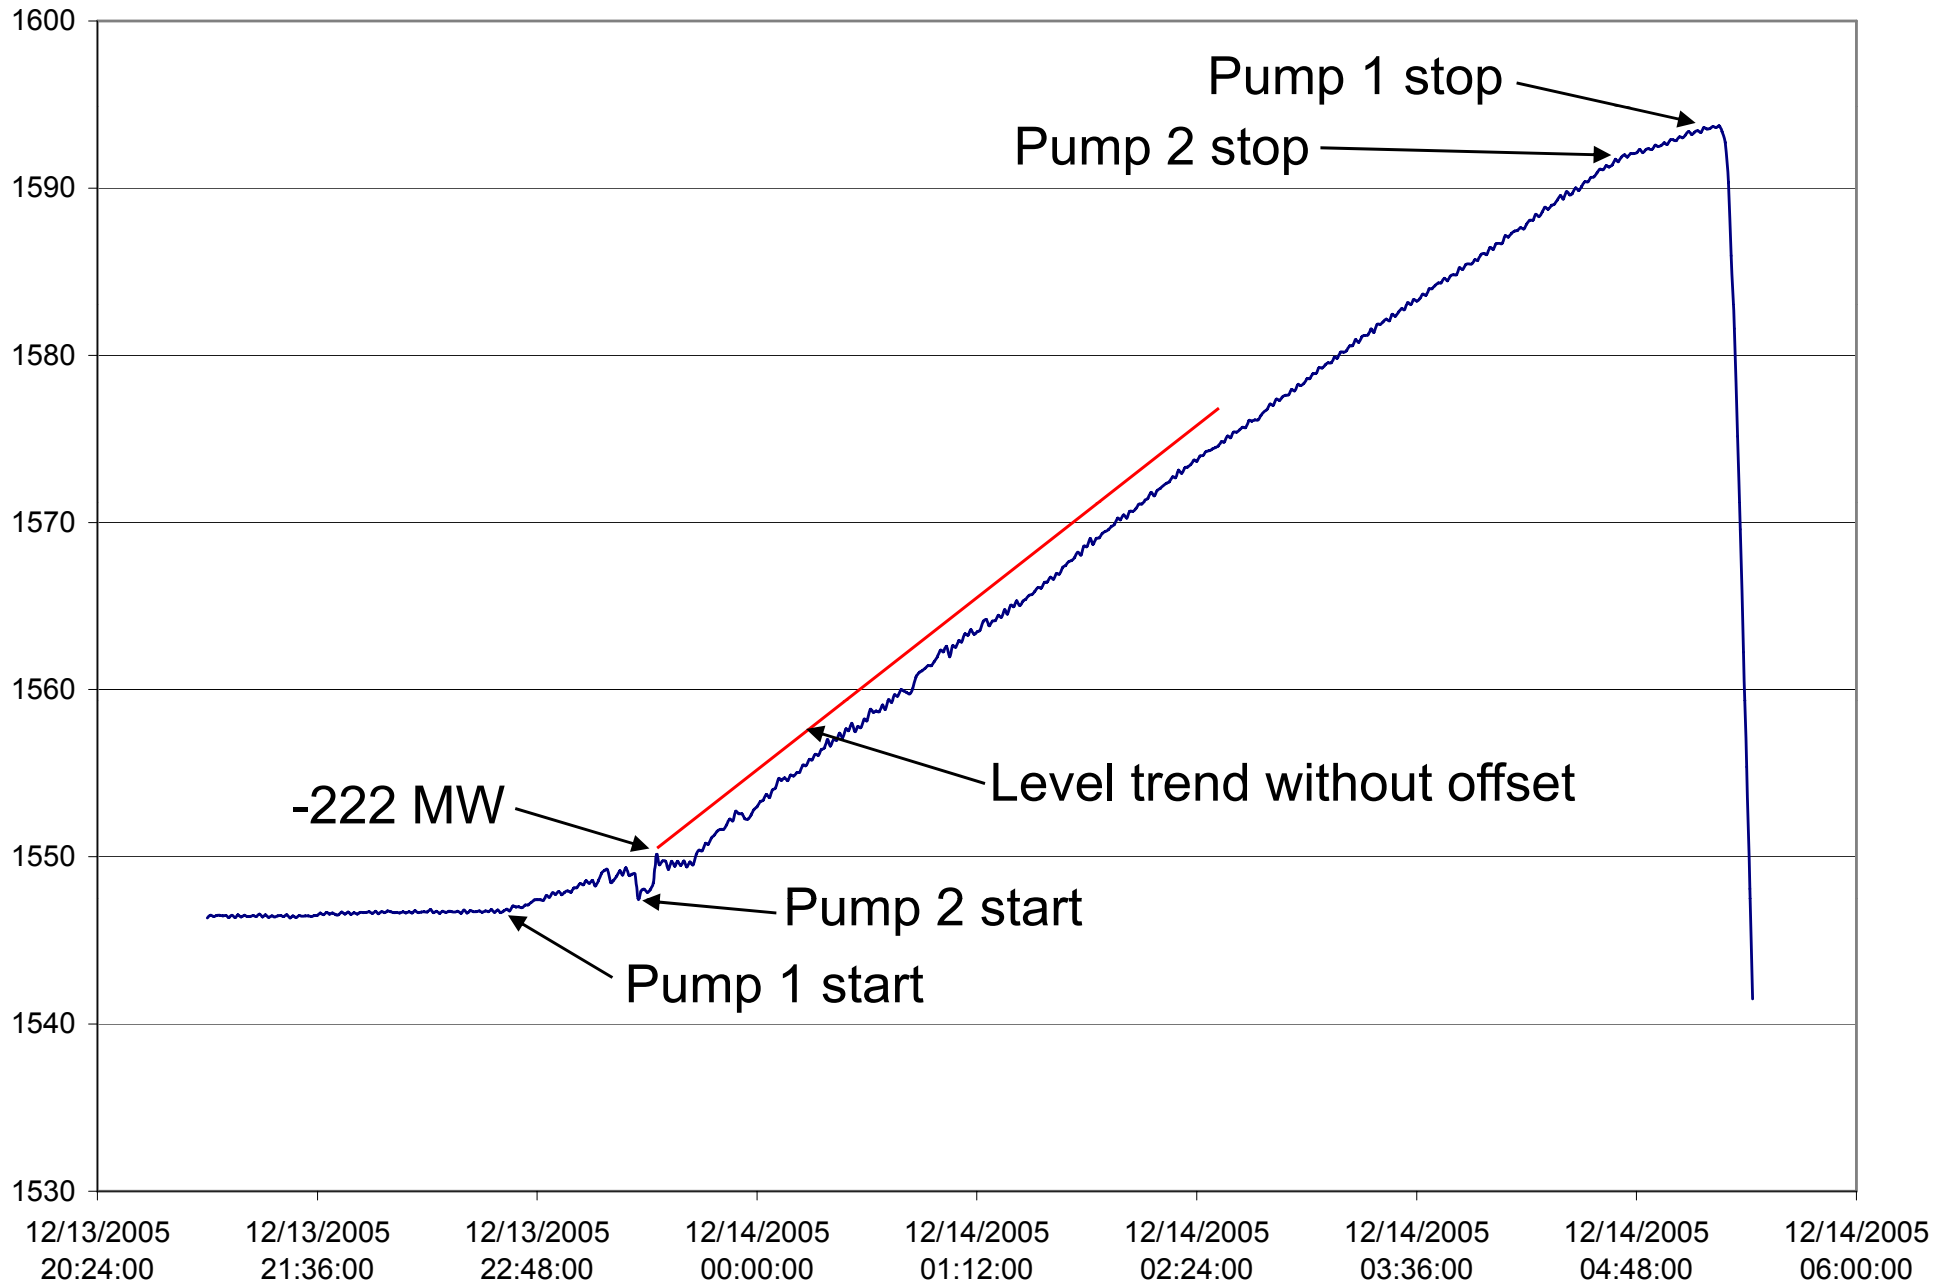
**Level indications after pump 2 start shows an offset.
-222 MW = Completion of pump 2 start sequence.**

- Movement of protective pipe raised transducers resulting in water level indication that was lower than actual level.
- Twelve minutes of two unit pumping on Dec. 14th without reporting water level increase resulted in additional two feet of water level compared to other Dec. days.
