Taum Sauk Upper Reservoir Failure

Technical Reasons for the Breach

Presented by: Joseph L. Ehasz
Kermit Paul

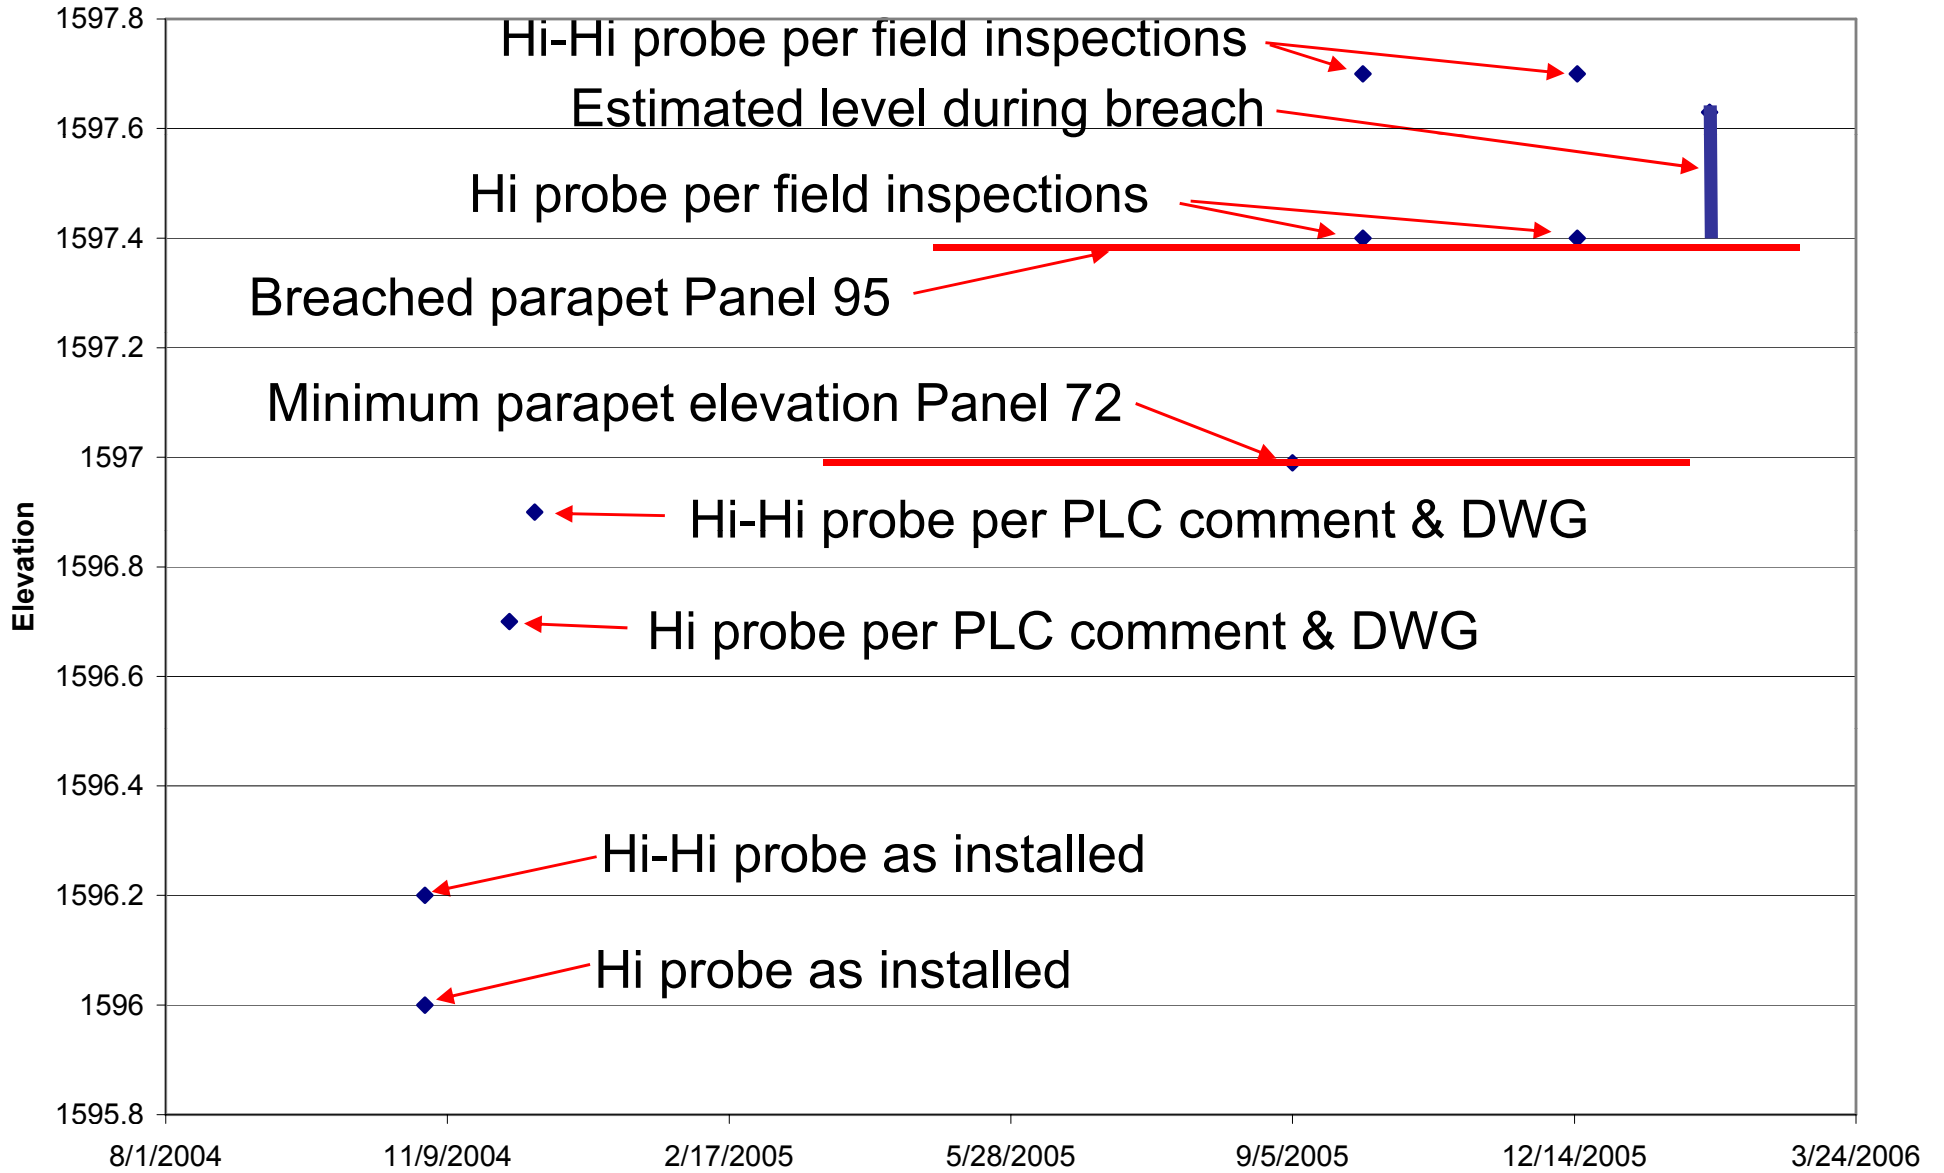
Parapet at probes

- No Hi or Hi-Hi pump shut down inputs or alarms came into plant on Dec.14th.

- The pressure transducers that monitored reservoir water levels became unattached from their supports causing erroneous water level readings.
- The emergency backup level probes were set too high to shut down the pumps before overtopping.
- The normal operating high water levels of 1 ft. below the top of the parapet wall did not allow adequate operational margin.
- The omission of a spillway from the design was a most important root cause of this failure.
