Mr. Chairman, Commissioners, I am pleased to present a summary of the FERC/NERC Staff Report on the September 8, 2011 Blackout. *The presentation is based on conclusions of the staff and not necessarily those of the Commission, the Chairman or any of the individual Commissioners.* This inquiry was truly a collaborative effort, with representation from the Offices of Enforcement, Electric Reliability, Energy Policy & Innovation, and External Affairs. As you know, it was a joint inquiry with the North American Electric Reliability Corporation, and we also had liaisons from the Nuclear Regulatory Commission and Department of Energy. I would also like to ask those who participated in the inquiry to stand and be recognized.

Staff Report on the  
**Arizona - Southern  
California Outages**  
on September 8, 2011

Item No: A-4  
May 17, 2012

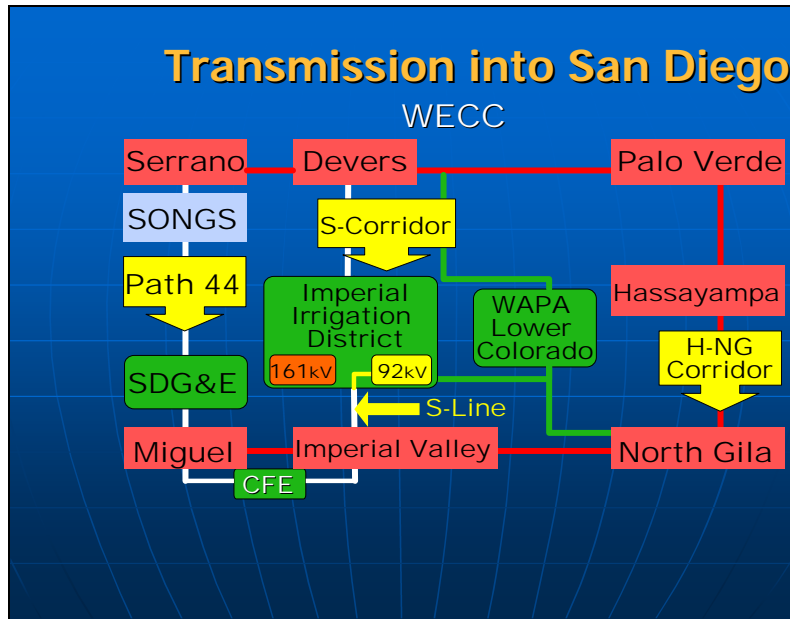
The inquiry determined that the blackout began with the loss of a single facility: Arizona Public Service’s 500 kilovolt transmission line from Hassayampa to North Gila. The loss of this line interrupted one of the three major power corridors into the San Diego area, labeled on this simplified diagram as H-NG Corridor, S-Corridor, and Path 44. The red lines represent 500 kilovolt lines, the white lines represent 230 kilovolt lines, and the green lines represent 161 kilovolt lines. When the H-NG Corridor was interrupted, power flows immediately redistributed through lower voltage systems, such as those in the Imperial Irrigation District and WAPA Lower Colorado (shown as the S Corridor), in order to deliver enough power to San Diego on a hot day during hours of peak demand. Flows also redistributed onto the five 230 kilovolt lines that form Path 44, also known as South of San Onofre Nuclear Generating Station, or SONGS, increasing its flow by 84%.

However, the Bulk Electric System is required to be operated in a manner that avoids instability, uncontrolled separation and cascading, even with the occurrence of any single contingency, such as the loss of a generator, transformer or transmission line. This is known as the “N-1 criterion.” The fact that the loss of a single transmission line led to cascading demonstrated that on September 8, 2011, the Western Interconnection was not being operated within a secure N-1 state.

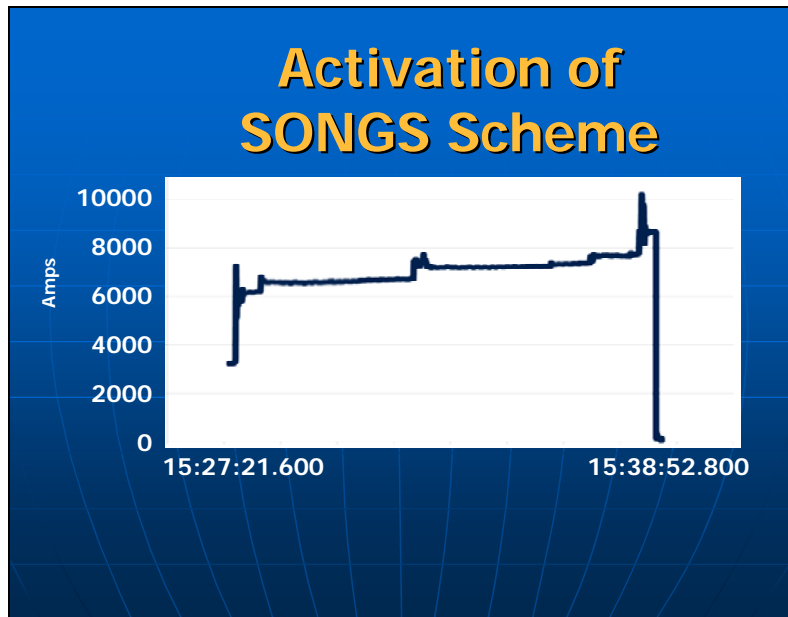
The inquiry divided its sequence of events into seven distinct phases, beginning with the initial trip of the H-NG transmission line and culminating in the initiation of an intertie separation scheme (the SONGS separation scheme) which separated San Diego and Path 44 at SONGS. This slide shows a simplified version of the loading on the five 230 kilovolt lines that form Path 44 (also known as South of Songs). When the aggregate current on Path 44 remained over 8,000 amperes, the SONGS separation scheme would separate San Diego from Path 44. The first spike on this slide resulted from the loss of the Hassayampa-North Gila 500 kV line, and the next two spikes resulted from the loss of below-100-kilovolt transformers in the Imperial Irrigation District.

The flow and voltage deviations and resulting overloads that began with the loss of the Hassayampa-North Gila 500 kV line had a ripple effect, as transformers, transmission lines, and generating units tripped offline, most of which had the effect of increasing the loading on Path 44, as seen on this chart. Just seconds before the blackout, Path 44 carried all flows into the San Diego area as well as part of Arizona and Mexico. Eventually, the excessive loading on Path 44 engaged the SONGS separation scheme, separating San Diego from Path 44, causing both SONGS nuclear units to trip offline, and resulting in the complete blackout of San Diego. The time elapsed, from line trip to complete blackout, was approximately 11 minutes.

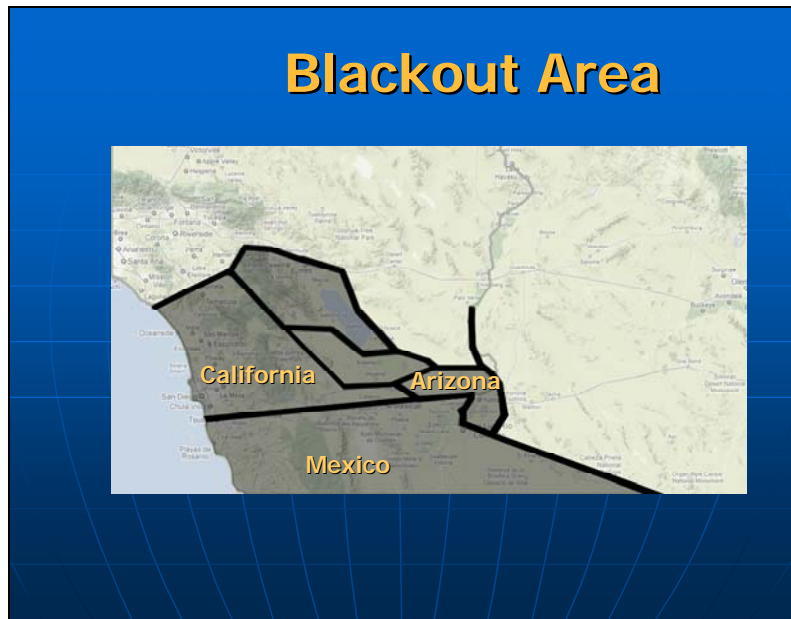
This slide shows the balancing authority/transmission operator areas affected by the blackout (and the islands into which they separated before the blackout).
