NIST Response to the World Trade Center Disaster

**Federal Building and Fire Safety Investigation
of
the World Trade Center Disaster**

**Media and Public Briefing
April 5, 2005**

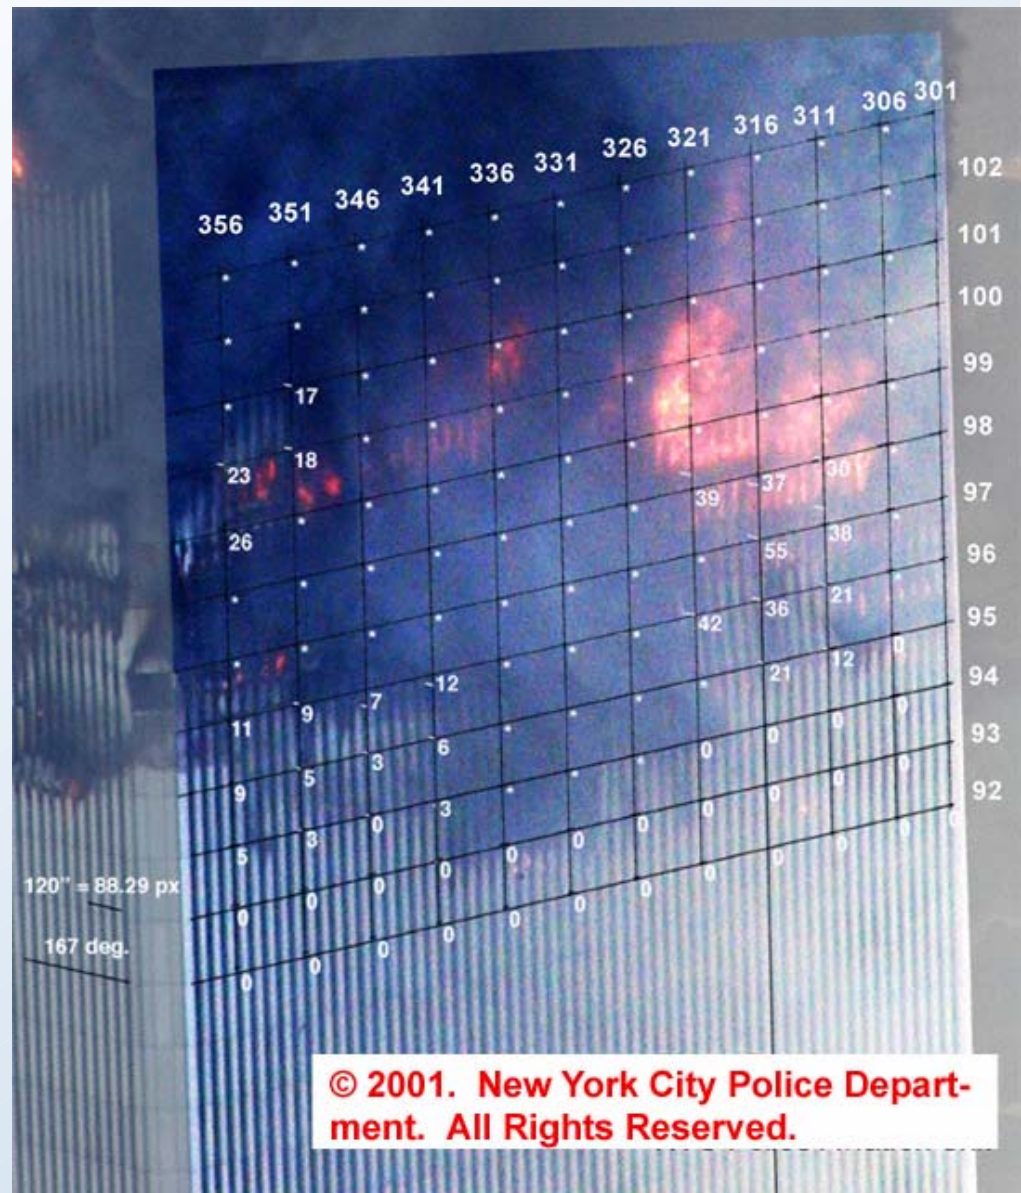
Inward Bowing of Perimeter Columns About 2 Minutes Prior to Collapse: WTC 2 East Face

9:58:56 a.m.

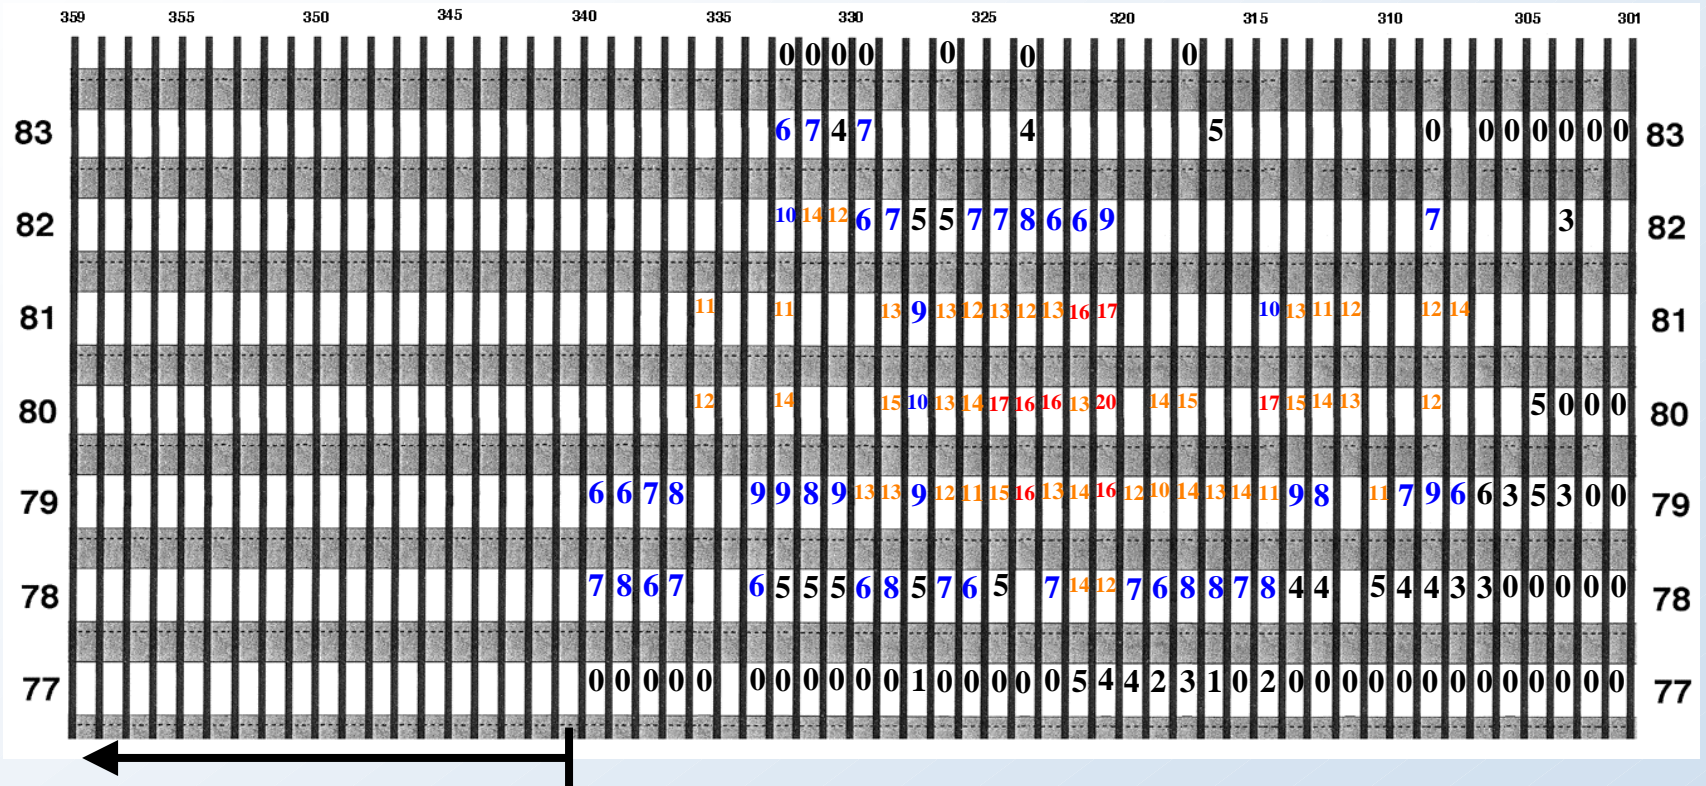
Map of Inward Bowing: East Face of WTC 2

Empty regions have no data (smoke, damaged aluminum, could not establish true vertical, etc.)

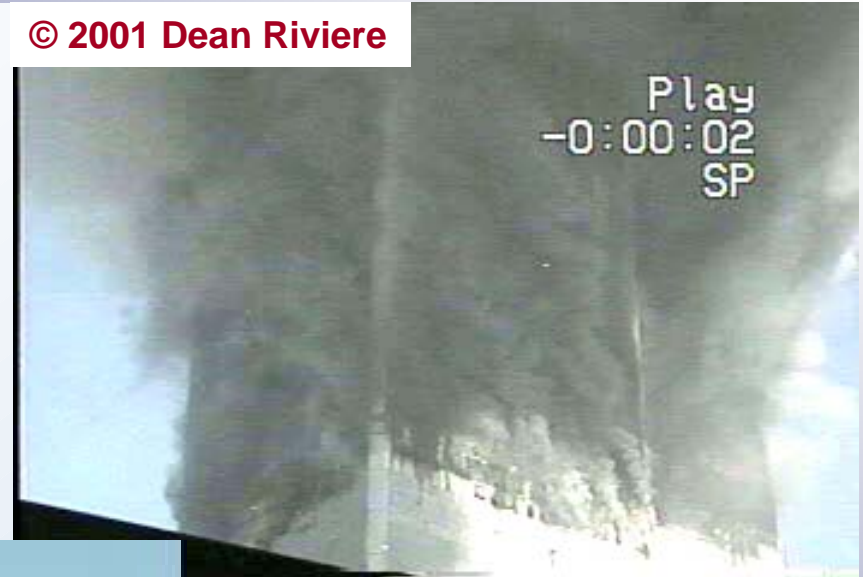
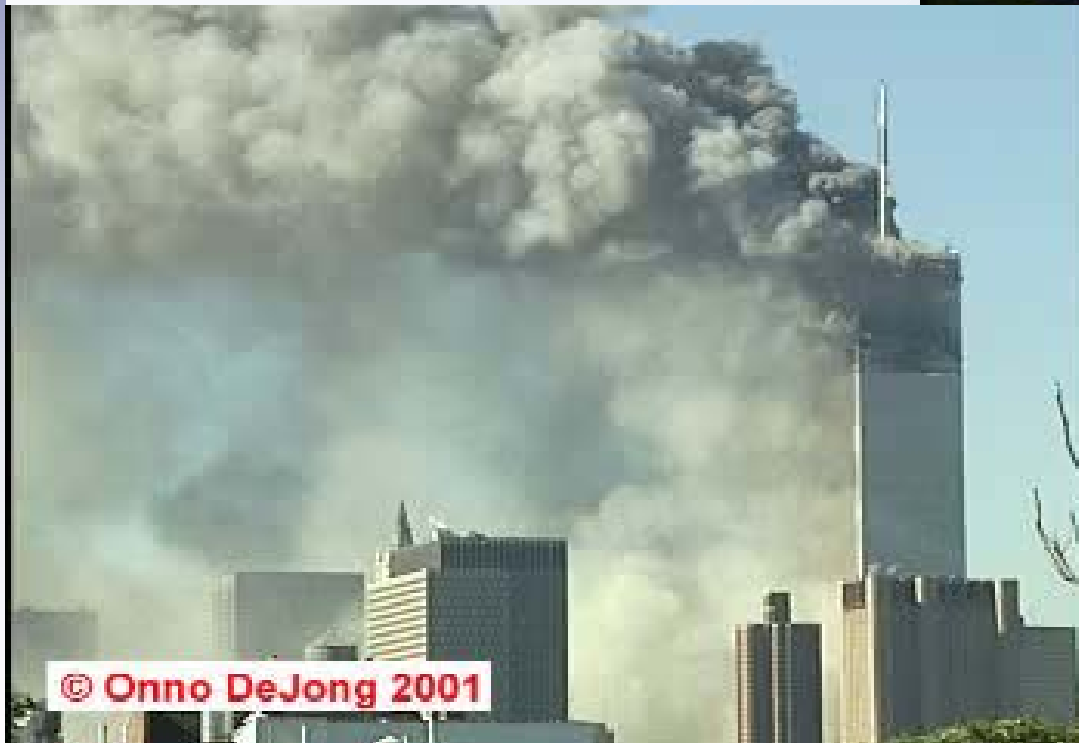
WTC 1 tilted to the south; WTC 2 tilted to the east and south.

Initiation of global collapse was first observed by the tilting of building sections above the impact regions of both WTC towers.

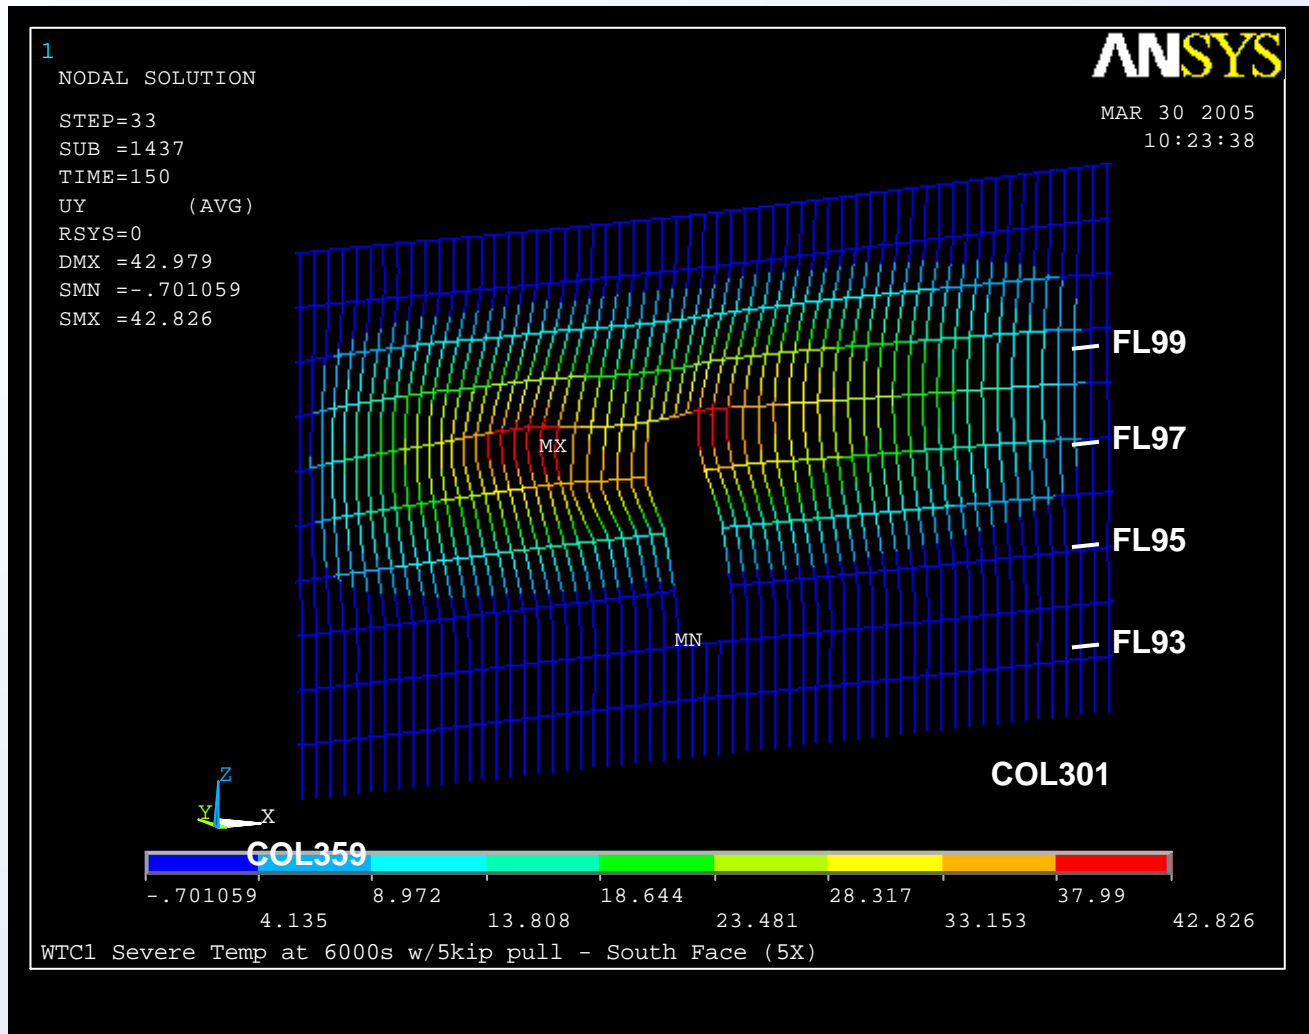
Inward Bowing of the WTC 1 South Face at 6000 s

Maximum Inward Displacement = 43 in.
Looking from the outside of the building
Inward displacement is shown as positive displacement

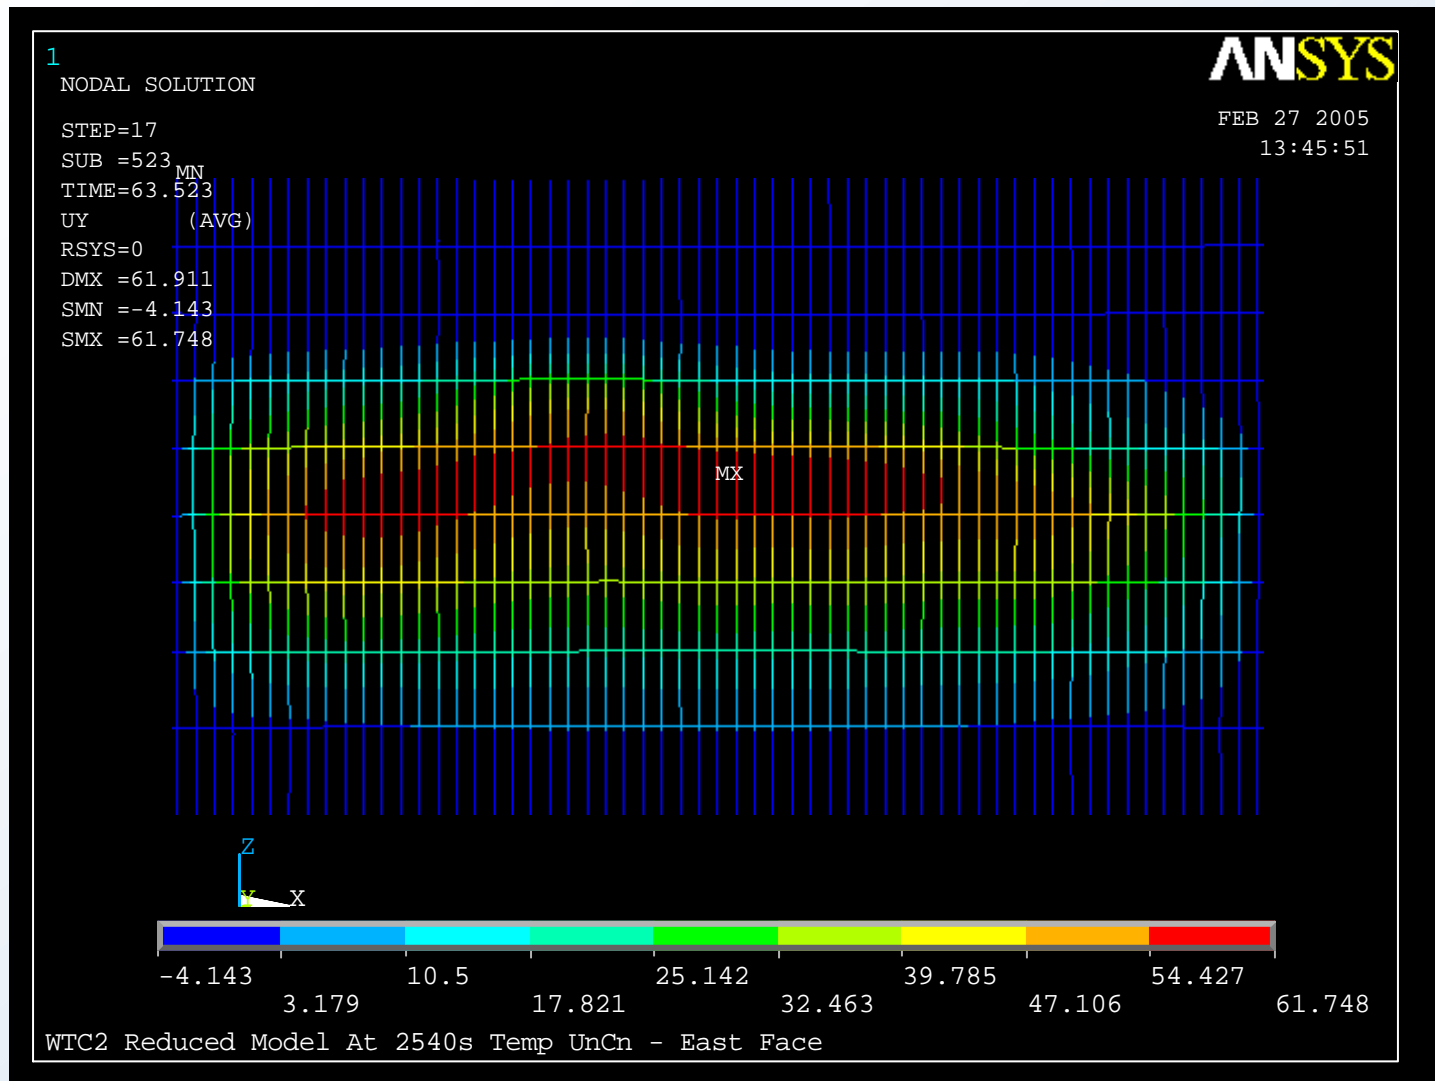
Inward Bowing of the WTC 2 East Face at 2,540 s

Maximum inward displacement = 60 in.

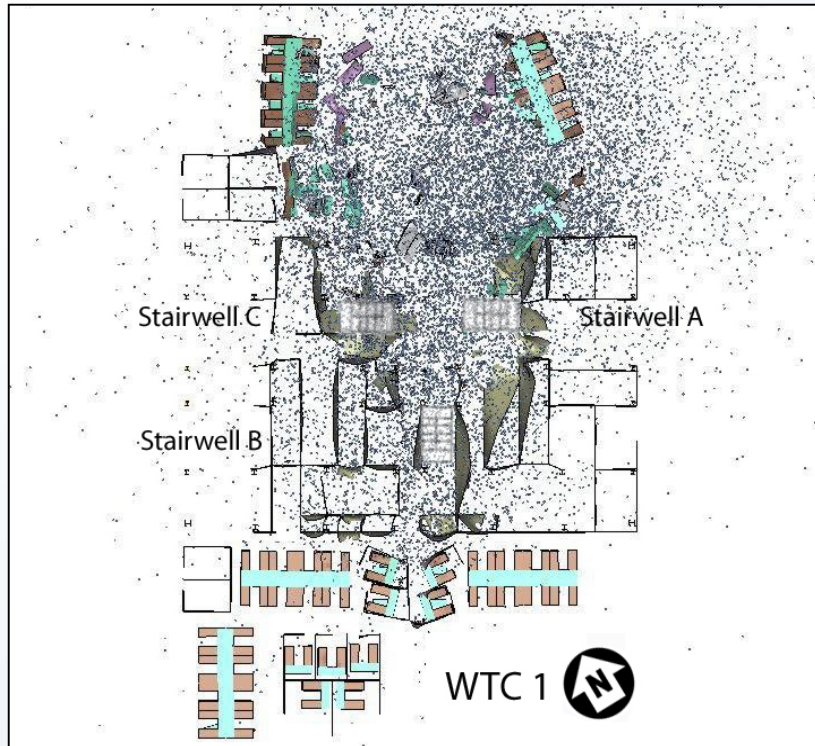
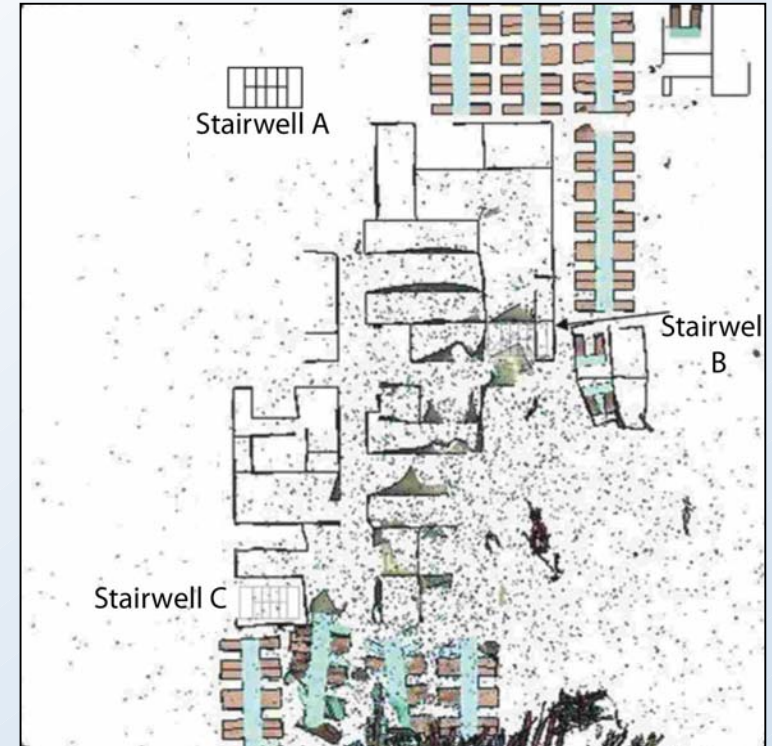
Condition of Stairwells

- The stairwells, with partition wall enclosures that provided a 2 h fire-rating but little structural integrity, were damaged in the region of the aircraft impacted floors.
- **One of the stairwells in WTC 2 (Stairwell A on the Northwest side) was passable in the region of aircraft impact for some period of time after WTC 2 was attacked.**
- All three stairwells in WTC 1 and the two other stairwells in WTC 2 were rendered impassable in the region of aircraft impact.

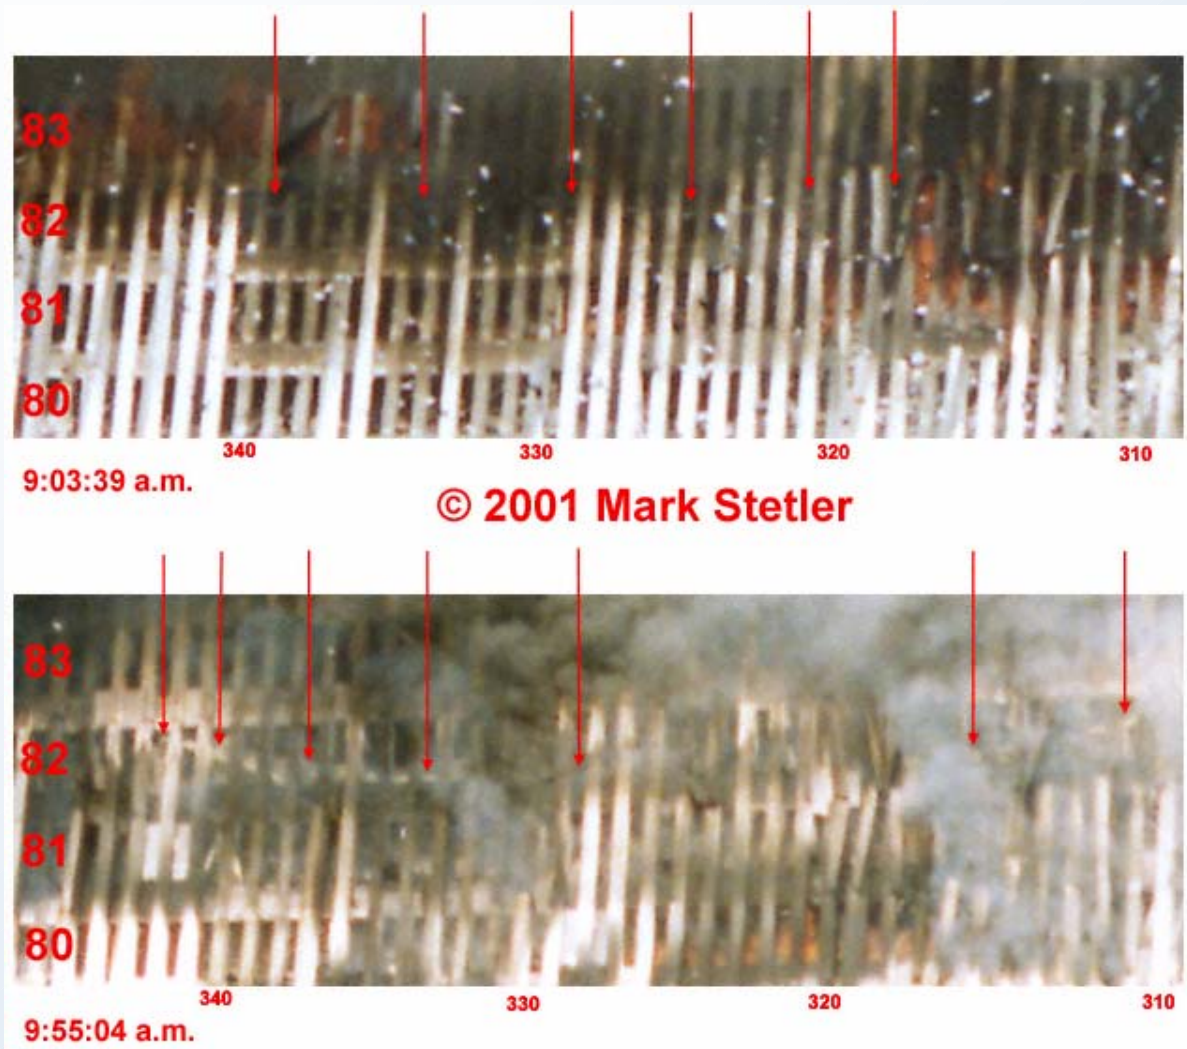
Photographic Evidence of Hanging Floor Slab

Amount and extent of floor sag increased over the 51 minute period.

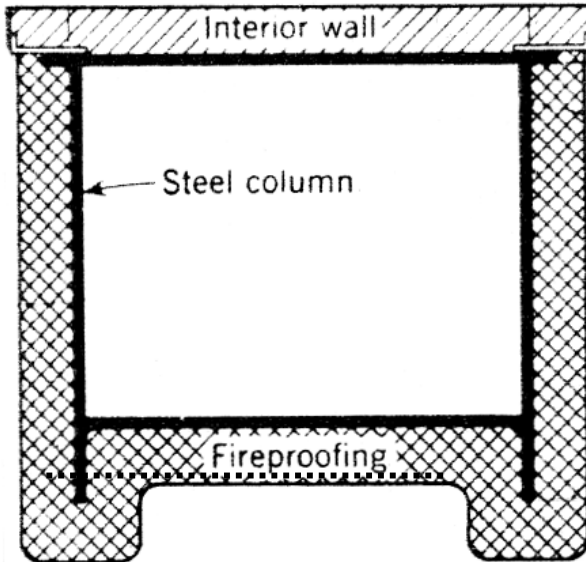
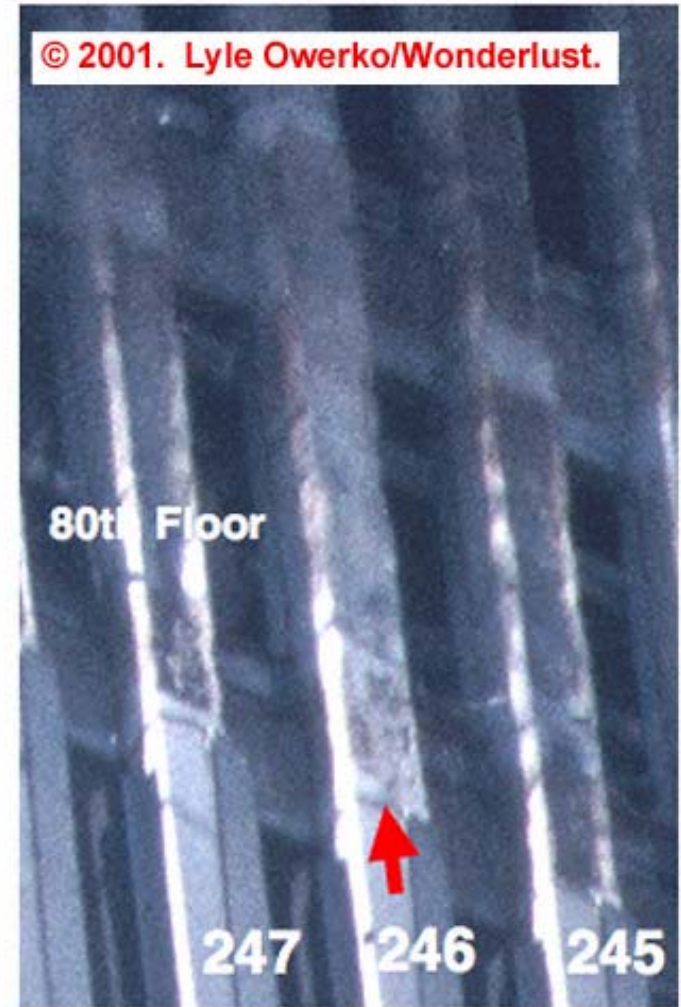
Application of SFRM to External Columns

- By design, uniform thickness
- As applied, region between flange tips filled (for example, see column 246 at right)
- Missing SFRM from outer flange indicated by shadowing and exposed red paint
