Dry Cask Storage Characterization Project—Phase 1: CASTOR V/21 Cask Opening and Examination

Idaho National Engineering and Environmental Laboratory

U.S. Nuclear Regulatory Commission
Office of Nuclear Regulatory Research
Washington, DC 20555-0001

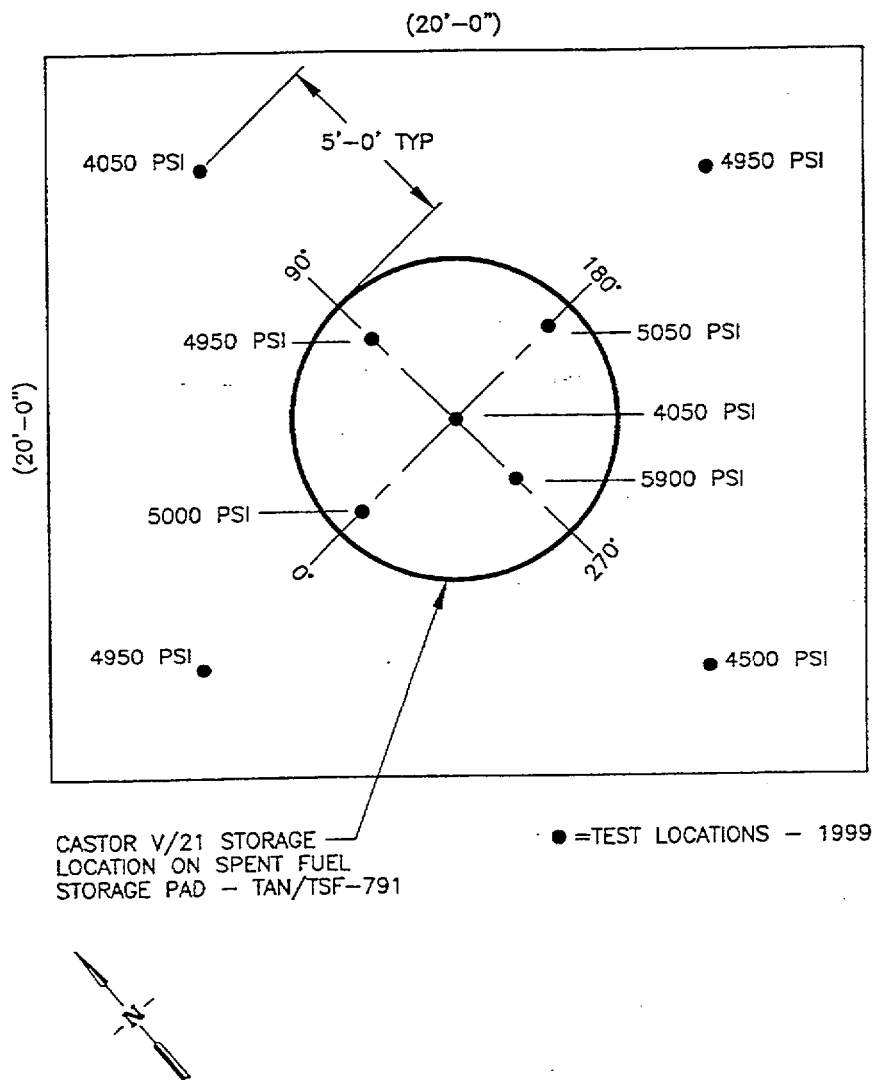
Figure 2-2. Rebound hammer test locations at CASTOR V/21 storage pad location.

The structural soundness of the concrete was determined by ASTM test standard C805-94 (Test Method for Rebound Number of Hardened Concrete, also known as the Swiss hammer test). The Swiss hammer test was performed on the concrete surface in 9 places in a 37.2 m (122 ft) area centered on the placement of the CASTOR V/21 cask, of which 5 places were selected in the area under the cask. The nine test results (Figure 2-2), which ranged from 28 MPa (4050 psi) to 41 MPa (5900 psi), averaged at 33 MPa (4800 psi) and demonstrated that the structural integrity of the concrete pad still meets or exceeds the 28 MPa (4050 psi) design strength of the concrete.

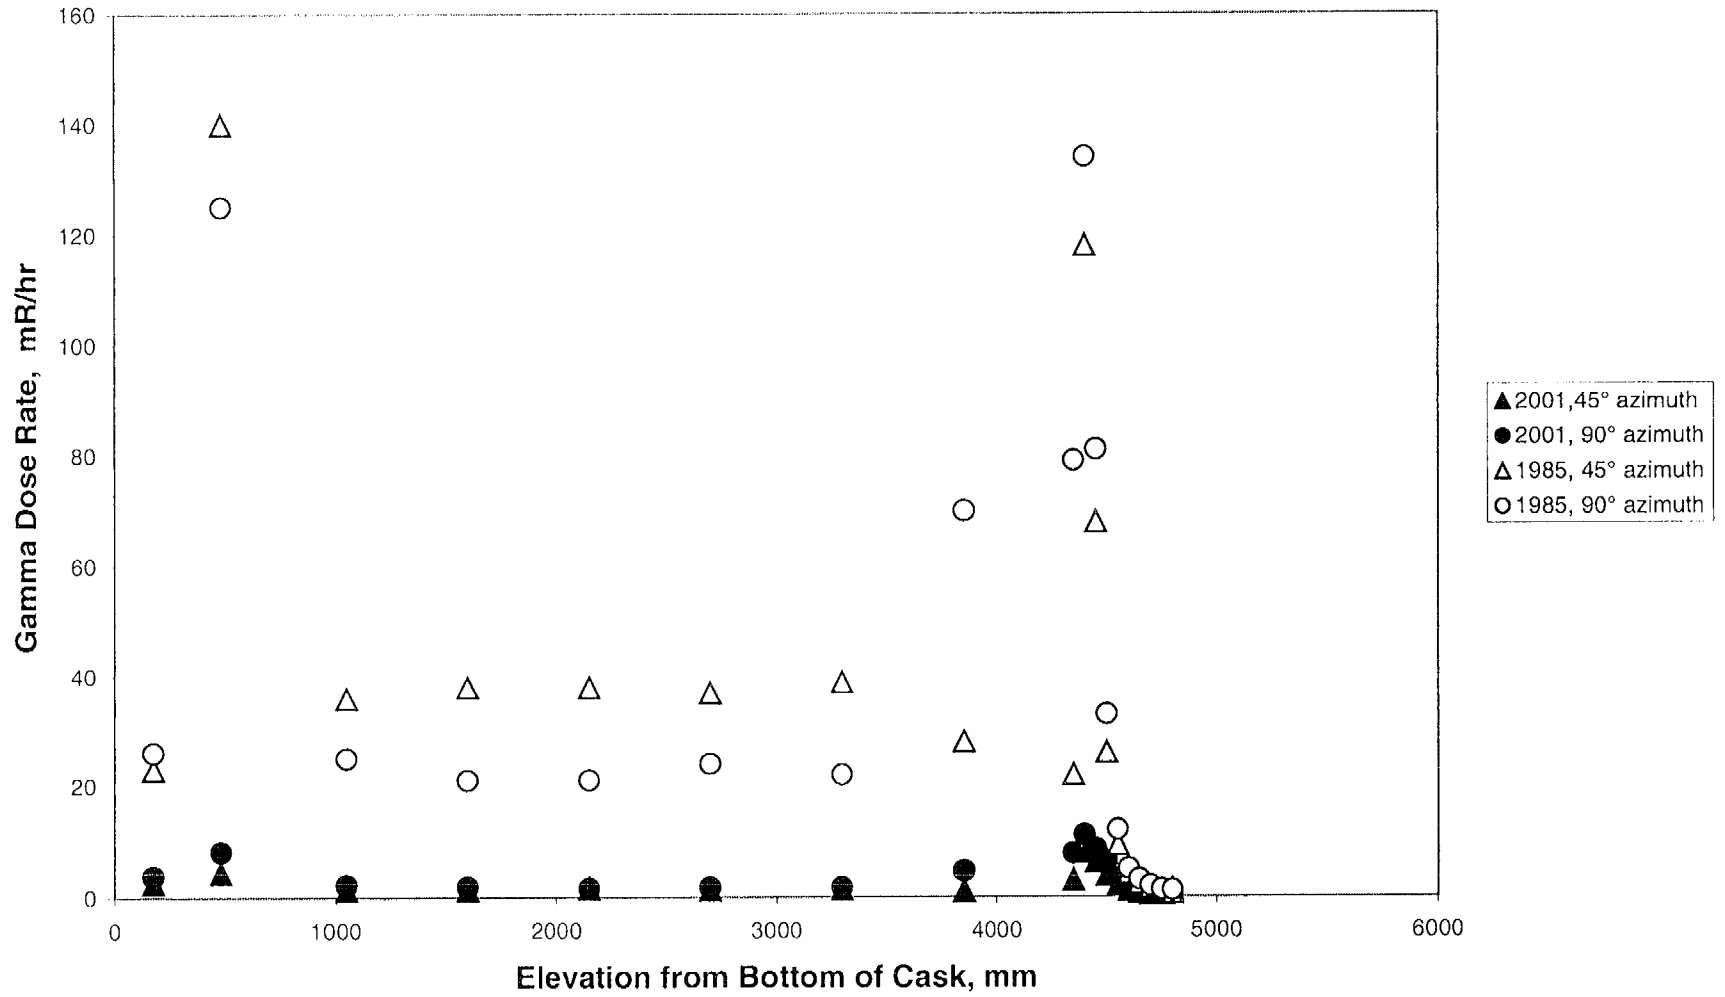
Figure 3-3. Comparison of the 2001 and 1985 gamma dose rates on the cask sidewall at the 45 and 90-degree azimuths.

The 1985 gamma data in Figure 3-3 show a slight difference in the gamma profiles for the 45 and 90-degree azimuths, primarily in the shoulder below the peak at 4400 mm in the 90-degree profile. The shoulder in the 90-degree profile was reproduced in the 2001 gamma dose rate measurements, as shown in Figure 3-4. The shoulder at 3850–4400-mm elevation of the 90-degree profile may be a consequence of the decreased shielding due to the flat milled seat at that location for the upper, bolt-on trunnion. As can be seen from the error bars in Figure 3-4, the dose rate peaks at each end show some differences in intensity between the two azimuths that may be statistically different, with slightly higher readings at the 90-degree azimuth, and is probably due to the proximity of three fuel assemblies to the cask wall at this azimuth. There is no significant difference in the two azimuthal sets of readings in the active fuel zone of the cask (1048 through 3850 mm).

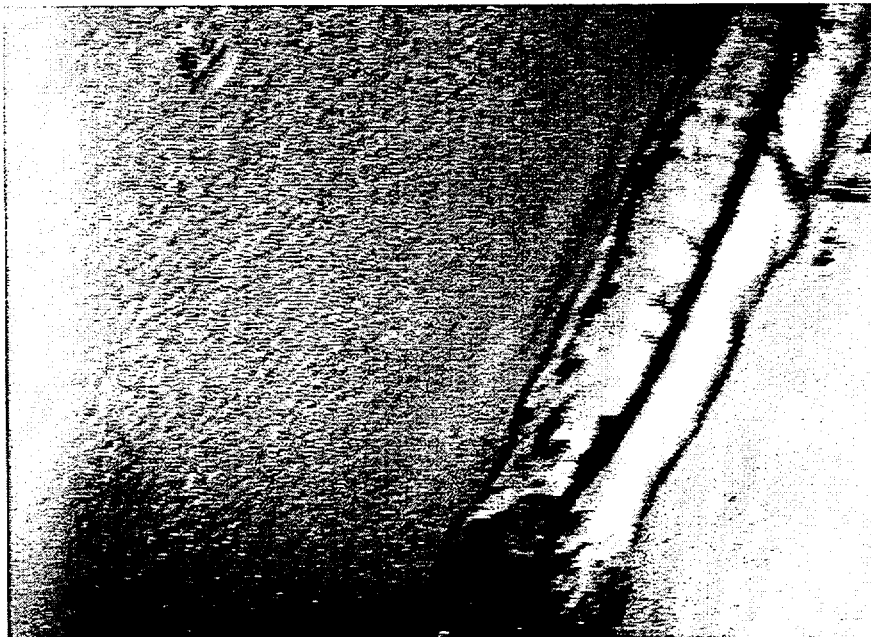
Figure B-6. Bottom weld crack at location 11 identified in Figure B-19.
(Triangular air channel between fuel tube A3 & B6)

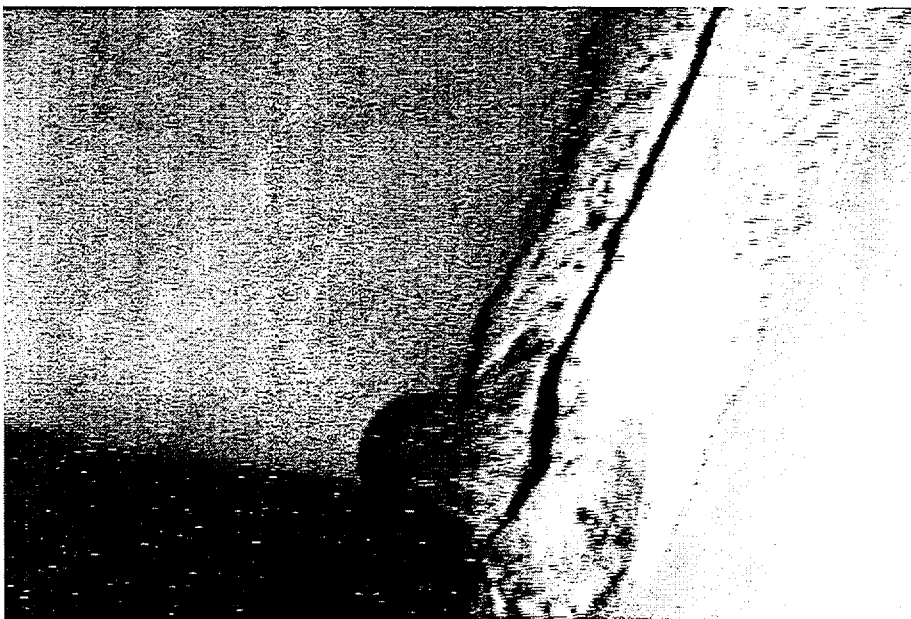
Figure B-8. Bottom weld crack at location 12 identified in Figure B-19.
(Triangular air channel between fuel tube B7 & B8)

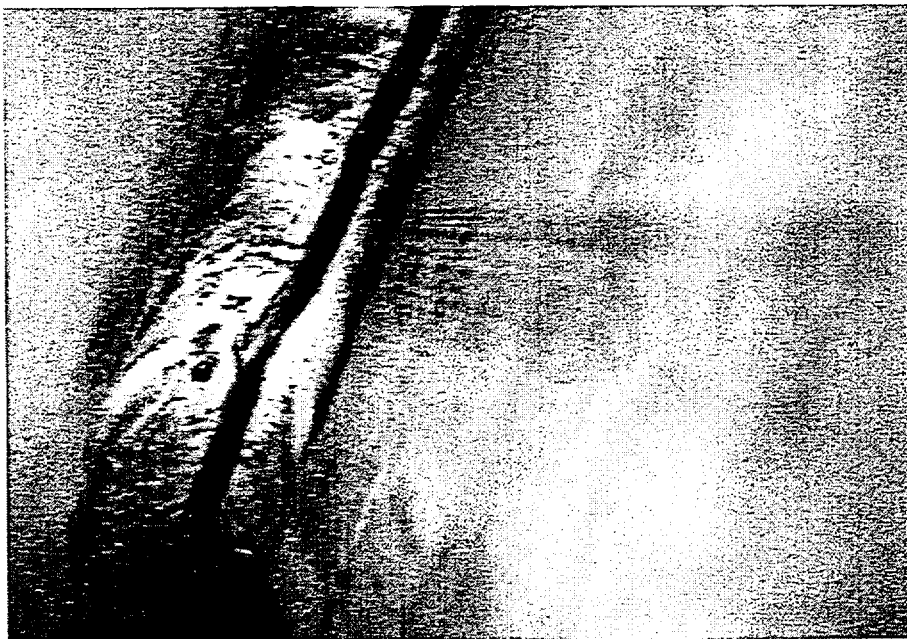
Figure B10. Botton weld crack at location 13 identified in Figure B-19.
(Triangular air channel between fuel tube B7 & C8)

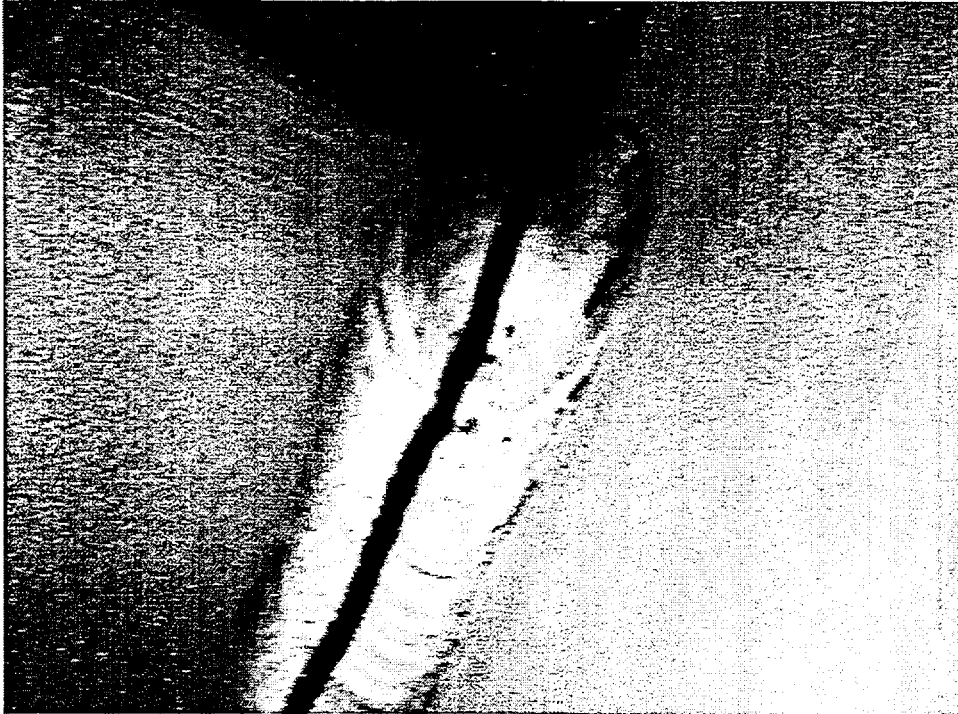
Figure B-11. Top weld crack at location 14 identified in Figure B-19.
(Triangular air channel between fuel tube C6 & D3)

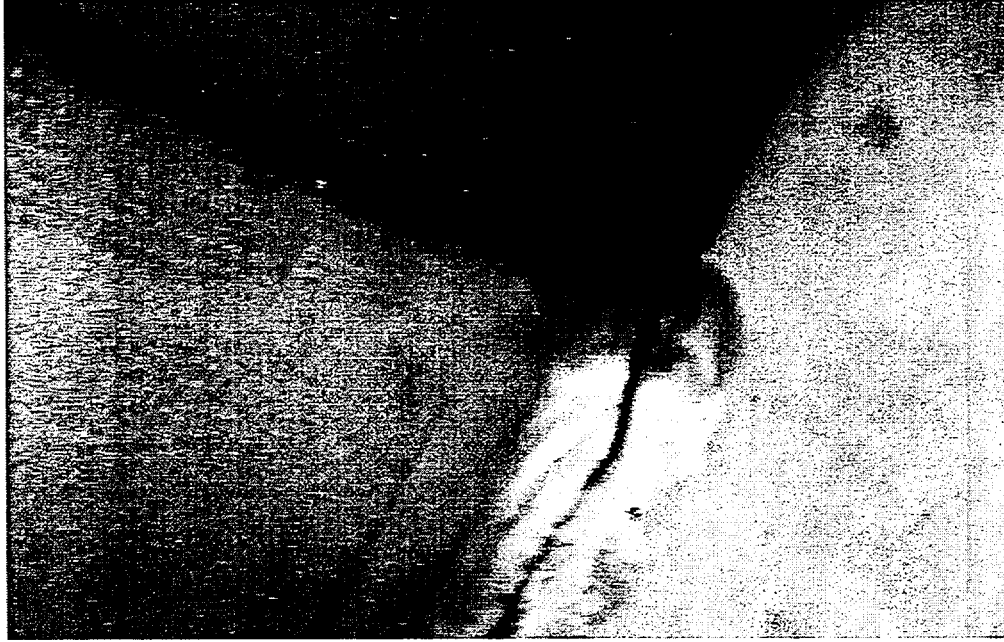
Figure B-15. Top weld crack at location 16 identified in Figure B-19.
(Triangular air channel between fuel tube A7 & D8)

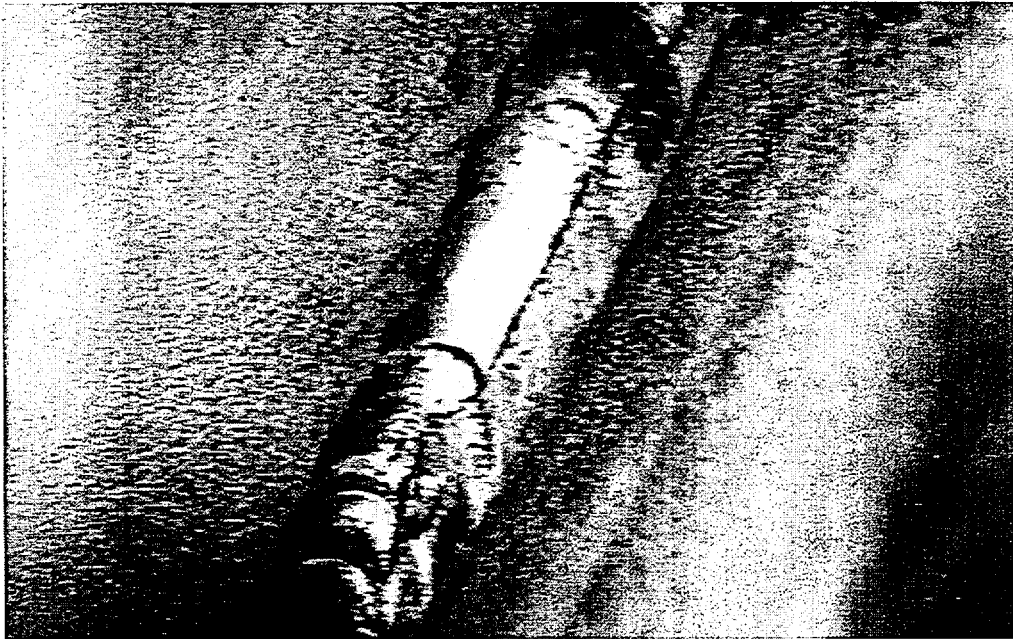
Figure B-16. Bottom weld crack at location 16 identified in Figure B-19.
(Triangular air channel between fuel tube A7 & D8)

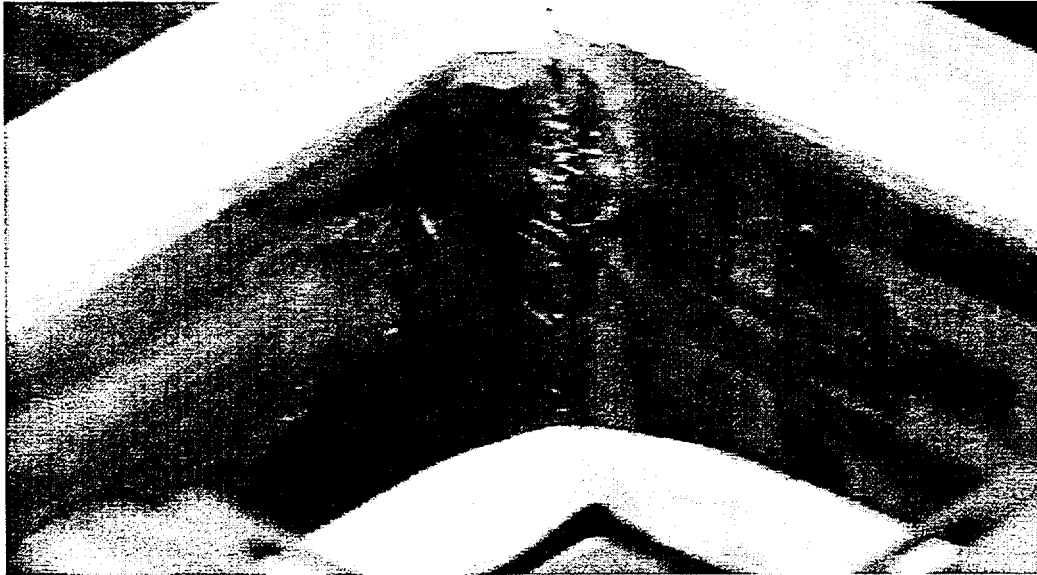
Figure B-17. Crack in basket weld below weld crack 4 (120°) identified in Figure B-19.

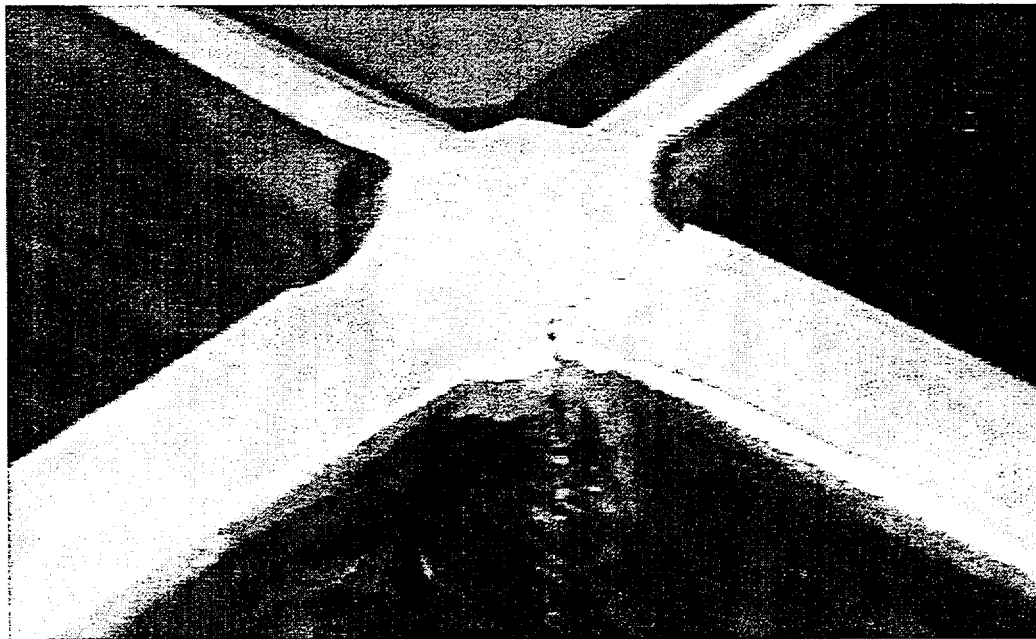
Figure B-18. Same as Figure B-17 with complete view of existing weld crack 4 identified in Figure B-19.

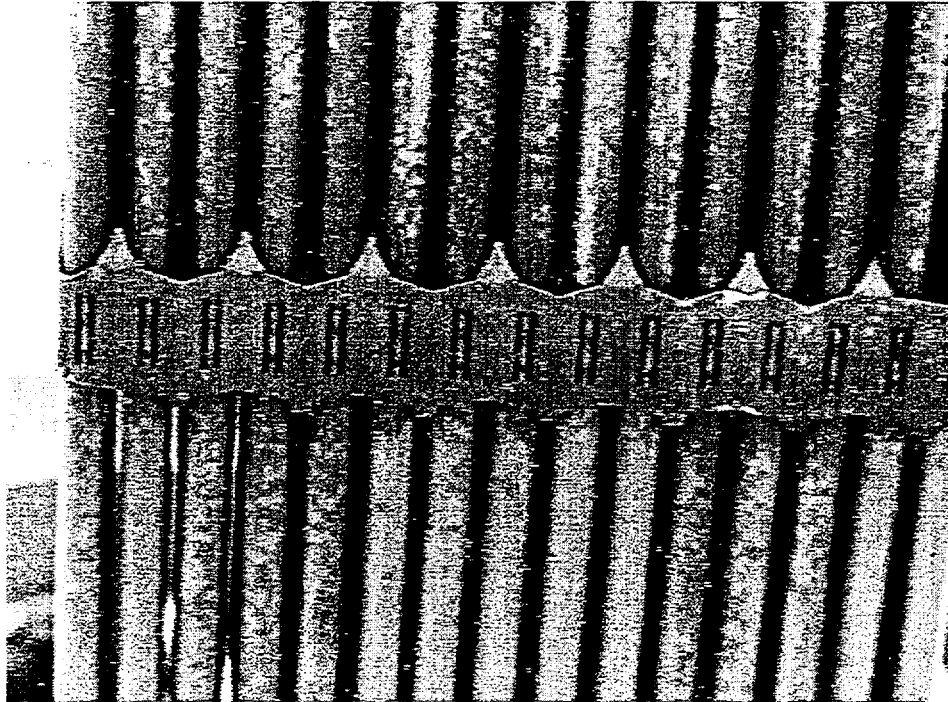
Figure C-3. Oxide mottling noted around spacer #5 on fuel assembly V-05.

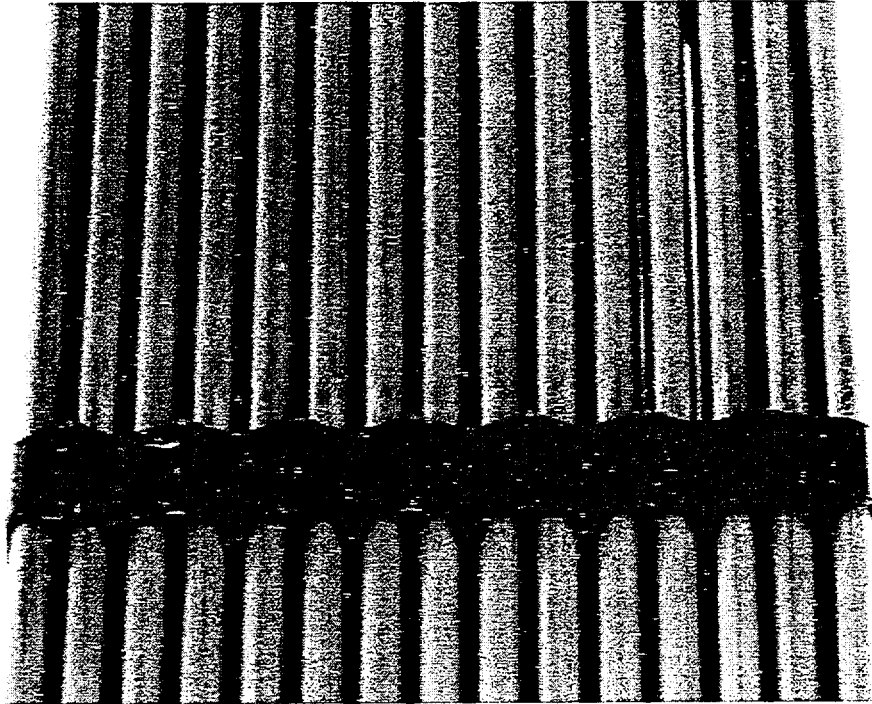
Figure C-5. Fuel assembly V-05—area around upper grid spacer—rods clean and minimal bowing noted.

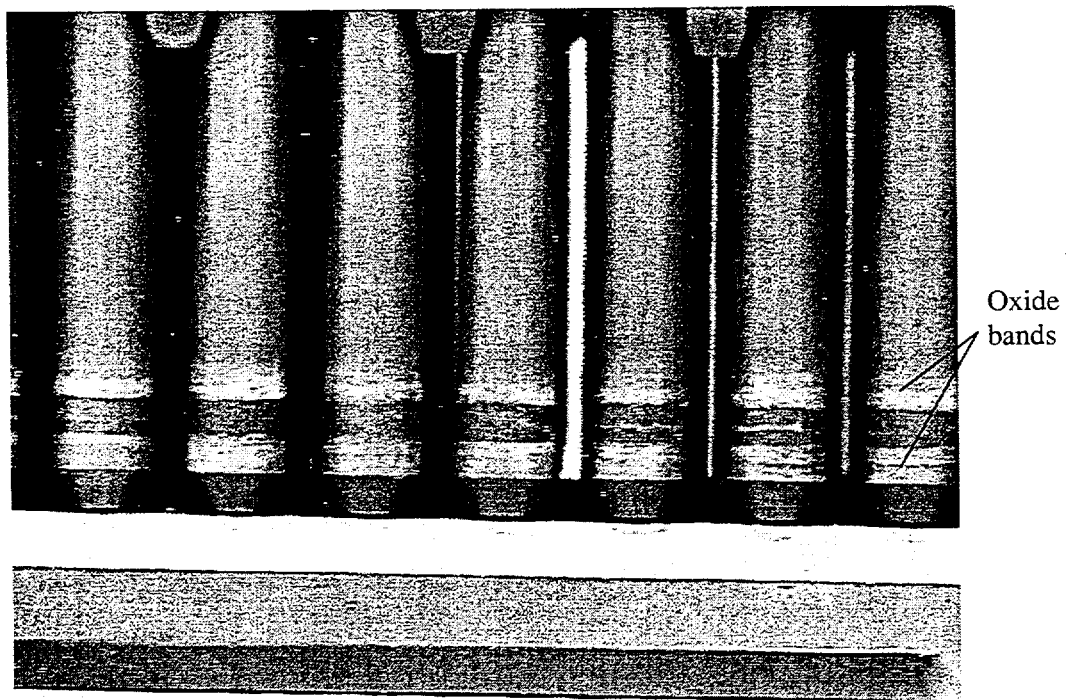
Figure C-13. Fuel assembly V-05 looking for loose “crud”—non was evident.

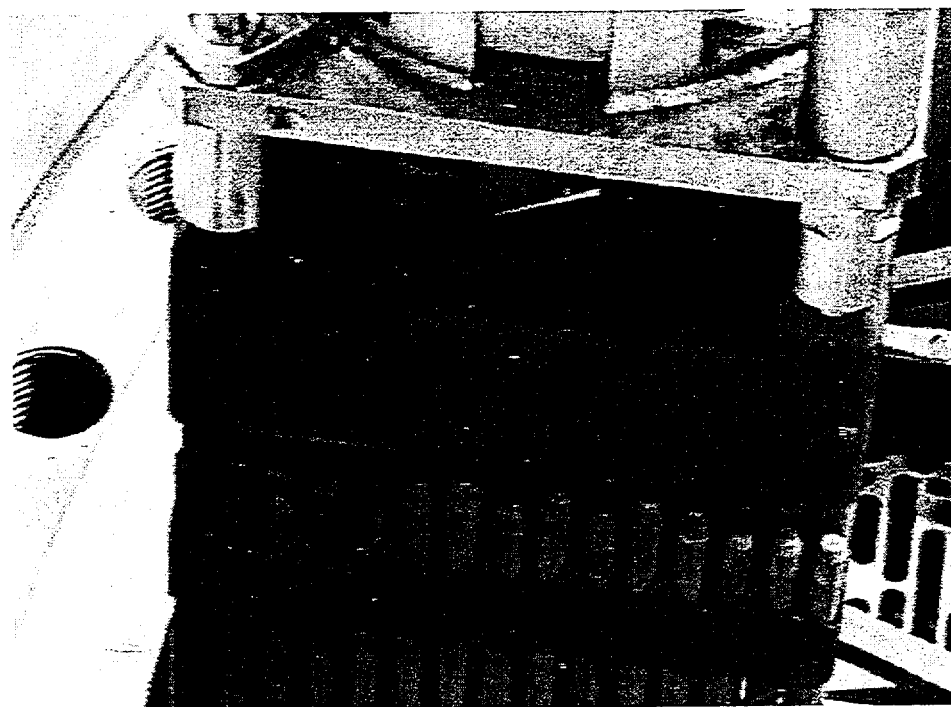
Figure C-14. Element T-03 being withdrawn—note fuel rod growth.

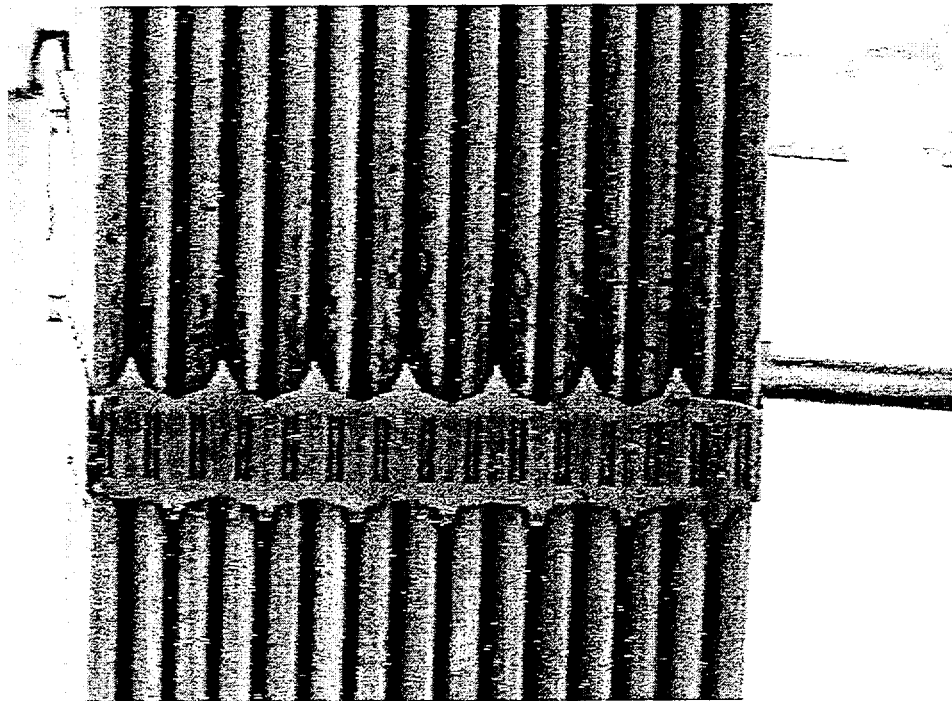
Figure C-66. Fuel assembly V-04 mottling at fifth grid spacer.
