TEMPORARY INSTRUCTION 2515/66

INSPECTION REQUIREMENTS FOR IE BULLETIN 84-03, "REFUELING CAVITY WATER SEALS"

VIRGINIA ELECTRIC AND POWER COMPANY
NORTH ANNA POWER STATION UNIT NOS. 1 AND 2
RESPONSE TO I.E. BULLETIN 84-03

NORTH ANNA POWER STATION
RESPONSE TO IEB 84-03
REFUELING CAVITY WATER SEAL

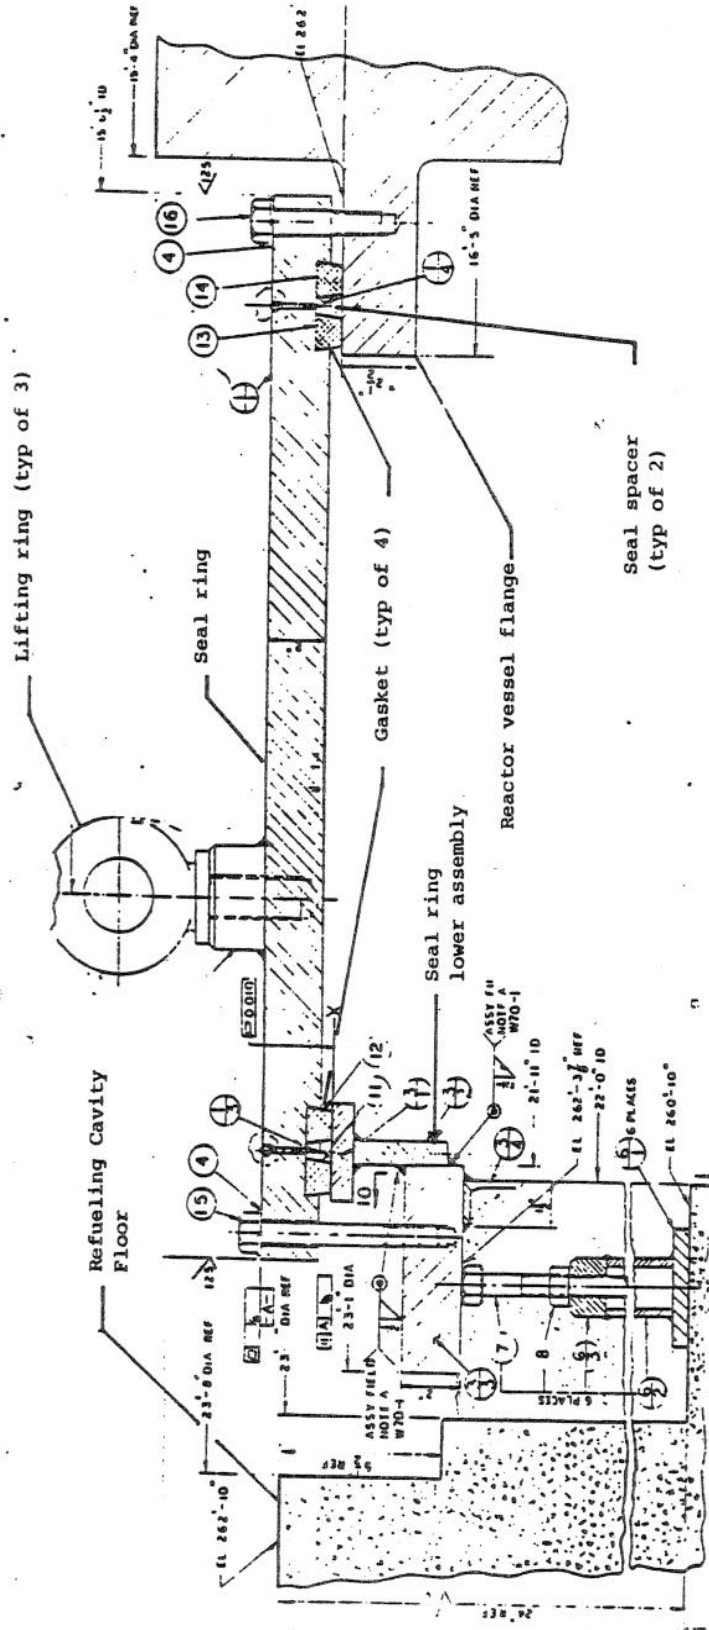
Figure 1. Refueling Cavity : Seal - North Anna Units 1 and 2

The refueling cavity seal assembly at North Anna Units 1 and 2 consists of a 2 inch thick carbon steel annular plate and neoprene gaskets as shown in Figure 1. The inner edge of the seal ring rests on the reactor vessel flange and is secured by thirty six 0.75 inch diameter bolts torqued to 100 ± 10 ft. lbs. The outer edge rests on the seal ring lower assembly, which is a permanent fixture in the refueling cavity floor, and is secured in the same fashion. Each of these sealing surfaces utilizes redundant neoprene gaskets which are trapezoidal in shape and firmly held in place by a bolted seal spacer. These gaskets are deformed by the hydrostatic load of the water in the refueling cavity and the torquing of the seal ring bolts to provide for leaktight integrity. This is verified prior to flooding the refueling cavity by the performance of a pressure drop test on each set of gaskets. This test consists of applying an air pressure of 20 psi between each set of gaskets and verifying essentially no pressure drop after 30 minutes.

In a postulated accident consisting of a complete loss of all gaskets, the hydrostatic pressure of the refueling water will force the seal ring against the reactor vessel flange and the seal ring lower assembly. In this event, some leakage from the refueling cavity is expected due to minor seal plate flatness irregularities, however this leakage would be minor and much less than the minimum make up capacity provided by the Chemical and Volume Control System (150 gpm). Additional makeup capacity is provided by the Refueling Purification pumps (400 gpm) and/or Low Head Safety Injection pumps (3000 gpm) taking suction from the Refueling Water Storage Tank. Due to the redundancy of the seal assembly design, a partial gasket failure would only result in minor leakage. A failure of one or several of the 72 bolts, which secure the seal ring, will not result in excessive leakage due to the hydrostatic load of the refueling cavity water. A failure of the annular plate (seal ring) is not considered plausible.
