NRC INSPECTION MANUAL

TEMPORARY INSTRUCTION 2515/142

DRAINDOWN DURING SHUTDOWN AND COMMON-MODE FAILURE (NRC GENERIC LETTER 98-02)

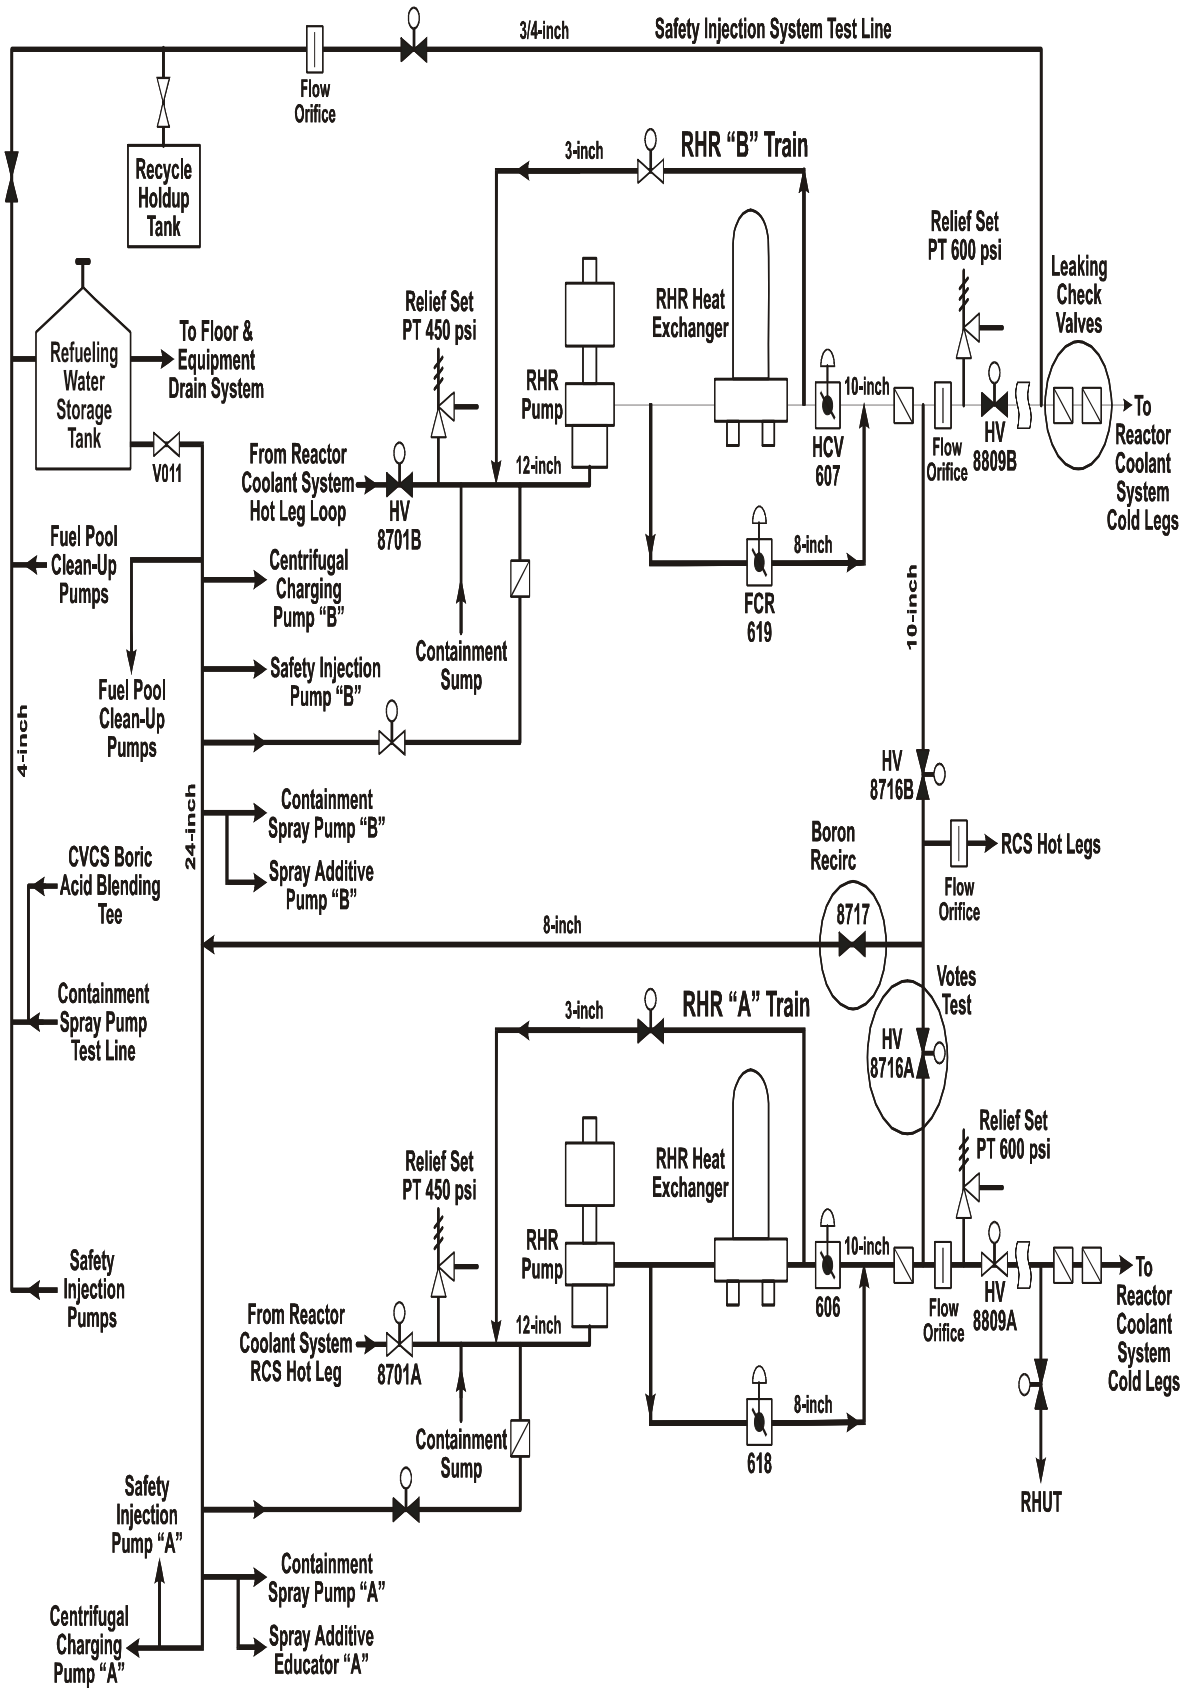
Figure 1. Simplified residual heat removal-refueling water storage tank
