Report on Condition of Schools Under Jurisdiction of Defense Education Activity

Department of Defense Education Activity
Report to the Congressional Defense Committees
Pursuant to section 2879 of Public Law 110-181 of the
National Defense Authorization Act for Fiscal Year 2008

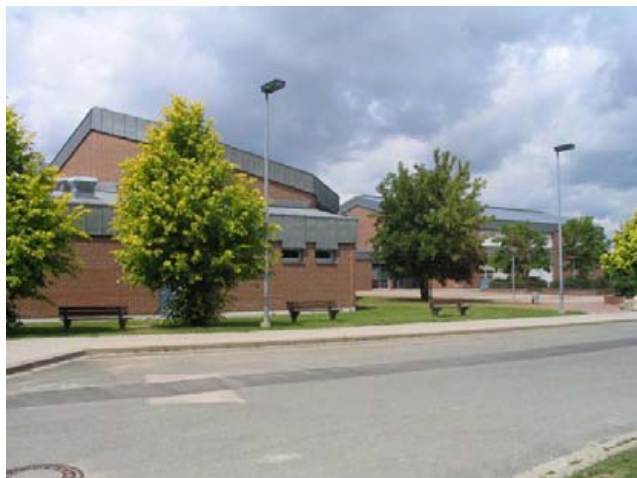
Ansbach Elementary School

SCHOOL SUMMARY	
Current Enrollment*	250
Maximum Capacity	295
GSF	42,190
Condition	62%
Average Q-Rating	Q-3

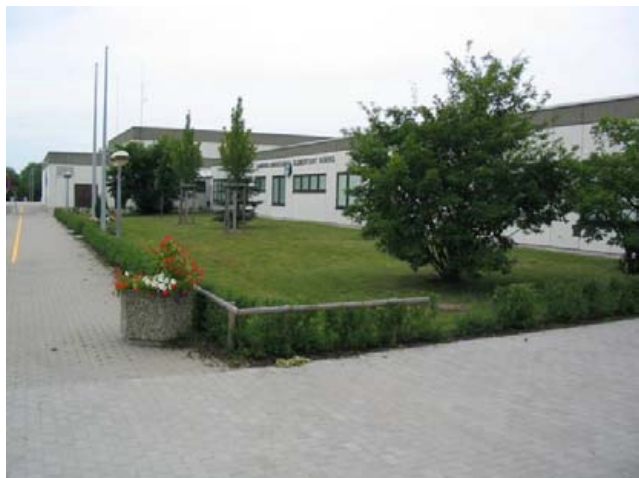
Bamberg Elementary School

SCHOOL SUMMARY	
Current Enrollment*	618
Maximum Capacity	650
GSF	97,255
Condition	53%
Average Q-Rating	Q-4

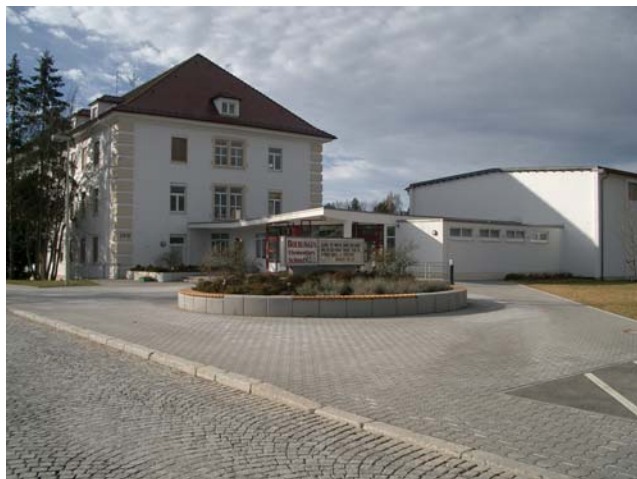
Boeblingen Elementary School

SCHOOL SUMMARY	
Current Enrollment *	516
Maximum Capacity	520
GSF	86,585
Condition	54%
Average Q-Rating	Q-4

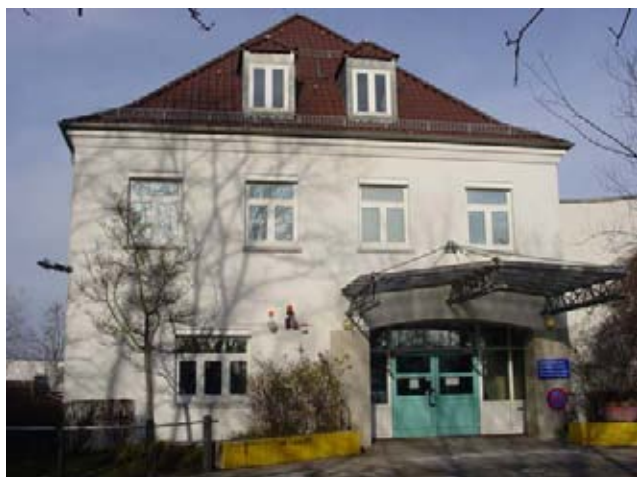
Robinson Barracks Elementary School

SCHOOL SUMMARY	
Current Enrollment*	352
Maximum Capacity	680
GSF	143,610
Condition	63%
Average Q-Rating	Q-3

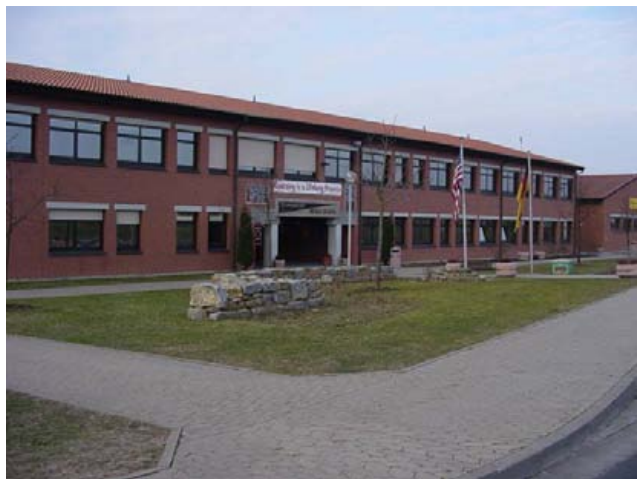
Schweinfurt Middle School

SCHOOL SUMMARY	
Current Enrollment*	252
Maximum Capacity	286
GSF	56,392
Condition	62%
Average Q-Rating	Q-3

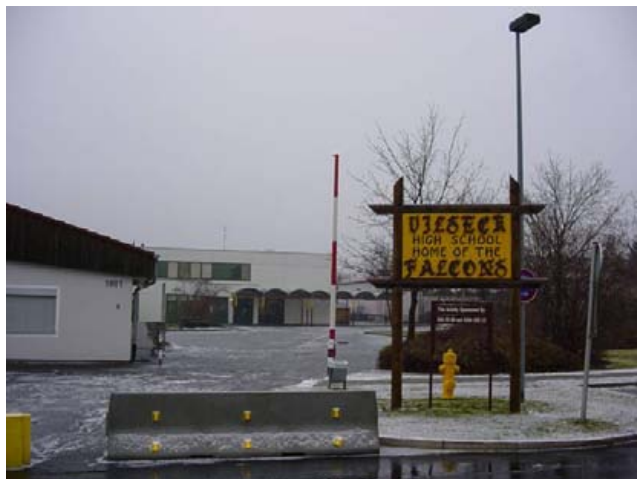
Vilseck Middle/High School

SCHOOL SUMMARY	
Current Enrollment*	414
Maximum Capacity	450
GSF	118,906
Condition	51%
Average Q-Rating	Q-4

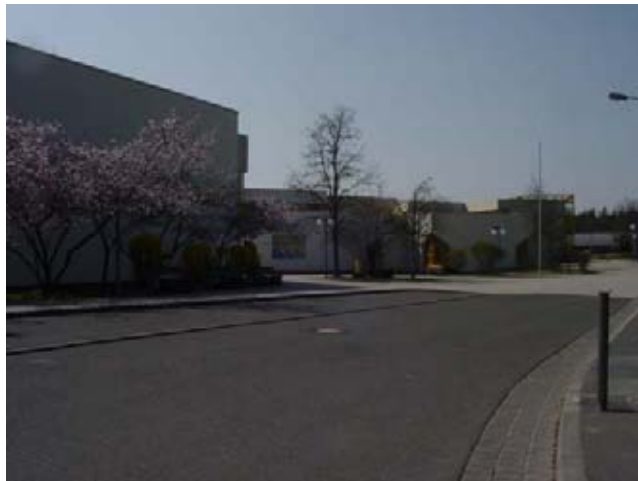
Darmstadt Elementary School and Middle School (Closing July 2008)

SCHOOL SUMMARY	
Current Enrollment*	371
Maximum Capacity	560
GSF	85,681
Condition	66%
Average Q-Rating	Q-3

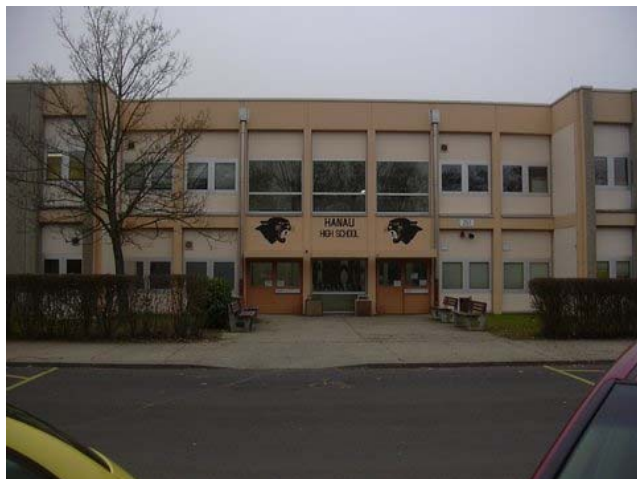
Hanau Middle School and High School (Closing July 2008)

SCHOOL SUMMARY	
Current Enrollment*	152
Maximum Capacity	520
GSF	113,043
Condition	47%
Average Q-Rating	Q-4

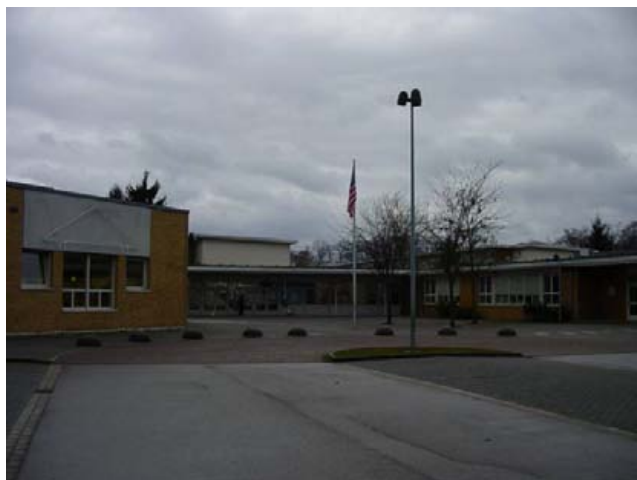
Mannheim Elementary School

SCHOOL SUMMARY	
Current Enrollment*	885
Maximum Capacity	990
GSF	180,396
Condition	51%
Average Q-Rating	Q-4

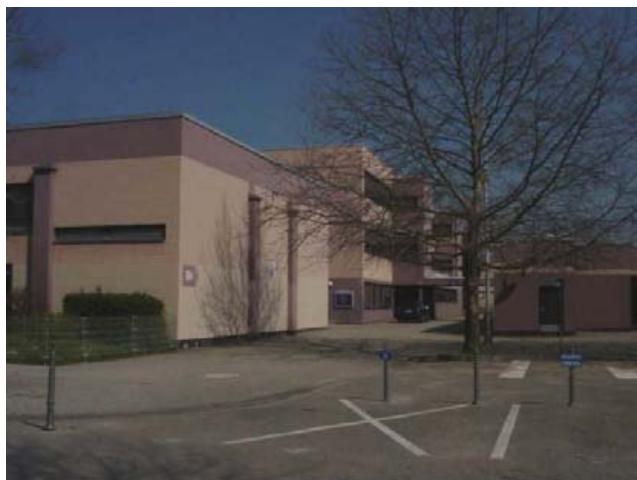
Mannheim Middle School

SCHOOL SUMMARY	
Current Enrollment*	324
Maximum Capacity	550
GSF	82,387
Condition	54%
Average Q-Rating	Q-4

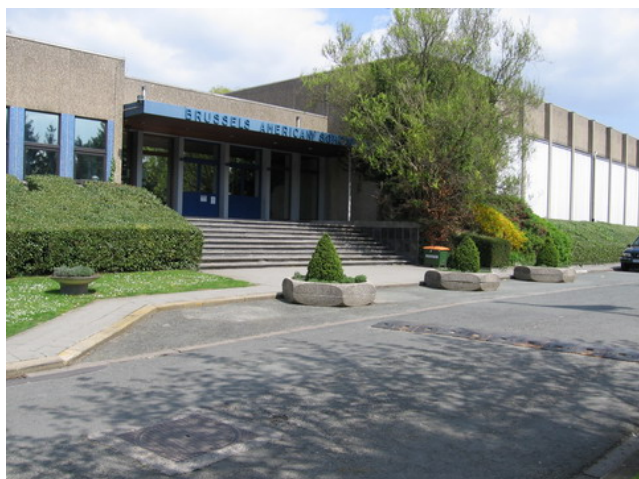
Brussels Elementary School/High School

SCHOOL SUMMARY	
Current Enrollment*	298
Maximum Capacity	430
GSF	75,128
Condition	49%
Average Q-Rating	Q-4

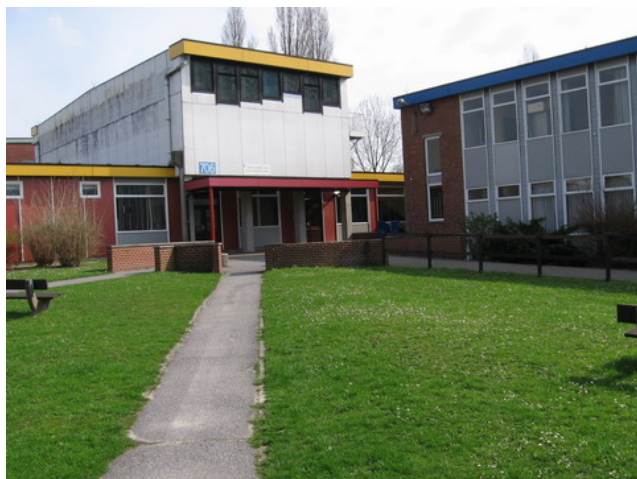
SHAPE High School

SCHOOL SUMMARY	
Current Enrollment*	509
Maximum Capacity	509
GSF	117,928
Condition	56%
Average Q-Rating	Q-4

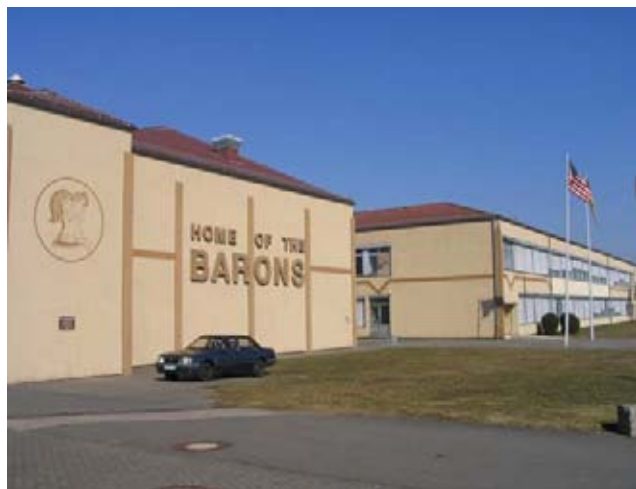
Bitburg High School

SCHOOL SUMMARY	
Current Enrollment*	311
Maximum Capacity	430
GSF	93,263
Condition	46%
Average Q-Rating	Q-4

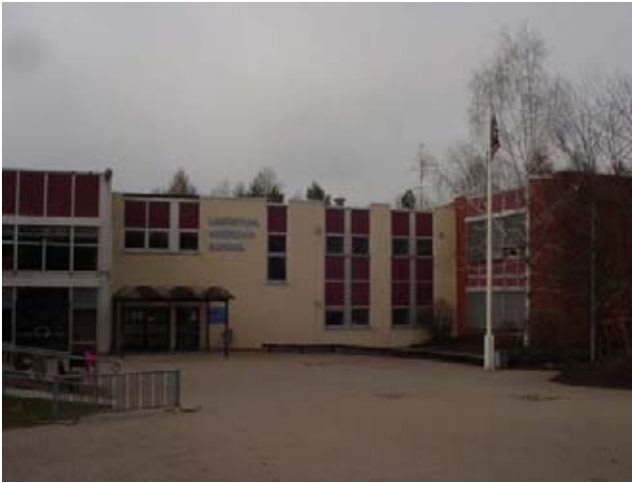
Landstuhl Elementary and Middle School

SCHOOL SUMMARY	
Current Enrollment*	869
Maximum Capacity	840
GSF	118,594
Condition	57%
Average Q-Rating	Q-4

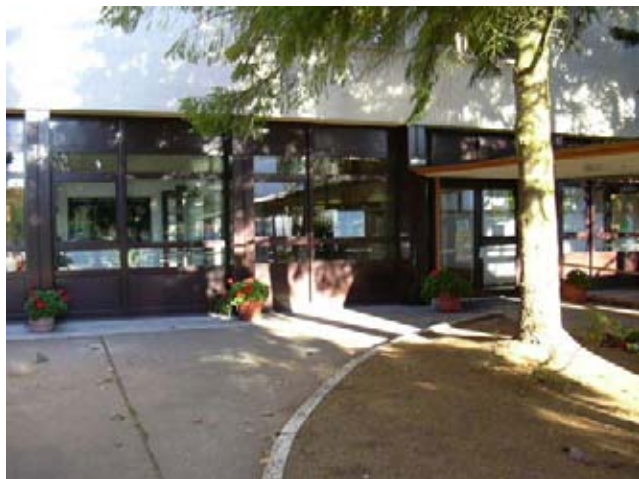
Sembach Elementary School

SCHOOL SUMMARY	
Current Enrollment*	202
Maximum Capacity	420
GSF	60,298
Condition	50%
Average Q-Rating	Q-4

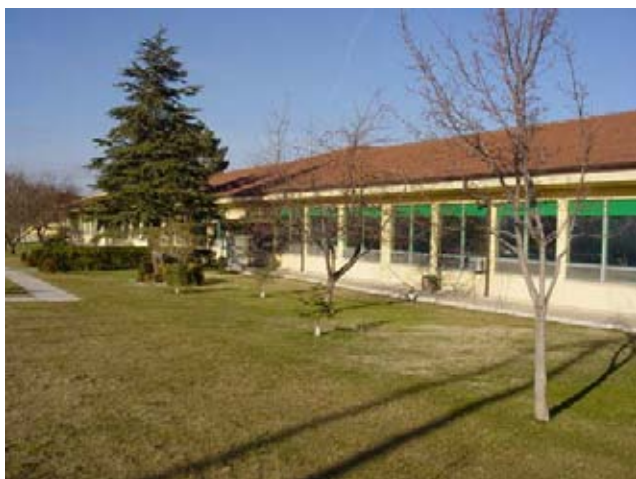
Ankara Elementary School and High School
(George C. Marshall Elementary and High School)

SCHOOL SUMMARY	
Current Enrollment*	206
Maximum Capacity	270
GSF	73,431
Condition	59%
Average Q-Rating	Q-4

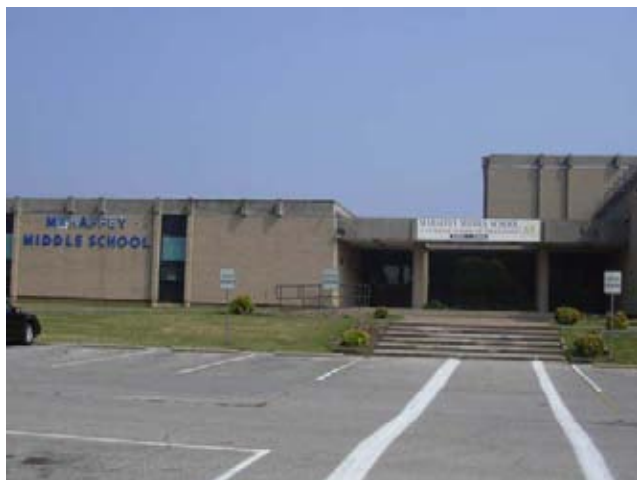
Mahaffey Middle School

SCHOOL SUMMARY	
Current Enrollment*	422
Maximum Capacity	634
GSF	72,999
Condition	52%
Average Q-Rating	Q-4

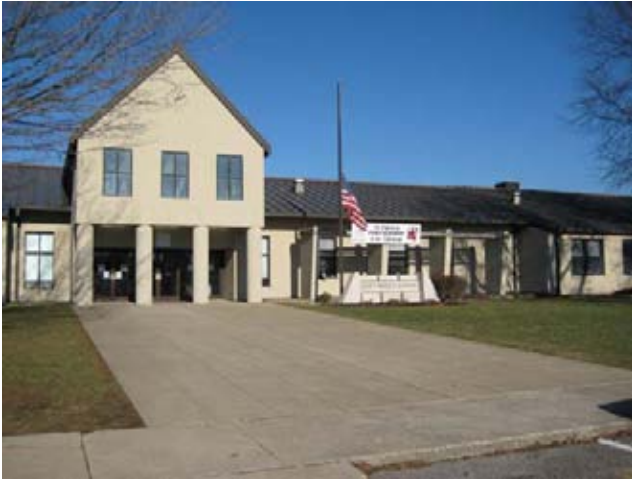
Scott Middle School

SCHOOL SUMMARY	
Current Enrollment*	307
Maximum Capacity	617
GSF	70,380
Condition	57%
Average Q-Rating	Q-4

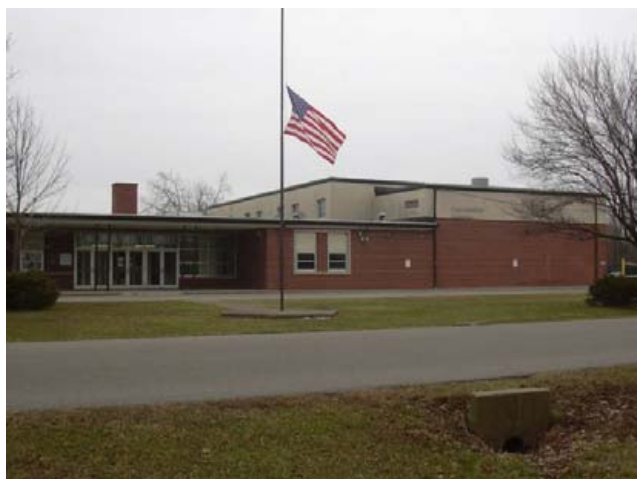
Van Voorhis Elementary School

SCHOOL SUMMARY	
Current Enrollment*	411
Maximum Capacity	675
GSF	82,431
Condition	40%
Average Q-Rating	Q-4

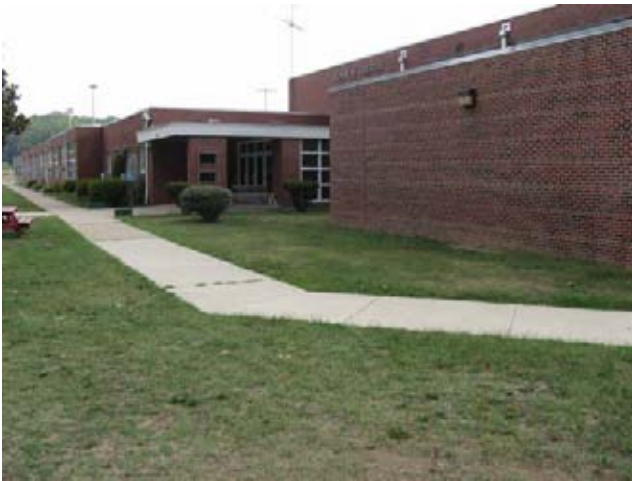
Russell Elementary School

SCHOOL SUMMARY	
Current Enrollment*	277
Maximum Capacity	329
GSF	43,059
Condition	34%
Average Q-Rating	Q-4

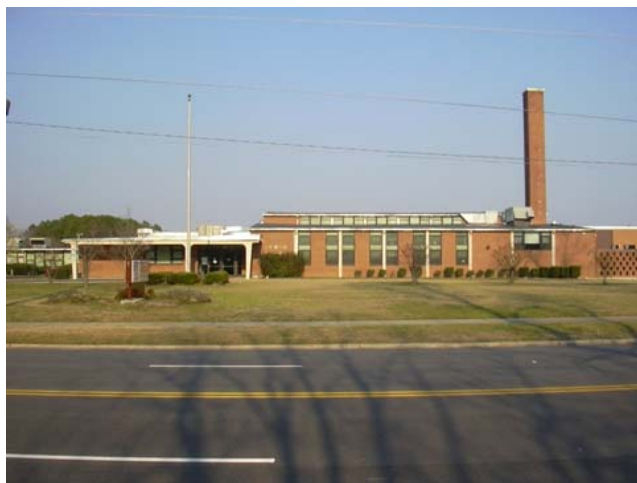
Irwin Intermediate School

SCHOOL SUMMARY	
Current Enrollment*	667
Maximum Capacity	792
GSF	96,170
Condition	53%
Average Q-Rating	Q-4

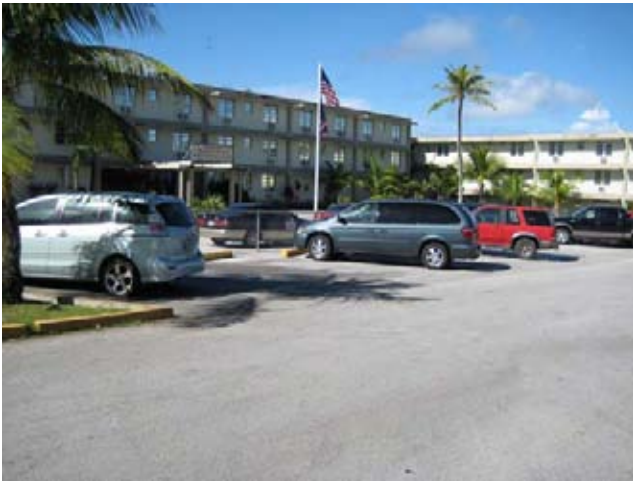
McCool Elementary and Middle School

SCHOOL SUMMARY	
Current Enrollment*	839
Maximum Capacity	850
GSF	116,980
Condition	49%
Average Q-Rating	Q-4

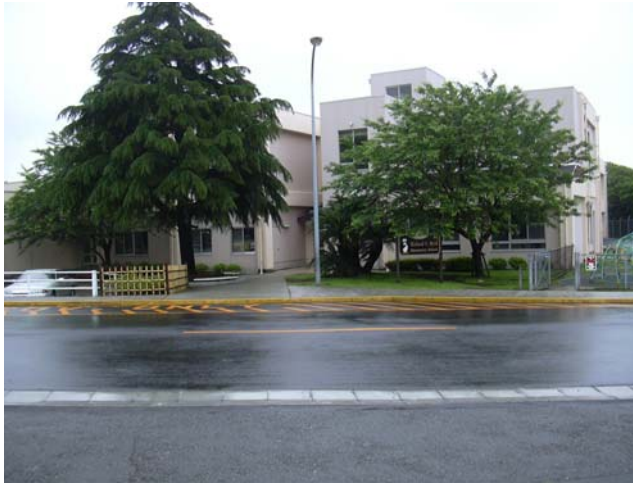
Byrd Elementary School

SCHOOL SUMMARY	
Current Enrollment*	80
Maximum Capacity	246
GSF	36,723
Condition	55%
Average Q-Rating	Q-4

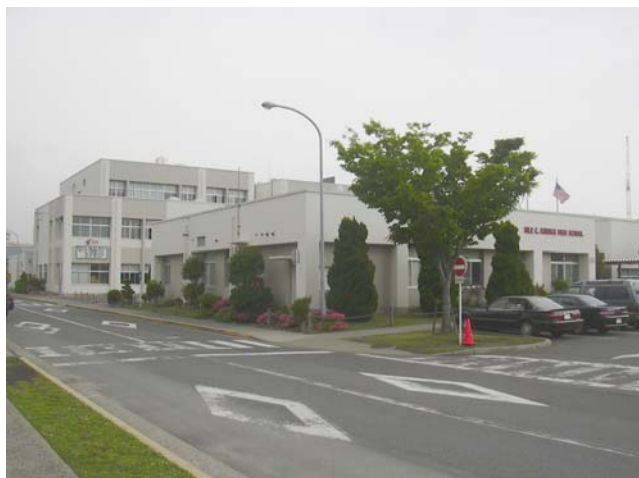
Kinnick High School

SCHOOL SUMMARY	
Current Enrollment*	517
Maximum Capacity	725
GSF	116,123
Condition	56%
Average Q-Rating	Q-4

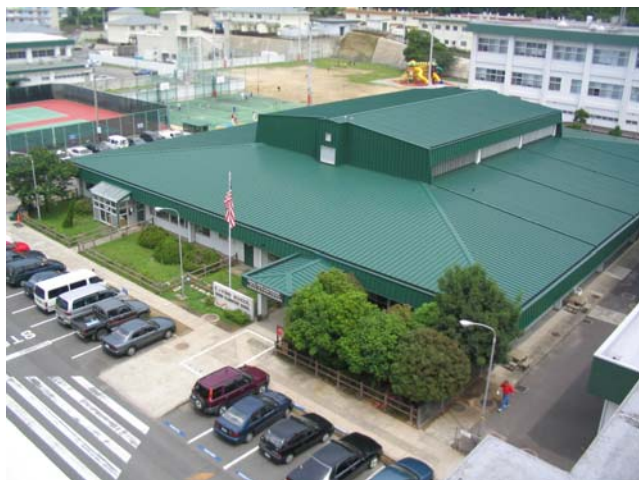
Sasebo Elementary School

SCHOOL SUMMARY	
Current Enrollment *	225
Maximum Capacity	280
GSF	49,313
Condition	58%
Average Q-Rating	Q-4

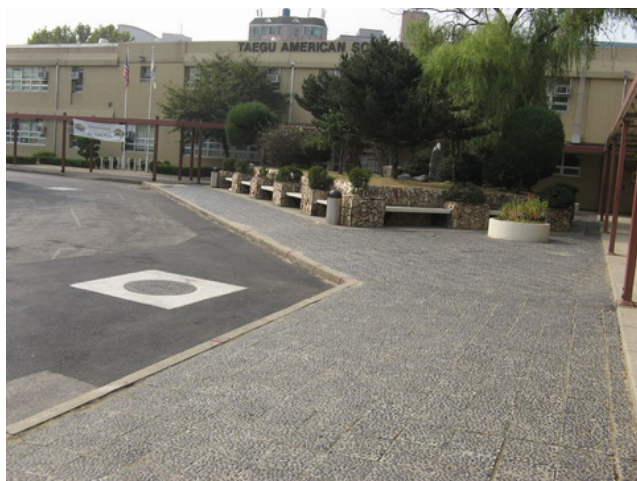
Daegu Elementary School and High School

SCHOOL SUMMARY	
Current Enrollment*	631
Maximum Capacity	725
GSF	80,933
Condition	43%
Average Q-Rating	Q-4

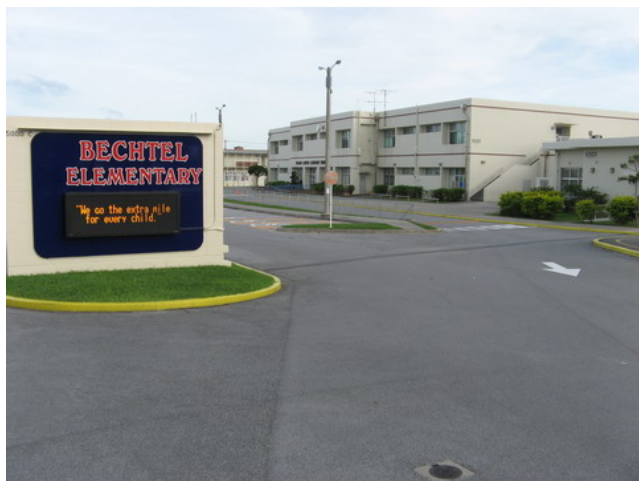
Bechtel Elementary School

SCHOOL SUMMARY	
Current Enrollment*	818
Maximum Capacity	1100
GSF	141,727
Condition	59%
Average Q-Rating	Q-4

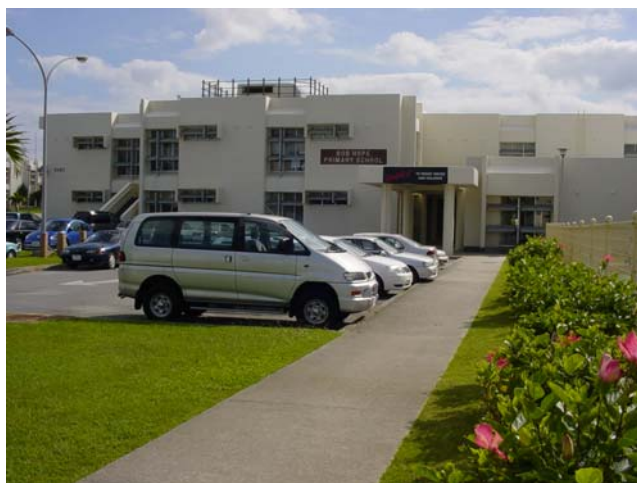
Hope Primary School

SCHOOL SUMMARY	
Current Enrollment*	804
Maximum Capacity	1000
GSF	105,953
Condition	51%
Average Q-Rating	Q-4

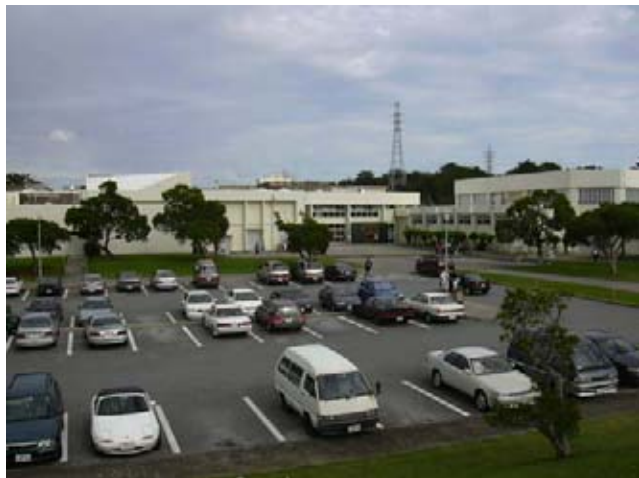
Kadena High School

SCHOOL SUMMARY	
Current Enrollment*	864
Maximum Capacity	900
GSF	183,662
Condition	43%
Average Q-Rating	Q-4
