U.S. Plant Experience With Alloy 600 Cracking and Boric Acid Corrosion of Light-Water Reactor Pressure Vessel Materials

**U.S. Nuclear Regulatory Commission
Office of Nuclear Regulatory Research
Washington, DC 20555-0001**

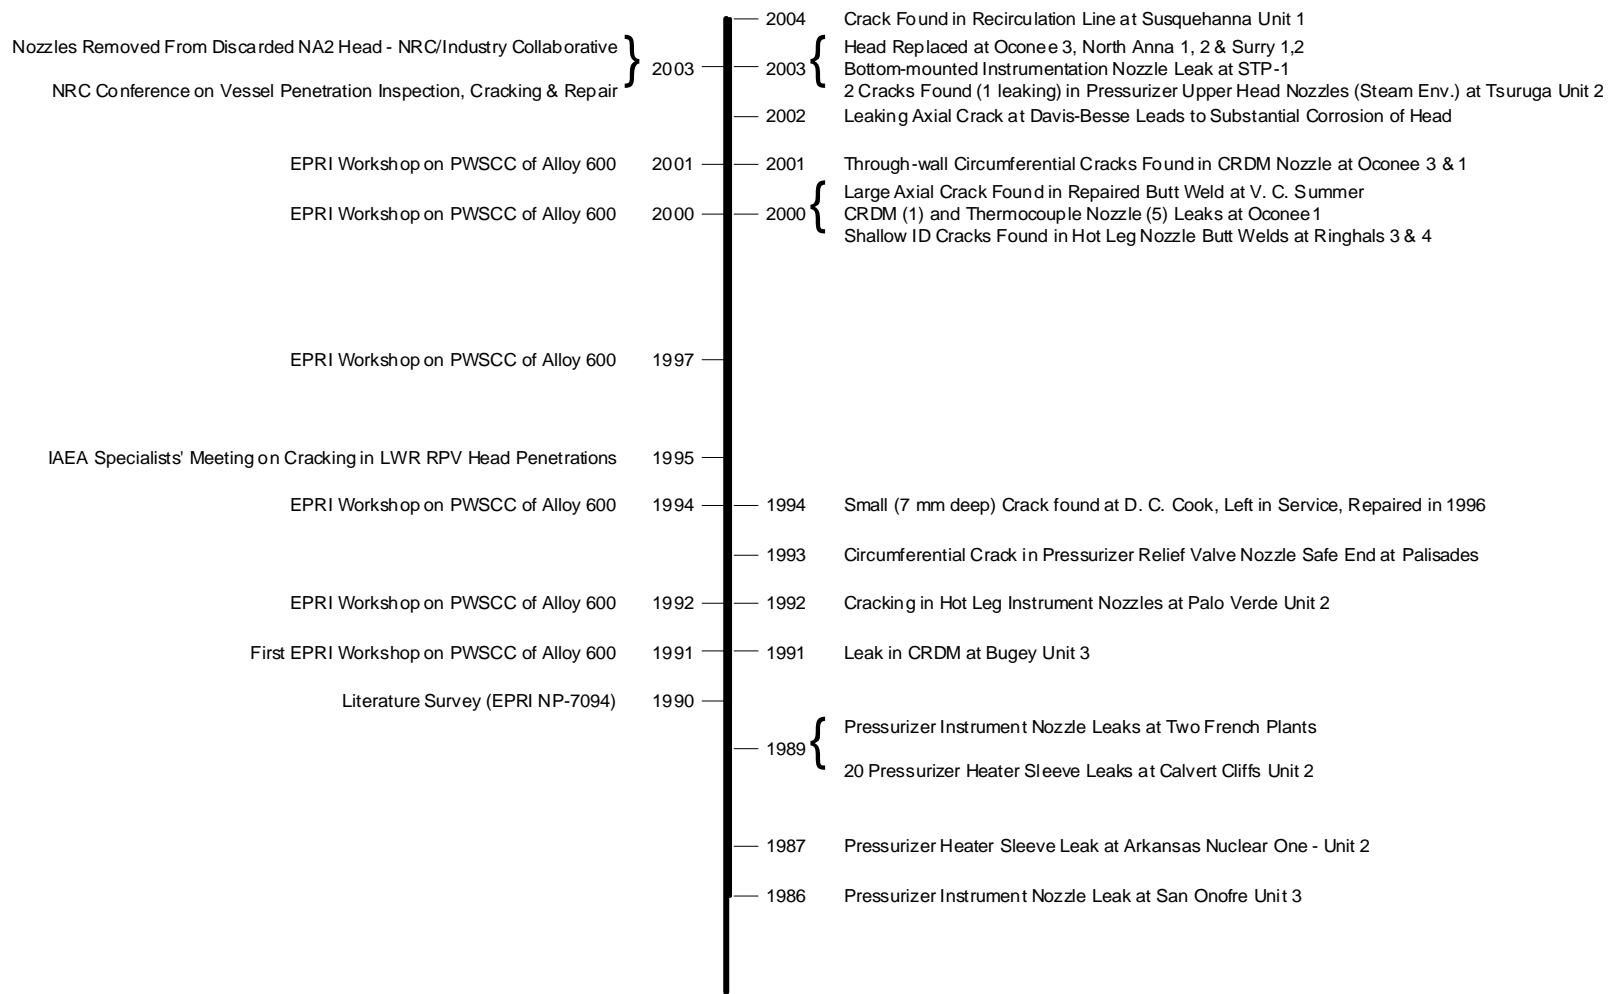
Figure 1. Timeline of findings of significant Alloy 600 cracking in NSSS plants, and important documentation, workshops, and conferences held to discuss this issue.

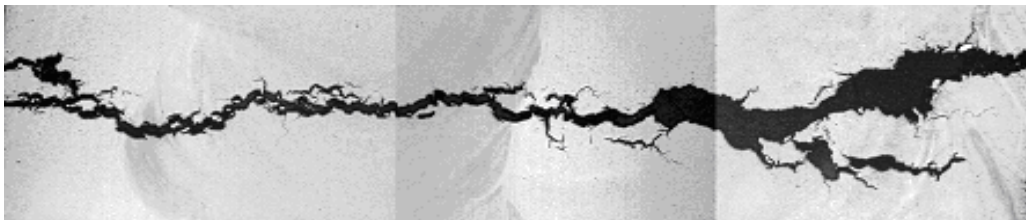
While conducting inspections in accordance with Bulletin 2001-01, severe boric acid corrosion wastage of the reactor pressure vessel head was discovered at Davis-Besse Nuclear Power Station in March 2002. Figure 2 is a metallograph of the flaw from Nozzle #3 — the location where significant head degradation occurred — from the Davis-Besse Plant. The characteristics of this discovery are detailed in Section 3.5. In response to this event, the NRC issued Bulletin 2002-01, which is described in Section 3.3. Subsequently, the NRC also issued Bulletin 2002-02 (Ref. 25) mainly to advise PWR licensees that visual examinations as a primary inspection method for the RPV head and VHP nozzles may need to be supplemented with additional measures (e.g., volumetric and surface examinations) to demonstrate compliance with applicable regulations.

Figure 2. A metallograph showing the profile of a crack in the attachment weld of Nozzle #3 in the (now discarded) Davis-Besse reactor head (Ref. 1).

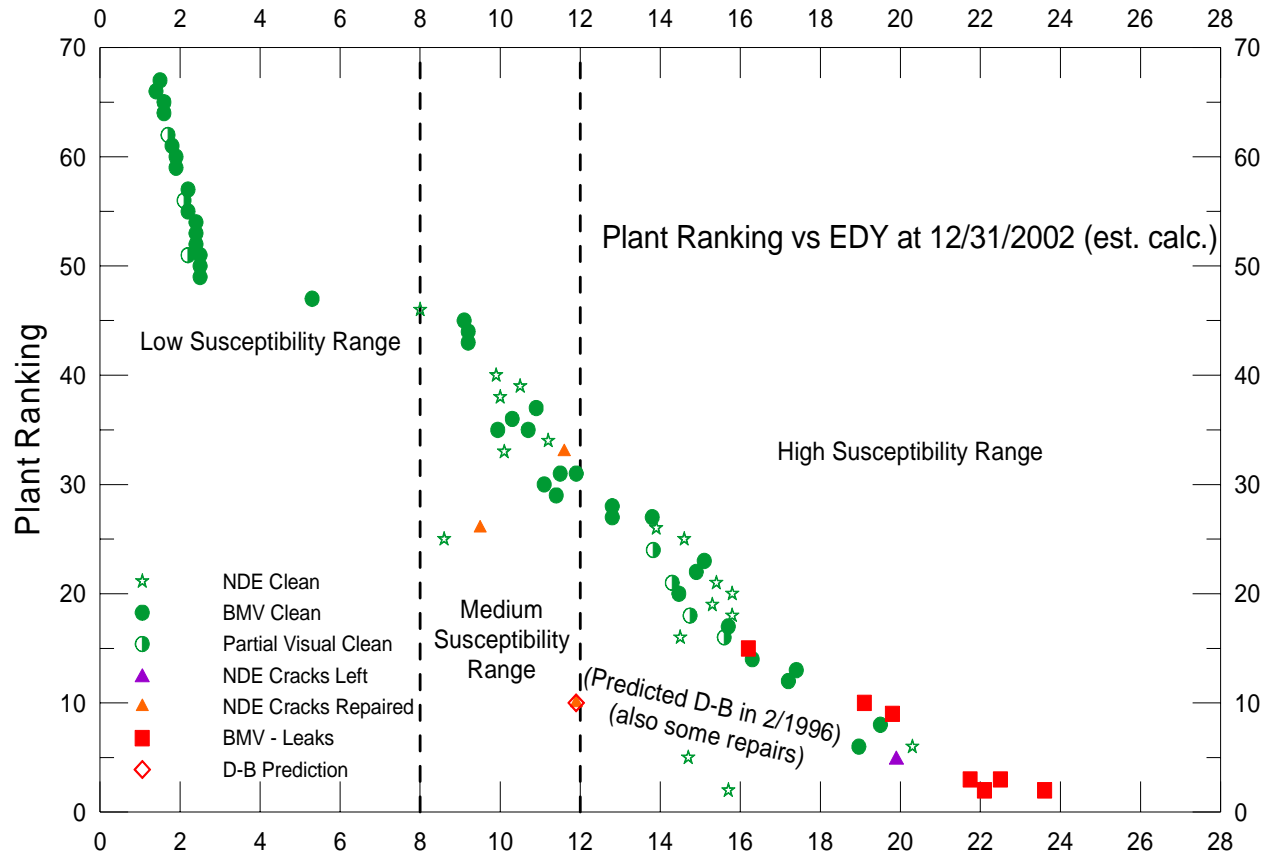
Using data supplied to the NRC by the Materials Reliability Program (MRP), Figure 3 is a plot of the EDY calculations for domestic plants, using firm operational data at February 28, 2001, and an approximation to update all values to December 31, 2002. The symbols filled with red designate plants that have discovered VHPs with cracks. This plot also shows an approximated calculation of the EDY (11.9) for Davis-Besse in February 1996, which is the earliest that Nozzle #3 is suspected to have begun to leak, according to the root cause report (Ref. 33). The plot shows that most plants either finding leaks, or making repairs, are well into the high-susceptibility range. The exceptions are the D.C. Cook 2 plant, which repaired one crack at EDY = 9.5 and has been free of leaks since (now at EDY = 13.9), and the Millstone 2 plant, which repaired non-leaking cracks in three nozzles at EDY = 11.6, after experiencing a clean NDE exam at EDY = 10.1.

Figure 3. Ranking of domestic plants according to the EDY formula, showing results of inspections, evidence of leakage, and repairs. Many plants are shown with multiple symbols, indicating a “clean” inspection at inspection opportunity, followed by a different finding at a subsequent inspection (e.g., Oconee 2: clean NDE @ EDY=15.7, leaks and circ. flaws @ 22.1)

The experiences at the Millstone and D.C. Cook plants, and possibly at Davis-Besse, challenge the choice of 12 EDY as the medium-to-high-susceptibility threshold. However, there are several plants with EDY > 12 and clean inspection results. For example, examination of the nozzles in the H.B. Robinson 2 RPV head did not identify evidence of leaking or cracking. This suggests that there may be other factors besides time and temperature that are controlling crack initiation in VHP nozzles. One of these factors may be the heat of the material in the head. If variables, such as the heat of a material in a reactor head, can cause a contribution to the EDY calculations, such variables are not factored into the susceptibility model in its present incarnation. However, because there was an urgency to develop a tool to measure a plant’s EDY after the Davis-Besse event, the current time-at-temperature EDY measurement tool was used. This was the logical choice because the time-at-temperature EDY calculation reasonably reflected industry cracking data, while leaning toward a more conservative position.

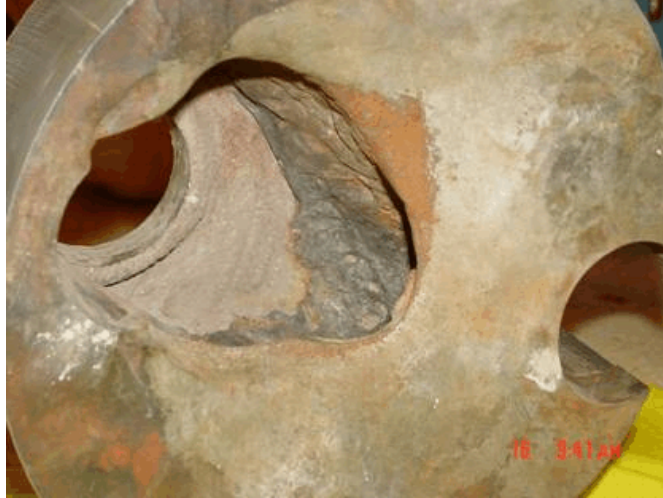
Degradation of the RPV head at Davis-Besse was discovered in March 2002. The integrity of the reactor coolant boundary was significantly compromised. A triangular cavity approximately 5 inches wide, 7 inches long, and completely through the low-alloy steel RPV head thickness was located downhill of VHP Nozzle #3 approaching Nozzle #11. The wastage consumed between 40 and 60 cubic inches of the vessel head. This reduced the reactor pressure boundary in the vicinity of the boric acid corrosion attack to a section of stainless steel cladding ranging in thickness from 0.199 inch to 0.314 inch. The cladding had an exposed surface area of 16.5 square inches and had deflected outward under system pressure. Additional boric acid wastage was also observed near VHP Nozzle #2. Figure 4 is a photograph of the extensive corrosion loss experienced on the head at the Davis-Besse plant.

Figure 4. A photograph of the 18-inch diameter section of the discarded Davis-Besse head, containing the corrosion cavity created by leakage from the included nozzle (#3). The hole at the right is from nozzle #11.
