# NATIONAL TRANSPORTATION SAFETY BOARD

## RAILROAD ACCIDENT REPORT

COLLISION OF NORTHERN INDIANA COMMUTER  
TRANSPORTATION DISTRICT TRAIN 102  
WITH A TRACTOR-TRAILER  
PORTAGE, INDIANA  
JUNE 18, 1998

NTSB/RAR-99/03  
PB99-916303  
Notation 7055B  
Adopted July 26, 1999

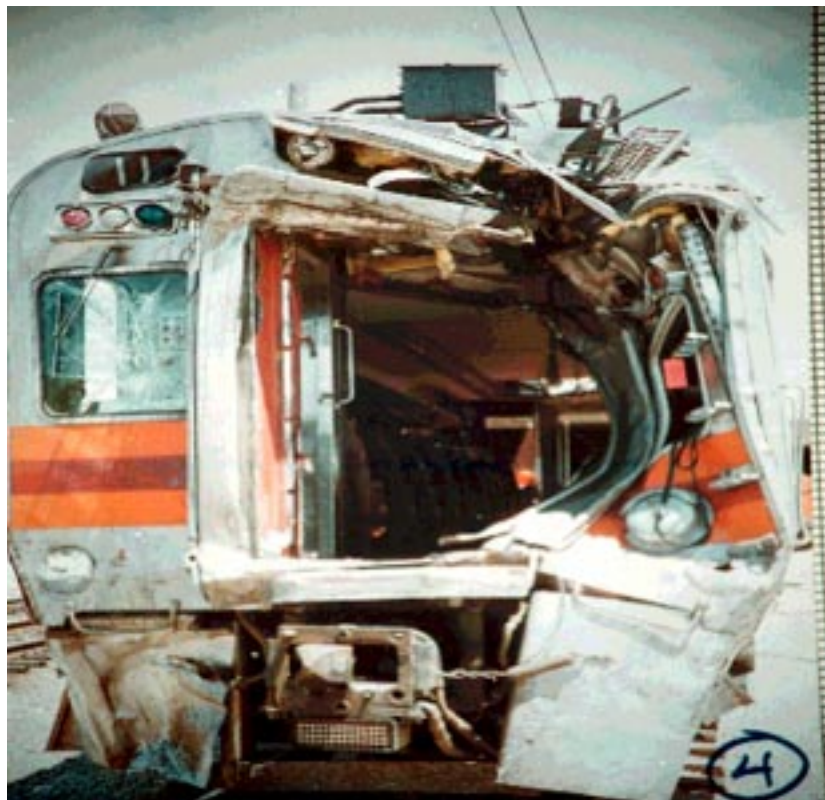
**Figure 4.** West (damaged) end of NICTD car 11

**NICTD Car 11.** The front bulkhead had sustained major impact damage, resulting in a breach that opened into the front vestibule and passenger compartment and extended from about the floorline to the ceiling and from the extreme left front corner post to the left edge of the right collision post, contained within the front bulkhead. The damage severed the wiring and electrical conduits routed through the front bulkhead. Neither the interior emergency lights nor the public address system in the first car was operable following the accident. A battery back-up arrangement supported these systems, but these circuits were also rendered inoperable by the front bulkhead damage.

The left collision post had fractured into two pieces at a point about 39 inches above its bottom end. The connections at its upper and lower ends were not completely severed, and the top and bottom segments did not fully separate from their anchorage points. (See figure 11 for a diagram showing the collision posts within the car structure.) The front window in the operator's cab area was fractured, and several wall panels had been slightly displaced and distorted.

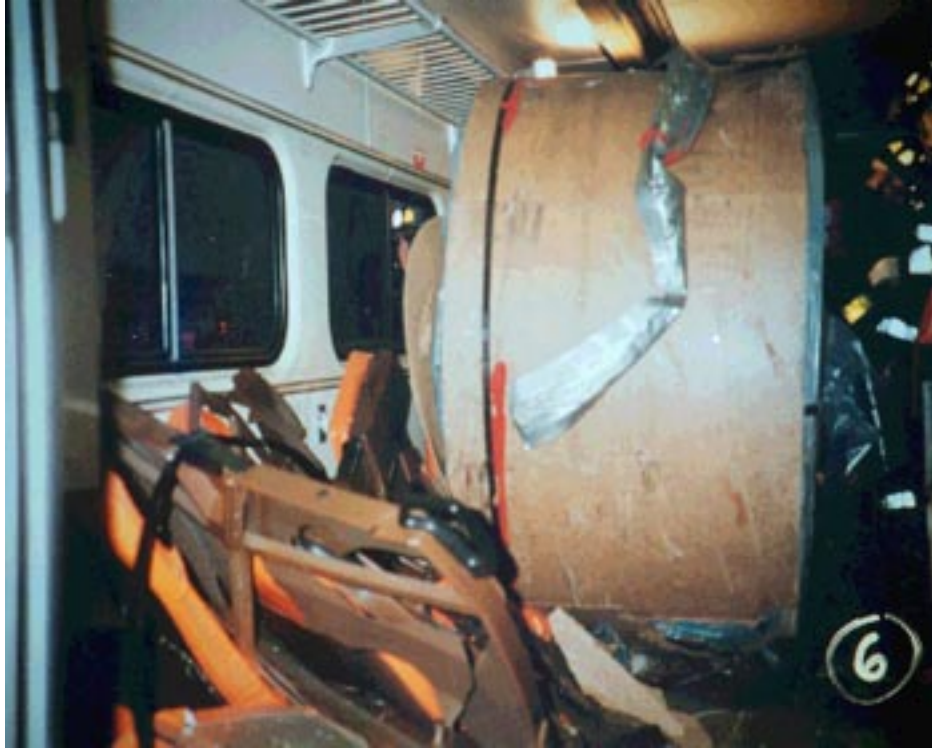
Figure 5. Steel coil inside NICTD car 11

The floor area adjacent to the restroom, where the steel coil came to rest about 34 feet from the front of the train, had partially collapsed. The coil was oriented with its parallel side faces about parallel to the exterior sidewalls.

A pronounced crescent-shaped gouge was found on the exterior aisle wall of the restroom partition, aft of the leading corner of the restroom aisle wall partition, consistent with the coil having traveled to the restroom partition wall before moving back toward the front of the car, a distance of about 56 inches, to the point where it came to rest.

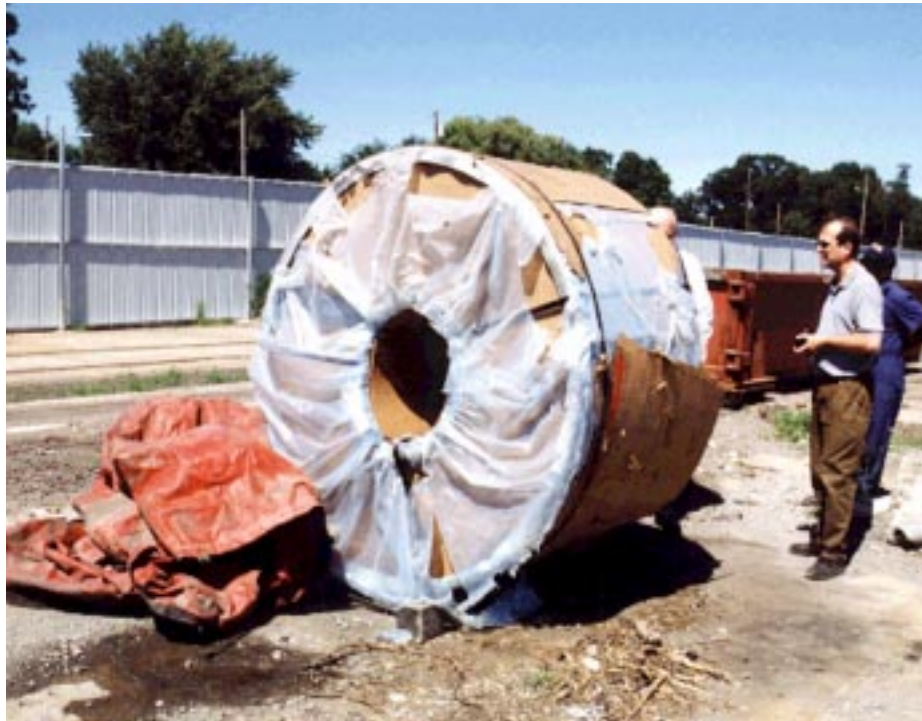
Figure 6. Steel coil outside NICTD car 11

The cargo of the struck trailer was a 72-inch-diameter by 41-inch-wide open-center coil of steel that reportedly weighed 38,030 pounds. It had reportedly been chained to the approximate center of the flatbed trailer deck and covered with a tarp. The coil had dislodged from the trailer on impact and penetrated the front bulkhead of NICTD car 11. Investigators found the tarp wrapped around the front end of NICTD car 11. They found the coil inside the forward passenger compartment area of car 11, it having traveled inward almost to the center vestibule area, a distance of about 34 feet. The coil was recovered from the car at the grade-crossing site with a heavy-lift crane that operated through a hole cut in the roof above the coil.

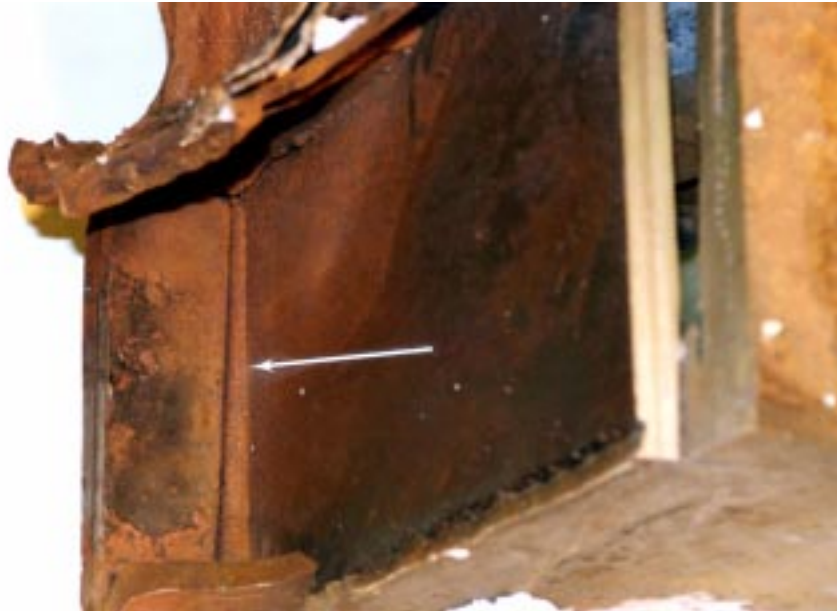
Investigators found two welds in the collision post attachment that were identified for further examination. The first was the vertical inboard rear weld, which had been specified<sup>33</sup> as a fillet weld. The weld was not readily visible due to the presence of a 6.7-inch-long threaded fastener at the joint. The fastener was 5/16-inch in diameter, rusted on the surface, and it did not have a head. It appeared welded and/or wedged in place. (See figure 12.) According to NICTD (Mechanical Department management), this fastener is not a normal component of the collision post. Comments were offered that it could have functioned as a shim or filler material during welding, although a positive determination could not be made.<sup>34</sup>

**Figure 12.** Arrow indicates threaded fastener at the joint welded and/or wedged in place

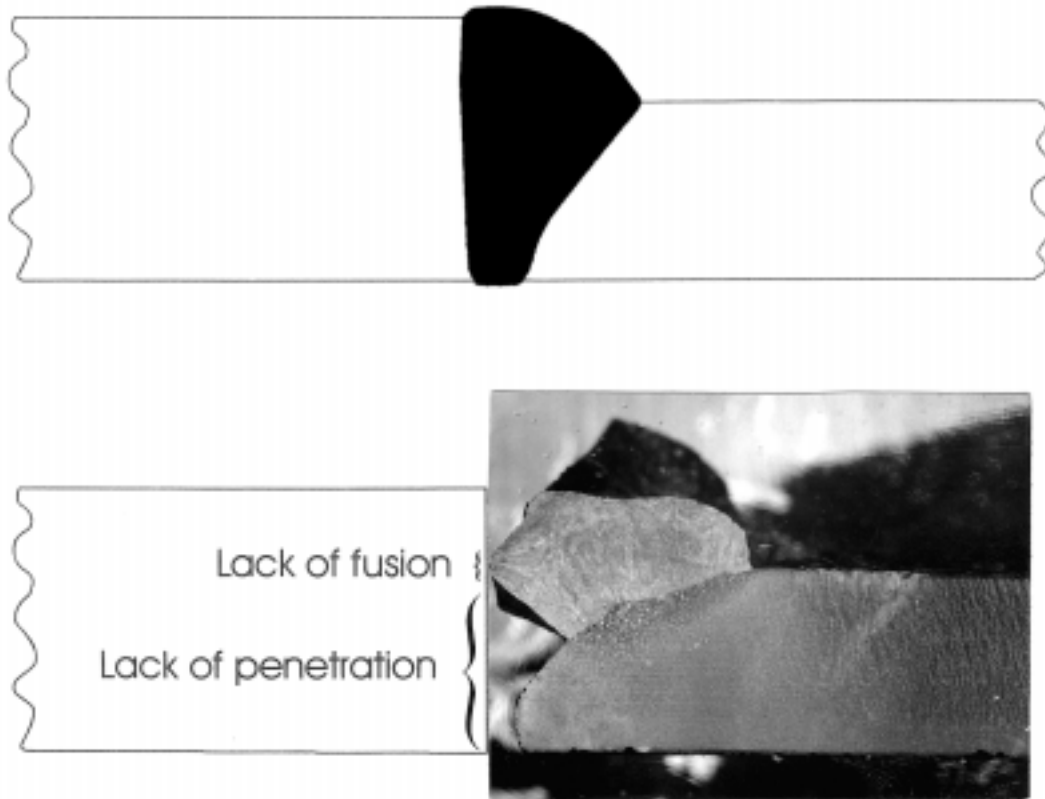
The second weld that was further examined was the vertical inboard front weld. This weld was specified<sup>35</sup> as a single-bevel groove weld and was required to have 100-percent penetration by the NICTD specification.<sup>36</sup> The front of the collision post had separated from the sill at this joint, with nearly all of the weld filler material remaining on the end sill side of the fracture.

**Figure 13.** Top graphic shows an illustration of a full penetration weld between two pieces of metal; bottom graphic shows a photograph of the weld found at the base of the collision post, where less than full penetration is indicated by the gaps on the left side and at the bottom
