PIPELINE ACCIDENT REPORT

**SAN JUAN GAS COMPANY, INC./ENRON CORP.
PROPANE GAS EXPLOSION IN SAN JUAN, PUERTO
RICO, ON NOVEMBER 21, 1996**

Abstract: About 8:30 a.m. on November 21, 1996, because of a propane gas leak, a commercial building in San Juan, Puerto Rico, exploded. Thirty-three people were killed, and at least 69 were injured.

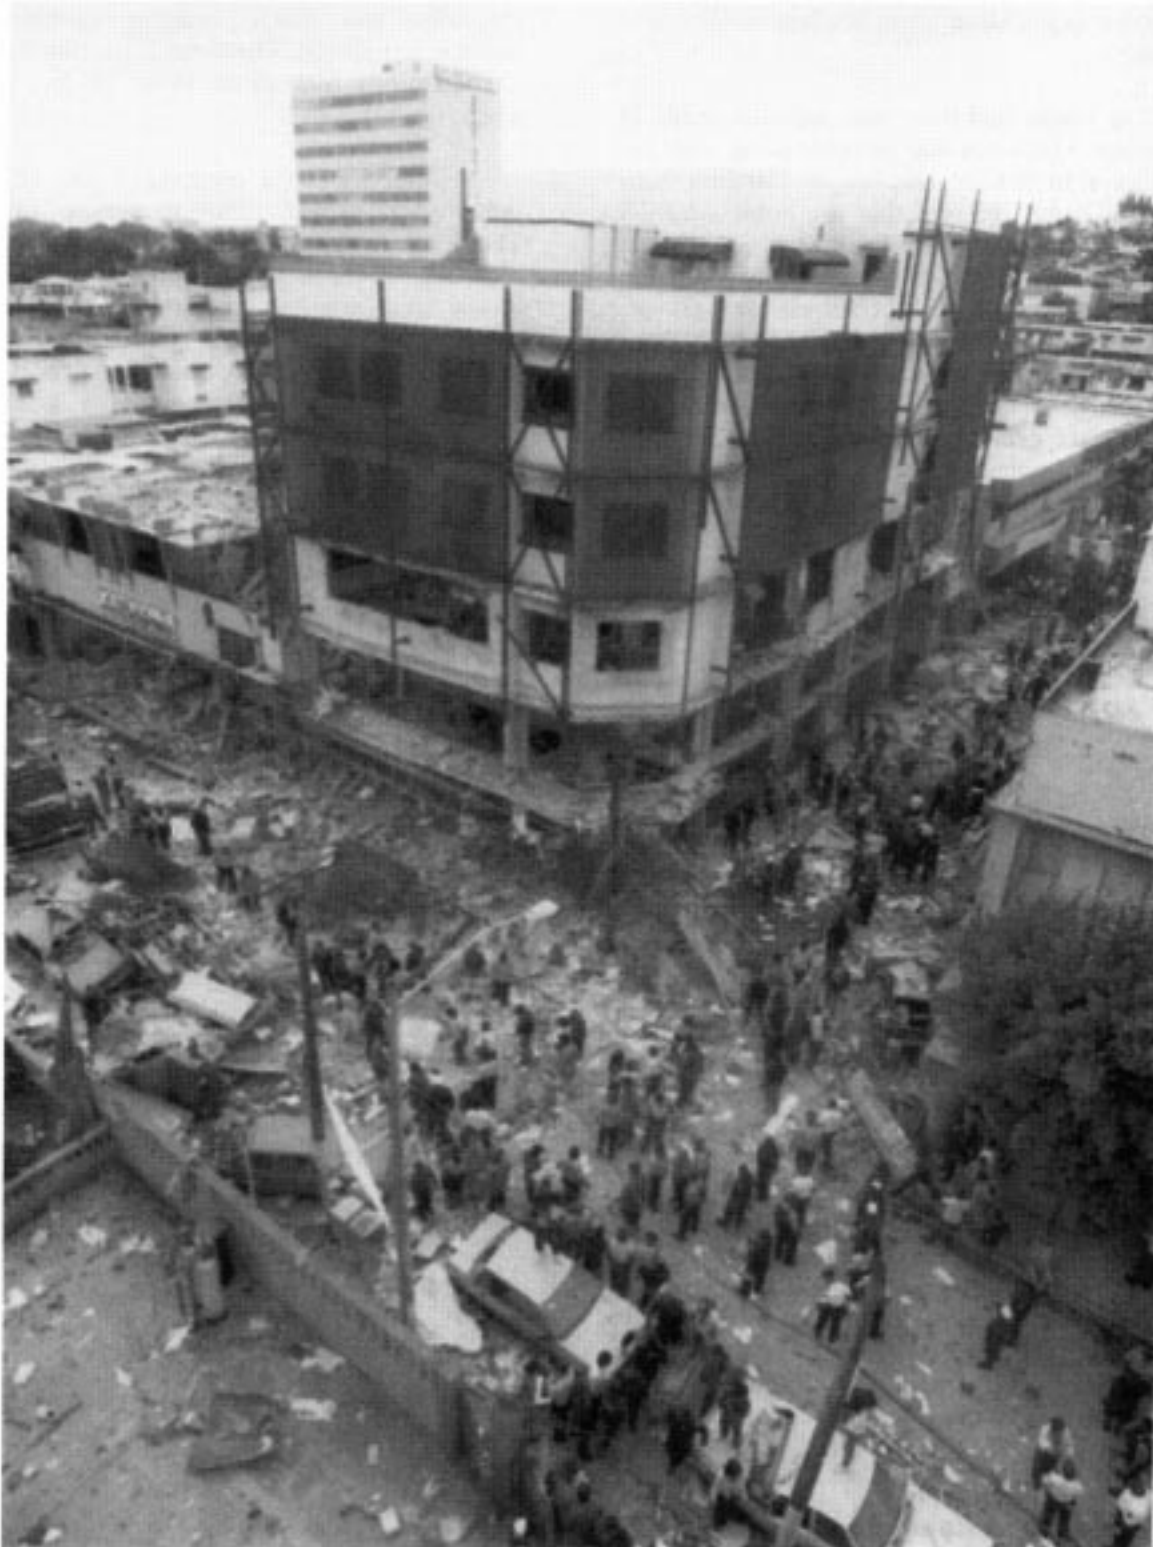
People who were in the HV and adjacent buildings sustained minor to serious injuries. Those on the lower floors of the HV building received the more serious injuries. The bodies of the store manager and the air conditioning service technician were later found in the basement. Some people outside and near the HV building were severely injured or killed by debris propelled by the explosion. (See figure 3.)

Figure 3. Building after Explosion (courtesy of *The San Juan Star*).

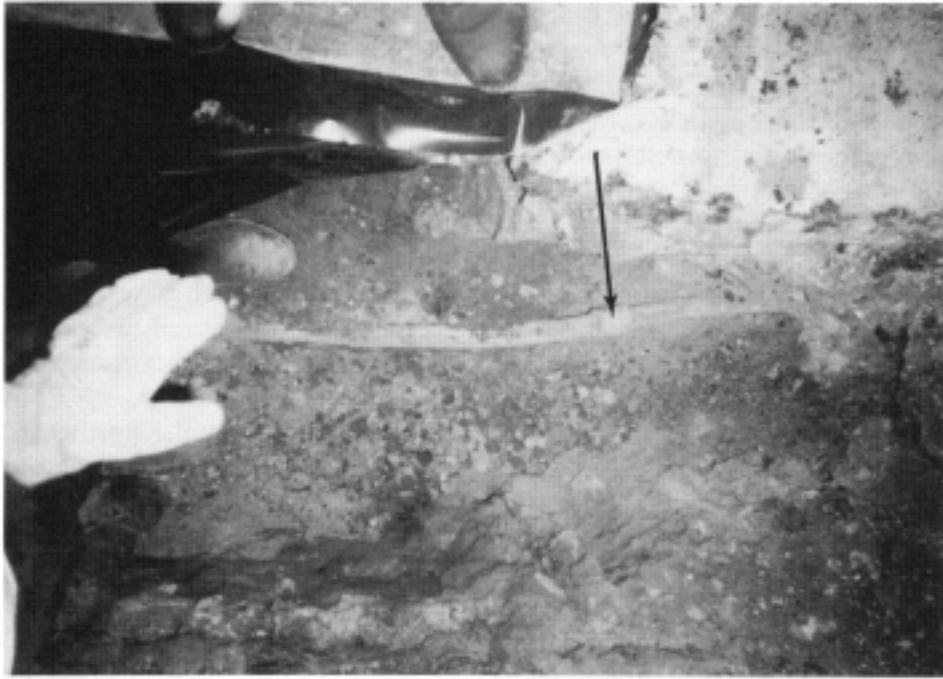
Figure 5. Location of Crack in Plastic Gas Line to Chicken Kingdom.

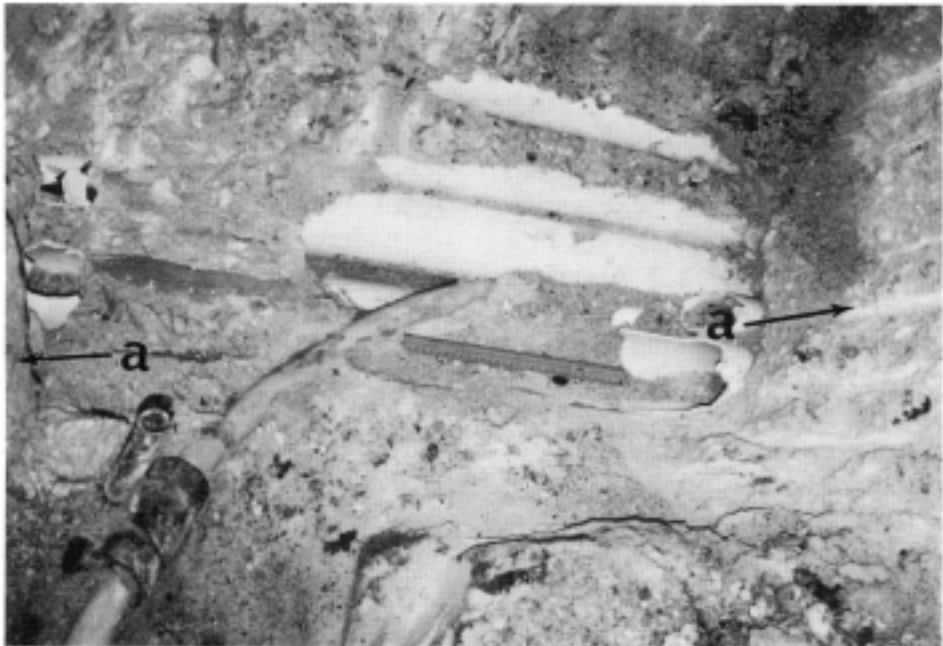
Figure 6. Plastic Gas Line Entering Telephone Conduit Bundle in Concrete under Camelia Soto. (Arrows point to the concrete walls on each side of the excavation.)

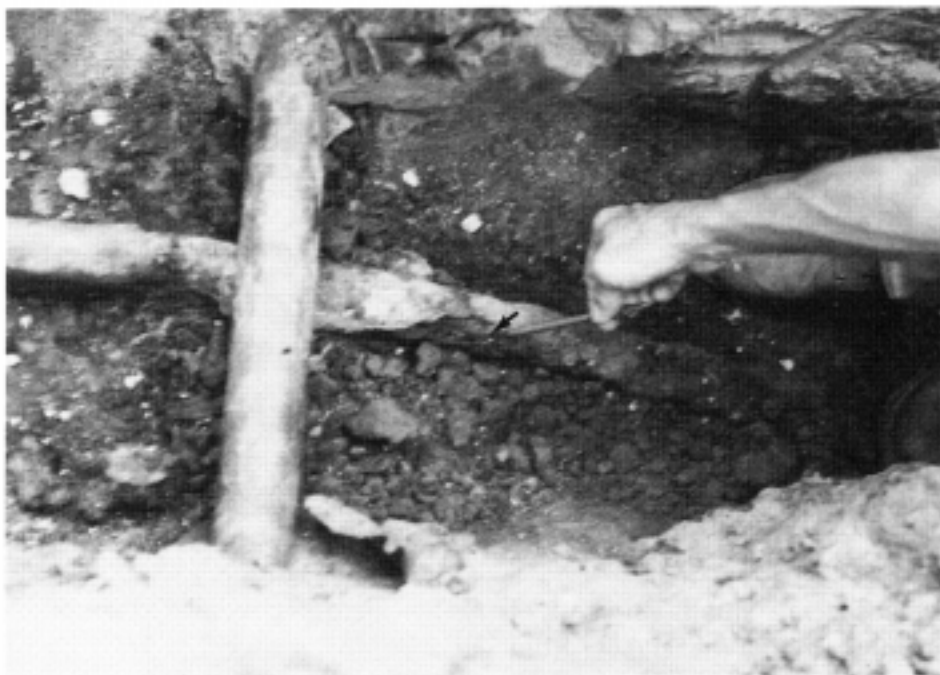
Figure 7. Location of Gas Leak from Inactive Gas Service Line under Arzuaga.

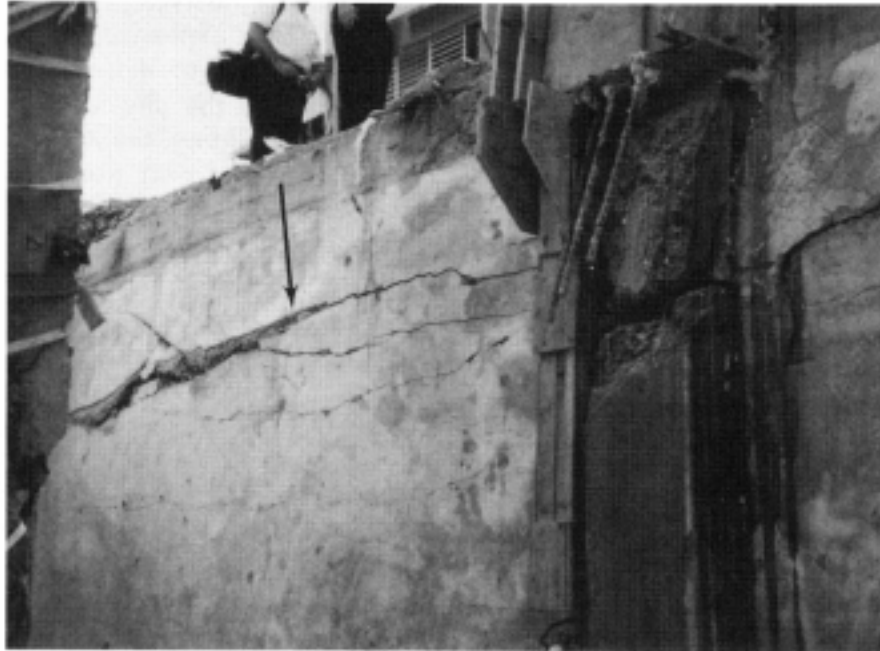
Figure 8. Major Crack in West Wall of Basement of HV Building.

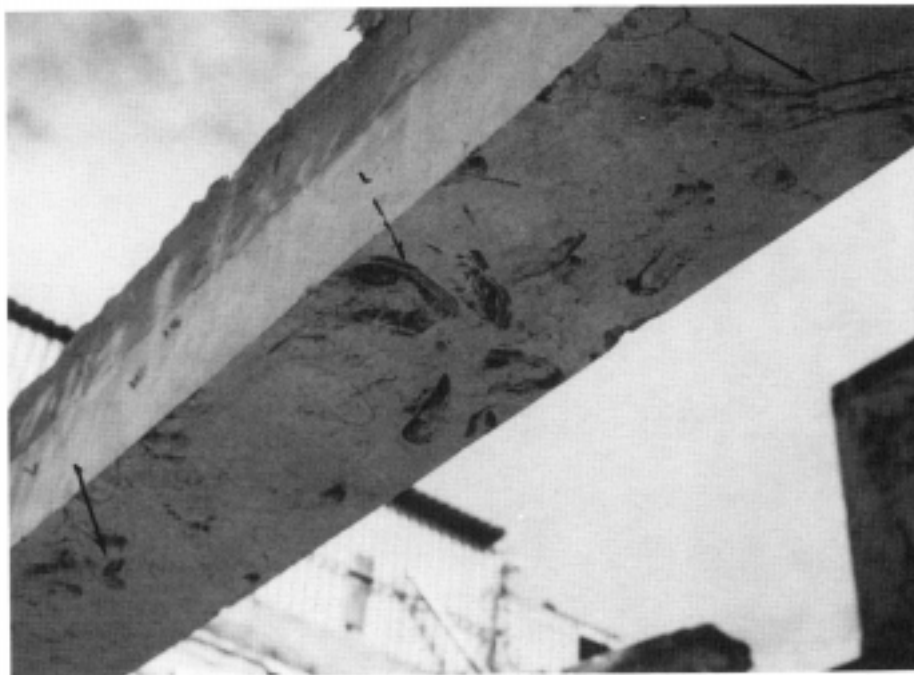
Figure 9. Shoe Sole Imprints on Bottom of Beam in Basement of HV Building.

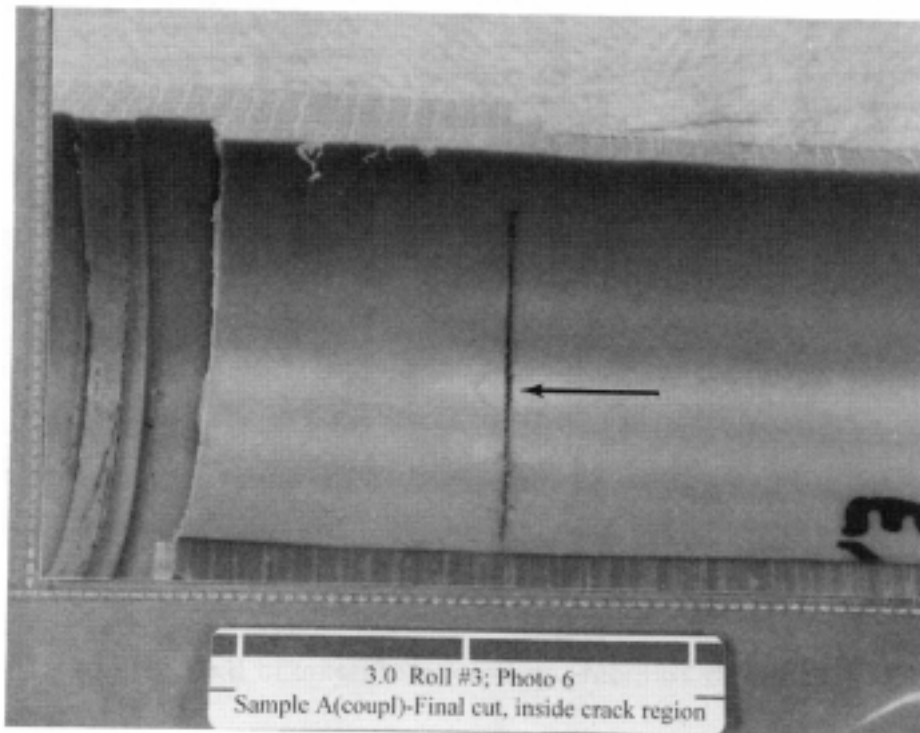
Figure 10. Crack in 1 ¼ Inch Plastic Gas Service Pipe to Chicken Kingdom.

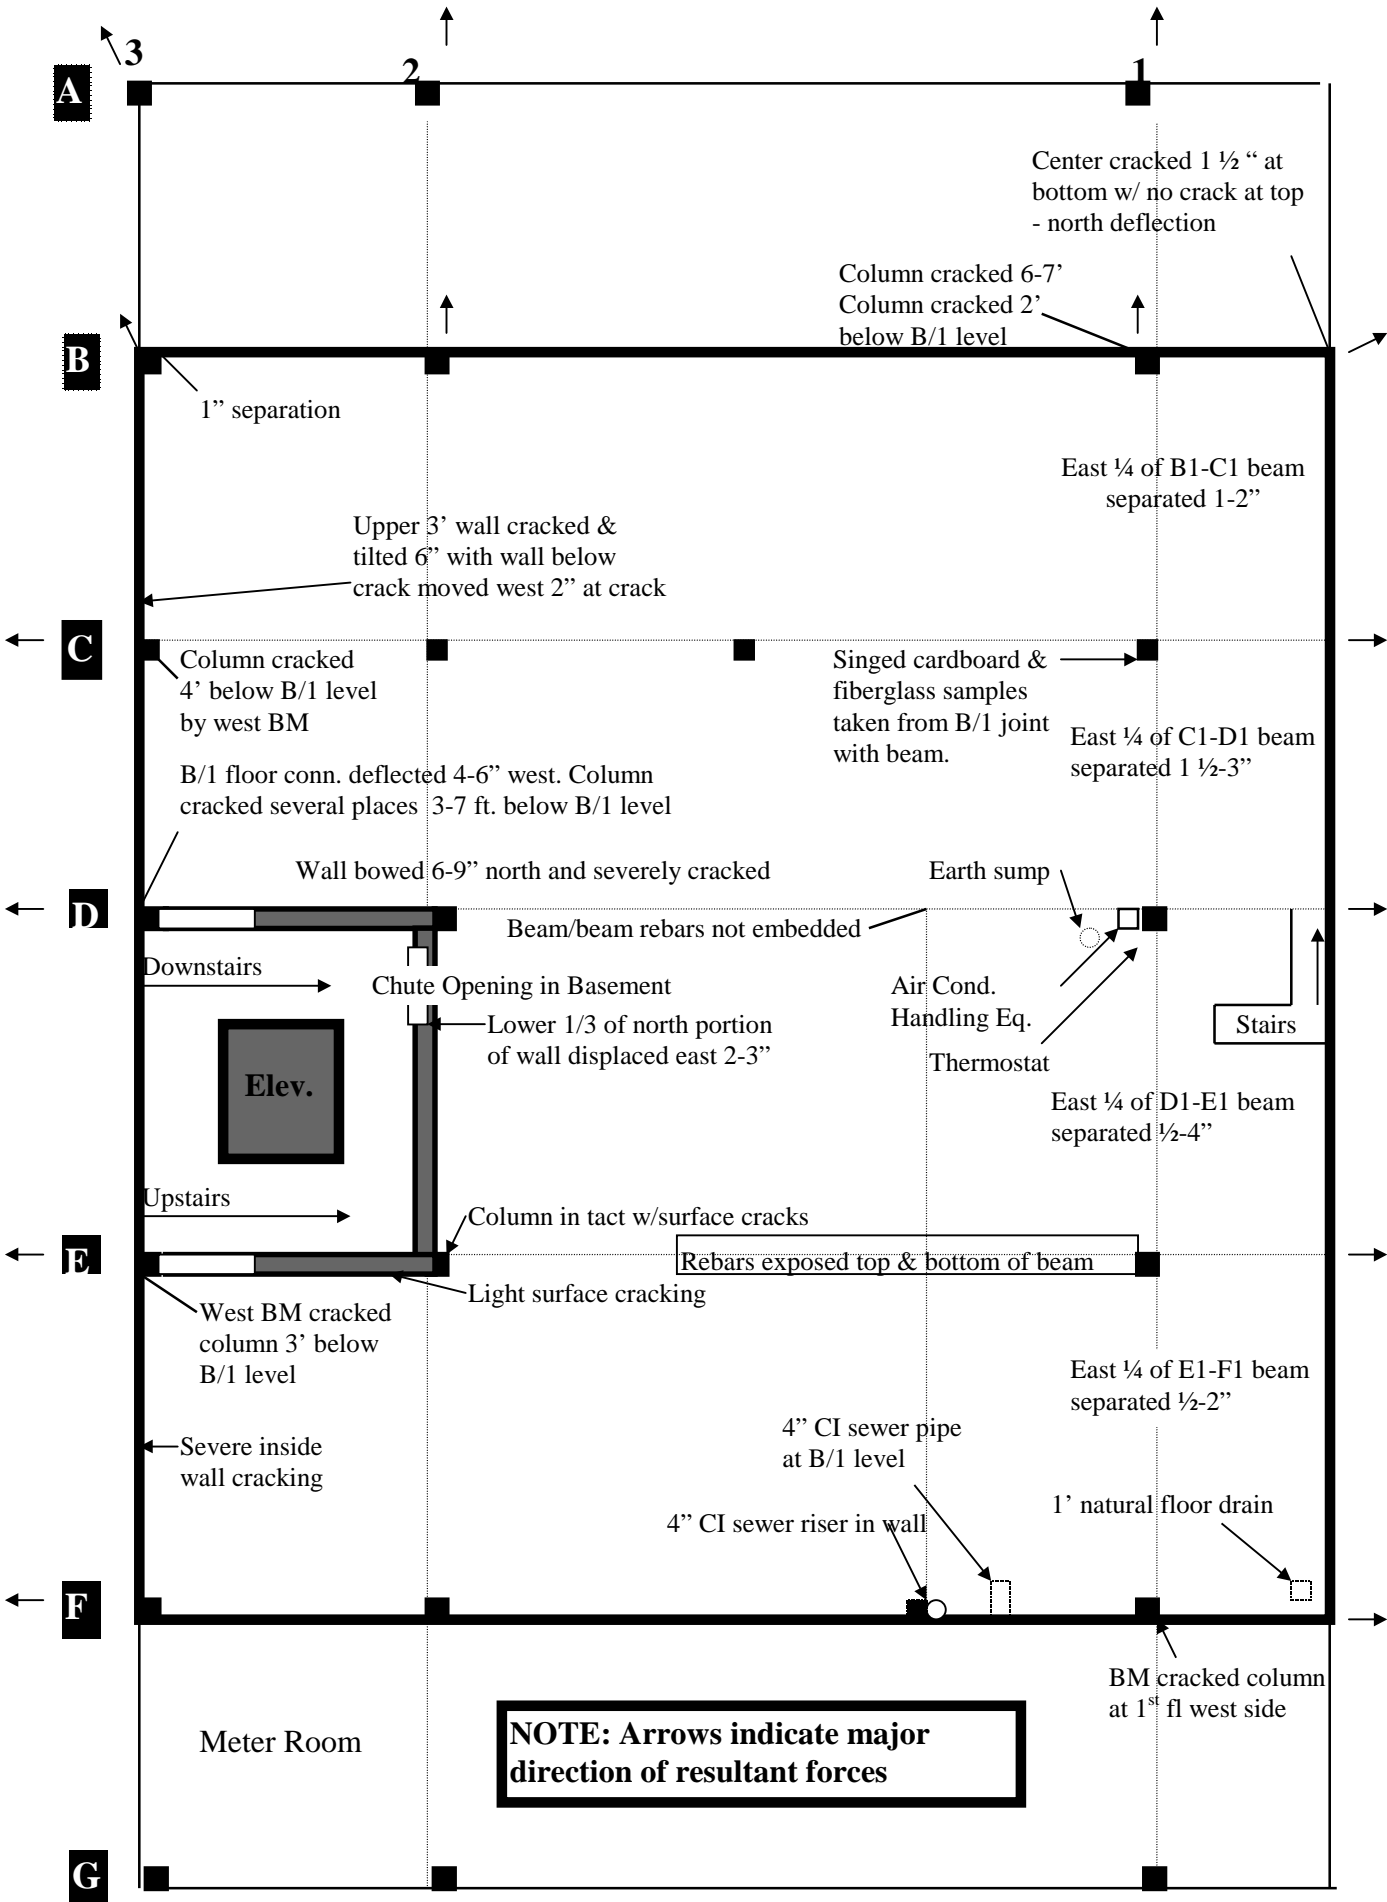
Sketch of Basement Showing Direction of Forces on Columns

| Column/ Beam | Observations |
|---|---|
| E3 | shear crack in basement due to west bending moment |
