National Transportation Safety Board

Aircraft Accident Brief

Accident Number: LAX03MA292
Operator: Sundance Helicopters, Inc.
Aircraft and Registration: Aerospatiale AS350BA, N270SH
Location: Near Grand Canyon West Airport, Arizona
Date: September 20, 2003
Adopted On: October 30, 2007

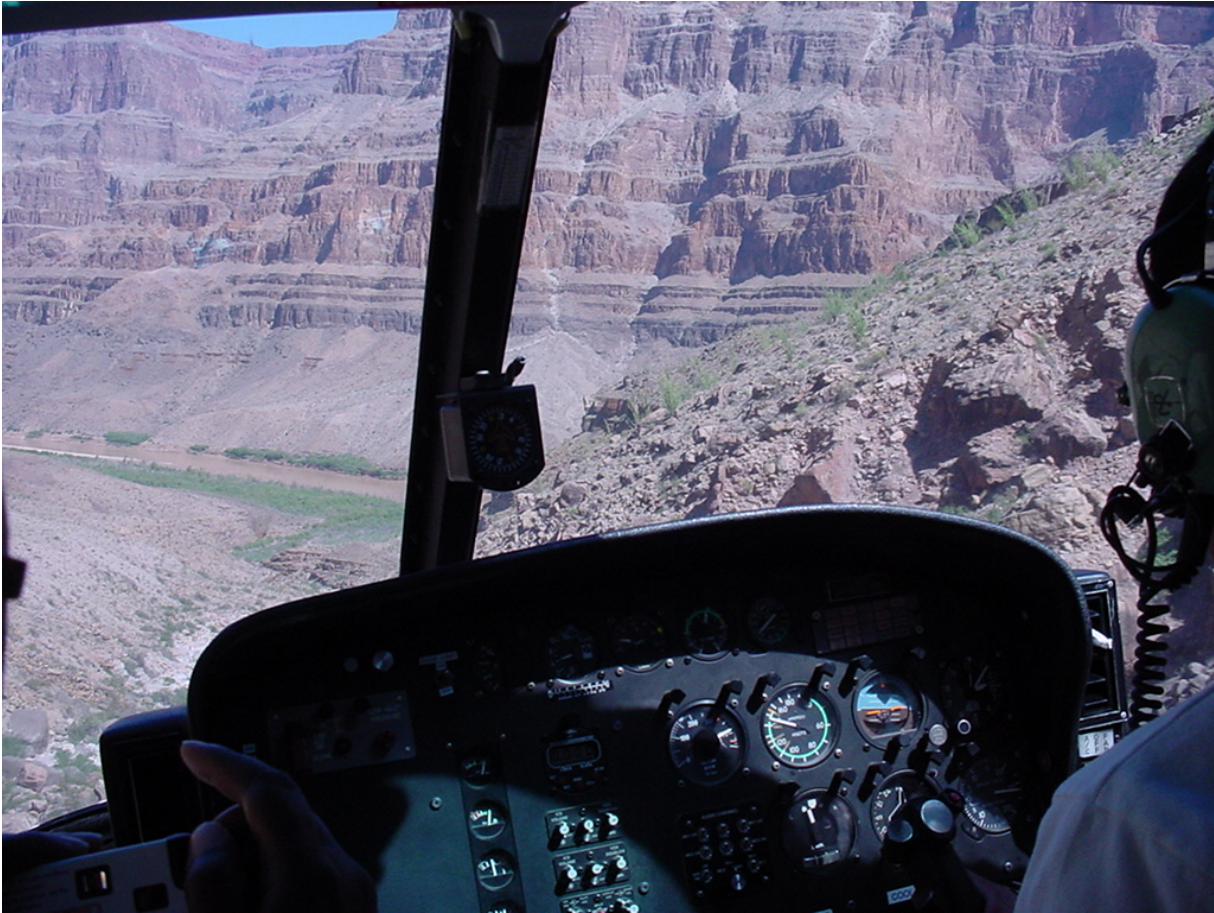
²⁰ The Sundance CEO reviewed the photograph depicted in figure 8 and estimated that the helicopter's altitude was about 100 to 150 feet agl and that its horizontal clearance from the right wall of the canyon was about 75 to 100 feet.

Figure 8. Passenger photograph showing the accident helicopter at low altitude, close to the canyon's right wall, and flying at an indicated airspeed between 145 to 150 knots.

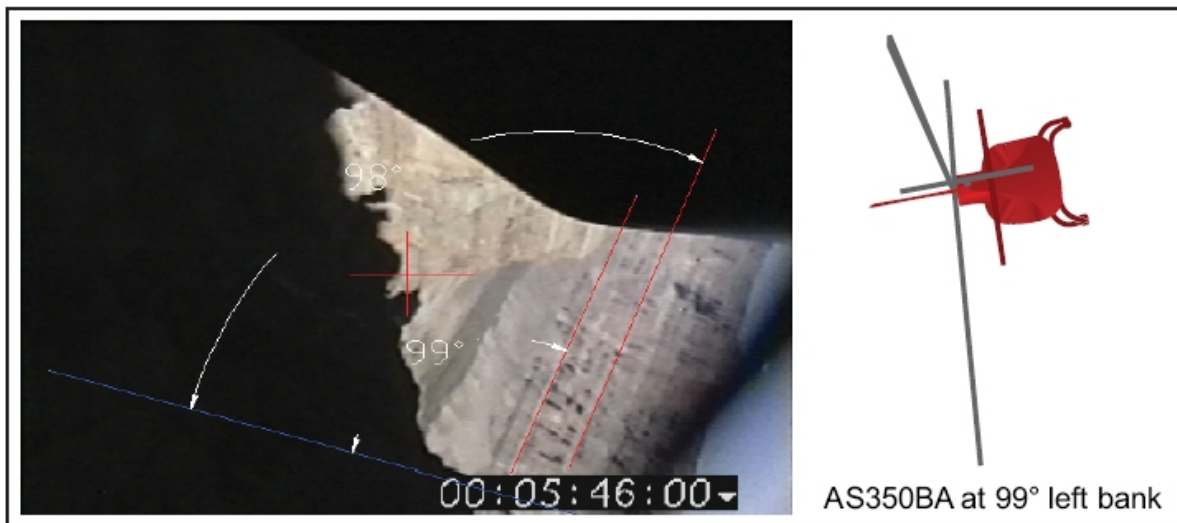
turns; one to the left and one to the right. The maximum left bank angle was about 99° , about 25 seconds into the flight, and the steepest right bank angle was about 53° during the helicopter's exit from the canyon (see figures 9 and 10).²¹

Figure 9. Passenger videotape image showing the helicopter in a 99° left bank and a tail-view graphic depicting an AS350BA at that bank angle.

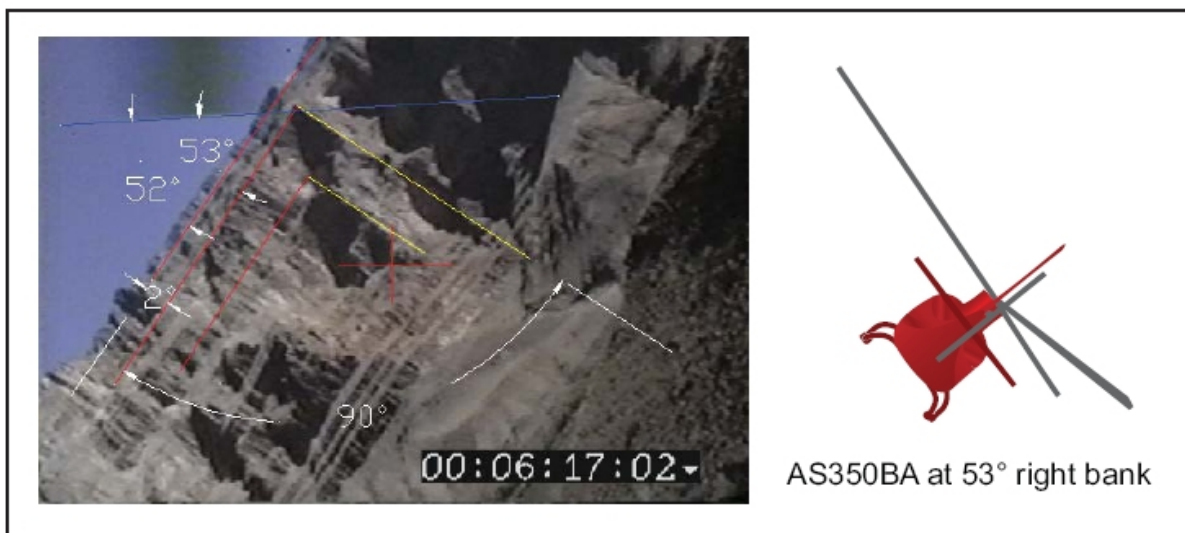
Figure 10. Passenger videotape image showing the helicopter in a 53° right bank and a tail-view graphic depicting an AS350BA at that bank angle.
