In-flight Separation of Right Wing  
Flying Boat, Inc. (doing business as  
Chalk's Ocean Airways) Flight 101  
Grumman Turbo Mallard (G-73T), N2969  
Port of Miami, Florida  
December 19, 2005

NTSB/AAR-07/04  
PB2007-910405

# **Aircraft Accident Report**

**In-flight Separation of Right Wing  
Flying Boat, Inc. (doing business as  
Chalk's Ocean Airways) Flight 101  
Grumman Turbo Mallard (G-73T), N2969  
Port of Miami, Florida  
December 19, 2005**

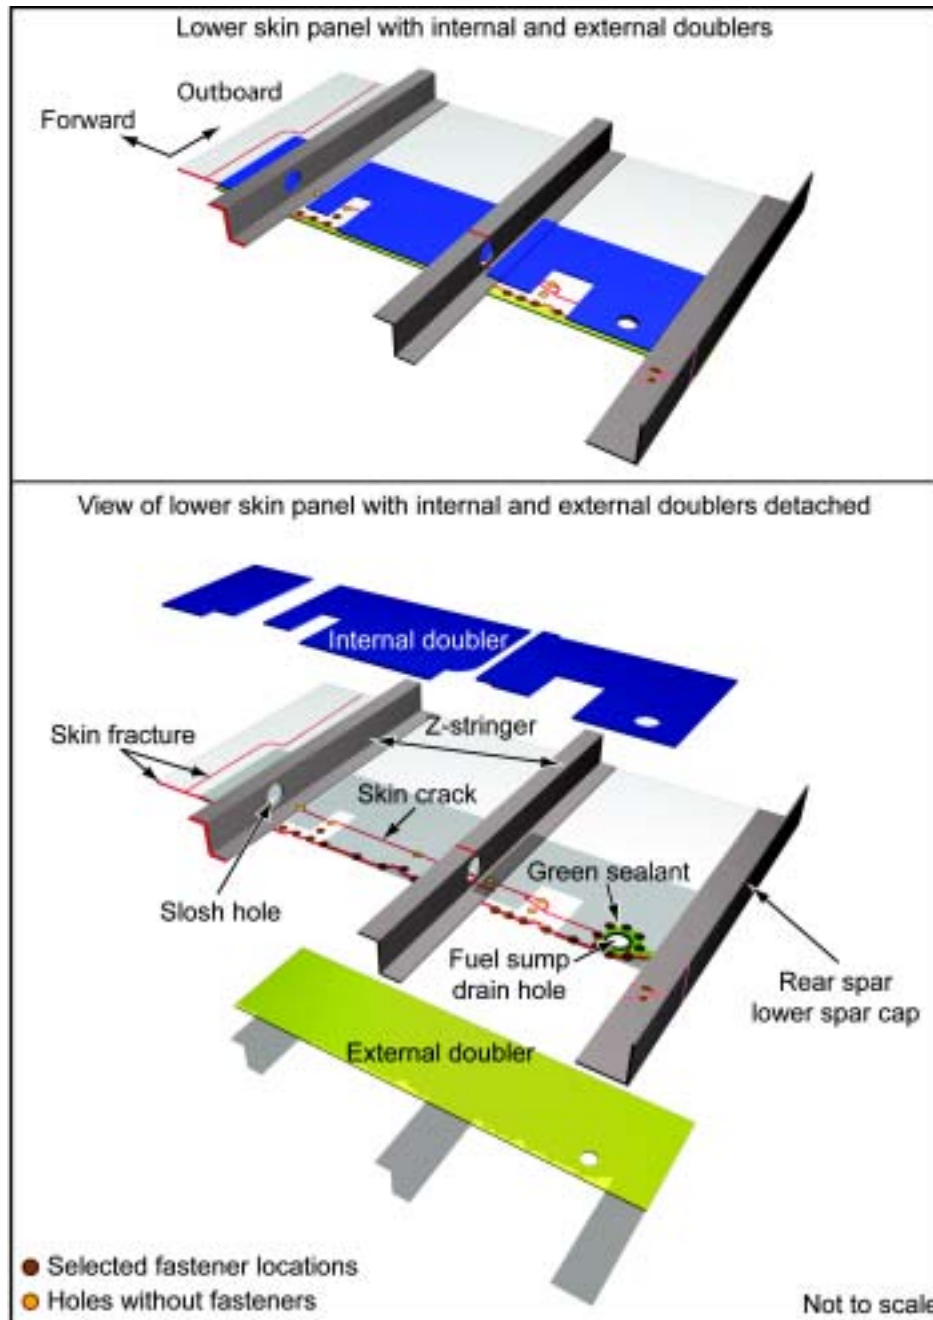
**Figure 2.** Locations of Fractures Near Right Wing Station 34

The upper part of figure 2 shows an overall view of right WS 34, including the locations of the rear spar lower spar cap, rear Z-stringer, the chordwise fracture in the lower skin, the crack (approximately parallel to and outboard of the chordwise lower skin fracture) in the lower skin, and the external and internal doublers. The lower part of

figure 2 shows a view with the doublers detached. Fatigue fracture features were found in the rear spar lower spar cap, rear Z-stringer, skin fracture (inboard), and skin crack (outboard).<sup>43</sup>

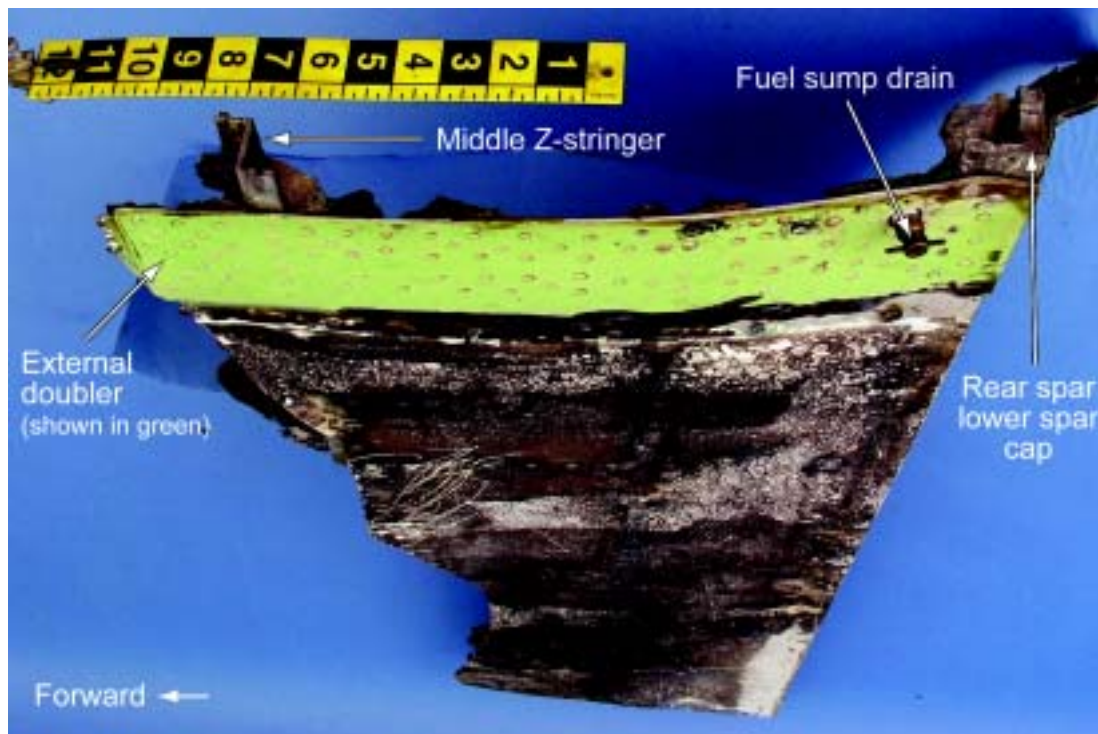
**Figure 3.** External Doubler Adjacent to Right Wing Station 34 (Before Removal)

Figure 3 shows a photograph of the external doubler that was adjacent to right WS 34 before it was removed from the lower skin for examination. The lower skin crack that was observed in the area that had been covered by this external doubler was about 16 inches long. The aft end of the crack extended from the skin trailing edge to a point near the aft side of the middle Z-stringer lower flange.

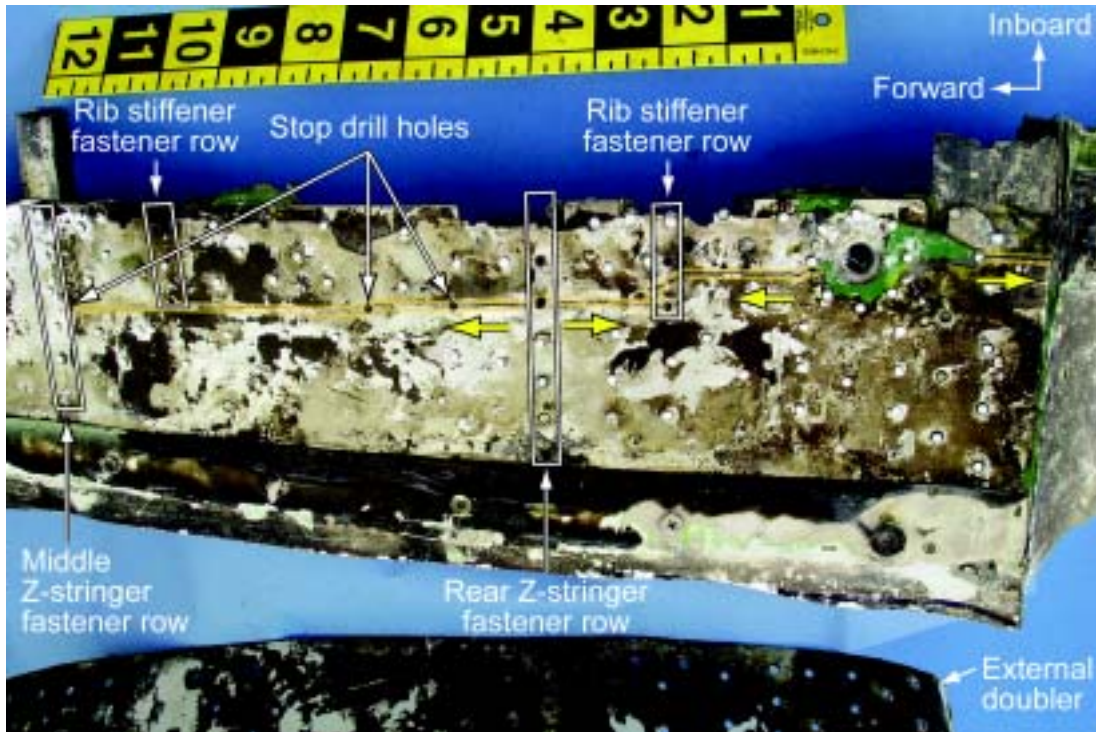
**Figure 4.** Lower Skin Crack in the Area That Was Covered by the Doublers Adjacent to Right Wing Station 34

The skin crack under the doublers at right WS 34 (see figure 4) intersected three unfilled machined holes in the skin that exhibited features consistent with stop drill holes.<sup>44</sup> These holes were located about 7, 9, and 16 inches forward of the skin trailing edge. Several fasteners at the inboard end of the doubler were inserted through hard green sealant around the fuel sump drain.

Note: The yellow arrows show the direction that each segment of the crack propagated.

The skin crack under the doublers at right WS 34 had an aft segment with fatigue features emanating from the area of corrosion around the fuel sump drain and a longer forward segment with fatigue features that initiated from a fastener hole adjacent to the rear Z-stringer fracture.

The lower skin chordwise fracture (inboard of the skin crack) at the separated area intersected the fastener holes at the inboard edge of the doublers. Regions of fatigue emanated from several of the fastener holes. Sliding contact marks consistent with repeated opening and closing of the chordwise skin fracture were observed on the surface of the external doubler between several fastener locations in the inboard fastener row for the doubler.

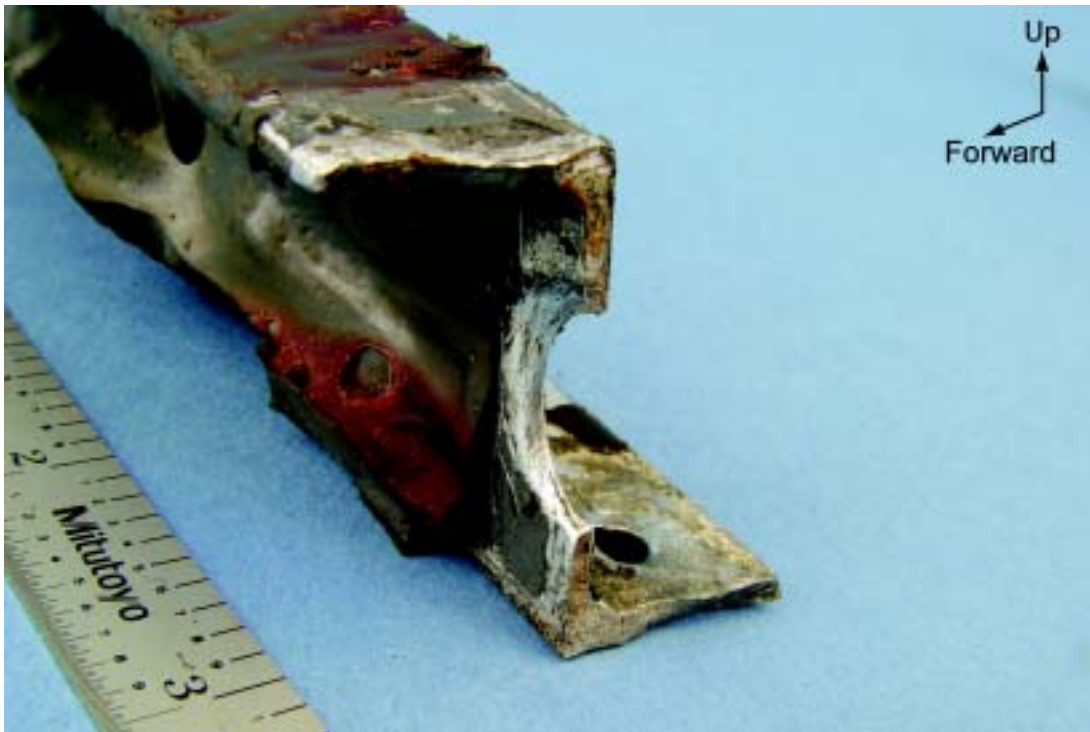
**Figure 5.** Right Wing Rear Z-Stringer Fracture

The fractographic examination at right WS 34 found that fatigue in the rear Z-stringer initiated from the slosh hole in the Z-stringer located about 1.5 inches outboard of right WS 34, as shown in figure 5. Sanding marks were observed under the sealant around the edge of the slosh hole, and sealant was observed on the fracture surface. In the sanded area, deformed material was observed curled over onto the edges of the fracture surface.

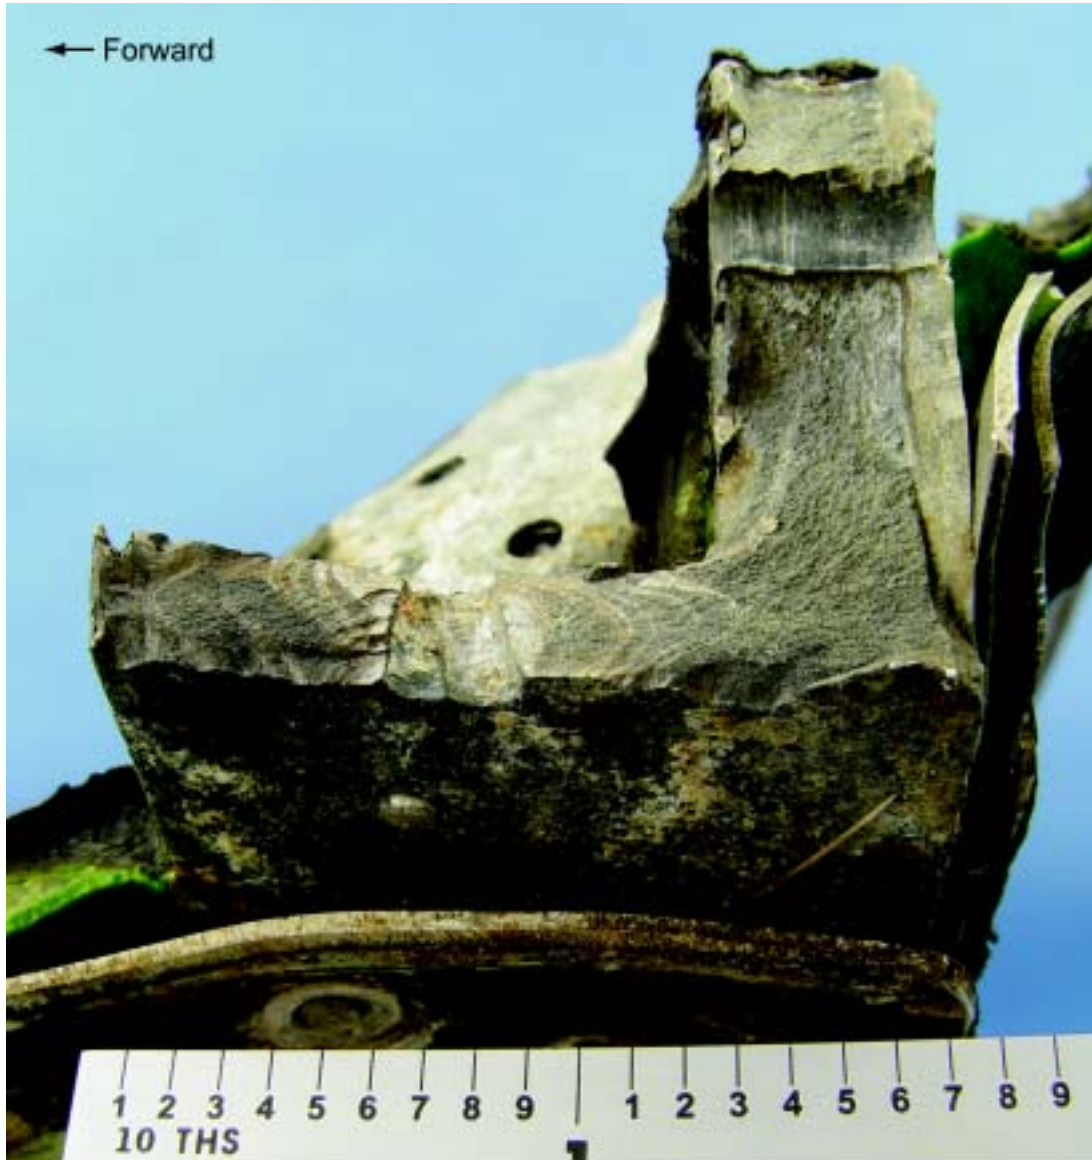
**Figure 6.** Right Wing Rear Spar Lower Spar Cap Fracture

Fatigue in the rear spar lower spar cap initiated from a double-drilled hole for a threaded fastener in the horizontal flange of the spar cap located about 1 inch inboard of right WS 34, as shown in figure 6. Multiple fatigue origins were observed along the double-drilled hole through the thickness of the horizontal flange. Relatively flat regions with large numbers of crack arrest positions, indicating slower growth fatigue cracking, emanated from the fatigue origin areas both forward and aft of the hole. The remainder of the fatigue regions had a mixture of curving flat regions (indicating areas of relatively slow crack growth) with crack arrest positions separated by rougher regions without crack arrest positions (indicating relatively fast crack growth or overstress regions). The portion

of the crack aft of the hole propagated from a length of 0.07 to 0.44 inch in about 11 increments of rapid crack growth.
