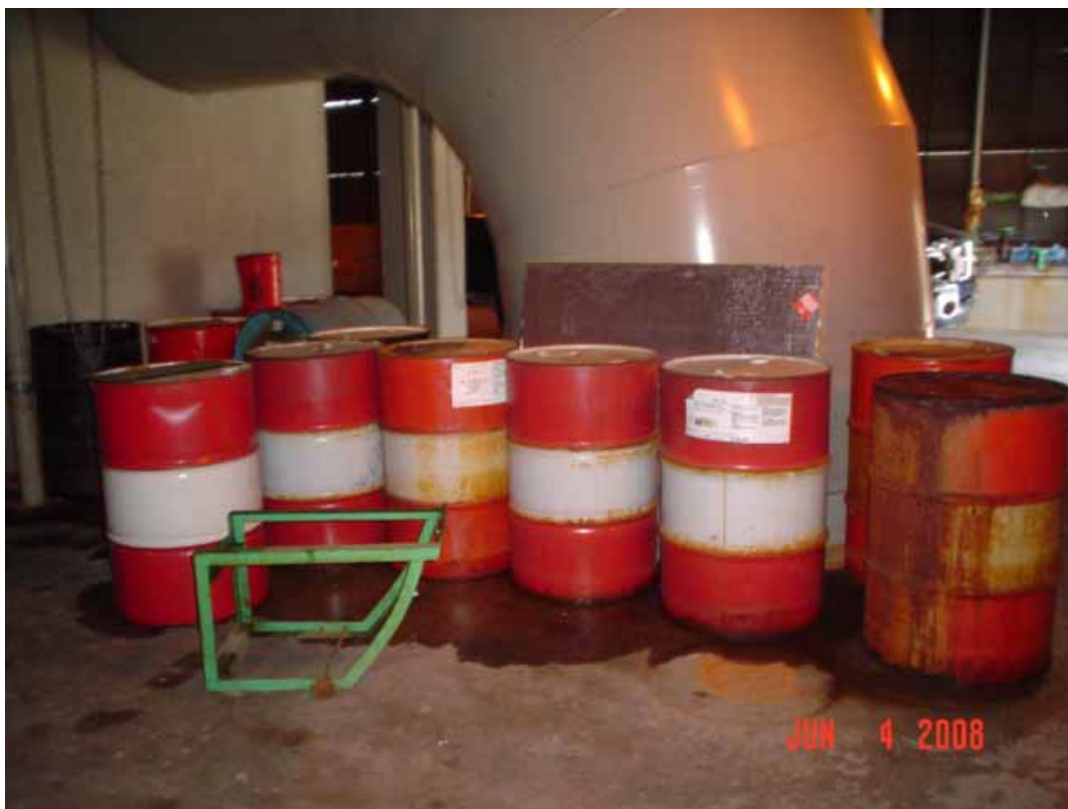
14. Leaky 55 gallon drums inside building.

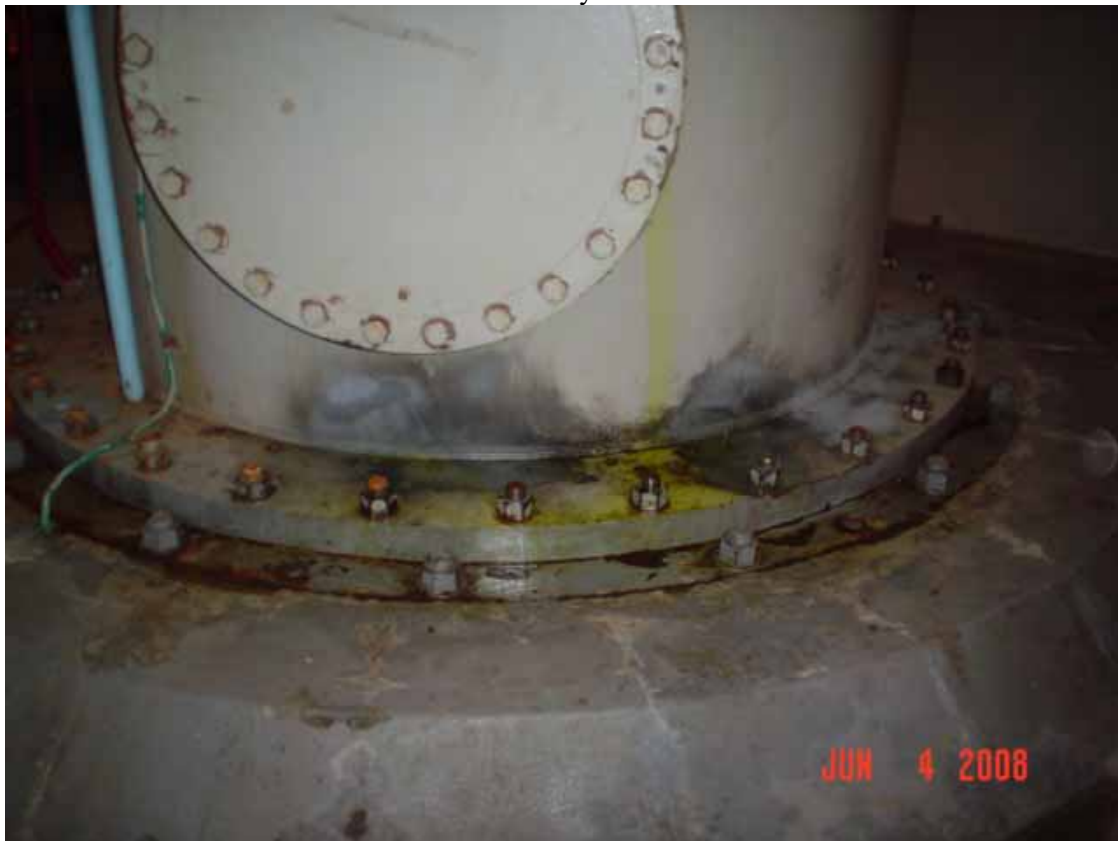
16. Antifreeze leak.

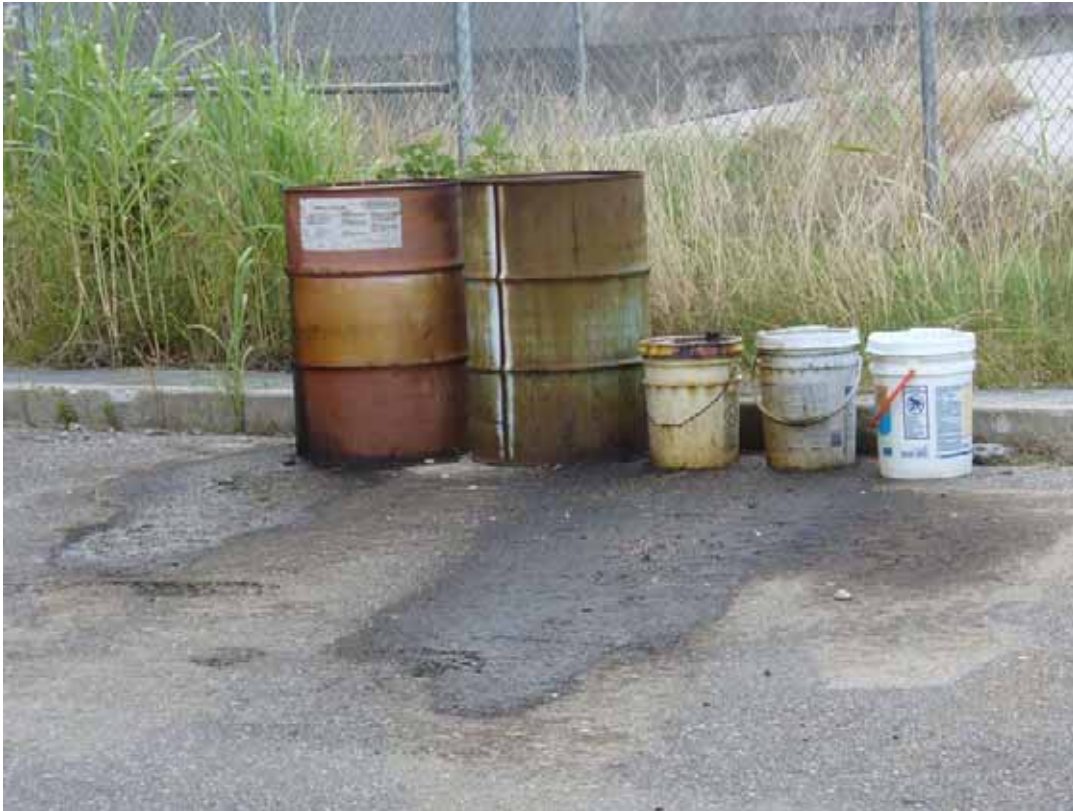
11. View of leaking 55 gallon drums and 5 gallon containers stored in northeast corner of site.

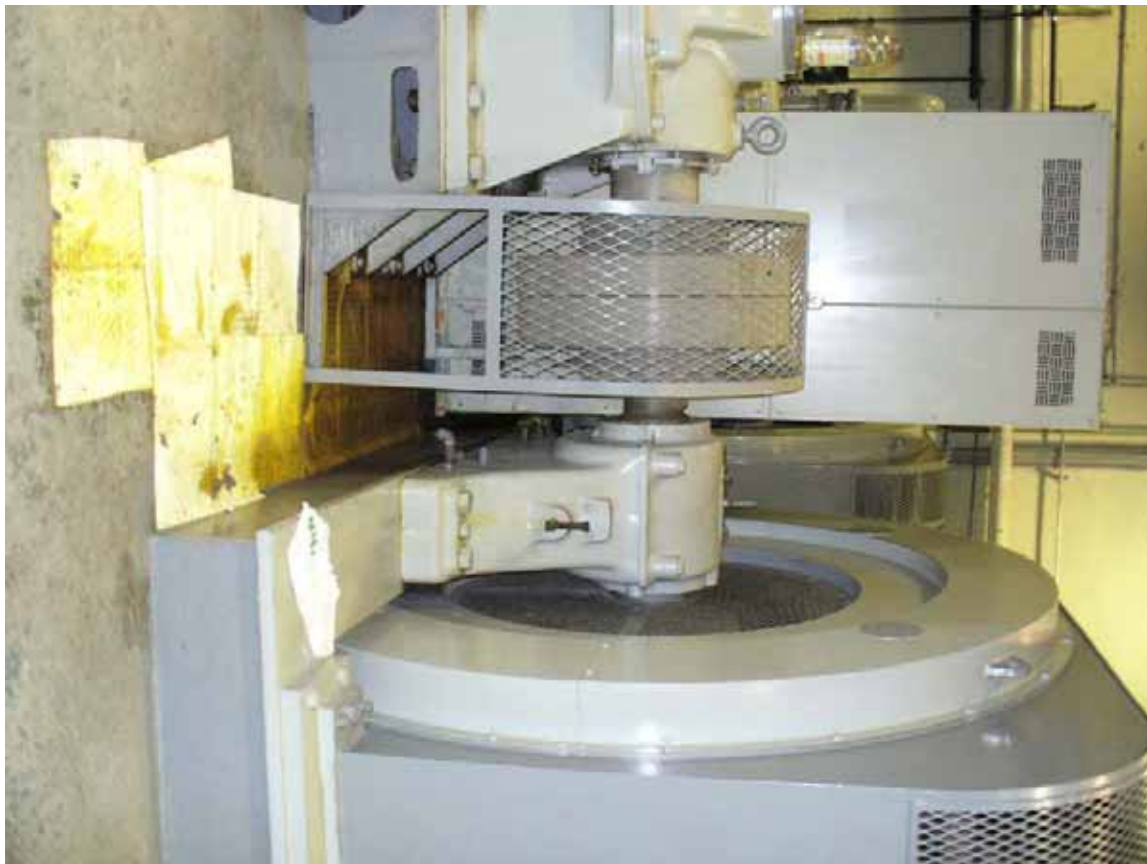
16. Oil leak from pump on floor. Observe oil pads used to soak up liquid.

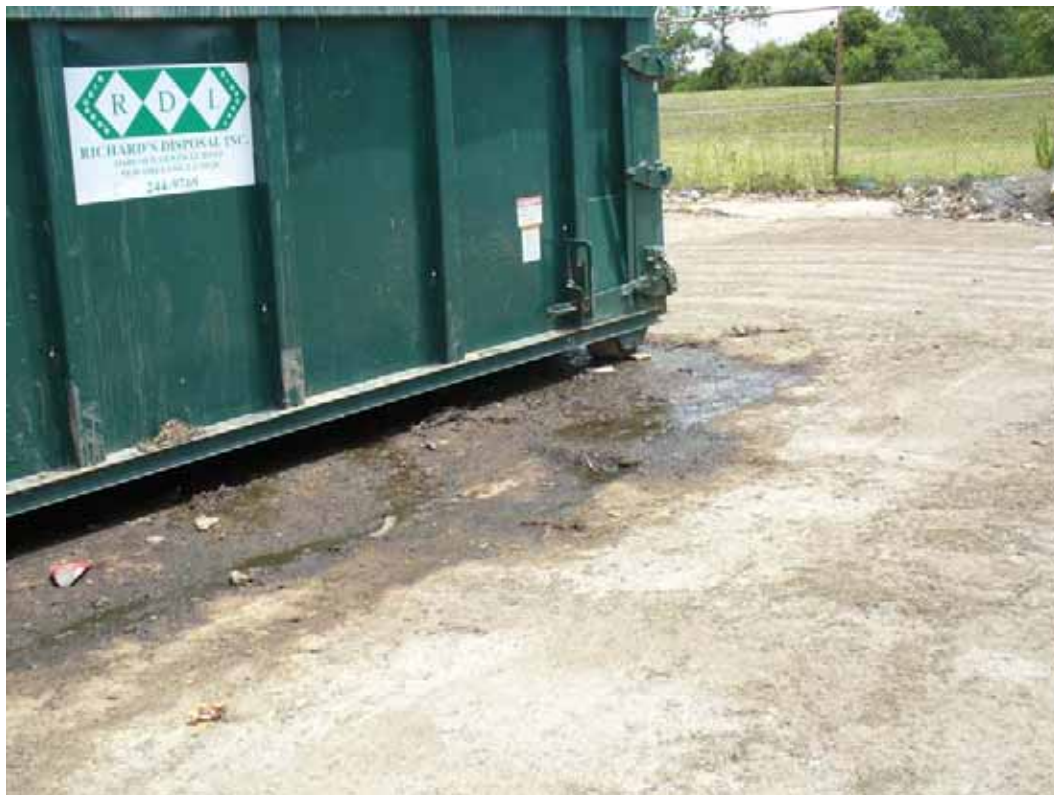
12. View of leaky dumpster observed in northwest corner of site.

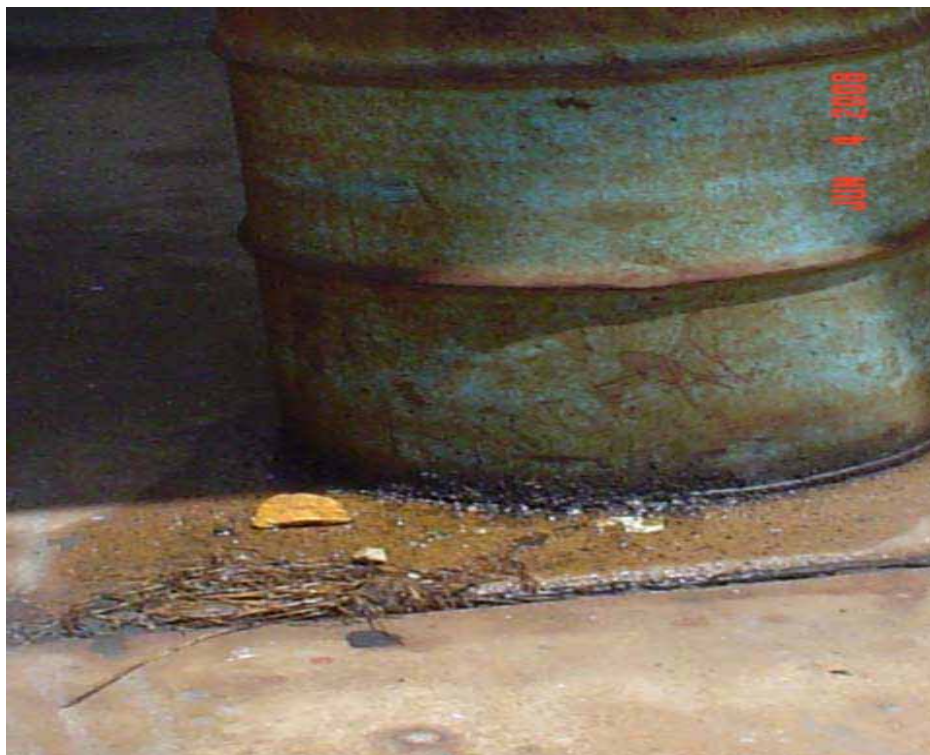
12. View of rusting, leaking 55 gallon drum located outside in southeast area.

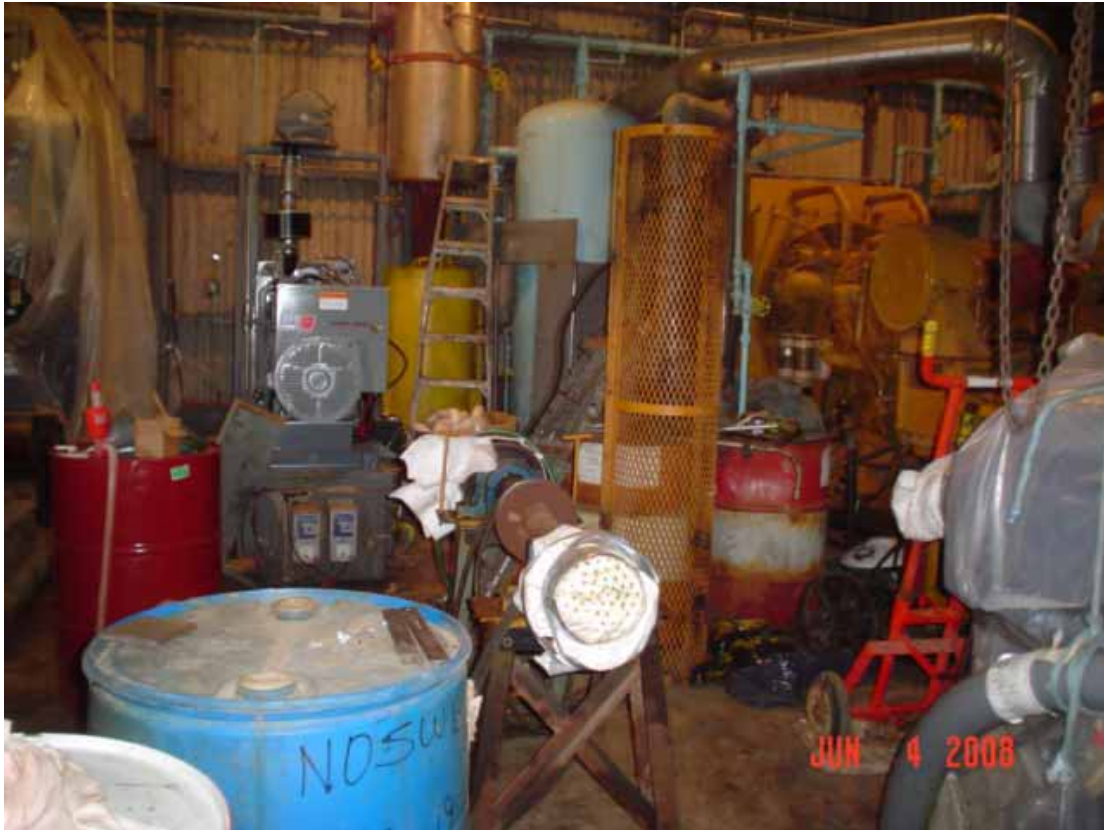
15. Various oils and lubricants inside building. Observe stains to concrete floor.

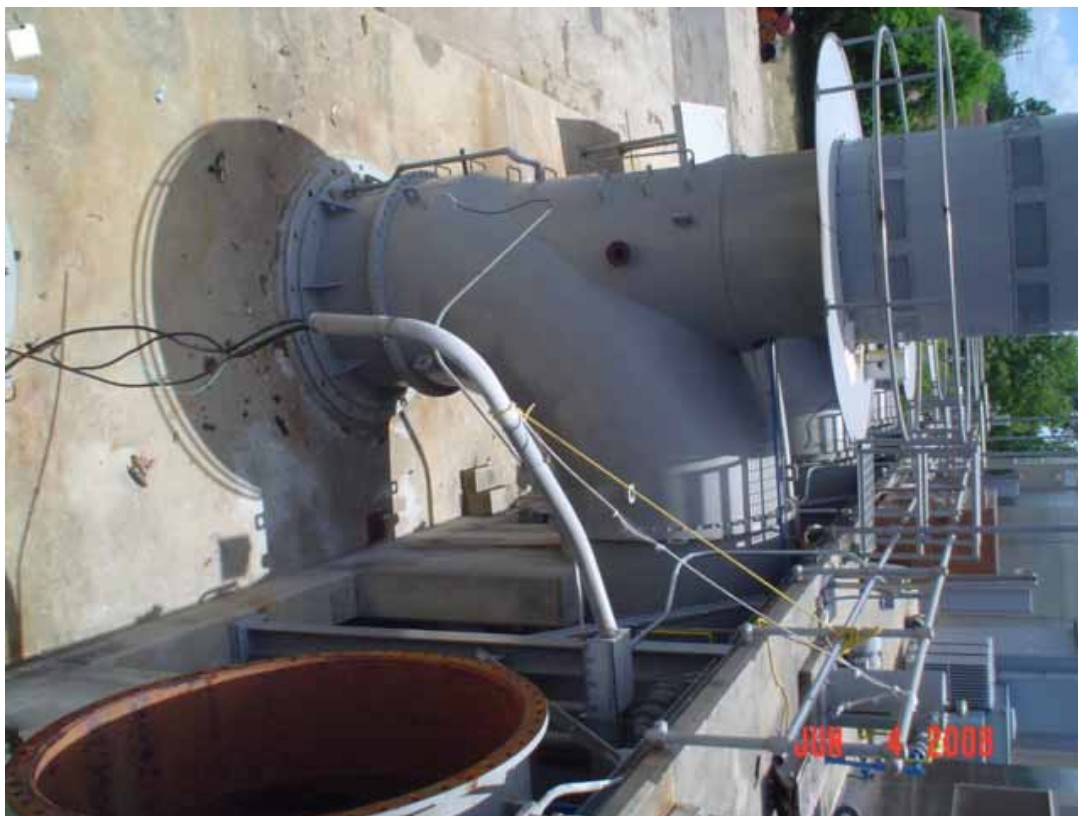
14. Loose electrical wiring from pump being repaired.

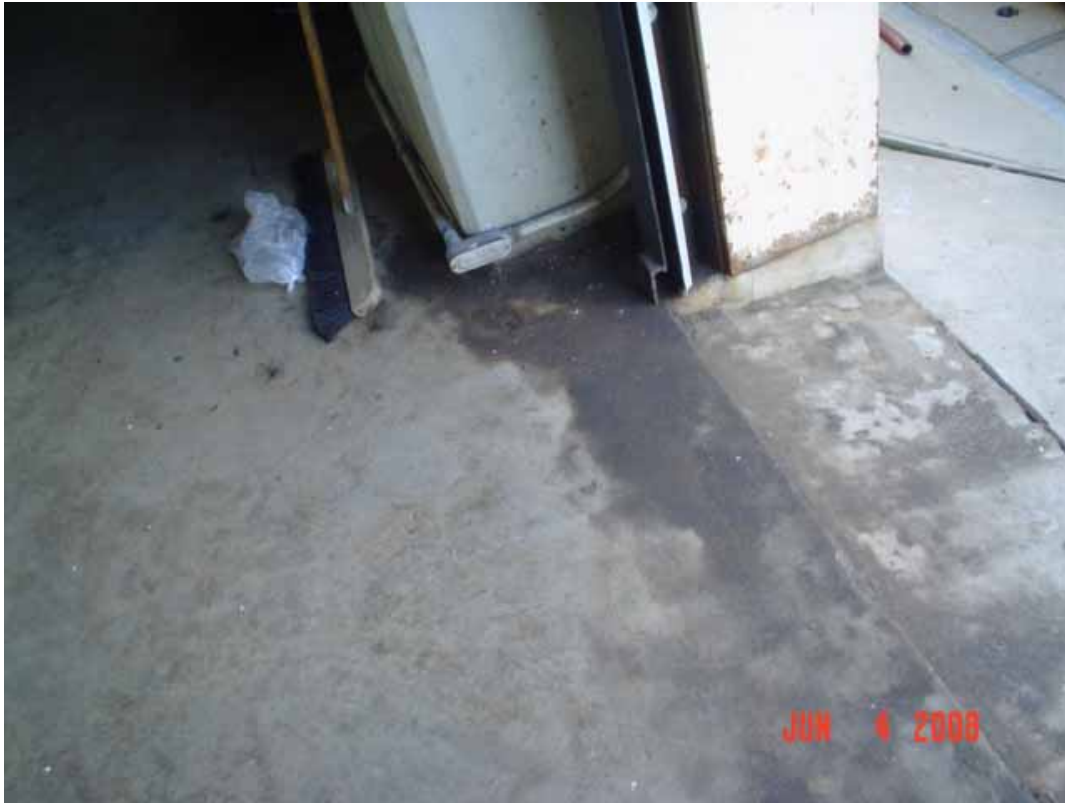
21. Oil stains by engine.

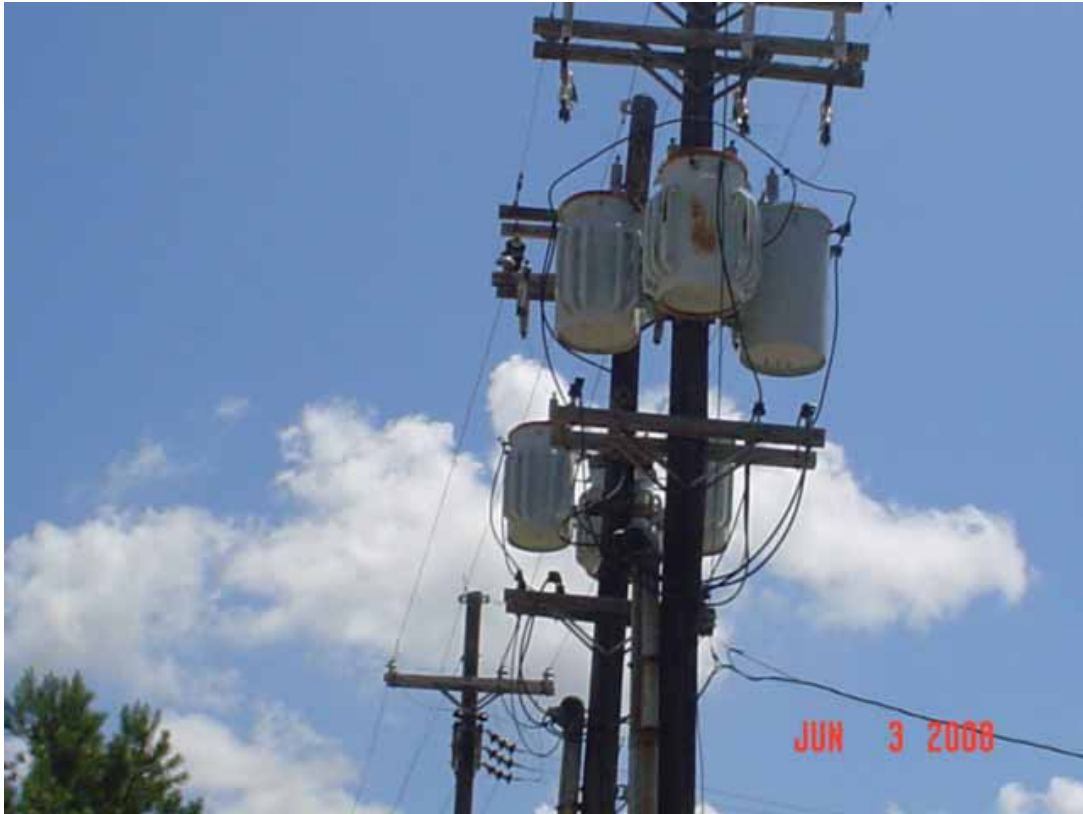
13. Six transformers located east of property. Three of the six had rust, but containment was not compromised.

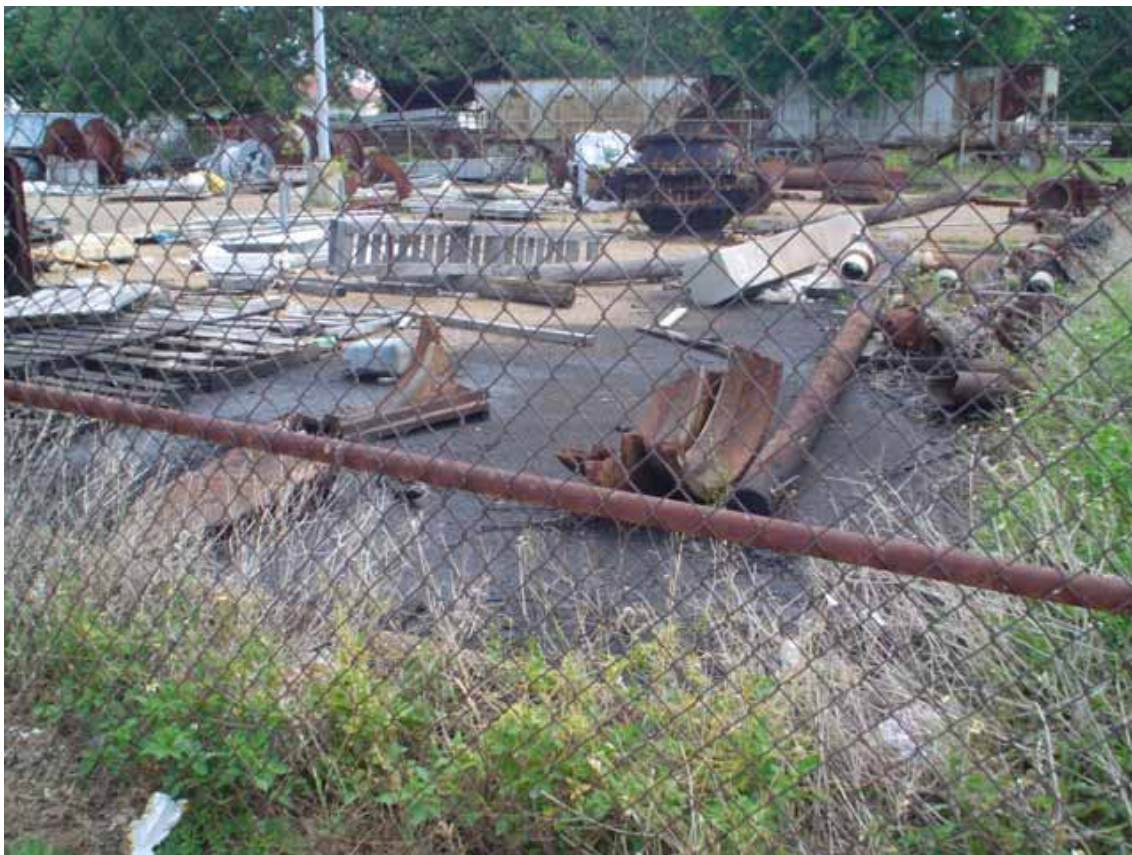
8. View of oil stained pavement and machine parts in south east corner of site at Spruce and Leonidas Streets.

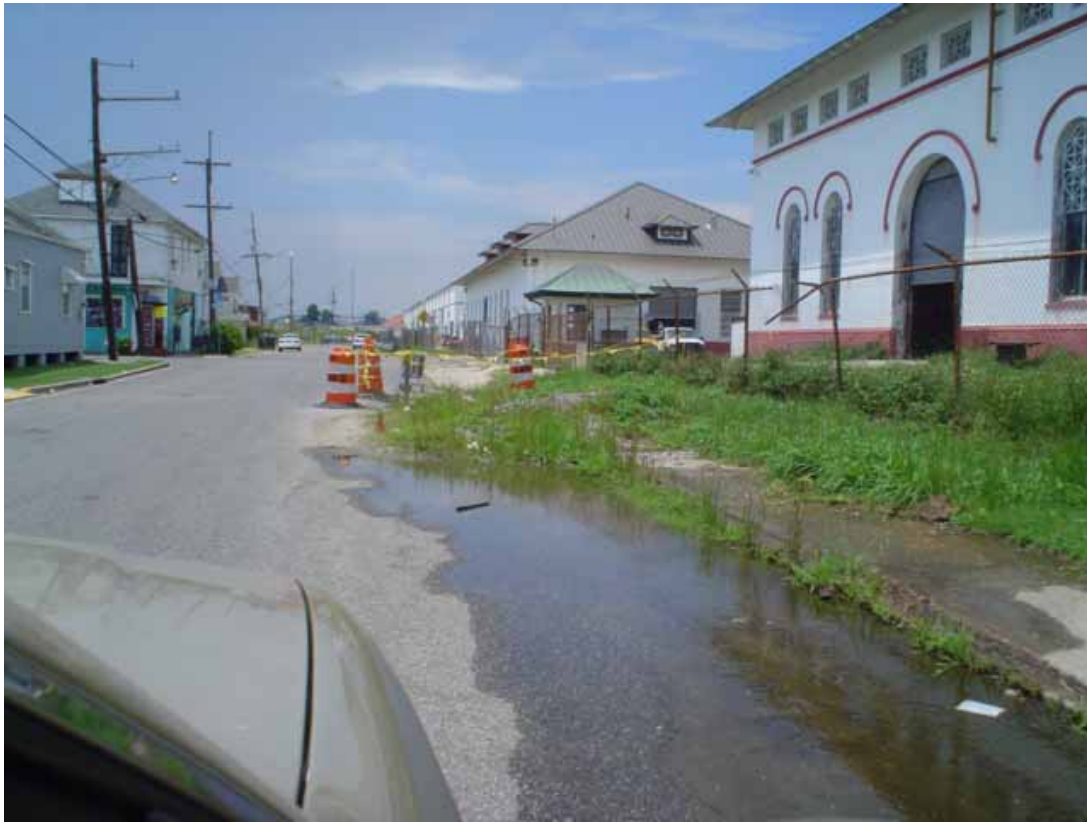
12. View of leak from low-lift building onto Spruce Street.

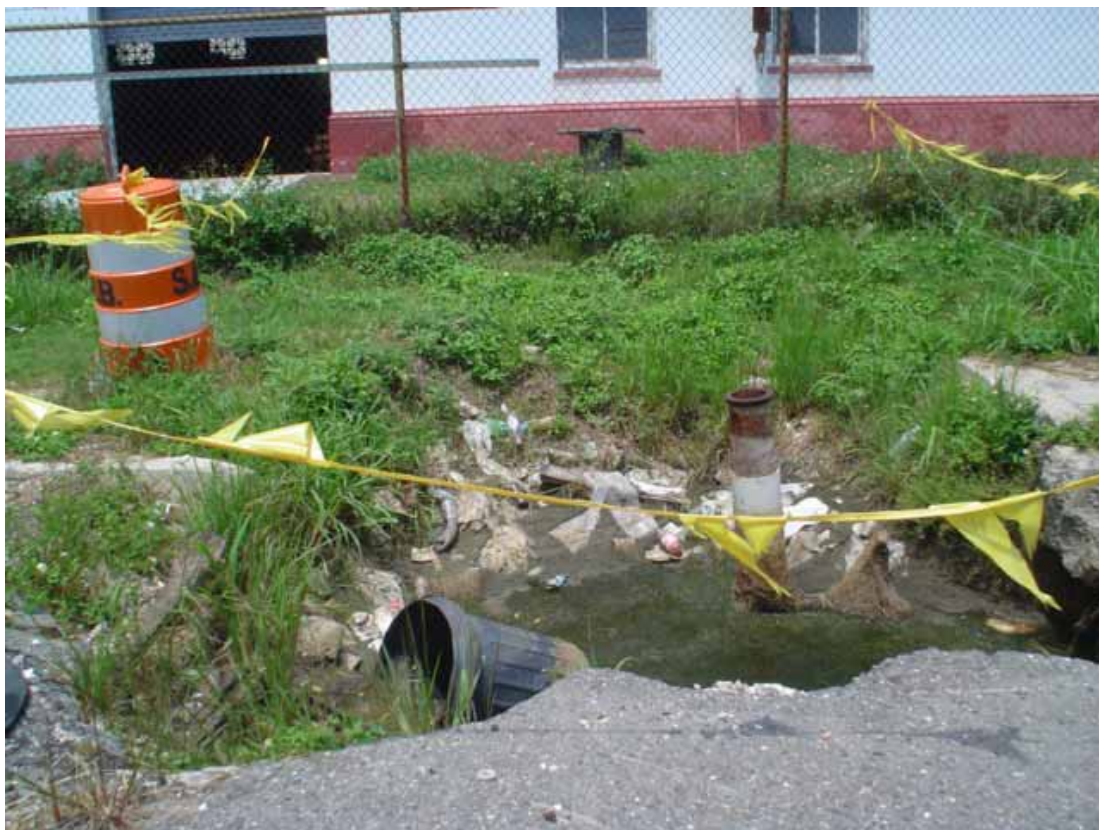
13. Close up view of damage due to leak from low-lift building.

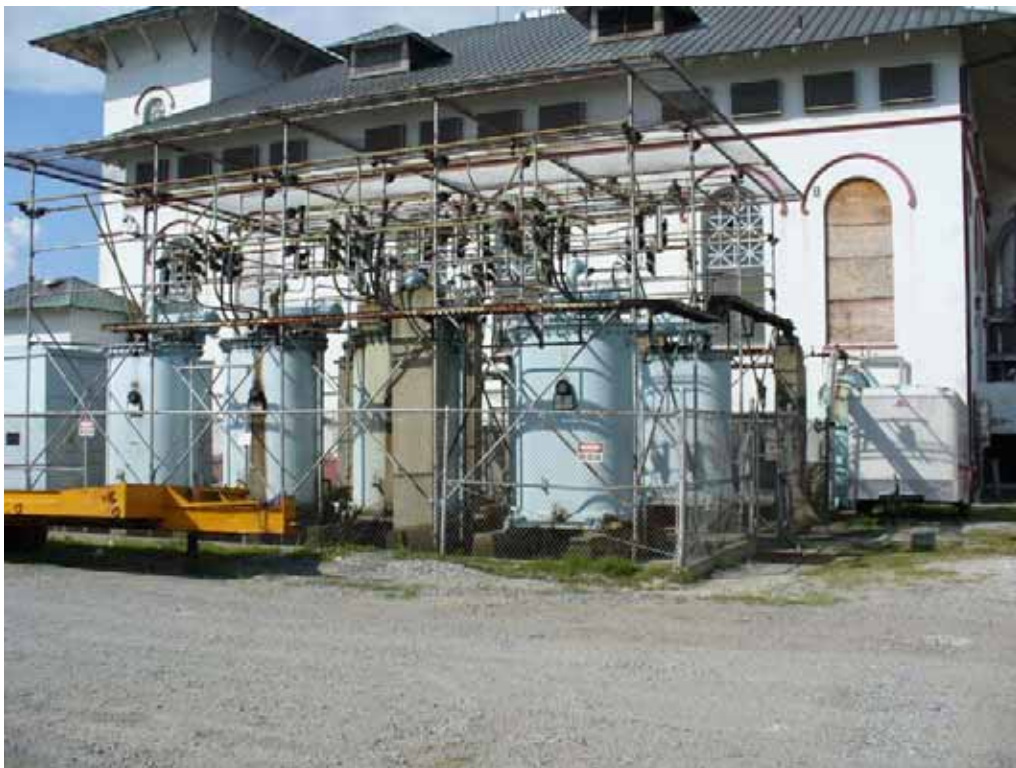
33. Observed stains on transformers located on north side of power house.

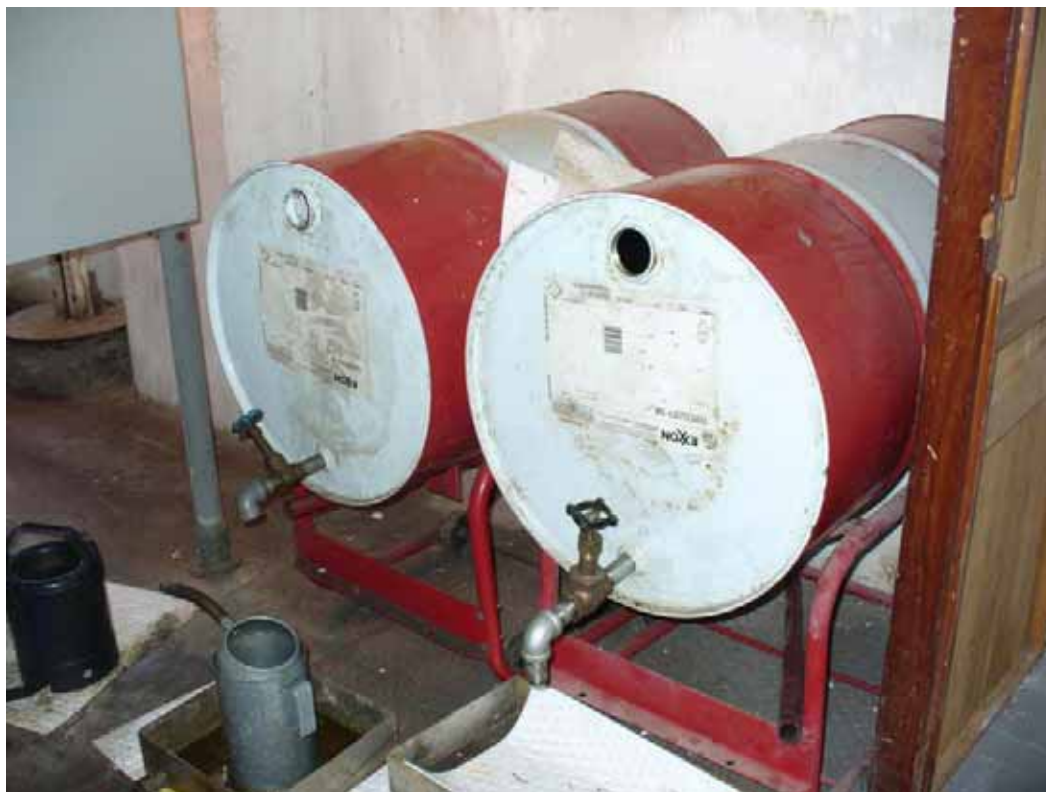
39. Oil lubricants located inside Panola Street station, observed open container.

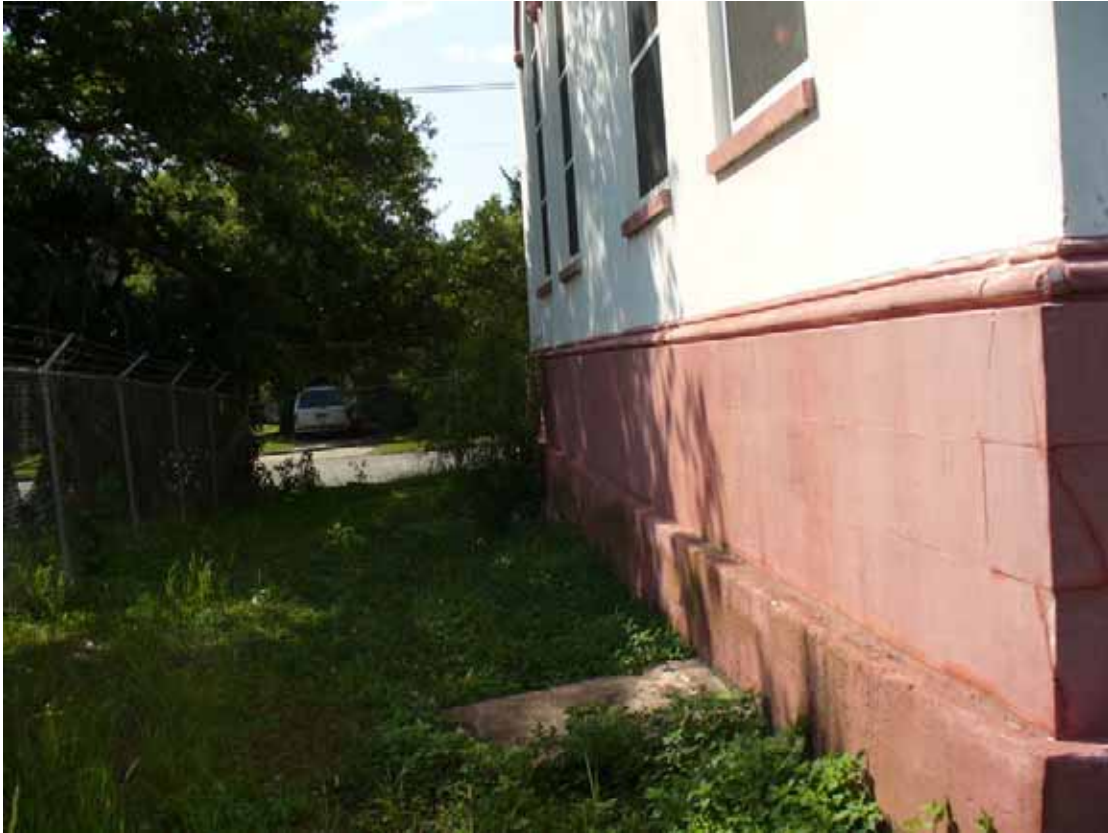
40. Observed standing water in large hole at corner of building.

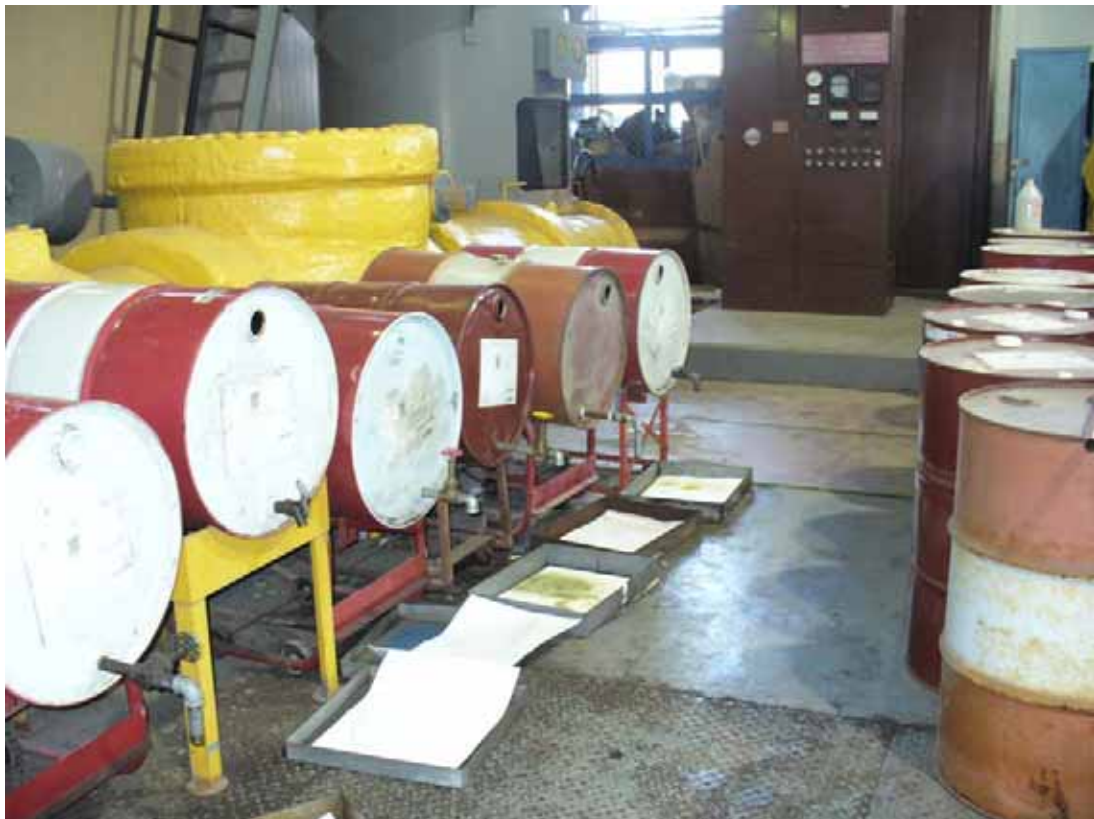
67. Drums containing petroleum products in low-lift building, observed open containers.

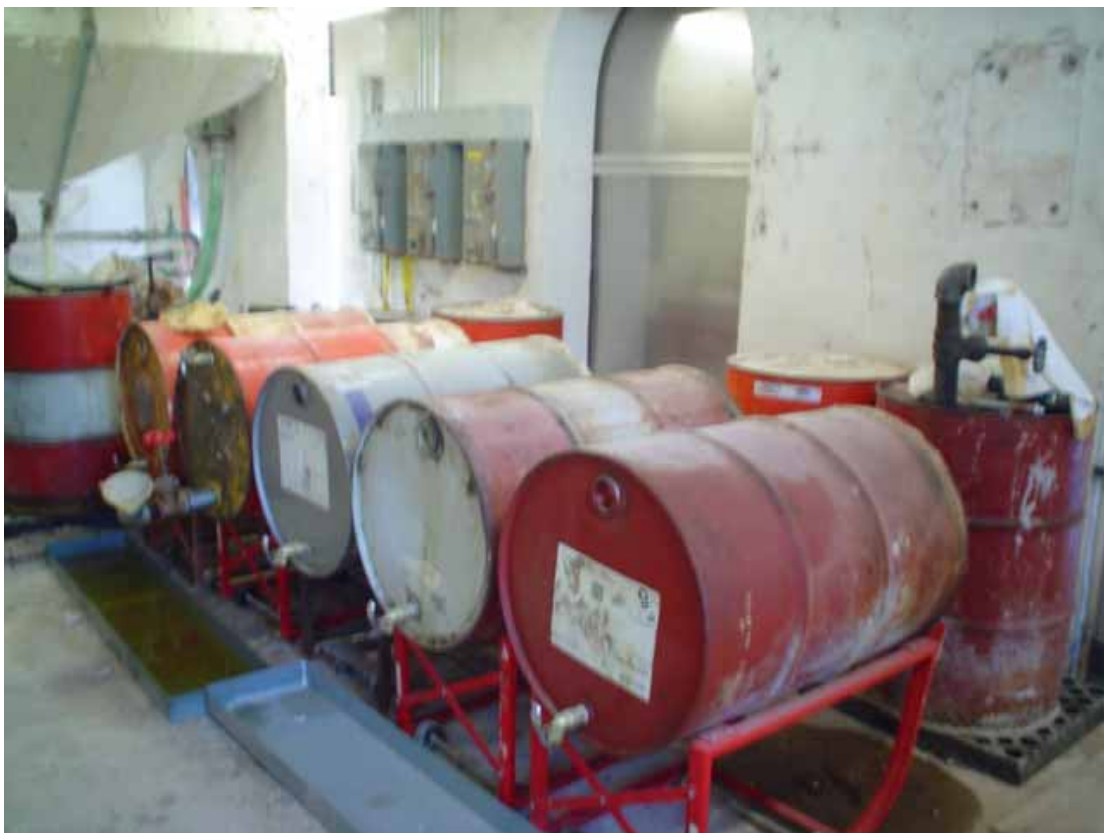
87. Oil drum storage in chemical house, observe standing liquid in spill tray, stains on concrete, open containers.

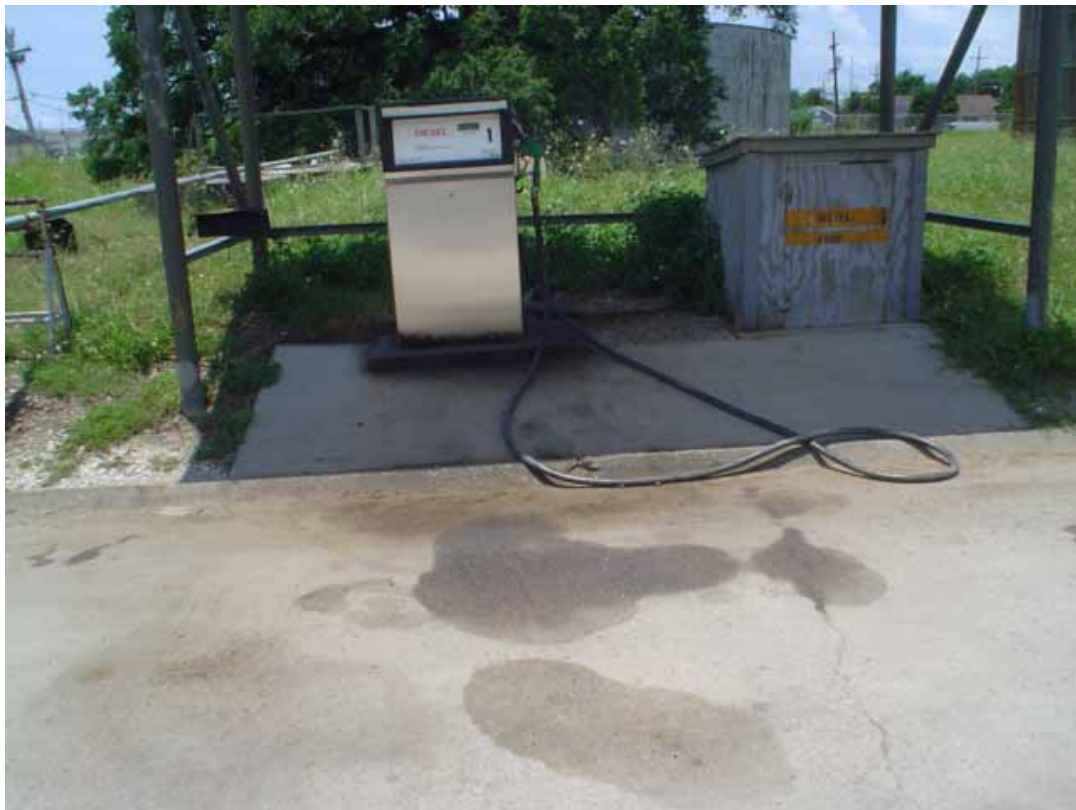
95. Diesel pump observe stains on concrete and surrounding dirt.
