Pedal Misapplication in Heavy Vehicles

Special Investigation Report

NTSB/SIR-09/02
PB2009-917003

NTSB/SIR-09/02
PB2009-917003
Notation 8141A
Adopted September 1, 2009

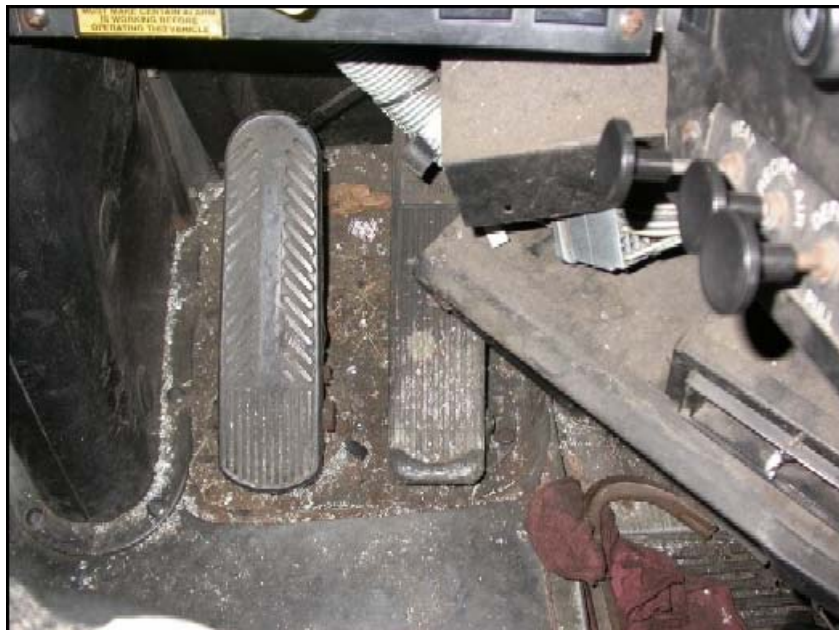
The bus driver suffered right foot injuries from accident deformation in the pedal area. Figure 3 shows this deformation in the foot well of the accident bus, just above the location of the accelerator pedal. The assertion of the Falls Township school bus driver that he was depressing the brake; the revving noise he heard; the lack of a mechanical defect on the bus; his report of feeling resistance when depressing the brake pedal; and his foot injury, apparently resulting from the foot well deformation, all provide evidence that the accelerator was being depressed. Therefore, the NTSB concludes that the circumstances of the Falls Township accident are consistent with driver pedal misapplication.

Figure 3. Accident damage in foot well of Falls Township school bus.

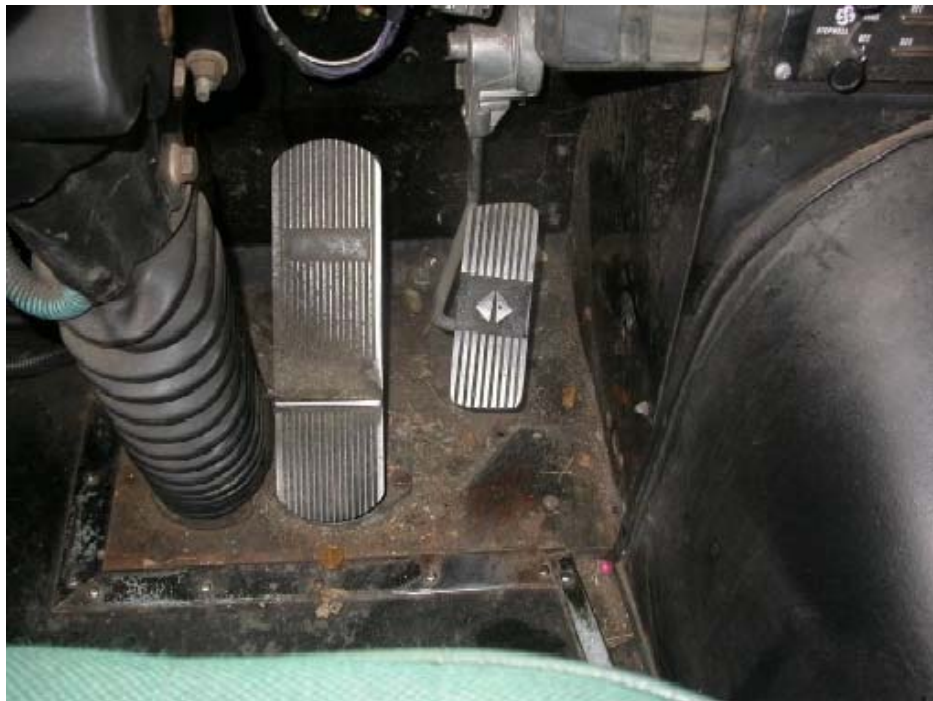
The Falls Township accident occurred while the driver was performing his typical daily route—but using a bus that was significantly different from the one to which he was normally assigned. The driver's usual bus incorporated a bulkhead-mounted accelerator pedal (see figure 4) that operated along a different arc of travel than the floor-mounted accelerator found on the accident bus. Moreover, each bus was equipped with a floor-mounted brake pedal that functioned along an arc of travel that was comparable to the accelerator on the accident bus. (See figure 5.)

Figure 4. Pedal configuration of Falls Township driver's usual bus.

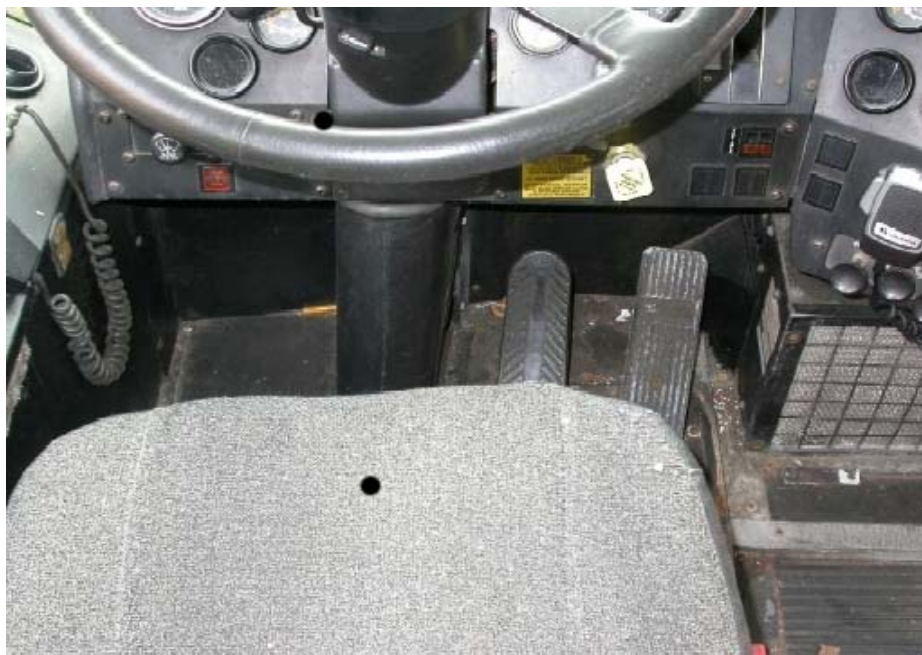
Figure 5. Pedal configuration of exemplar Falls Township accident bus.

In 1994, another driver was involved in a collision while operating the Falls Township accident bus, only weeks after it had been placed in service. An investigation by the school district, with input from Thomas Built, concluded that this earlier accident was the result of pedal misapplication. Of particular interest, both drivers of the accident bus (in 2007 and in 1994) had previously operated buses manufactured by International Corporation. Accordingly, it appears that drivers transitioning from one bus to another—especially from a bus with a different pedal configuration—may be more prone to pedal application error.

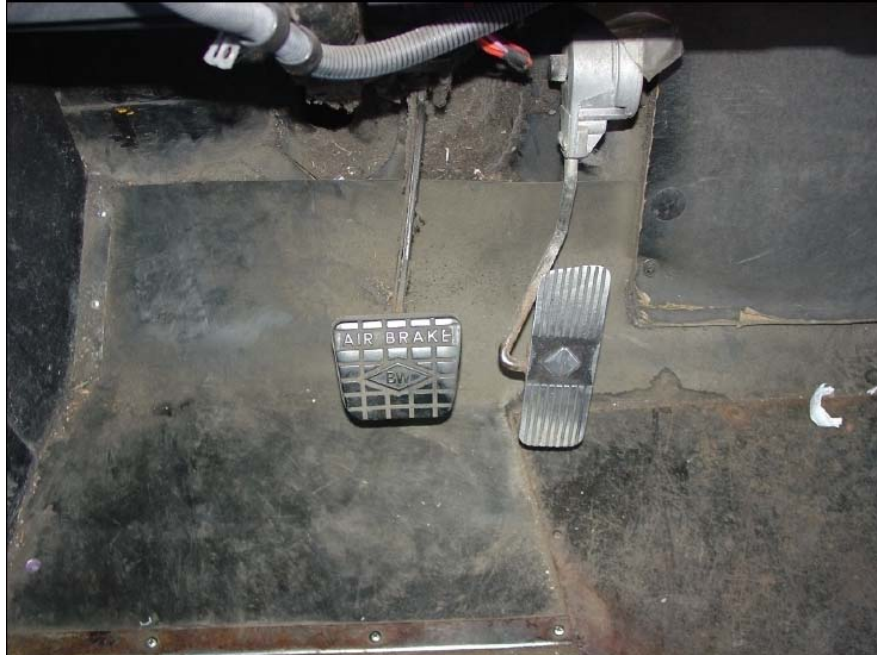
As in the Falls Township accident, the Nanuet bus driver was driving a substitute vehicle—a 1995 Bluebird bus—because her 2004 International conventional-style school bus was being repaired. The pedals on the two buses are similar; however, the accelerator on the International bus is set further back than the brake pedal relative to the driver, while the two pedals are on the same plane in the accident Bluebird bus. (See figures 6 and 7.) Further, on the Nanuet driver's usual bus, a console is located immediately to the right of the accelerator; on the accident bus, there are no objects next to the accelerator—just empty space. As in the Falls Township accident, the Nanuet driver's learned pedal response from her usual bus likely interfered with her attempted braking response on the day of the accident. In addition, though the movement of the accelerator in the Nanuet accident bus is similar to the brake movement in the driver's usual bus, it is not the same as the accelerator movement in her usual bus—thereby reinforcing her belief that her foot was on the brake pedal.

Figure 6. Pedal configuration of Nanuet accident bus (Bluebird), with accelerator and brake pedals on same plane.

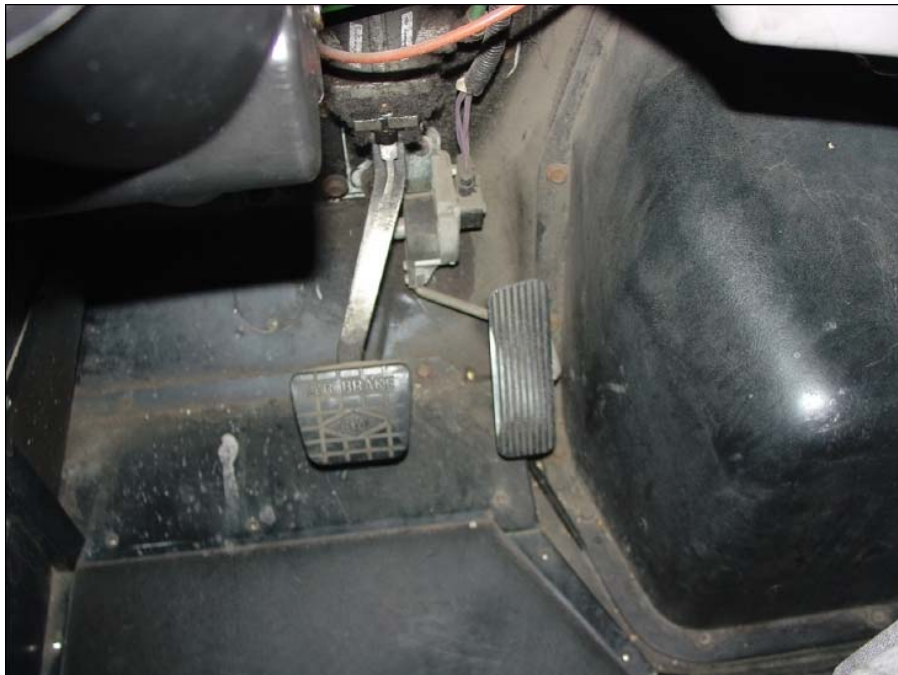
Figure 7. Pedal configuration of Nanuet driver's usual bus, showing accelerator set farther back than brake pedal and accelerator mounting below accelerator pedal.

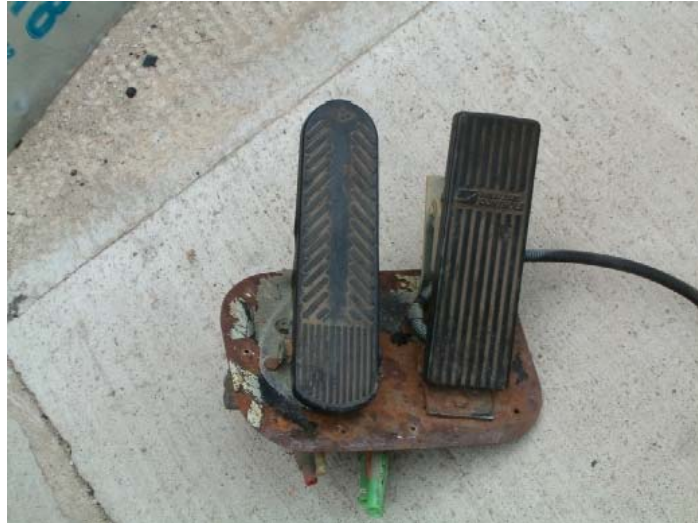
Although the Liberty accident vehicle was the driver's usual bus, the accelerator pedal and the brake pedal were nearly identical. Figure 8 shows the pedal layout for the Liberty accident bus. In addition to having similar size, the two pedals had the same arc of travel and were both mounted to the vehicle at the bottom of the pedal.

Figure 8. Pedal configuration of Liberty accident bus.
