NTSB National Transportation Safety Board

An insiders look at aircraft accident investigation

Robert L. Sumwalt

**The anatomy of an
accident:
Colgan Air flight 3407**

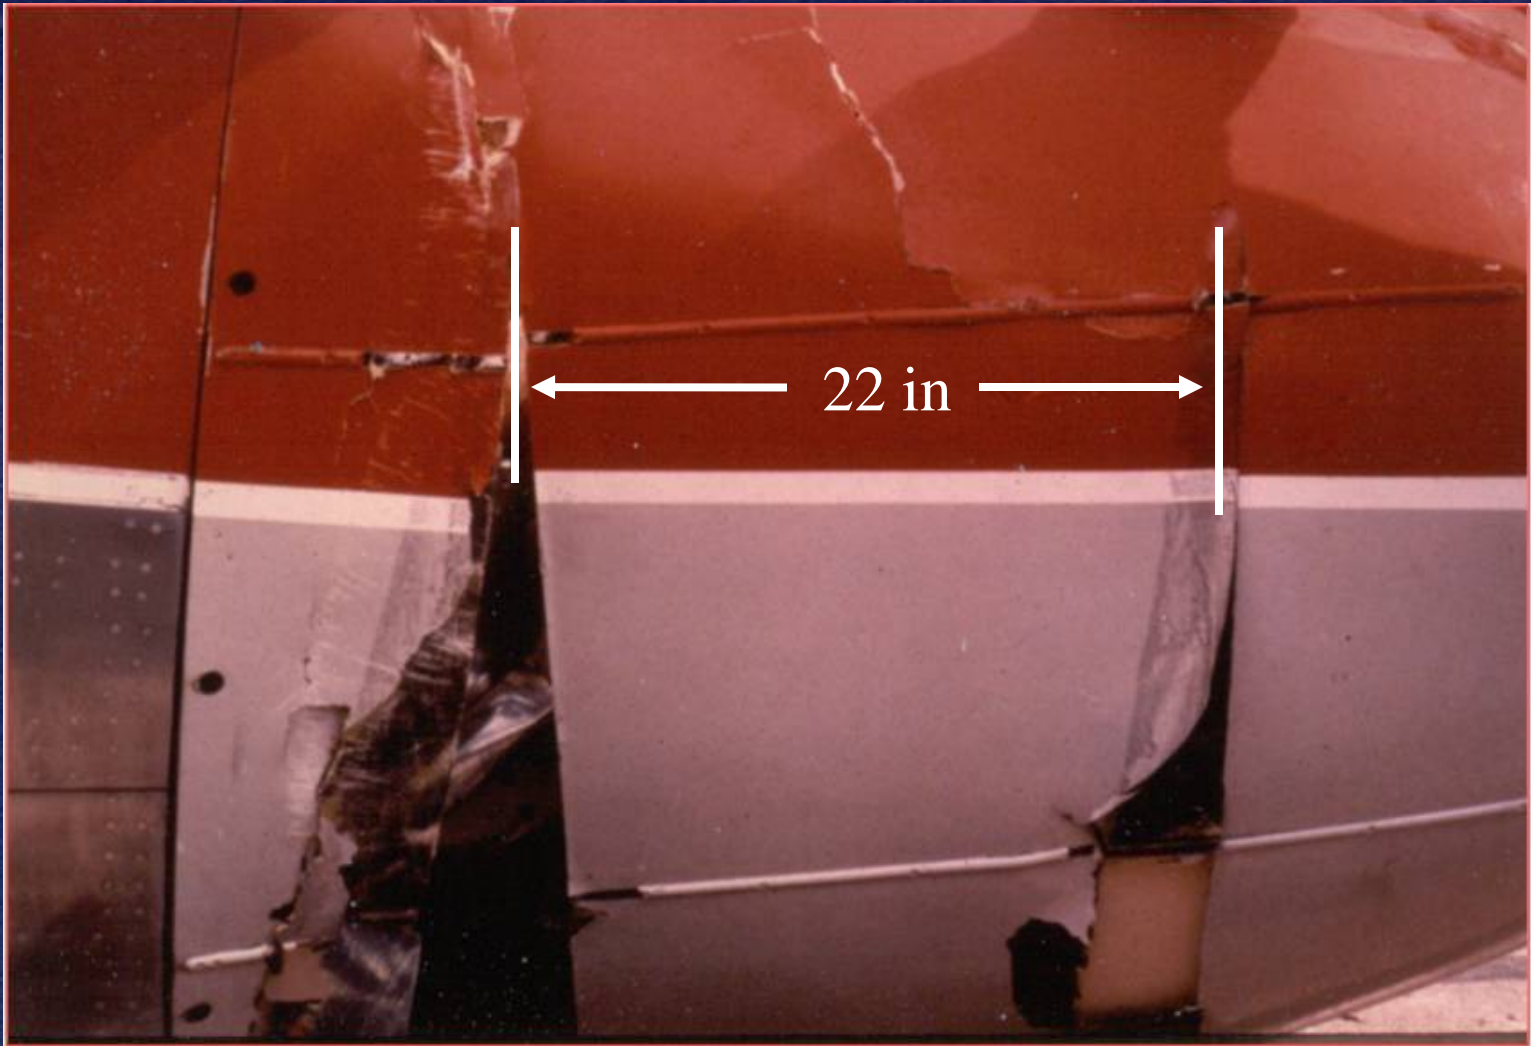
SPEED = DISTANCE / TIME

DISTANCE = 22 in / 12 = 1.833ft

PROP SPEED = 1543rpm / 60 = 25.7rps

BLADES/SEC = # OF BLADES X PROPSPEED

= 4 BLADES X 25.7 rps = 102.9 bps

TIME = 1 / bps = 1 / 102.9 bps = .00972 sec/blade

SPEED = DISTANCE / TIME = 1.833ft / .00972sec

SPEED = 189 fps = 112 knots

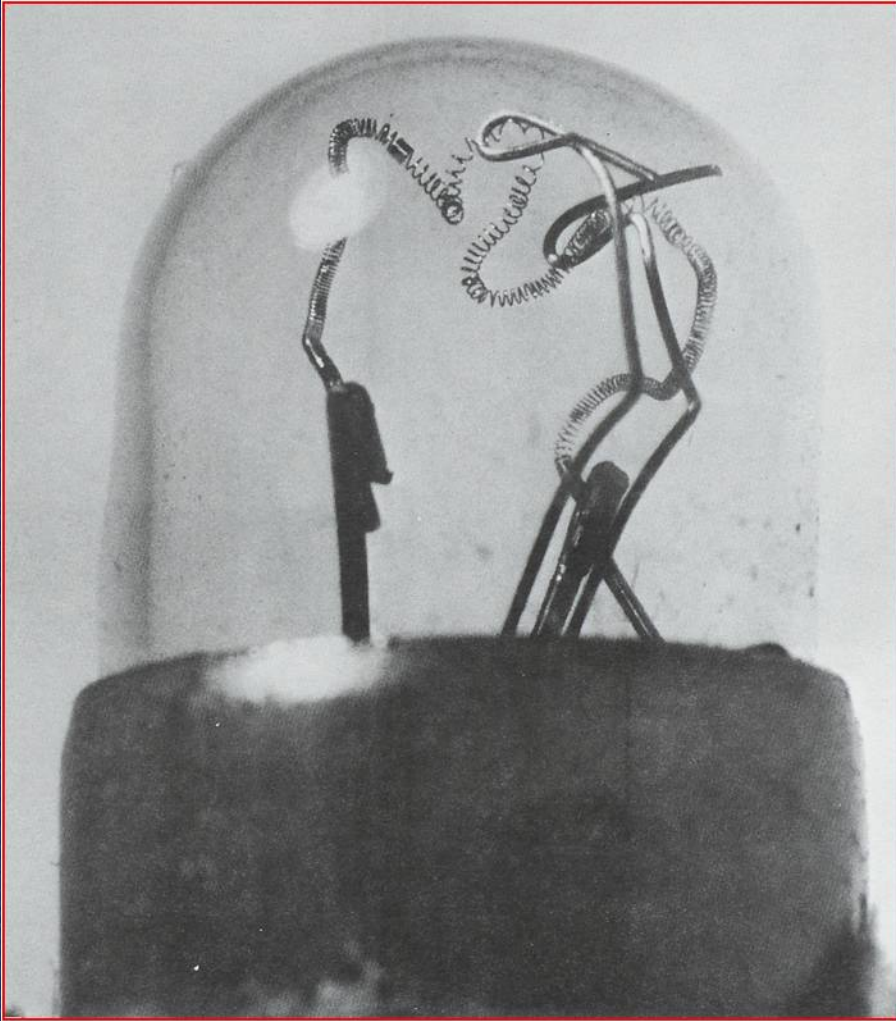
Light Bulb Filaments

- Was this light illuminated or extinguished at impact?

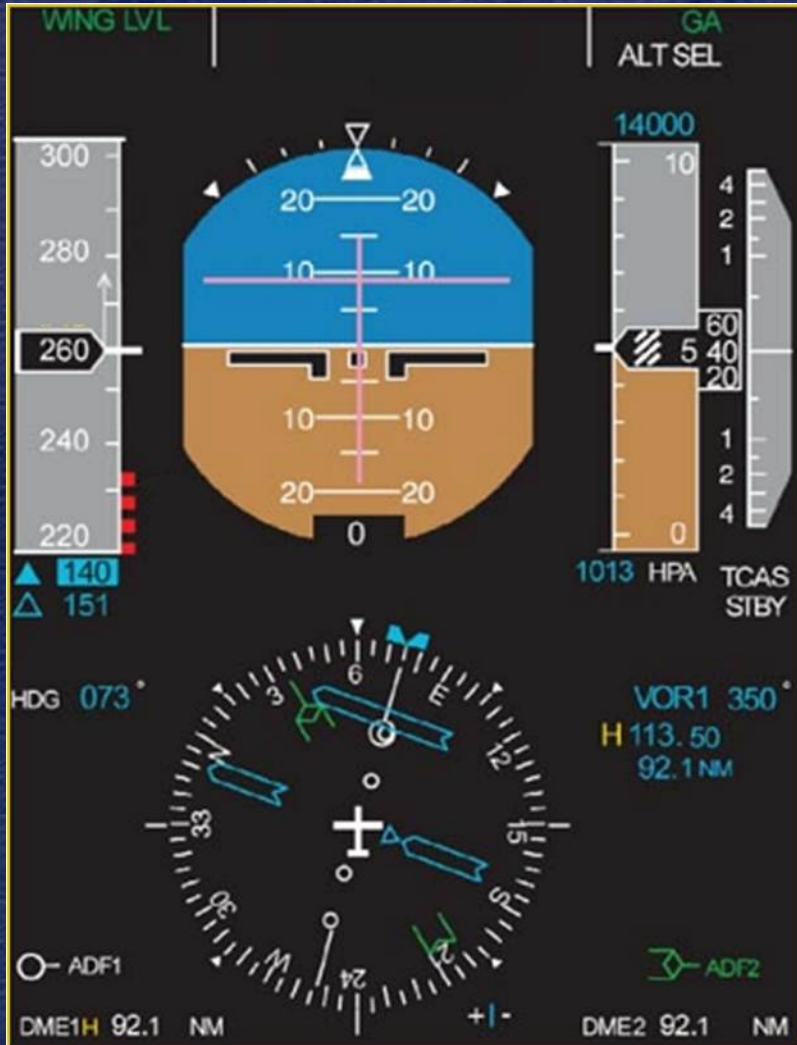
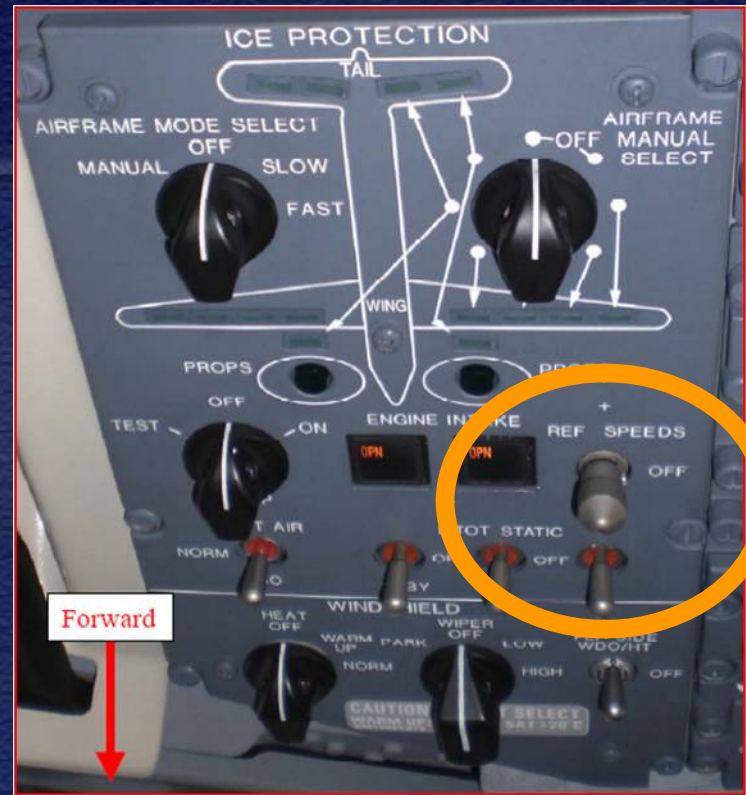
Ice Protection Panel

Mismatch of Landing Ref Speeds

- Flight operated in light-to-moderate icing en route and on approach
- Captain set reference speeds switch to increase (icing conditions)
- First officer obtained landing speeds for non-icing conditions
 - Mismatch with position of ref speeds switch resulted in landing speed that was 13 knots lower than stick shaker activation speed
 - 118 vs. 131 knots

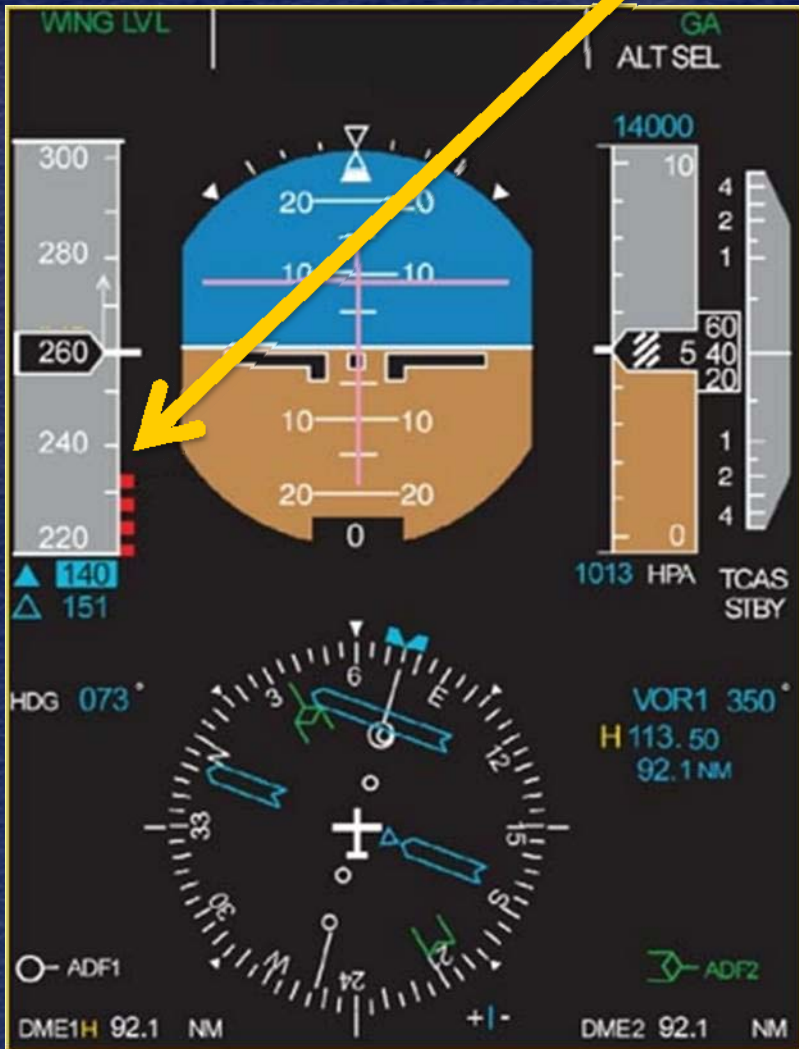
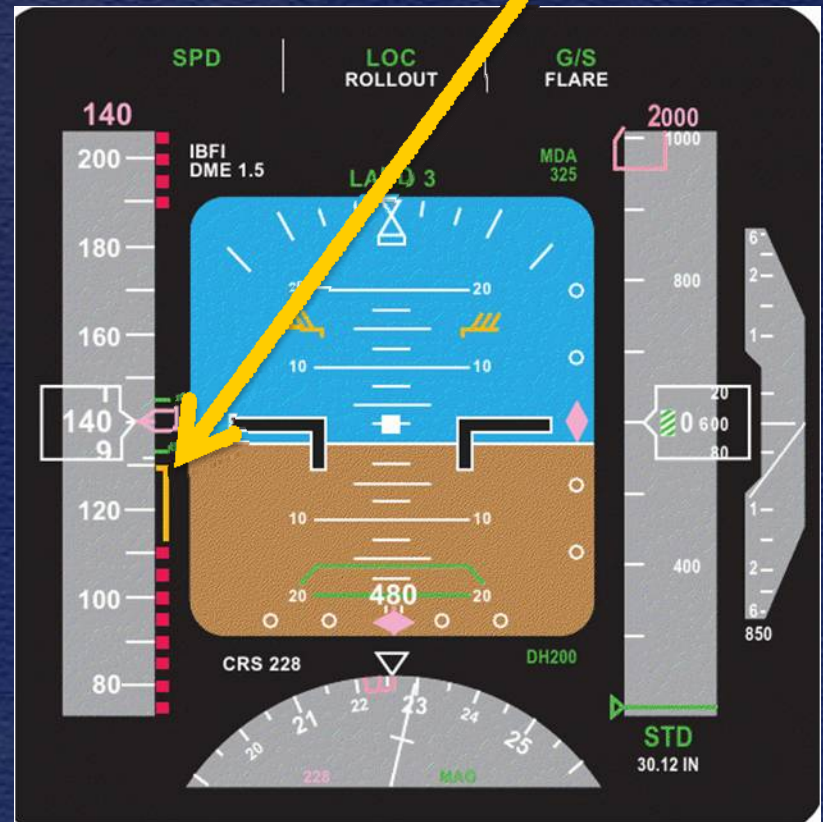
No Cautionary Range

Cautionary Range

- The Q400 airspeed indicator lacked low-speed awareness features, such as an amber band above the low-speed cue ...that would have facilitated the flight crew's detection of the developing low-speed situation.
- An aural warning in advance of the stick shaker would have provided a redundant cue of the visual indication of the rising low-speed cue and might have elicited a timely response from the pilots before the onset of the stick shaker.

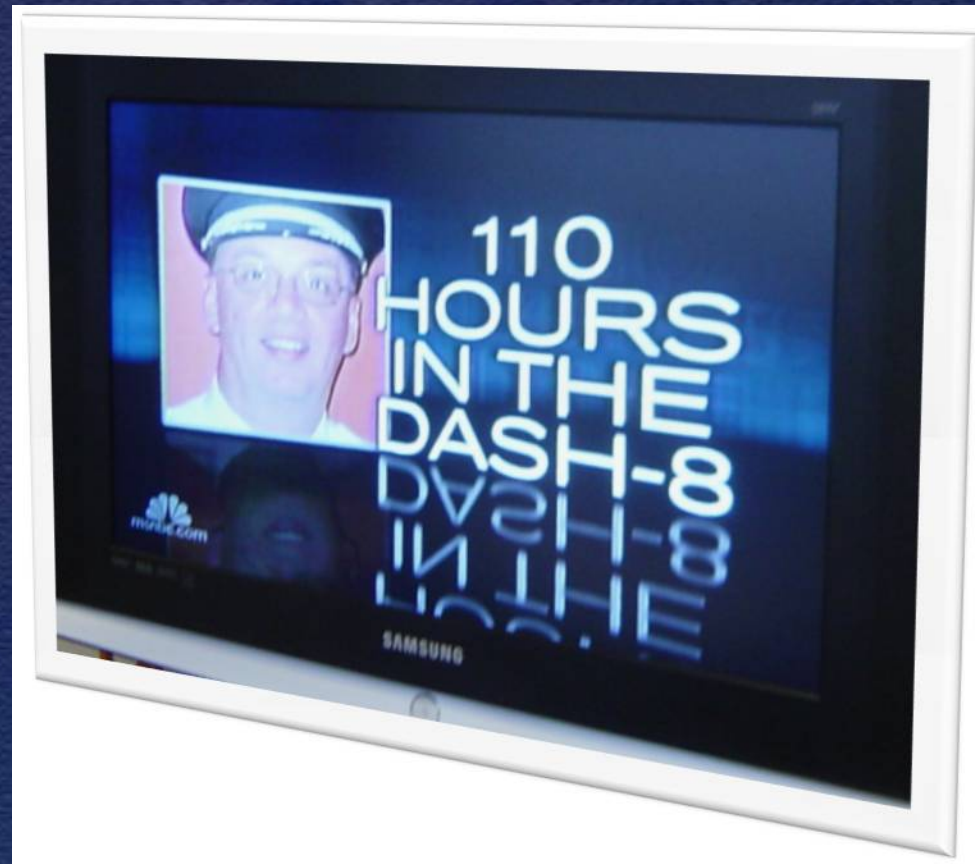
Captain's record of failed FAA checkrides

Date of Checkride	Certificate Attempted
October 1991	Instrument Rating
May 2002	Commercial SEL
March 2004	Commercial MEL
October 2007	ATP and Saab 340 type rating

- Captain had not established good foundation of attitude instrument flying skills early in career
- Weaknesses in basic aircraft control and instrument flying continued
- Colgan did not proactively address these issues
