**UNITED STATES
NUCLEAR REGULATORY COMMISSION
REGION IV
611 RYAN PLAZA DRIVE, SUITE 400
ARLINGTON, TEXAS 76011-4005**

EA-03-141

**SUBJECT: SOUTH TEXAS PROJECT ELECTRIC GENERATING STATION - NRC SPECIAL
INSPECTION TEAM REPORT 05000498/2003008 AND 05000499/2003008 AND
EXERCISE OF ENFORCEMENT DISCRETION**

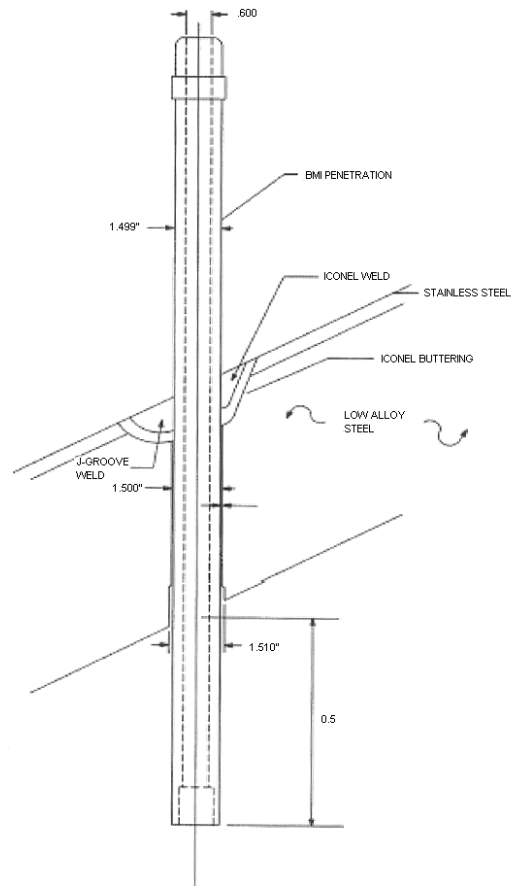
Figure 1

BMI Guide Tube Penetration
