Truck-Tractor Semitrailer Median Crossover
Collision With 15-Passenger Van
Munfordville, Kentucky
March 26, 2010

Accident Report

NTSB/HAR-11/02
PB2011-916202

Highway Accident Report

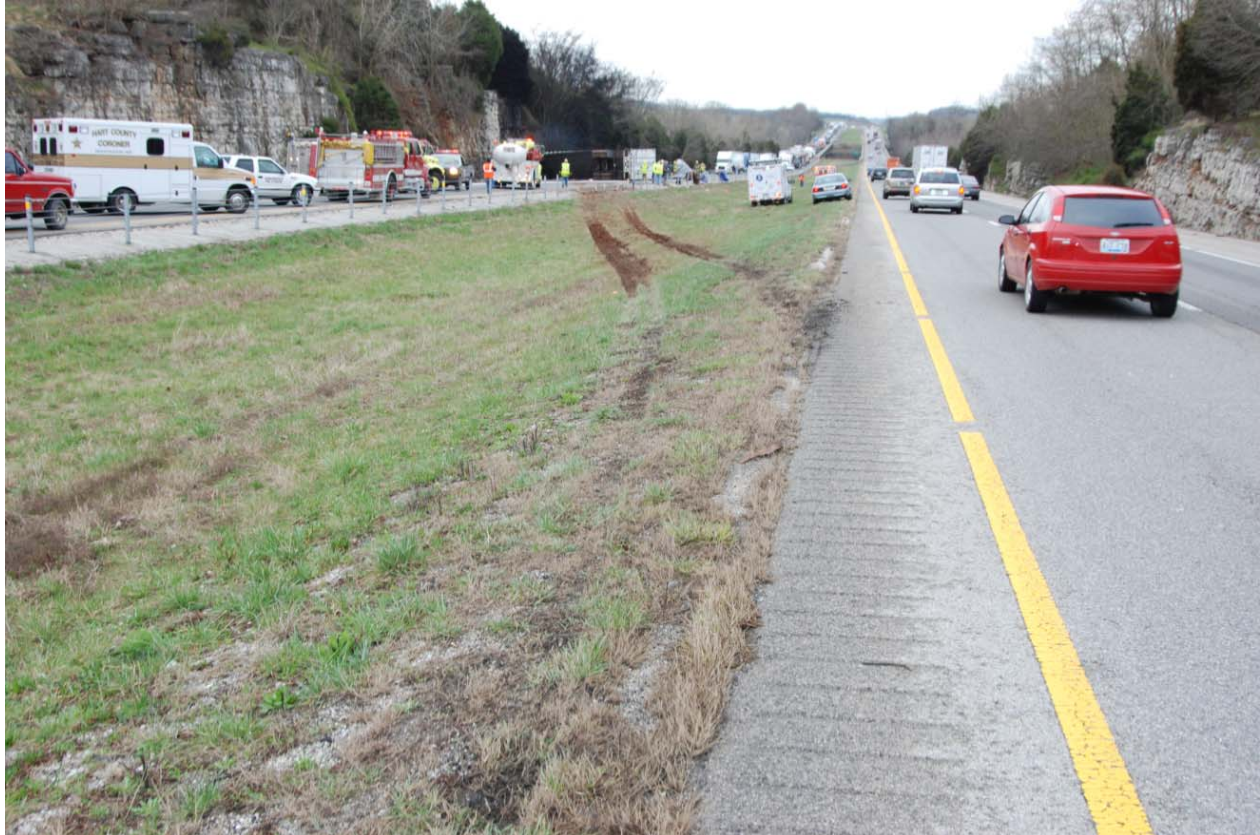
Figure 2. Looking southbound along the truck's cross-median path.

approximately 96 feet after the truck left the roadway, evidence of braking began,¹¹ and it continued for 173 feet as the vehicle traveled across the depressed median. After crossing the median, the truck struck a four-strand, high-tension cable barrier located 8 feet from the edge line markings of the northbound travel lanes. One of the six high-tension cable barrier posts that the truck struck punctured the vehicle's right saddle fuel tank, resulting in a 2-foot-long tear, which leaked fuel as the truck exited the median. The truck overrode the barrier and entered the northbound lanes at approximately a 15° angle. (Figures 2 and 3 show the truck's median crossover path.)

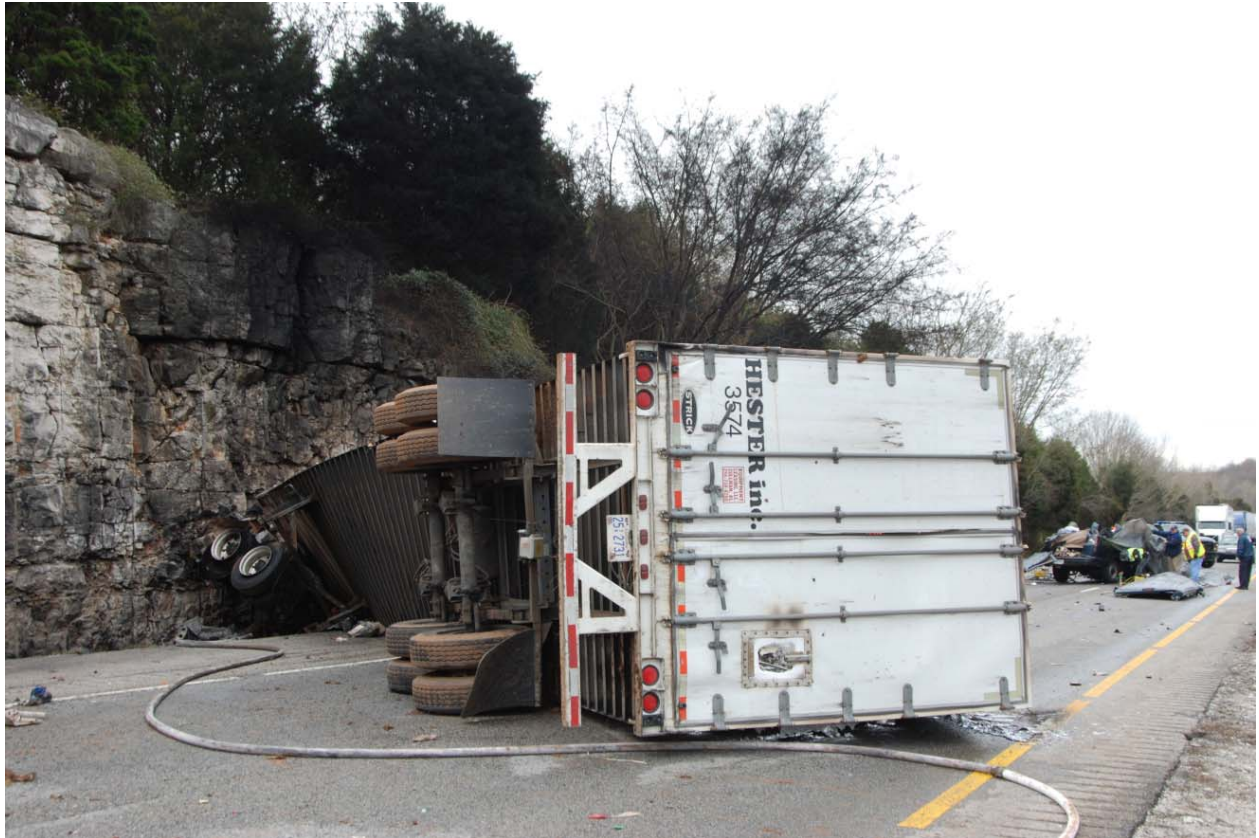
Figure 4. Postaccident scene.

The truck hit a cut rock wall¹² located 26 feet to the right of the travel lanes, causing significant crush to the front driver (left) side of the tractor. The semitrailer overturned onto its right side, blocking the northbound travel lanes and spilling its cargo of brake drum parts out of its roof and side along several hundred feet of a roadside drainage ditch. A postaccident fire engulfed the tractor and semitrailer. (See figure 4.)

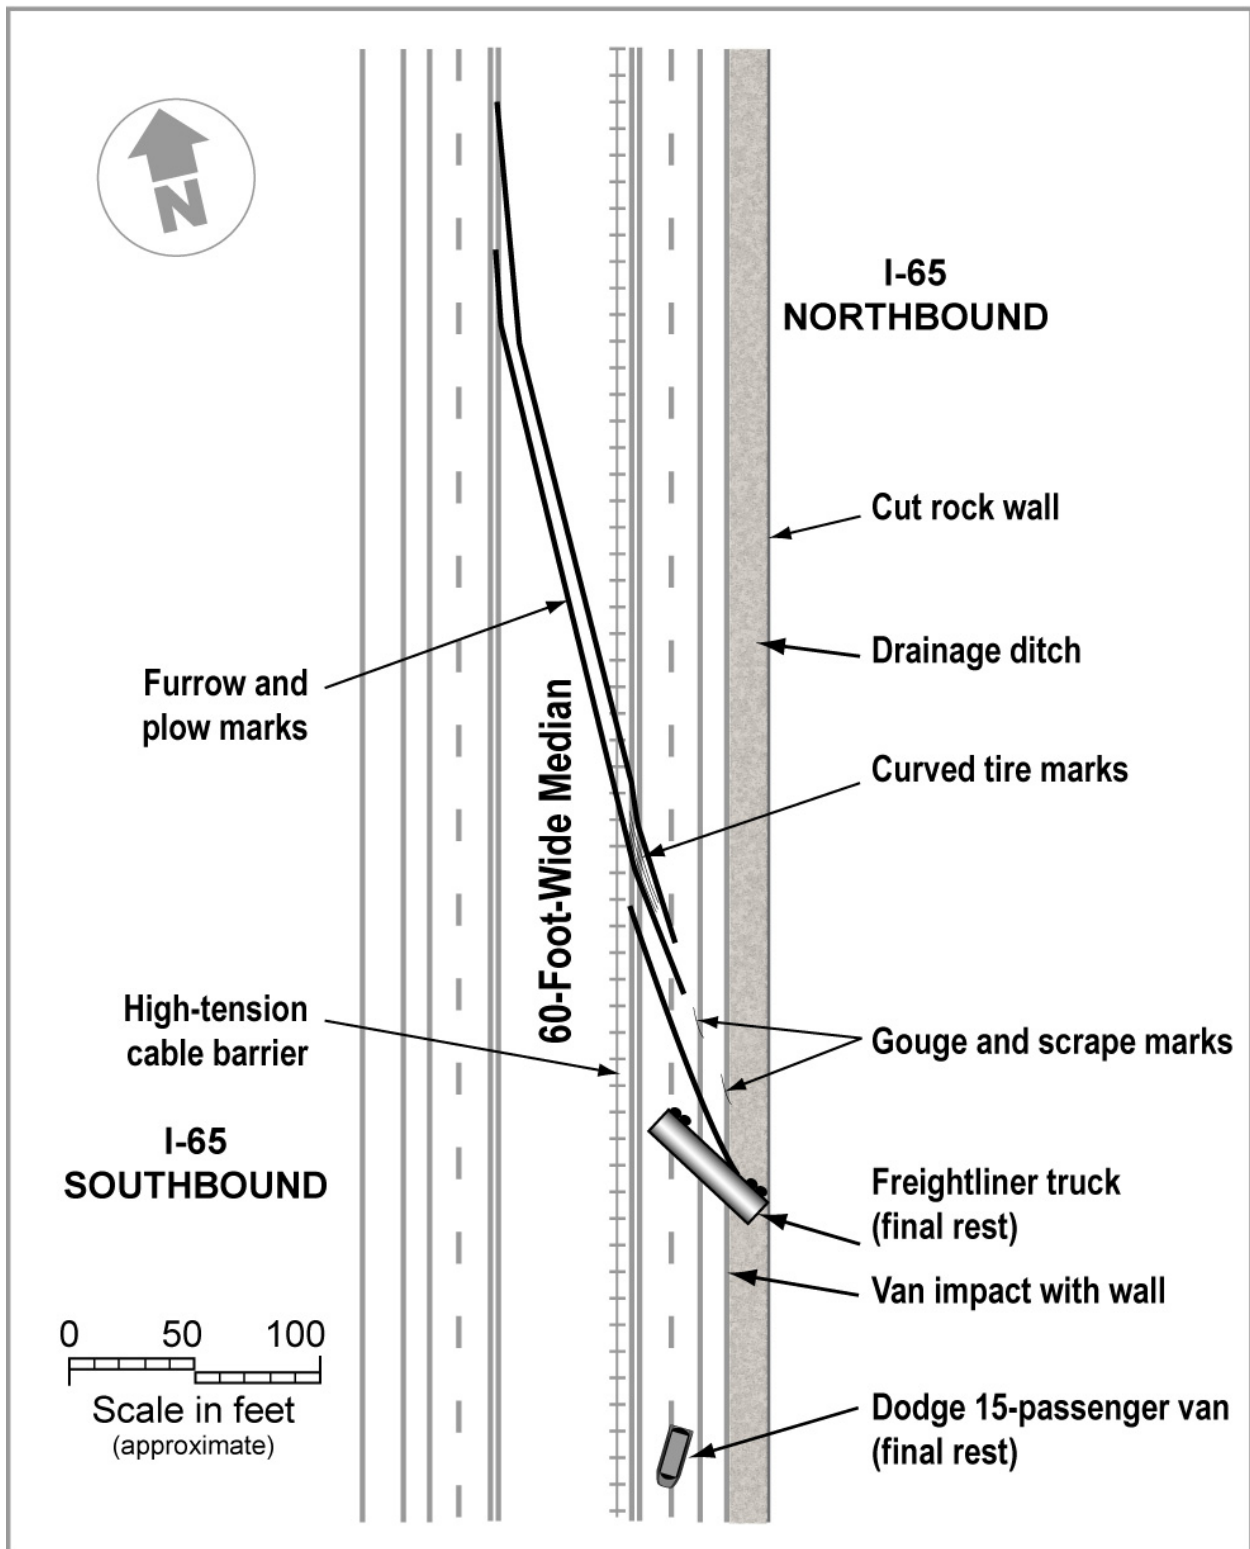
Figure 5. Accident scene diagram.

As the truck traveled off the edge of the paved shoulder of the northbound traffic lanes and into the 8-foot-wide drainage ditch, the van spun clockwise away from the larger vehicle and struck the cut rock wall south of the truck. The rear left corner of the van hit the cut rock wall 87 feet southeast from the point of its initial impact with the truck. When the van struck the cut rock wall, it was redirected back into the travel lanes, where it came to rest facing south/southwest in the northbound travel lanes 107 feet south from the location of its impact with the rock wall. (For a representation of the overall accident scene and final rest dispositions of both vehicles, see figure 5.)

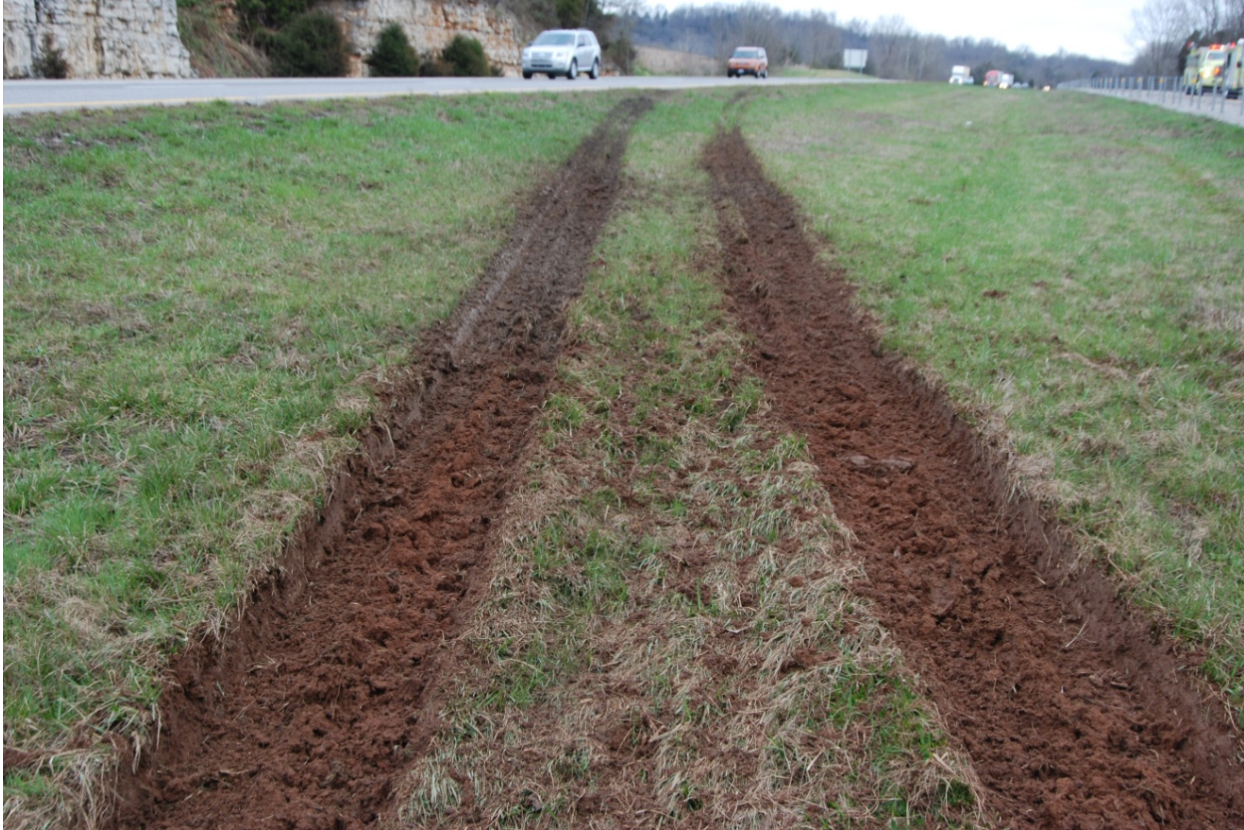
Figure 9. View looking north of truck tracks across the median, showing furrows from brake application.

The physical evidence at the accident scene indicated that the southbound truck departed the left shoulder at approximately a 5° angle,⁵⁶ traveled 269 feet across the median, and entered the northbound traffic lanes at approximately a 15° angle. As shown in figure 9 below, investigators found evidence of braking 96 feet from the point of departure from the roadway⁵⁷ but no evidence of steering input.⁵⁸ The roadway prior to the point of departure was inspected for evidence of tire failure or mechanical disablement; none was found. No witnesses mentioned any maneuvering by the truck that would have resulted in a loss of lateral stability, and investigators found no evidence of evasive maneuver on the part of the driver.

⁵⁷ Braking is indicated by the deeper and more distinct tire tracks through the soft earth and by the pieces of mud and turf thrown up from the tracks.

⁵⁸ The sides of the tire tracks in the earthen median were sharp and vertical, with clear raised areas between the tracks from the dual tires; this indicates that no steering was taking place when the tracks were made.

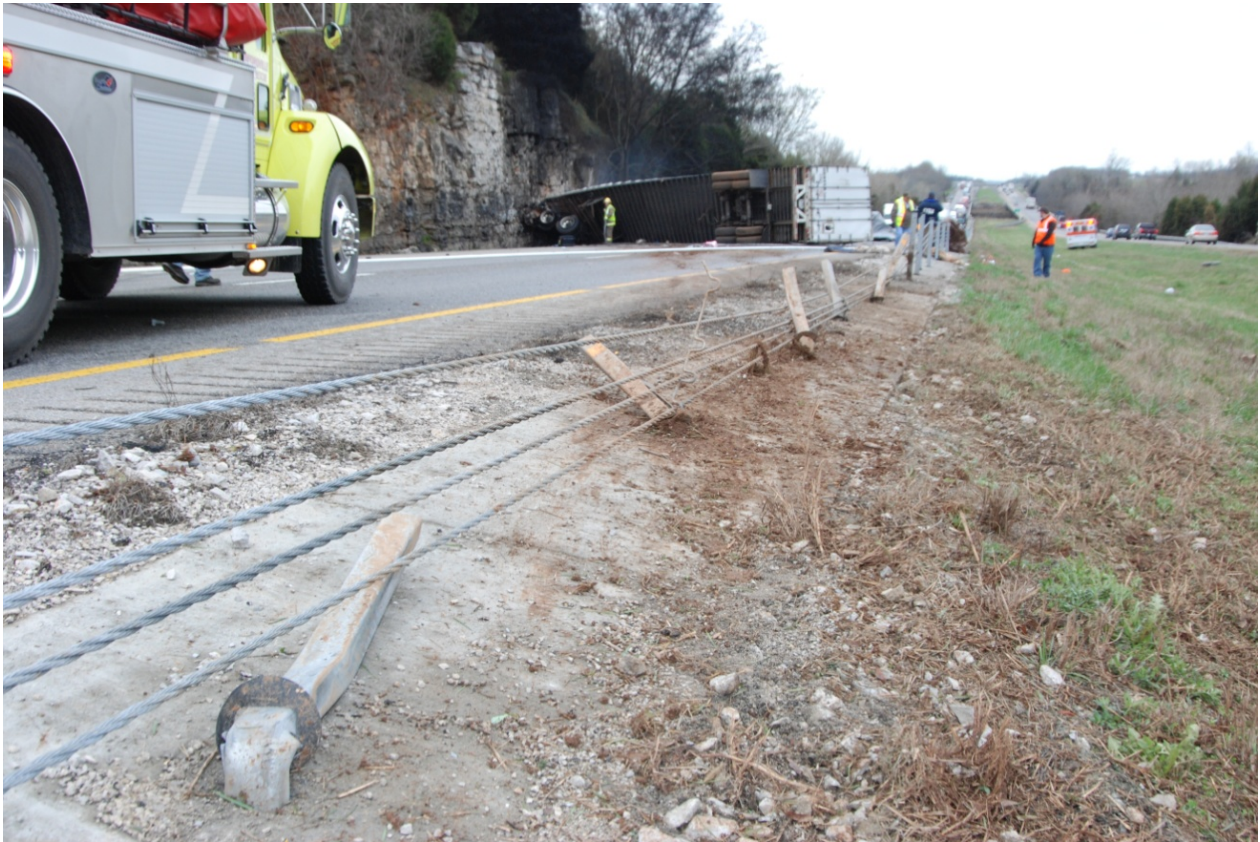
Figure 12. Overridden and damaged cable barrier.

As the truck exited the median, it struck and overrode the four-strand, high-tension cable barrier, as shown in figure 12, below. The initial impact by the truck was at a post located on the median side of the cables, and six posts in the impact area were bent over. The barrier system had a downward vertical loading from the truck's overriding it; the truck did not become entangled in the steel cable ropes.
