NTSB National Transportation Safety Board

Lessons from Icing Accidents and Incidents

Presentation of NTSB Board Member Dr. Earl Weener

Experimental Aircraft Association February 1, 2011

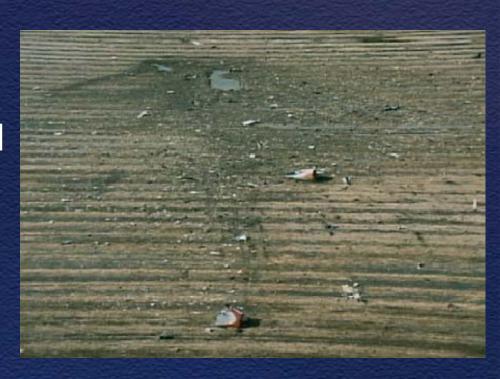
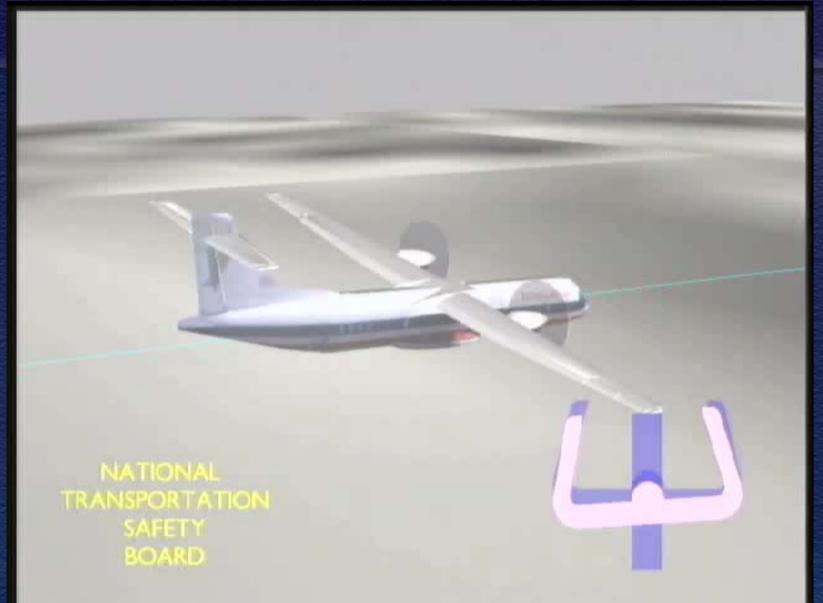
Roselawn, IN, American Eagle ATR-72

- 68 fatalities
- Involved Supercooled Large Droplets
- Created ridge of ice aft of deice boots
- Caused ailerons to deflect, resulting in loss of control

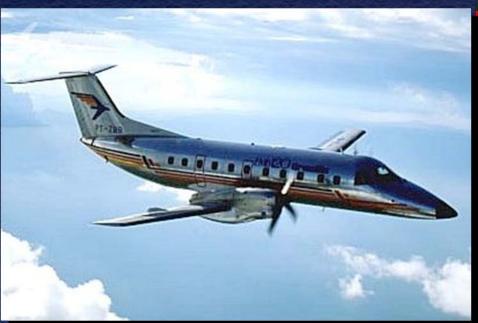
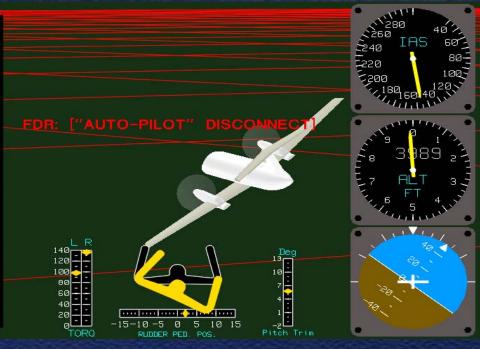
- Comair Embraer EMB-120
 Monroe, MI January, 1997
 - -39 fatalities

- Approach to DTW with autopilot engaged
- Ice accreted for 4 ½ to 5 minutes (some SLD)
- De-ice boots not operated during approach
- Airplane rolled to 45 deg left roll despite autopilot right roll input
- Rapid roll left when autopilot disconnected due to stick shaker
- Presence of an estimated ¼ to 1/2 of an inch of ice created a rolling moment the A/P could not counteract.
- Airplane did not recover in the 3000 feet agl available

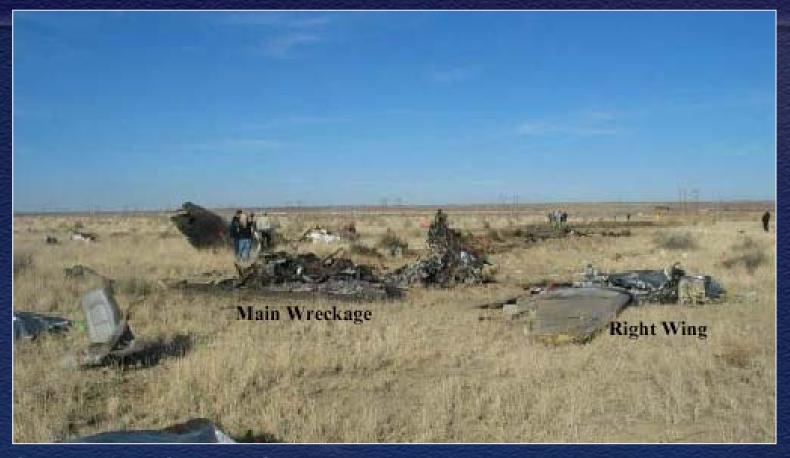
- Circuit City Cessna 560
 Pueblo, CO February, 2005
 - -8 fatalities

- Airplane slowed below Vapproach
- De-ice boots not operated in second icing layer
- Presence of an estimated 1/6 of an inch or less of ice accreted in SLD conditions caused the airplane to stall prior to stick shaker
- Airplane entered a rapid left roll prior to stall warning
- Airplane did not recover in the 1,500 feet agl available

"The flight crew's failure to effectively monitor and maintain airspeed and comply with procedures for deice boot activation on the approach, which caused an aerodynamic stall from which they did not recover..."

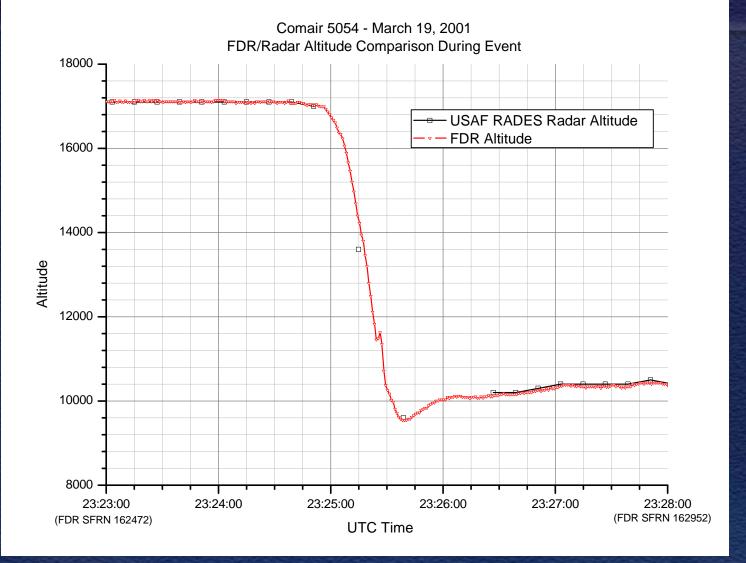
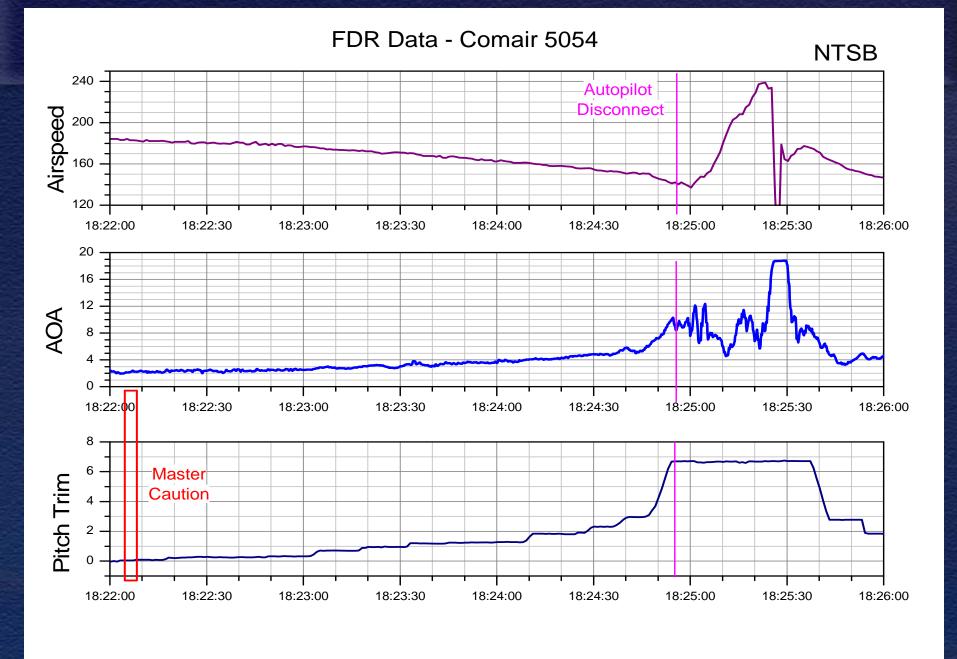
Comair Flight 5054 EMB-120 Incident West Palm Beach, FL - March 19 2001

- Pilot reported using de-icing boots (3 minute activation cycle); SAT = -4 Deg C
- Autopilot engaged
- Indications from FDR, CVR Ice Detector was active
- Loss of control in icing conditions
- 8000 ft altitude loss, structural damage to horizontal tail and elevator
- Intercycle Ice case

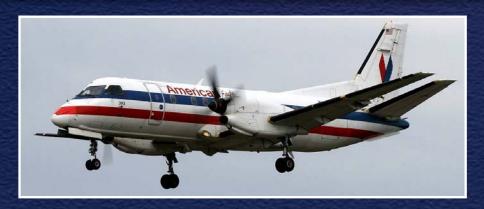
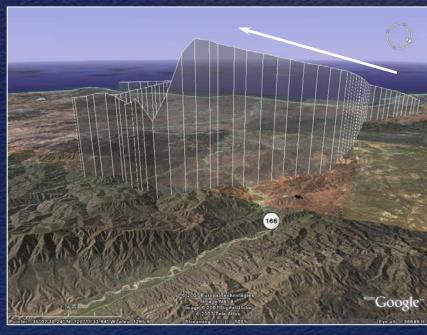
- American Eagle Saab 340B San Louis Obispo, CA - January, 2006
 - Slowed on autopilotLost 5000 feet altitude

- Nearly inverted

- Resulted in 4 recommendations
 - Minimum airspeed
 - Modify stall protection
 - Ice detection
 - Disengage autopilot in icing conditions, except in periods of high workload
- FAA working with Saab and EASA to determine response.
- FAA issued Safety Alert for Operators

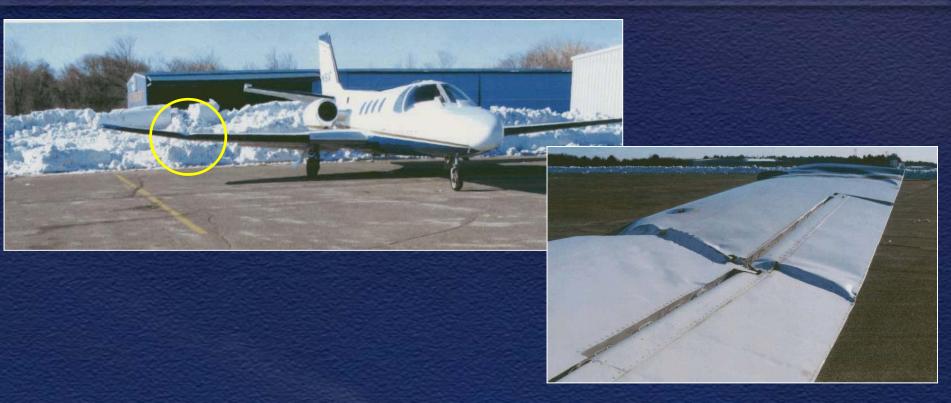
- Cessna 500 Air Ambulance Beverly, MA – March, 2007
 - Uncommanded roll during landing
 - Struck wing on runway

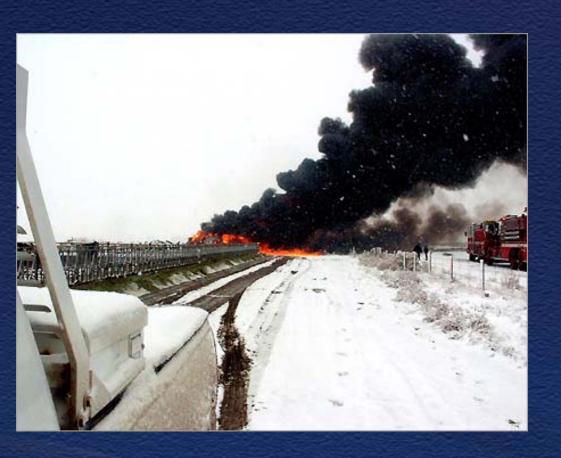
Bombardier Challenger CL-600 Montrose, CO – November 29, 2004

- 3 fatalities, 3 seriously injured
- Crashed during takeoff in snow

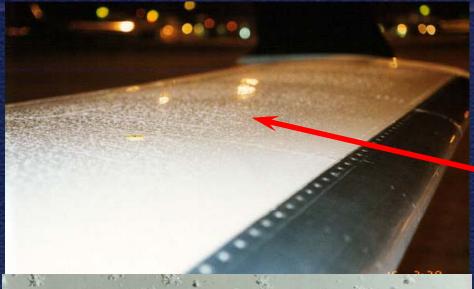
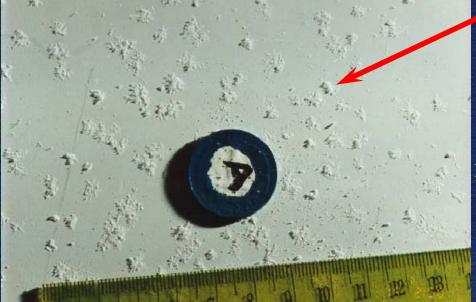
Small, almost imperceptible accumulations
