SPECIAL WEAPONS AND TACTICS
(SWAT) POLICE STATION
HILLA, IRAQ

SIGIR PA-05-018
JANUARY 30, 2006

SUBJECT: Report on Project Assessment of the Special Weapons and Tactics (SWAT)
Police Station in Hilla, Iraq (Report Number SIGIR-PA-05-018)

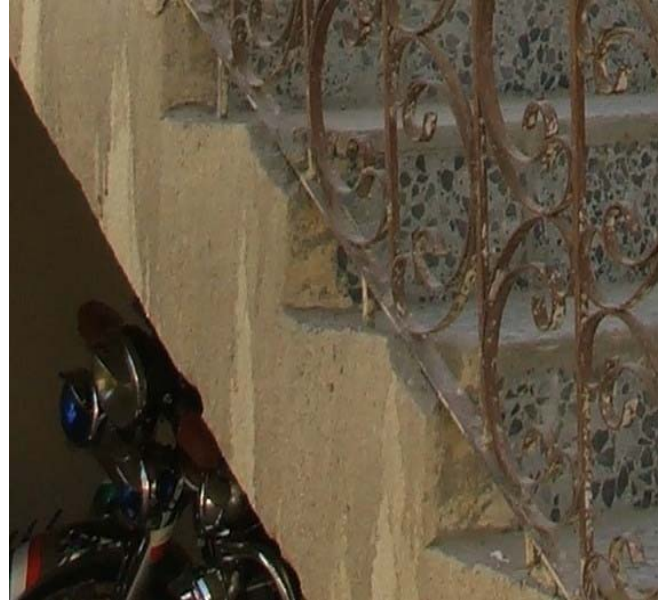
During the site visit, we identified discrepancies in the construction of the handrails on the external staircases and the finishing of the concrete sidewalks. For example, the handrails lower cross member was imbedded in the concrete stairs. The lower member should be located above the concrete stairs with anchoring points imbedded into the concrete. Detail design drawings were not included in the design package, which would have clarified proper installation of the handrails. See Site Photos 2 and 3 for illustrations of the external stairwell and a close up of the lower rail imbedded into the concrete steps, respectively. Surface finishing of the concrete sidewalk and access areas was of poor quality. The surface was rough and uneven with the appearance that the finishing was not completed. For an illustration of the surface finishing near the sleeping quarters building, see Site Photo 4.

Site Photo 3. Close-Up of Stairwell

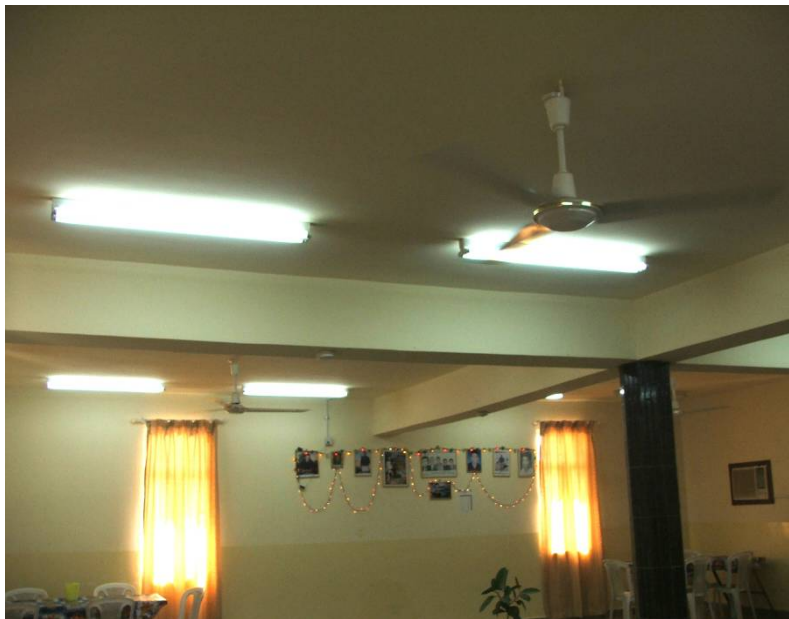
The contract and design required the construction of a one-story facility with reinforced concrete footings, reinforced concrete slab, reinforced concrete columns and beams, and stucco over block exterior. The building design required a 16.93 M (55.5 ft) by 16.61 M (54.5 ft) facility. The building included one large area for dining, one room for food preparation, two rooms for storage, and a common lavatory. The contract required the facility to include A/C units. During the site visit, we verified the building was constructed and used as a dining facility. For an illustration of the exterior front of the dining facility, see Site Photo 5. For an illustration of the dining facility's interior dining room, see Site Photo 6. We observed A/C, lights, and fans to be operational.

Site Photo 6. Interior of Dining Area

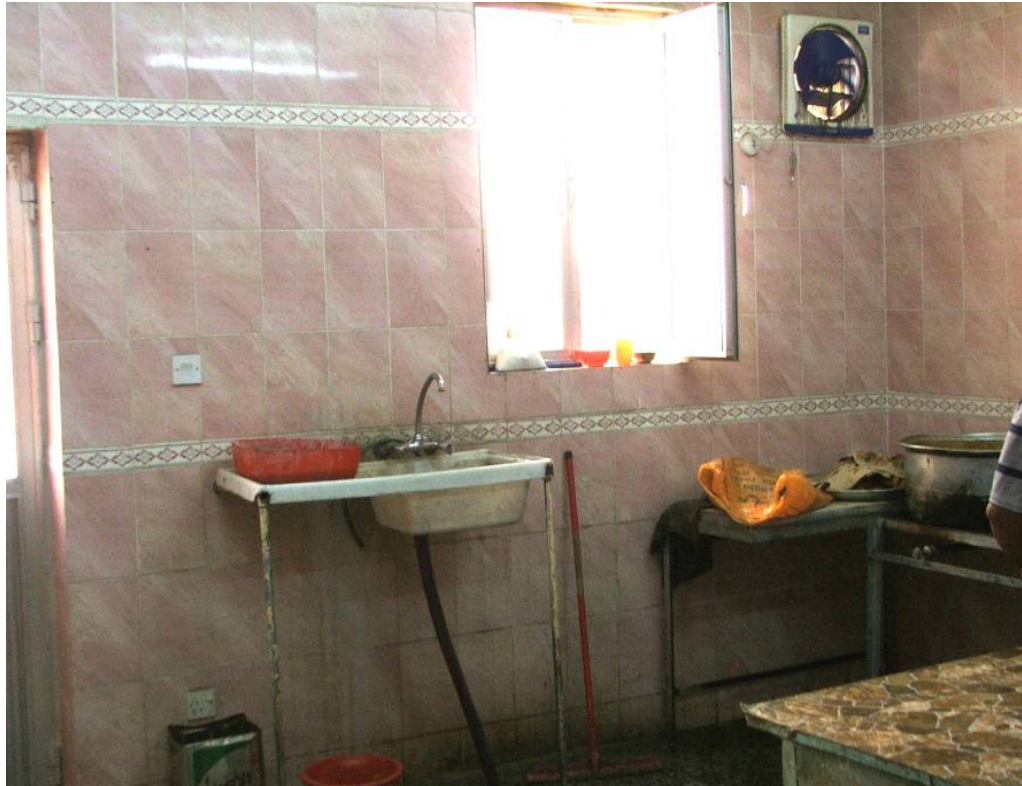
During the site visit, we noted discrepancies, including the quality of appliances in the food preparation area. The contract required “catalog cuts” for all types of equipment installed under this contract. The contract stated, “[c]uts shall include the manufacturers name, address and telephone number, rating and physical size of equipment.” The contractor did submit catalog cuts in the design submittal but the equipment currently installed in the kitchen does not match the equipment listed in the catalog cuts. Currently there is a small sink, worktable, and cooking stove located in the food preparation room. For an illustration of the dining facility’s interior food preparation room, see Site Photo 7.

Site Photo 7. Interior of Kitchen Area

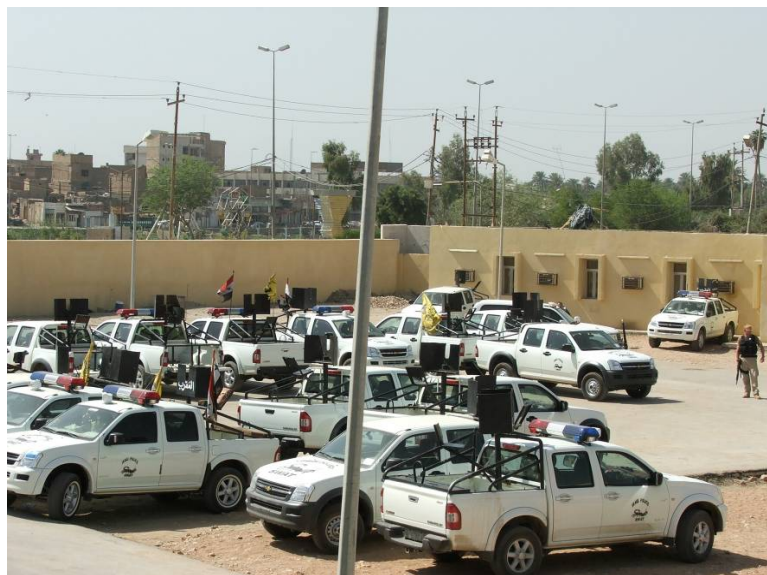
The contract’s SOW did not specifically address the requirement for a helicopter pad; however, a 26 January 2005, USACE Memorandum for Record stated, “The contractor was aware of the requirement for a heli [helicopter] pad and included it in the initial bid for the project.” At the time of the site visit, the helicopter pad was in place, but was of poor quality. The construction of the pad consisted of a concrete base overlaid by an asphalt surface. For illustrations of the helicopter pad area with vehicles parked on top of the pad and the edge of the helicopter pad surface, see Site Photos 9 and 10, respectively. The edge of the pad shows that concrete has broken away from the pad. The USACE Area Engineer stated he is in discussions with the contractor to repair or replace the helicopter pad.

Site Photo 9. Helicopter Pad Area with Non-Plumb Light Poles

- “Helicopter Pad. After reviewing site conditions, it was determined that the helicopter pad would not meet minimum clearance requirements due to nearby existing buildings and power lines. A settlement was negotiated converting the pad to a parking area and providing a credit to the government.”

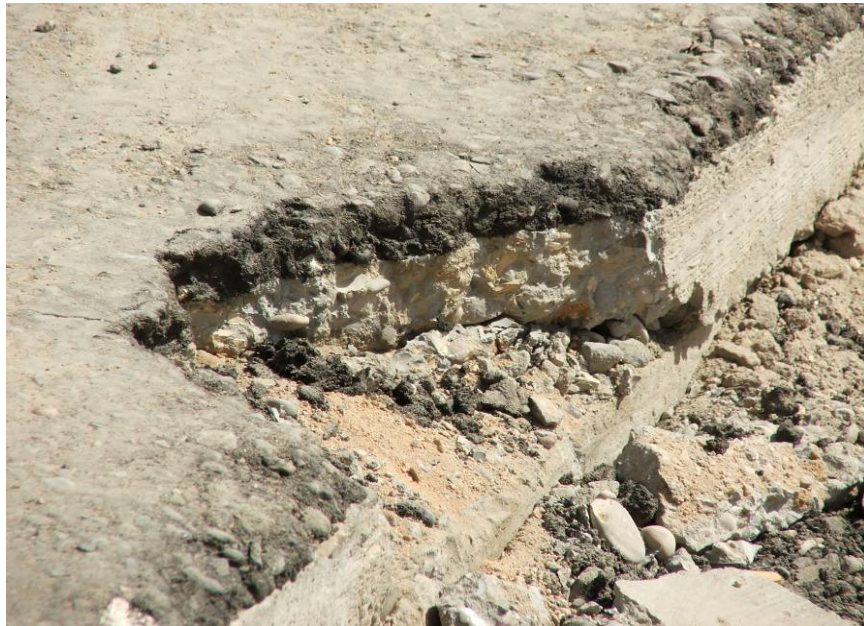
Site Photo 10. Edge of Helicopter Pad

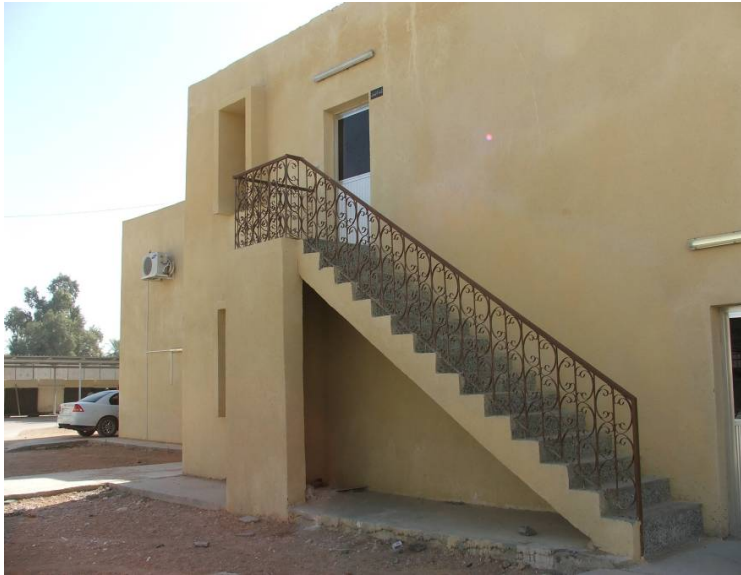
The contract and design required the construction of a two-story facility with reinforced concrete footings, reinforced concrete slab, reinforced concrete columns and beams, and stucco over block exterior. The building design required a 5.99 M (19.7 ft) by 14.51 M (47.6 ft) facility with one external staircase. The contract required the facility to include A/C units. During the site visit, we verified the building was constructed; however, we did not assess the interior of the facility. For an illustration of the exterior wall of the Operations Room facility and the external staircase, see Site Photo 12. During the site visit, we noted discrepancies in the construction of the handrails of the external staircases. The handrails discrepancies of the Operations Room facility are identical to those of the Sleeping Quarters facility. For an illustration of the external stairwell, and a close-up of the lower rail embedded into the concrete steps, see Site Photo 13.

Site Photo 12. Exterior of Operations Room Building

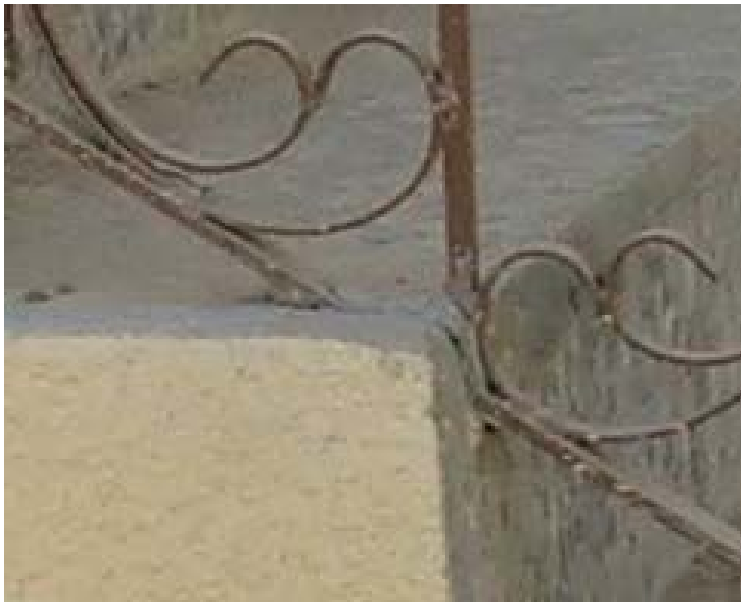
Site Photo 13. Lower Stairwell Railing of Operations Room

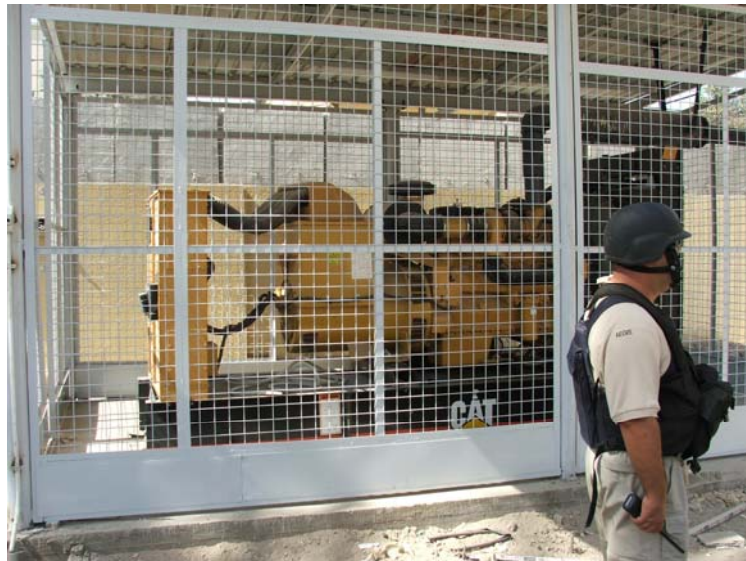
Site Photo 17. Generator Unit with Mesh Enclosure

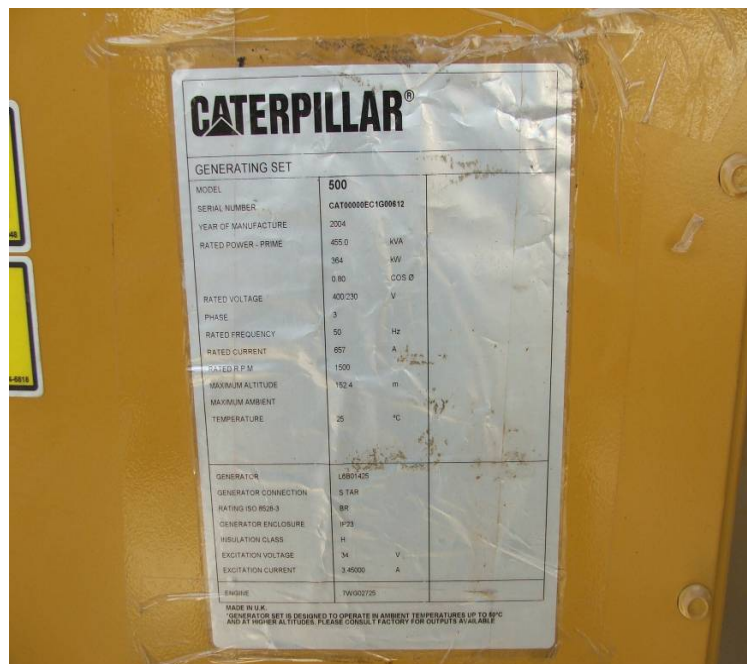
The engine block factory nameplate showed the Engine Serial Number as 7WG02725, although the engine block serial number was partially painted over. For illustrations of the paper copy of the generator nameplate and the engine block factory nameplate, see Site Photos 18 and 19, respectively.

Site Photo 18. Paper Copy of Factory Nameplate

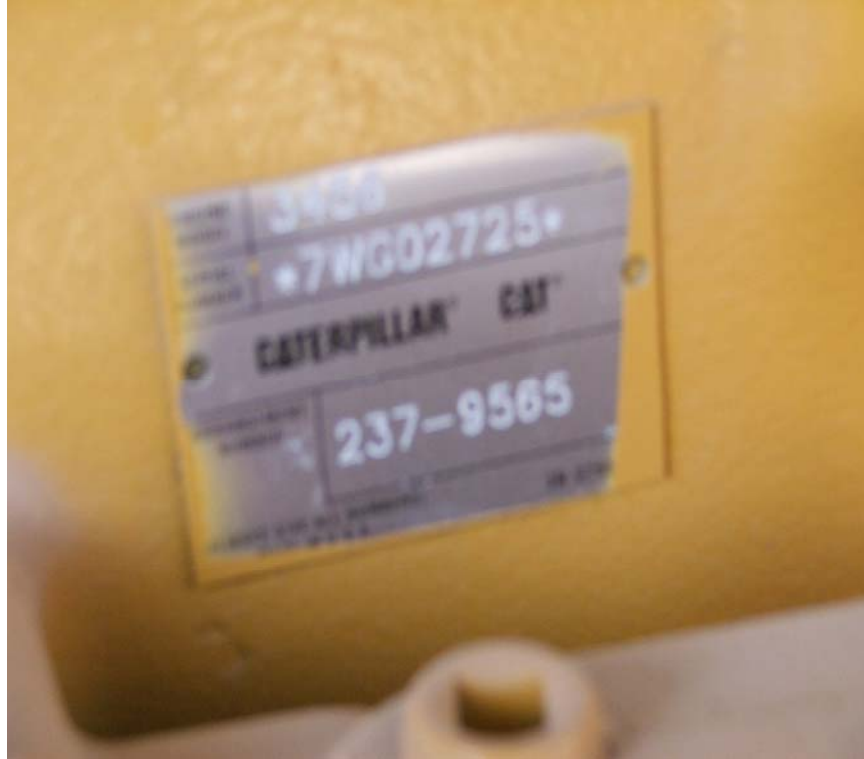
Site Photo 19. Engine Block Factory Nameplate

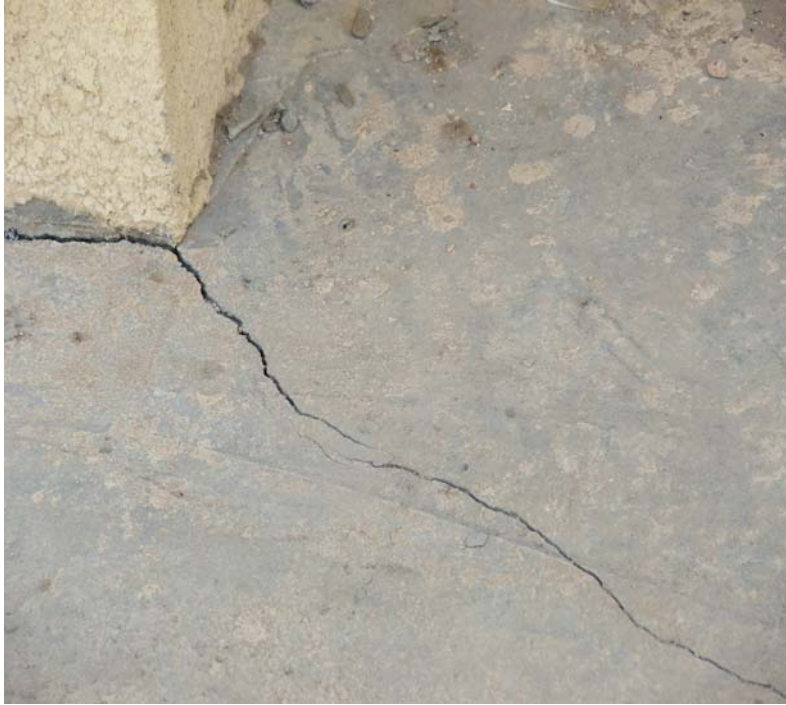
The contract's SOW required the renovation of the remaining buildings after the demolition of the damaged buildings. The SOW stated, "the second phase is the renovation of remaining buildings to temporarily house SWAT personnel as described in the attached Bill of Materials (BOM)." A complete assessment of the renovation of the existing facilities was not completed, although we conducted a walk through of the renovated buildings. Observations of cracks in the new side walks, cracks in the stucco exterior of the building, improperly installed stairwell railings (similar installation to the sleeping quarter and operations room facility), and cracks in the interior security walls are signs of poor workmanship during the rehabilitation of the facilities. For illustrations of the cracks in the front of renovated building #2 and in the interior security walls behind the Vehicle Affairs building, see Site

Site Photo 20. Cracks in Concrete Sidewalks of Renovated Building #2

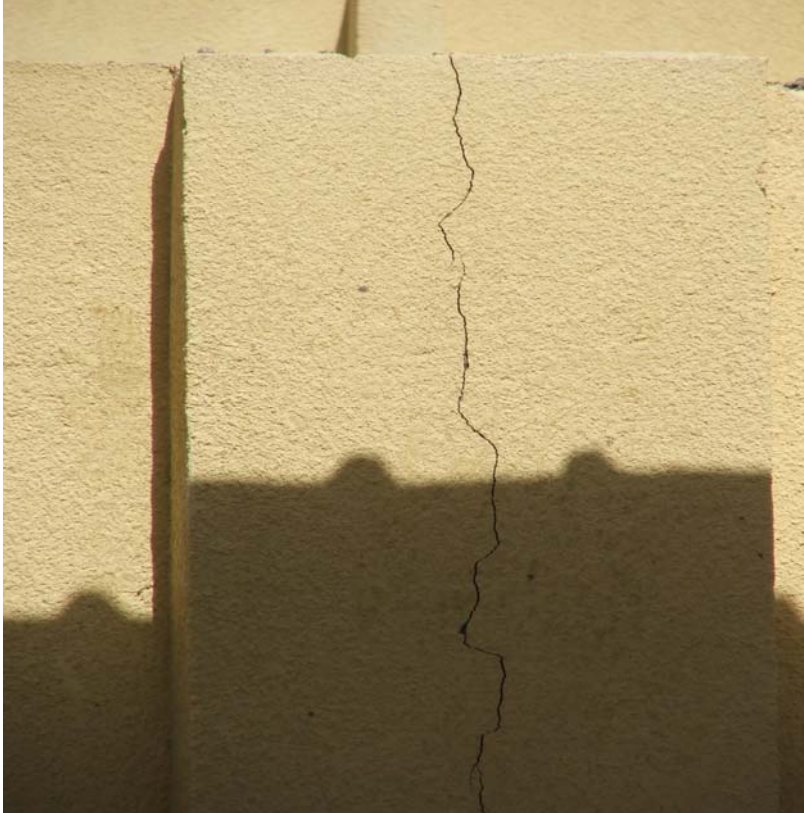
Site Photo 21. Cracks in Stucco of Interior Security Wall
