UMM QASR WATER SCHEME, IRAQ

PROJECT NUMBER SIGIR-PA-05-028

JULY 24, 2006

SUBJECT: Report on Project Assessment of the Umm Qasr Water Scheme, Iraq (Report
Number SIGIR-PA-05-028)

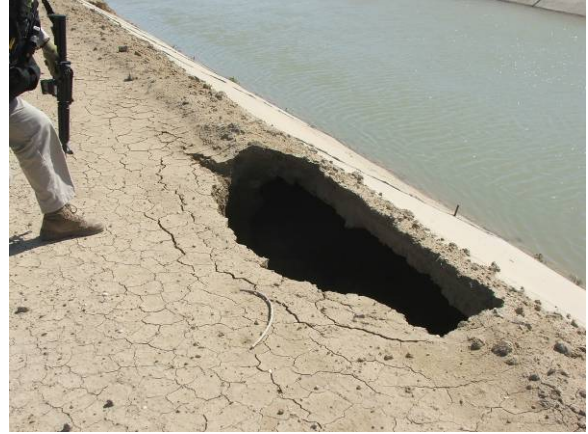
Site Photo 5 shows an example of the SWC with undamaged embankment and concrete liners. Site Photos 6 through 9 show examples of areas along the lined section of the canal where repairs and maintenance are required. Site Photo 10 shows an area where native rock instead of concrete panels was used for repair.

Site Photo 8. Example of under-cutting of canal

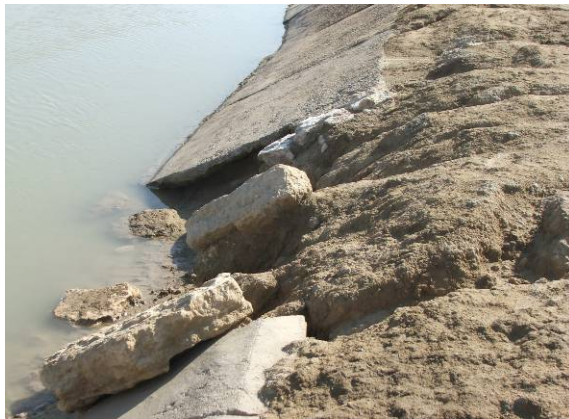
Site Photo 13. Example of concrete liner failure at km 168 repair area

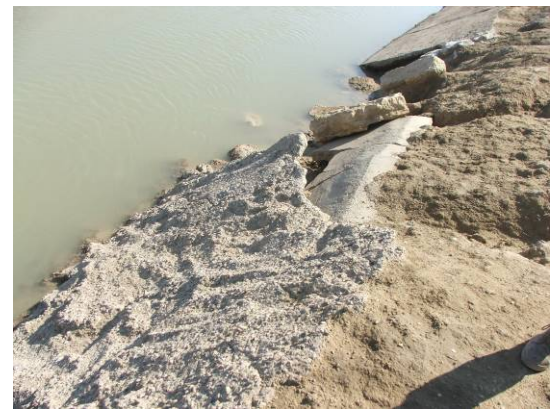
Site Photo 14. Repair of concrete liner with concrete slurry at km 168 repair area

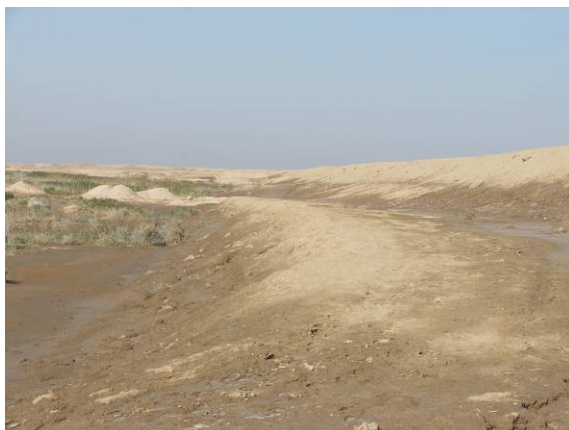
During the site assessment, both areas where emergency repairs were completed were visited. The area in the vicinity of km 168 showed signs of recent repair activities of the canal bank. It appeared the concrete liners were repaired with a concrete slurry applied instead of utilizing prefabricated concrete tiles. The concrete liners were not completely intact and several areas along the canal back showed signs of being undercut by soil erosion, causing large voids in the embankments. Similar conditions were observed at the area in the vicinity of km 188 emergency repair with the addition that surface erosion of the side banks were observed. Maintenance equipment, maintenance staff, or signs of recent maintenance activities were not observed at either of the locations.

Site Photo 15. km 188 repair area

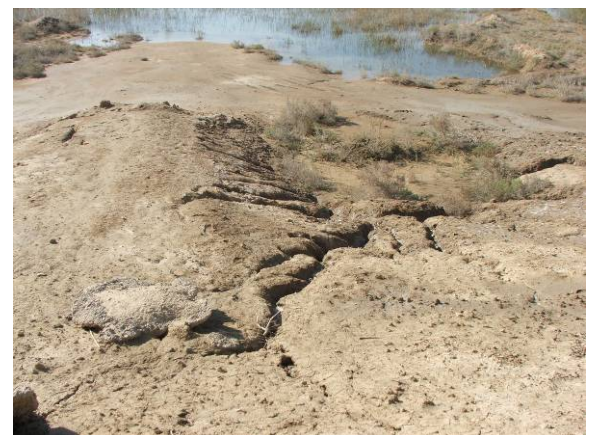
Site Photo 16. Surface erosion of canal banks at km 188 repair area

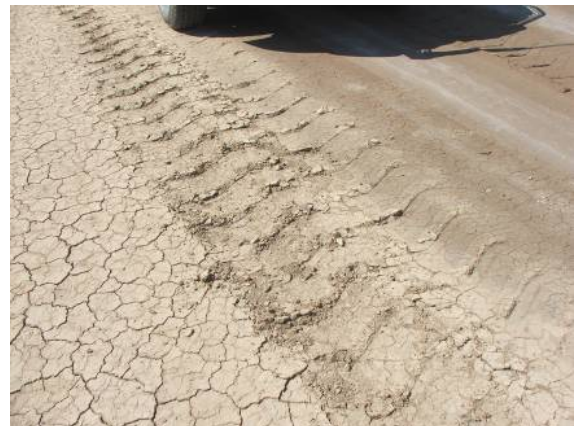
The 45 km unlined portion of the SWC we were able to visit was located between km 193 and the settling basins (km 238). Signs of past maintenance activities were observed and included dredge spoils located parallel to the canal route. Dredge spoils included a combination of soils and vegetation. Maintenance equipment, maintenance staff, or signs of recent maintenance activities were not observed at any point of the unlined section of the canal. A single set of tire prints from a heavy equipment vehicle was observed parallel to the canal. The main channel appeared free of vegetation, although vegetation was observed growing on the sides of the canal. The sluice gates which control water from the SWC to the settling basins and the settling basins themselves appeared serviceable.

Site Photo 19. Recent tire tracks from heavy equipment vehicle
