FIRE STATION CONSTRUCTION
AINKAWA, IRAQ

SIGIR PA-06-036
APRIL 12, 2006

SUBJECT: Report on Project Assessment of the Fire Station Construction, Ainkawa,
Iraq (Report Number SIGIR-PA-06-036)

Fire Station Construction, Ainkawa, Iraq

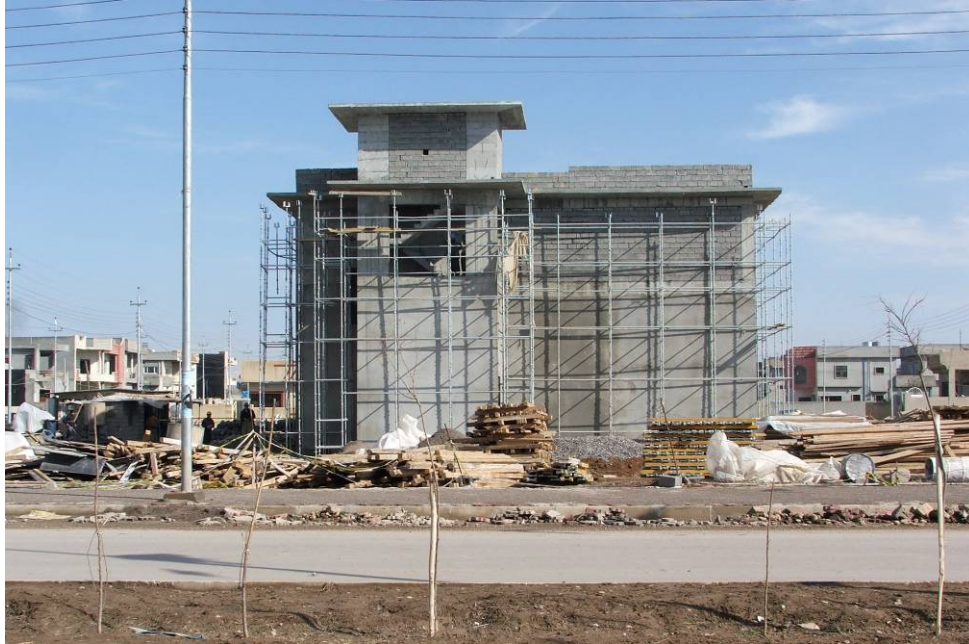
Site Photo 1: Side elevation of fire station showing lot and adjacent lane use

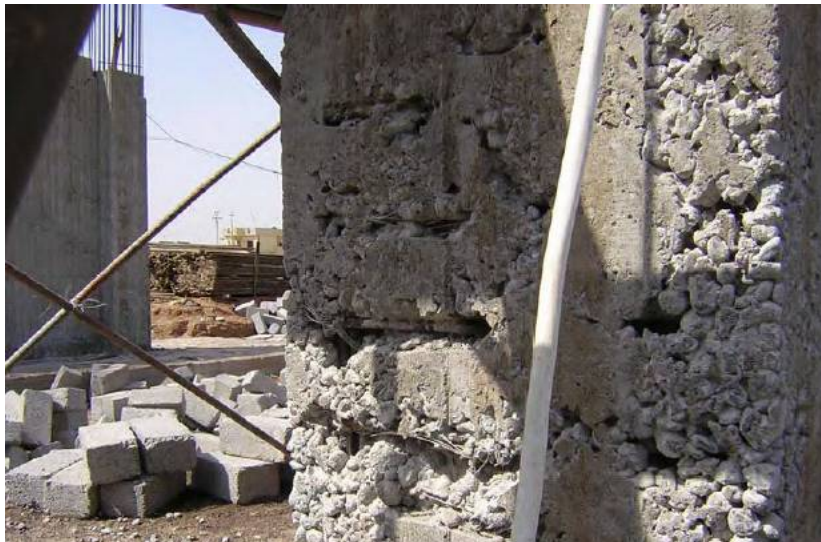
The USACE RE informed us there is a serious issue with the quality and possible structural integrity of the reinforced concrete shear walls, columns and beams located in Level 1. Parsons constructed these structural members in Level 1 in early May 2005. There were considerable voids in the reinforced concrete on this level, particularly in the columns. The first three meters of the columns contain significant honeycombing³ resulting from improper placement and poor vibration of the concrete. The contractor batched the concrete onsite utilizing a small drum mixer (less than 1 cubic meter (m³) in size). The mixer produced one small batch at a time without proper controls in place to assure the same mix ratio was utilized for every batch. The process used by the contractor to fill the forms with concrete was similar to a "fire brigade," where buckets of concrete were passed down a line of workers, up a ladder and poured into the form from the top. By pouring the concrete from the top of the forms, vibrators could not reach the bottom. As a result, the concrete could not be uniformly distributed, especially in the lower areas of the column or wall. Site Photos 4-8 show honeycombing found in columns in Levels 1 and 2 after concrete placement.

Site Photo 4. Honeycombing/exposed reinforcing steel in concrete column on Level 1 - Photo provided by USACE.

The construction of the Ainkawa Fire Station may not currently meet the standards of the contract and design. The honeycombing in the lower sections of the shear walls and columns may affect the structural integrity of the building. The honeycombing occurred because the contractor failed to follow its specifications for placing and vibrating concrete.

1. Formally direct Parsons to certify that the shear walls, beams and columns are structurally sound and consistent with the design specifications.
2. Require Parsons to provide evidence regarding the durability of the rich cement-sand mortar patches made to the honeycomb areas of the structural concrete.
3. Direct a review of the requirements of the task order and clarify whether the contractor or the Iraqi Ministry of Interior is responsible for constructing driveways, sidewalks, and perimeter walls.

2. This directly relates to Recommendation 1. Mortar patches were made to the walls and columns to correct the defects in the concrete. The district has formally directed the contractor to certify that the sheer walls and columns are structurally sound and consistent with the design specifications on two occasions; 17 June 2005 and 4 April 2006. The contractor was asked to respond within 15 days of receipt of the latest letter.
3. On 27 March 2006 and again on 6 April 2006, GRN requested GRD-PCO (Programs Directorate) determine if the task order requires driveways, sidewalks, and perimeter walls.

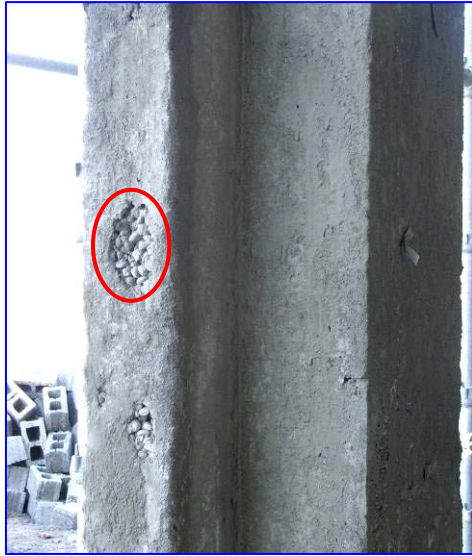
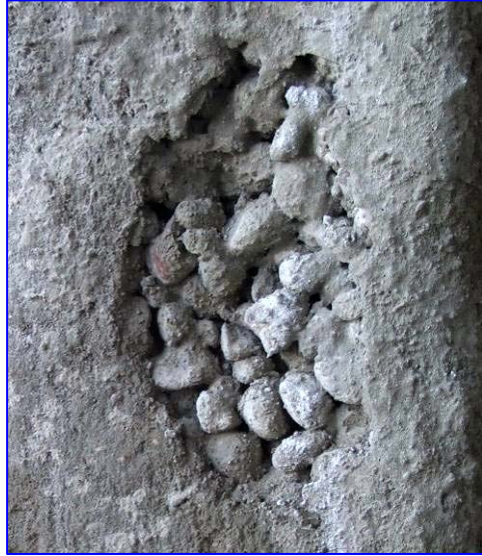
Site Photo 5. Honeycombing after surface coating

Site Photo 6. Closeup of Site Photo 5

Site Photos 5 and 6 show the honeycombing on an exterior t-shaped stub wall after the gypsum plaster surface coating had been applied.

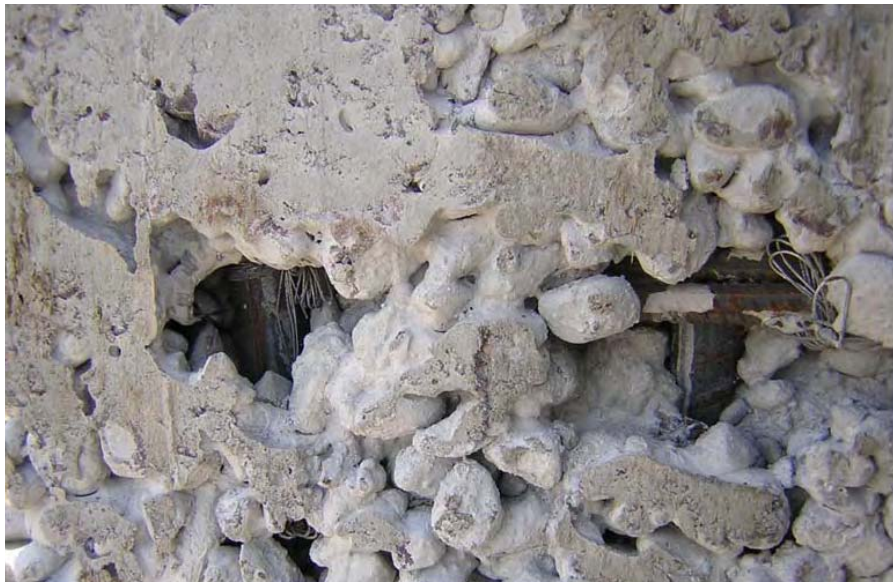
**Site Photo 7. Honeycombing and exposed rebar in concrete on Level 1.
Photo provided by USACE.**

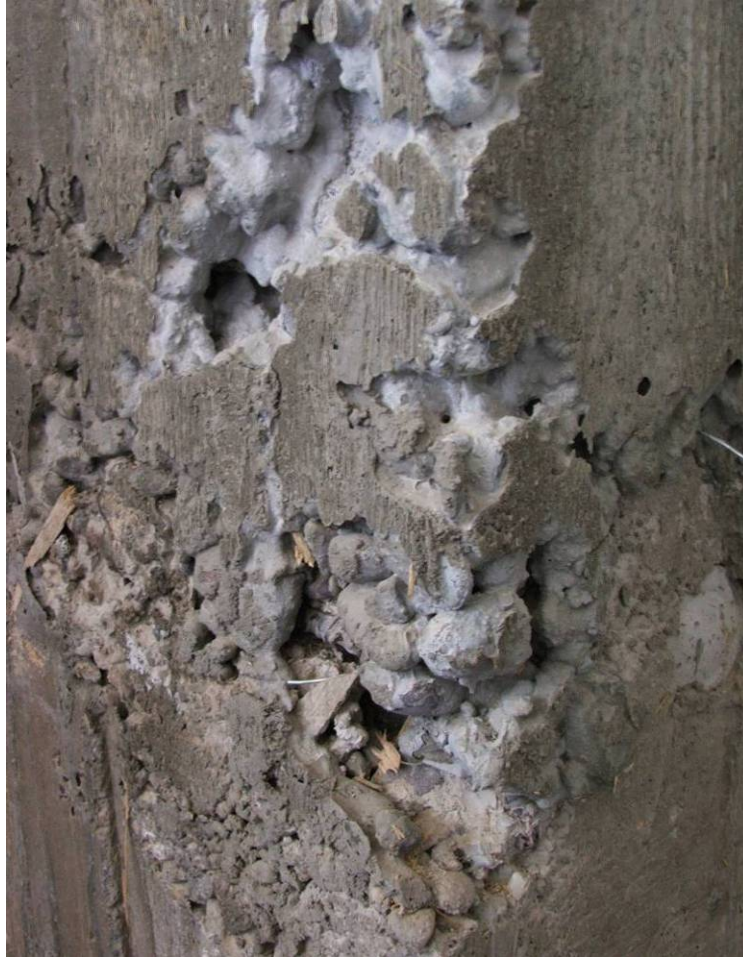
Site Photo 8. Honeycombing on Level 2 column

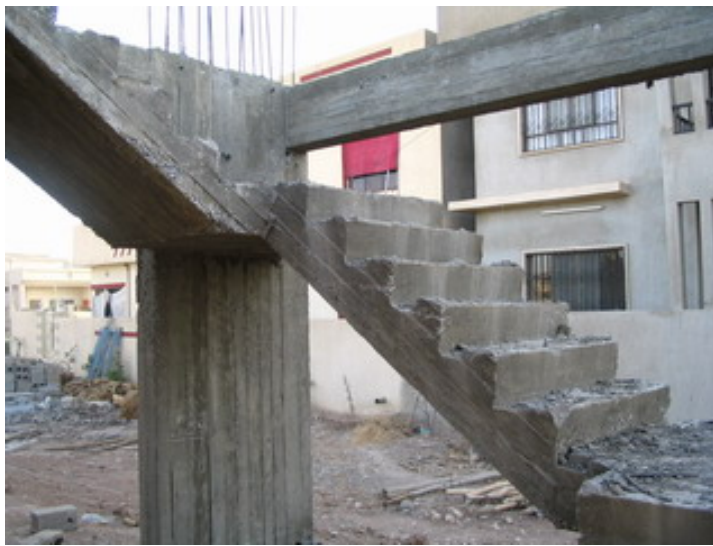
The design required two reinforced concrete staircases on each side of the fire station, serving levels 1-4. Reinforced concrete walls support the staircases, which are connected at each staircase landing. At the time of our assessment, the structural elements of the staircases were completed, but finish work had not started. Site Photo 10 shows the staircase connections to the shear walls.

**Site Photo 10. Staircase construction and supporting shear wall.
Photo provided by USACE.**

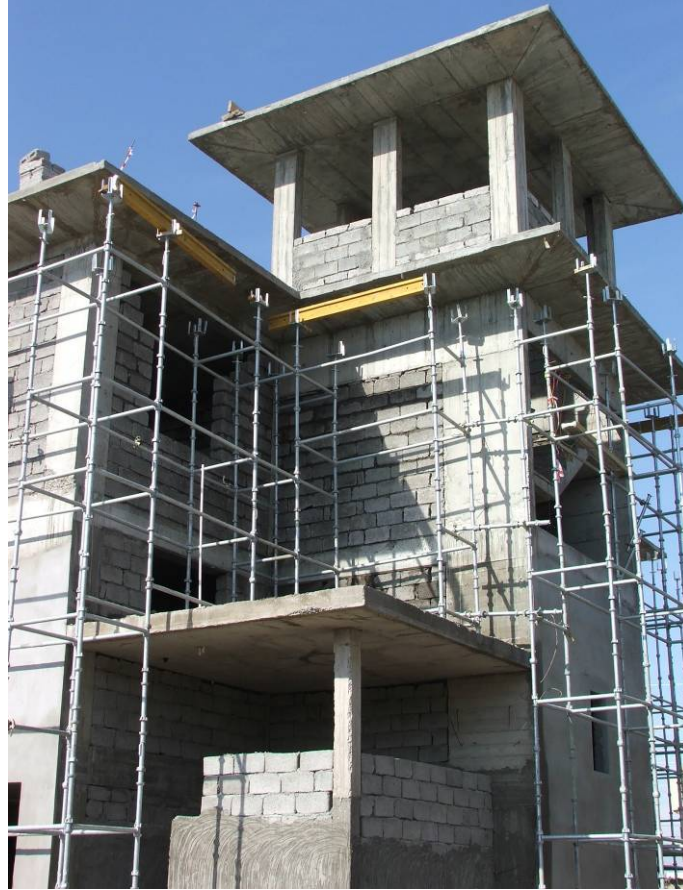
Site Photo 11. Exterior view of staircase # 1

We inspected the staircases from level 1 to the roof level and determined the rise and run of the steps were adequate and consistent with the design.

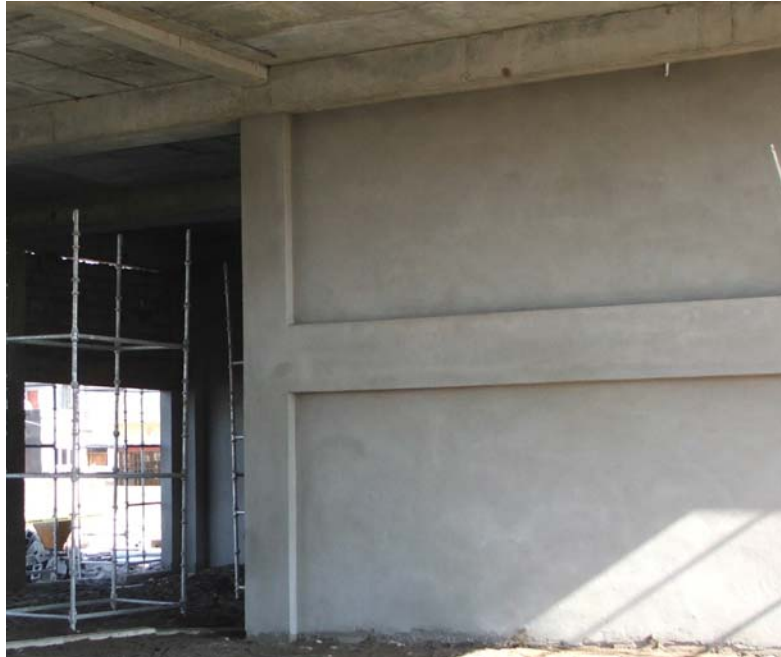
Site Photo 14. Finish coating applied to concrete surfaces on Level 1

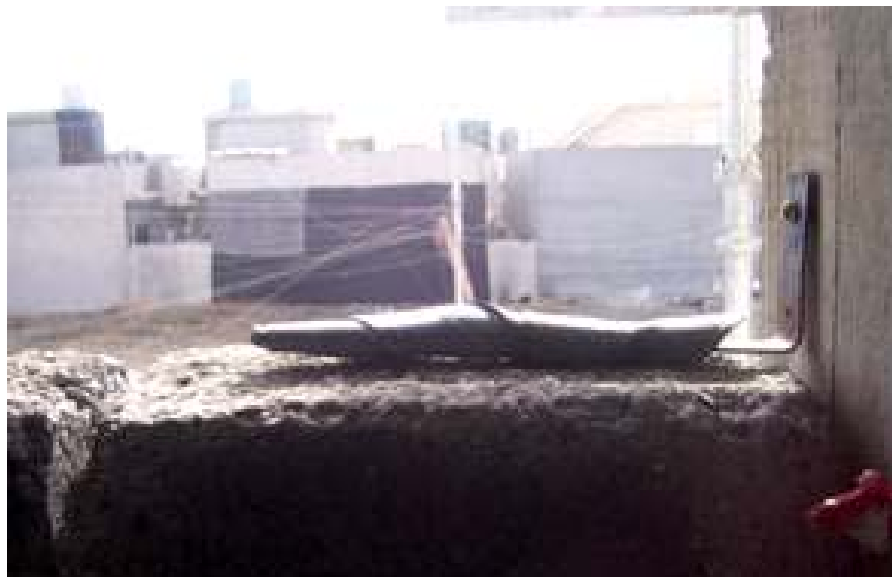
We reviewed prior site reports to determine if the contractor documented examples of the tie-in connections. Site Photo 15 taken from the contractor's 25 November 2005 site report shows the tie-in for the concrete block walls to the supporting wall. Our observations of the concrete wall work underway at the time of our assessment indicated the contractor is complying with the design standard.

**Site Photo 15. Concrete block wall tie-in connection to structural frame.
Photo provided by USACE.**

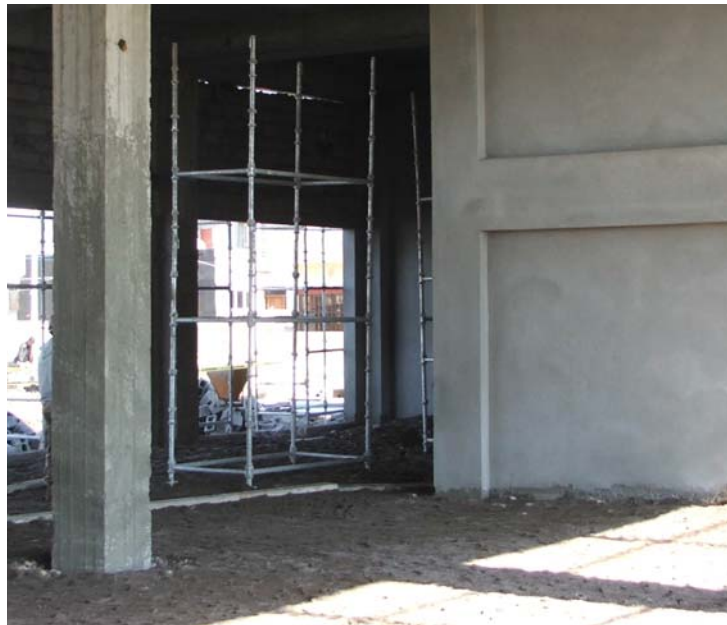
The design specifications for the reinforced concrete floor on Level 1 required a 200 mm thick reinforced concrete slab over a 150 mm thick consolidated hardcore (crushed aggregate) base. A damp proof membrane separates the hardcore and concrete. In addition, to fill in the voids within the hardcore and to create a smooth surface, the design called for a thin layer of fine material over the hardcore. At the time of our site assessment, the hardcore installation was in progress in Level 1. In the fire truck and SUV parking bays, the contractor had placed the hardcore and covered it with a layer of fine material. In the other areas, the hardcore was in place, but had not yet been covered with the fine material layer. Site Photo 16 provides an illustration of the fine material covering the hardcore in the fire truck parking bays. The work in Level 1 appeared to meet the contract requirements.

Site Photo 16. Base Preparation in Level 1 prior to floor slab construction
