SHEILE PRIMARY SCHOOL
DAHUK, IRAQ

SIGIR PA-06-038
APRIL 5, 2006

SUBJECT: Report on Project Assessment of the Sheile Primary School in Dahuk, Iraq
(Report Number SIGIR-PA-06-038)

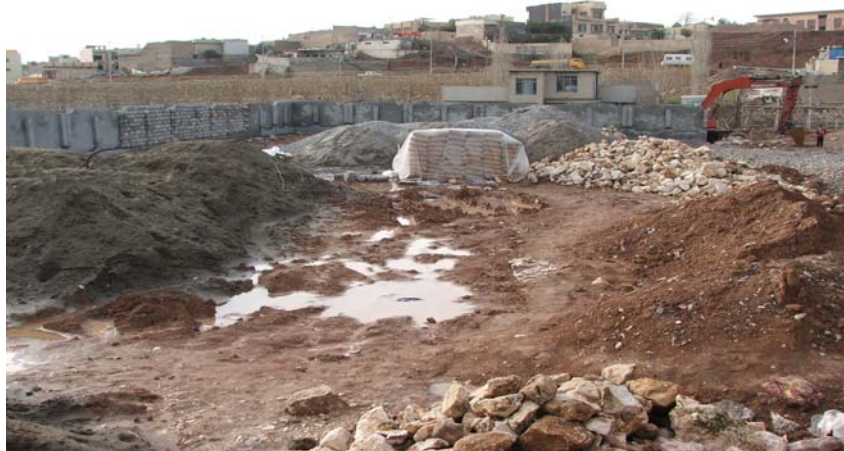
At the time of our assessment, site preparation for the buildings was completed. The garden areas in front of the school and the play yard were still being used as a staging area for construction materials and had not been completed. Site Photo 2 shows the condition of the garden area (with the play yard in the background) at the time of the assessment.

Site Photo 2. Garden area at the time of the assessment on January 24, 2006.

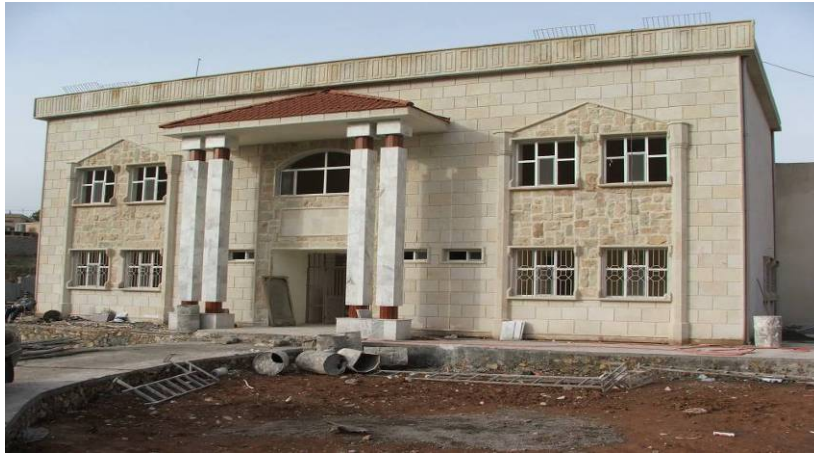
Construction of the main school building and the auxiliary buildings was completed and included installation of the plumbing, electrical circuitry, and fixtures. Tiling inside both buildings was completed along with painting, both inside and outside. Window frames were installed throughout and glass was partially installed. Touchup painting was underway on both buildings. Site Photo 3 shows the completed work on the front exterior of the building at the time of the assessment.

Site Photo 3: Front of the building at the time of the assessment

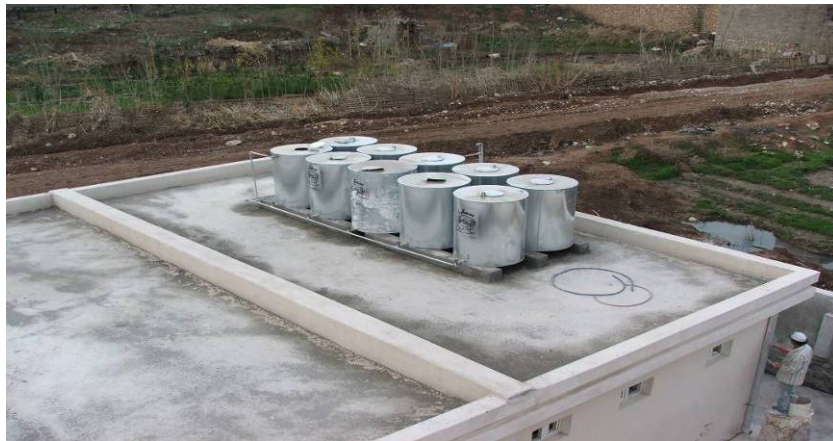
Water tanks, plumbing, electrical circuitry, and associated fixtures were installed but not yet operational because the electricity had not been connected. Ten water tanks were installed on the top of the auxiliary building and connected to the main water supply from the city (Site Photo 4). Six eastern style toilets were installed in both the girl's and boy's restrooms and four faucet handwash areas were installed outside each restroom. Three additional water tanks, also connected to the city water supply, were installed on the roof of the main building to provide service to the faculty restrooms. The men's and women's restrooms are furnished with two water closets each. Ceiling fans and lights were installed in each room. Site Photo 5 shows the handwash areas outside the boy's bathroom in the auxiliary building.

Photo 4. Water tanks installed on roof of the auxiliary building

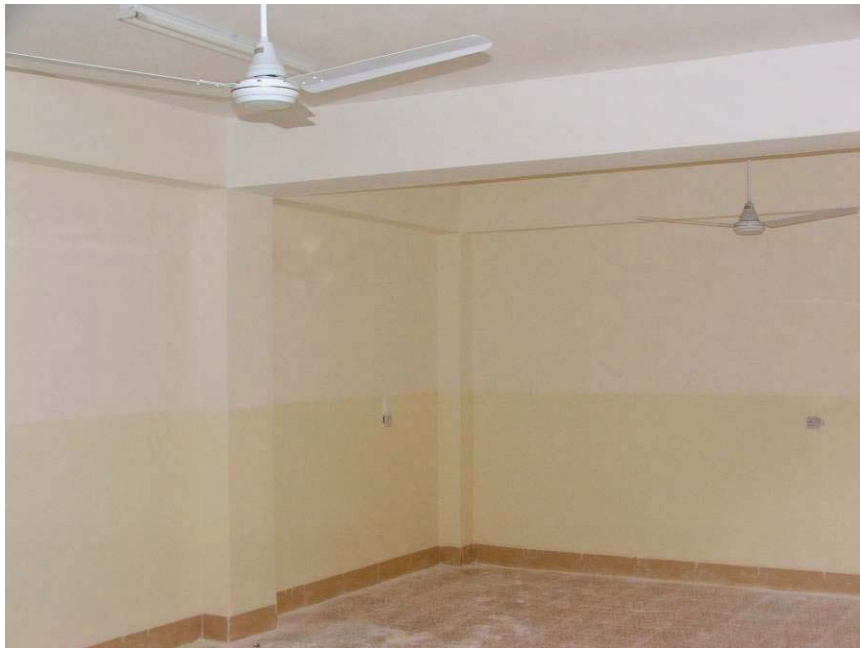
The interior classrooms and the assembly room were complete. Terrazzo tile flooring was installed and walls were gypsum plastered and painted. Electrical outlets, light fixtures, and ceiling fans were installed in each classroom and workroom as shown in Site Photo 6.

Site Photo 6. Ceiling fan installation

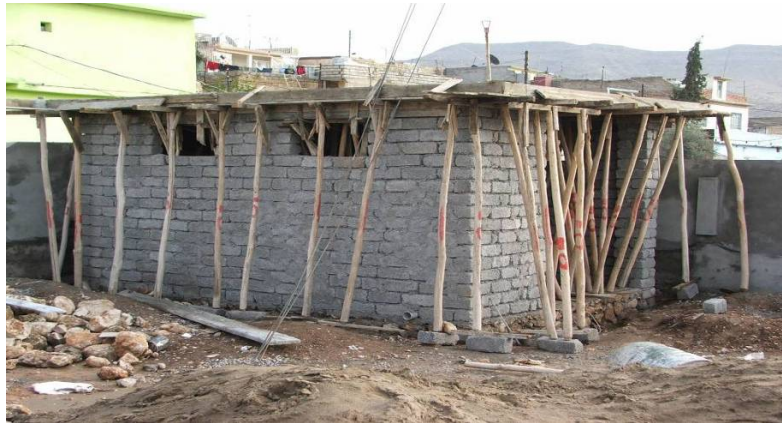
Construction of the generator building was underway at the time of our assessment. The foundation, concrete floor, and cinderblock walls were completed and the concrete roof construction was in progress. Site Photo 9 shows the generator building at the time of the assessment.

Site Photo 9. Generator building

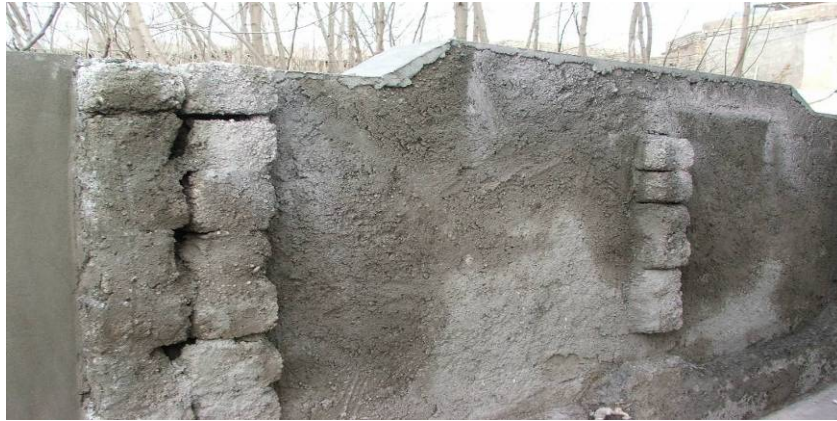
The contract required a 2 meter high concrete block, cement finished perimeter wall and entry gate to enclose the school site. Construction of the perimeter wall was complete except for one section of approximately 6 meters that was used as an entry way to the play yard for delivering materials. The wall was partly covered with cement finish and unpainted. The single gate to the facility was not yet installed. Site Photos 12 and 13 show examples of the perimeter wall construction.

Site Photo 12. Unfinished perimeter wall

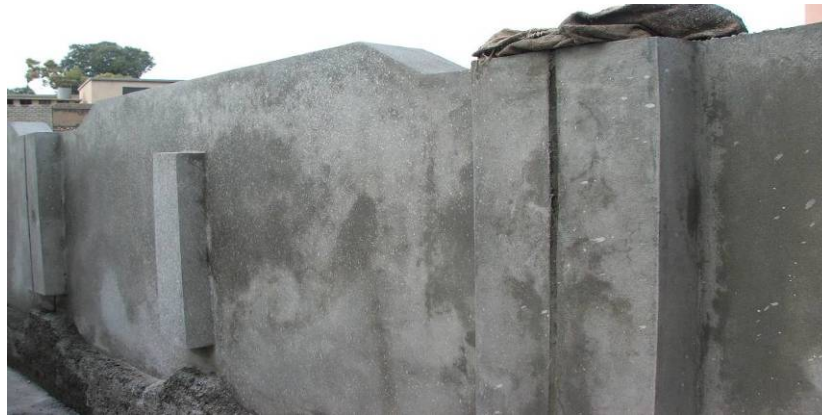
Site Photo 13. Perimeter wall with unpainted cement finish
