AVIATION BASE BUILDING
KIRKUK, IRAQ

SIGIR PA-06-040
APRIL 12, 2006

SUBJECT: Report on Project Assessment of the Aviation Base Building, Kirkuk, Iraq
(Report Number SIGIR-PA-06-040)

Aviation Base Building, Kirkuk, Iraq

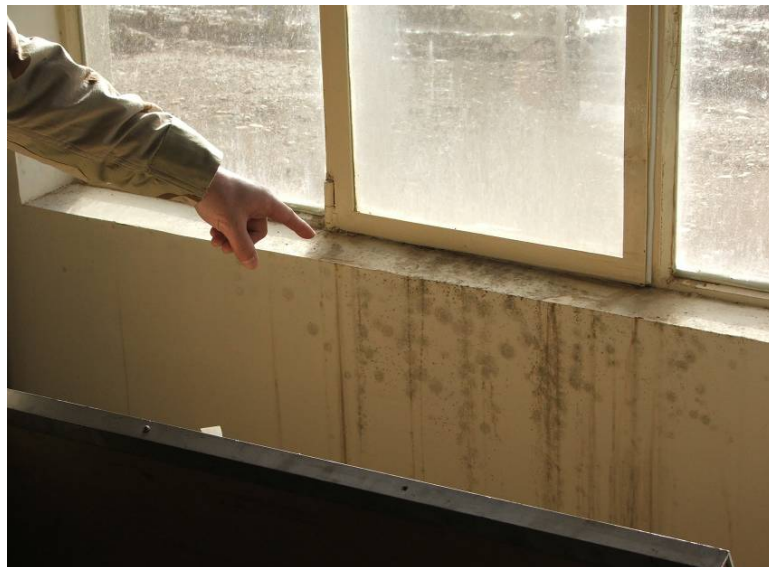
Two days prior to our site visit, the Kirkuk area experienced significant rainfall. During the site visit, we identified water damage within the hangar's offices (Site Photo 9) and bathroom. The cause of the water damage was twofold – the windows were not properly sealed and the outside window ledge was flat, resulting in insufficient drainage. Consequently, the water leaked around or through the window frame into the hangar office rooms and down the wall (Site Photo 9) and onto the floor (Site Photos 10 and 11). The contractor's project manager was on site during the assessment and stated the problem was being addressed. The contractor was in the process of drilling drain lines on the outside of the windows (Site Photo 12).

Site Photo 9. SIGIR Engineer pointing out water leakage

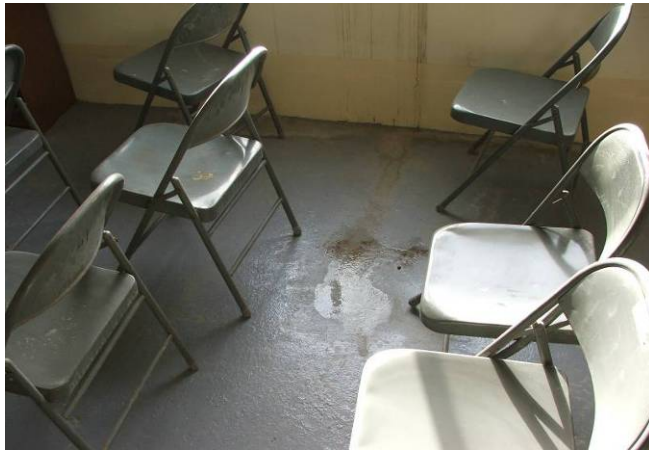
Site Photo 10. Water on floor because of window leakage

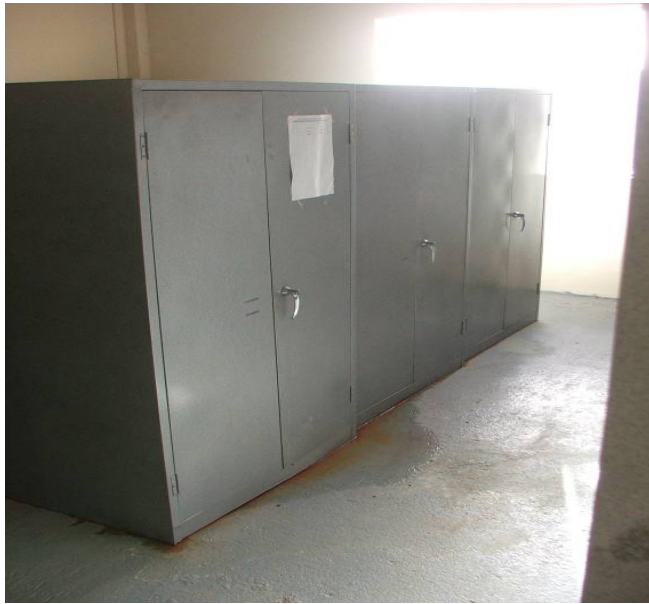
Site Photo 11. Leaking water on classroom floor

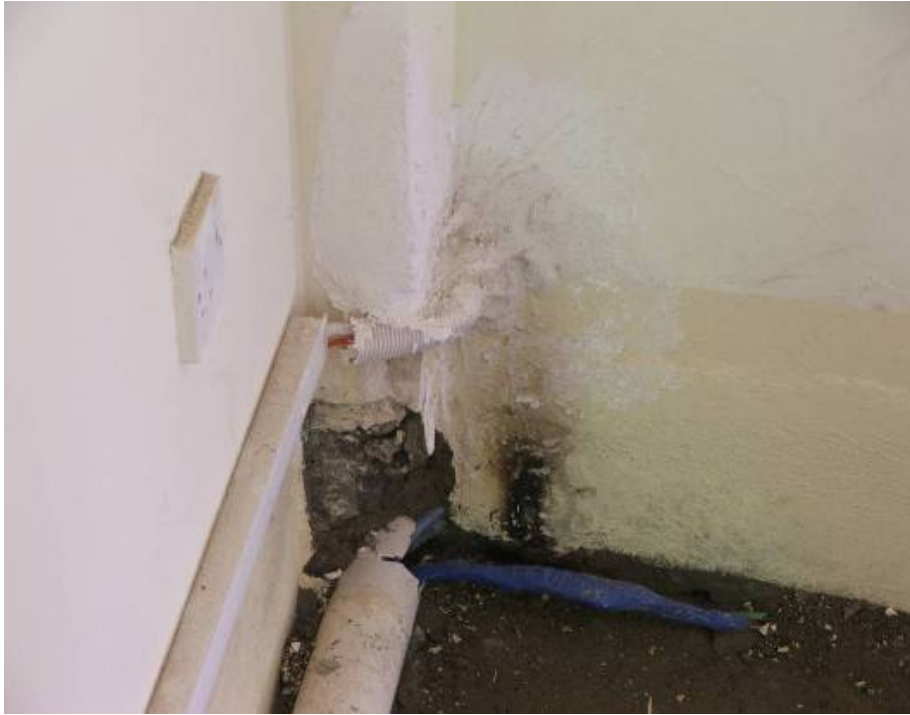
During the site assessment, USAF personnel pointed out an area of the aviation hangar which was scorched because of a fire due to an electrical short circuit. Site Photo 13 shows the burn from the fire and the partial repair to the wiring problem. Additional repairs will be required to ensure another short circuit will not occur in the future. Further, in mid-December 2005, upon moving into the aviation hangar, the USAF representative stated that he had to point out to the contractor that the wiring in one of the offices was not installed correctly and ultimately had to be re-done.

Site Photo 13. Small fire damage and repair to the wiring

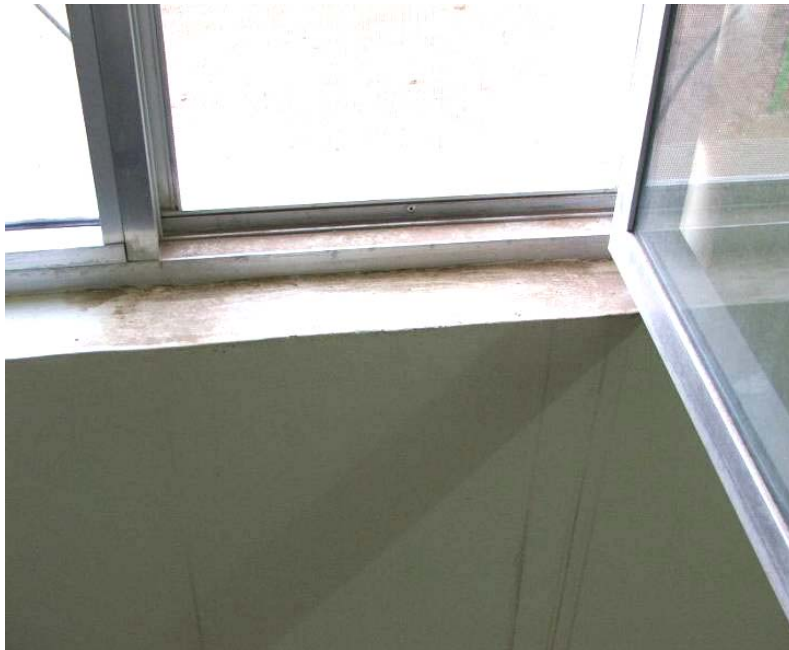
The first floor provided the Iraqi Air Force with living quarters. Currently, each room housed four Iraqi Air Force personnel with each person provided a bed, a metal locker, and lighting above the bed (Site Photo 18),. In addition, each room consisted of two windows a split air conditioning (A/C) unit, two ceiling fans (Site Photo 19), and fixed connections for all electrical equipment (Site Photo 20). We identified water leaking from windows in the living quarters (Site Photo 21) and office spaces, similar to the problems found in the aviation hangar.

Site Photo 21. Close-up view of water leaking through window

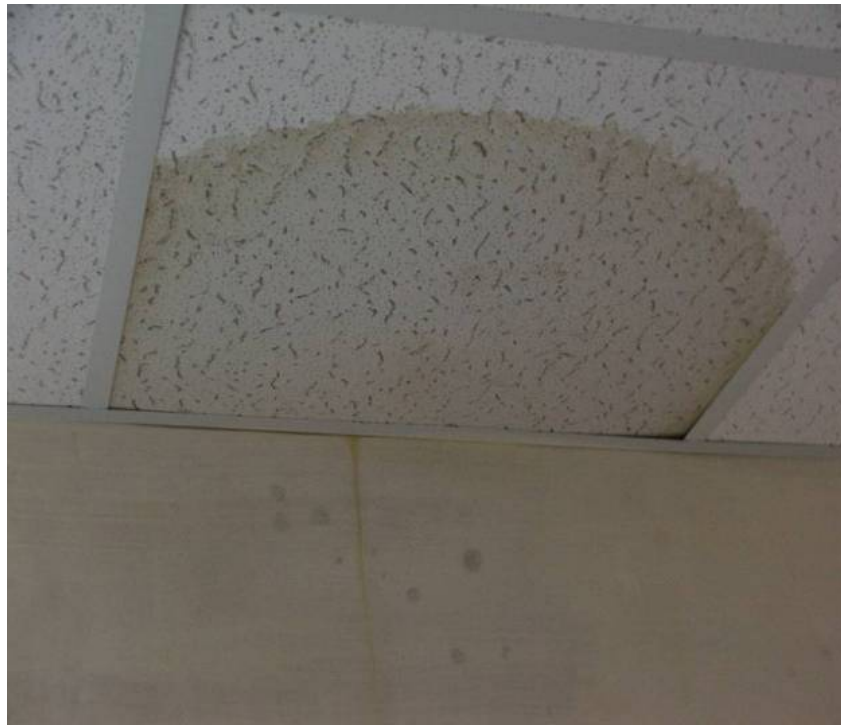
We identified plumbing issues on the ground and first floors. For example, water leaked from the first floor restroom through to the ground floor ceiling, damaging the ceiling tiles (Site Photos 27 and 28).

Site Photo 27. Evidence of water leakage

The contractor responded to the letter by making repairs under the contract’s warranty. We observed some corrective actions during the site visit. As mentioned in the site assessment section of the report (Site Photo 29), the contractor has removed the bathroom tiles to identify the cause of the leak and will correct the damage to the ground floor ceiling that was caused by the leak.

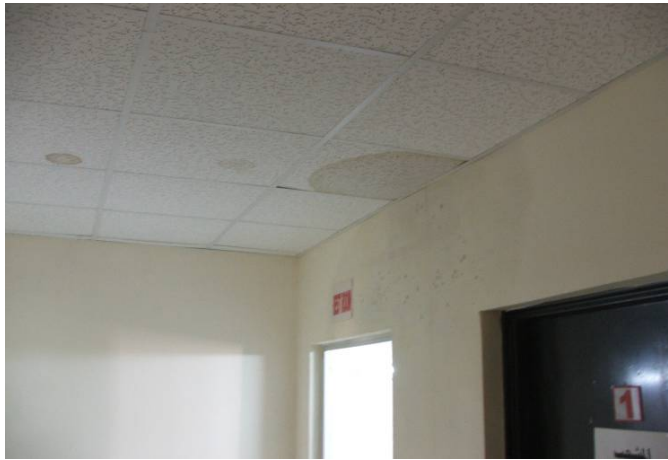
Site Photo 28. Example of water leakage

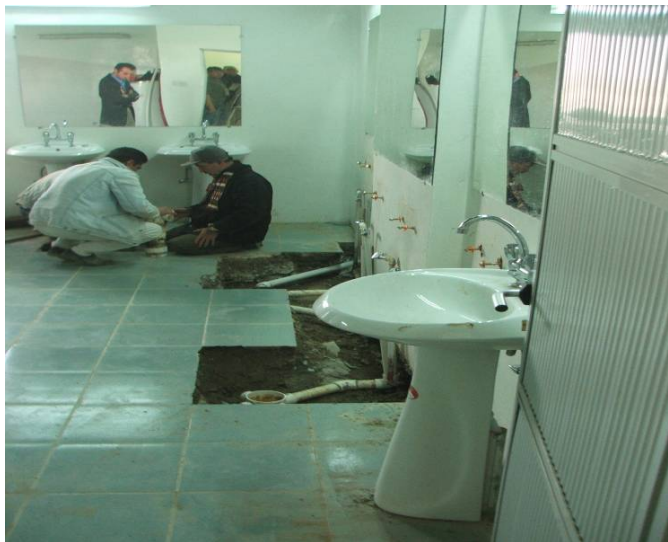
In addition, in the first floor restroom, the contractor removed floor tile in an effort to determine the cause of the leak (Site Photo 29).

Site Photo 29. Floor tiles removed to determine cause of leak

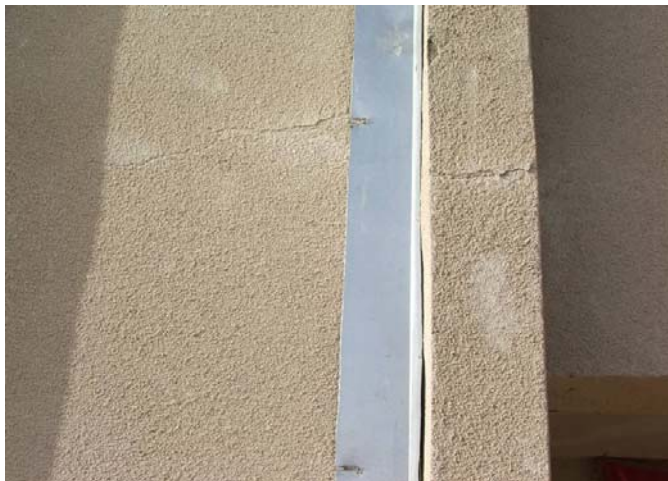
During the site assessment, we also identified minor construction issues that the contractor needs to correct under the contract's warranty. For instance, there were cracks in the outside wall stucco (Site Photo 30).

Site Photo 30. Cracks in the outside wall stucco
