PRIMARY HEALTH CARE CENTERS
NUMBERED KE-01, KE-02,
KE-03, KE-04, AND KE-05
KIRKUK, IRAQ

SIGIR PA-06-042
SIGIR PA-06-043
SIGIR PA-06-044
SIGIR PA-06-045
SIGIR PA-06-046

SUBJECT: Report on Project Assessments of Primary Health Care Centers Numbered
KE-01, KE-02, KE-03, KE-04, and KE-05 in Kirkuk, Iraq (Report Numbers
SIGIR-PA-06-042, PA-06-043, PA-06-044, PA-06-045, and PA-06-046)

Primary Health Care Centers Numbered KE-01, KE-02, KE-03, KE-04, and KE-05 Kirkuk, Iraq

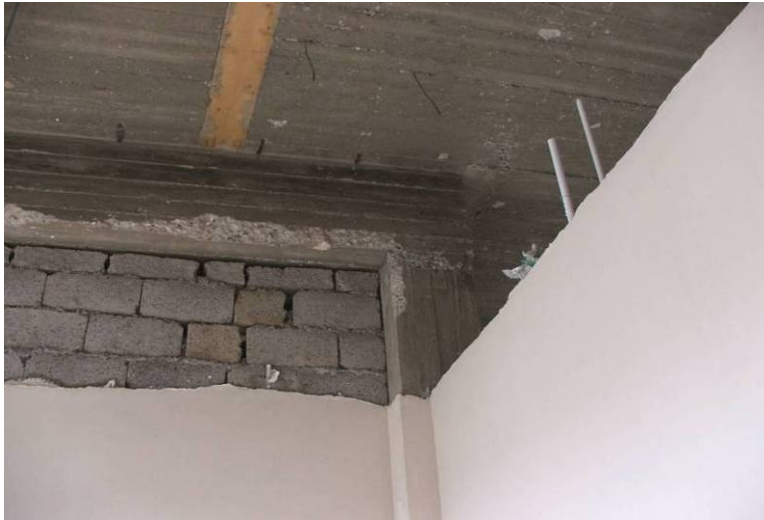
We identified what appeared to be concrete segregation, honeycombs, and reinforcement bar exposure on the surface of the load-bearing reinforced concrete ceiling beams (Site Photo 1 and Site Photo 2). We observed some significant discrepancies with the columns, such as columns with chipped concrete (Site Photo 3) and a column that was not plumb (Site Photo 4).

Site Photo 1. Load-bearing ceiling beam (PHC Hai Alasra Wa Al Mafqoodeen)

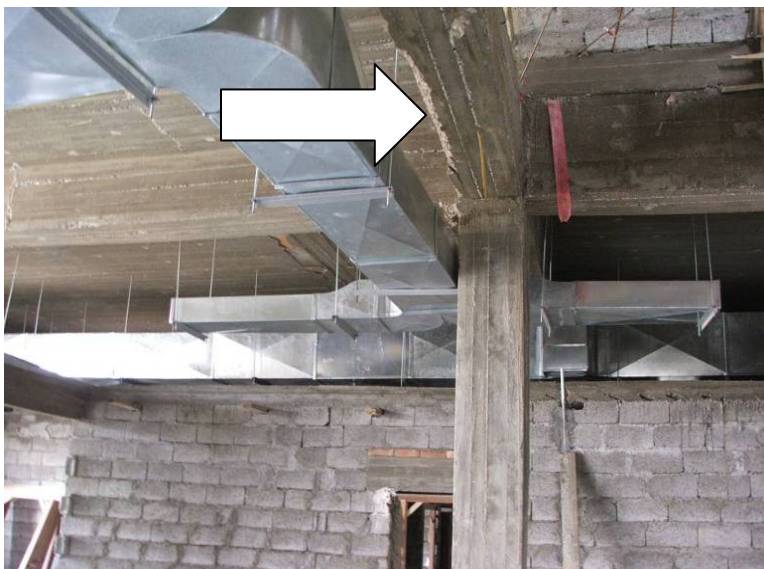
Site Photo 2. Honeycombing on ceiling beam (PHC Hai Alasra Wa Al Mafqoodeen)

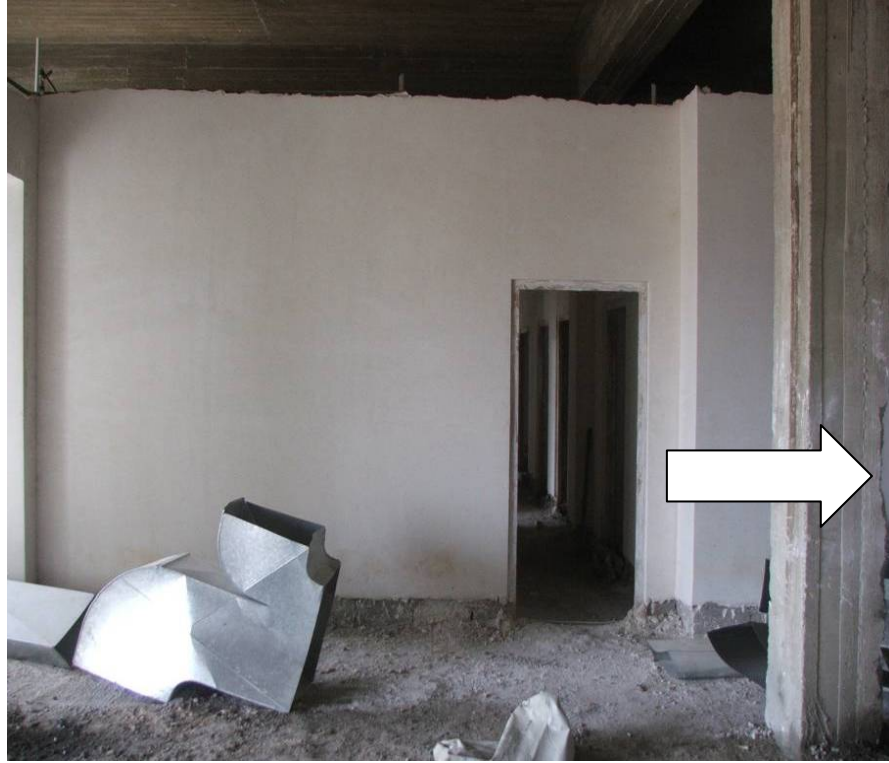
Site Photo 3. Honeycombing of concrete column (PHC Hai Alhajjaj)

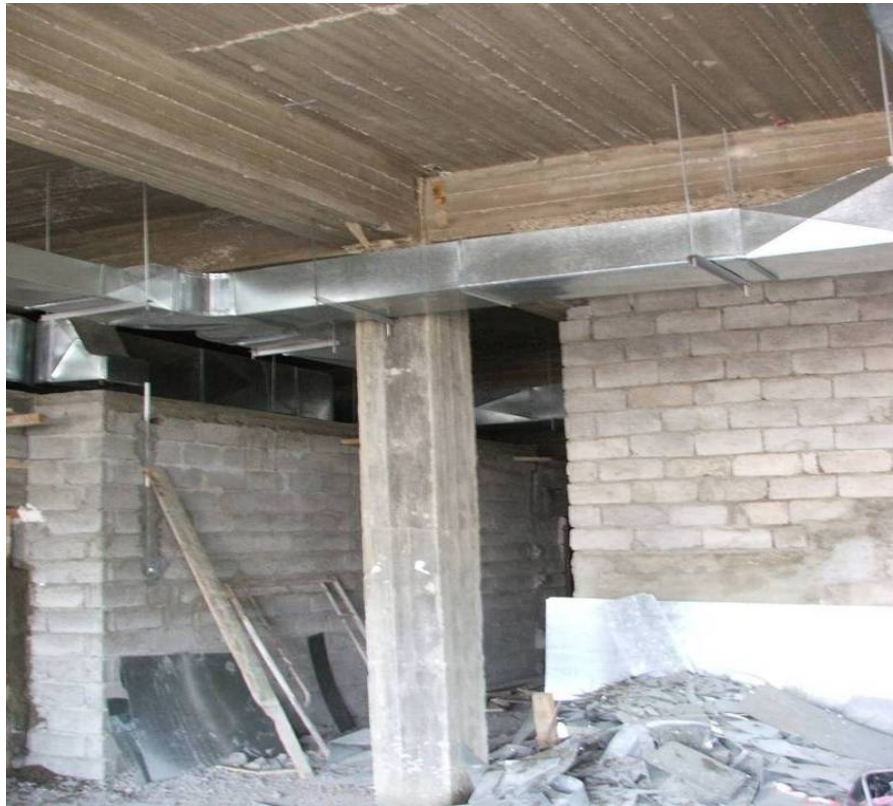
Site Photo 4. Column that is not plumb (PHC Hai Alasra Wa Al Mafqoodeen)

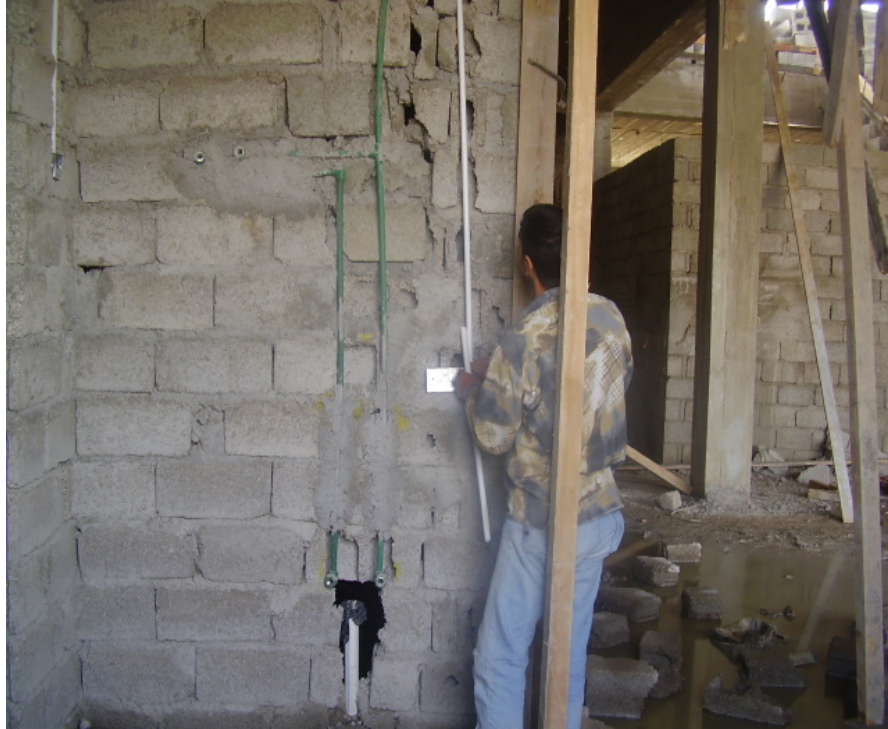
At the time of the assessment, some cinder block walls had been constructed and then plastered with gypsum. We identified numerous defects in workmanship of the nonload-bearing walls such as gaps in the walls, the use of broken blocks or other materials, and improper and uneven block placement. For an illustration of poor workmanship with block work, see Site Photo 5. From the contractor and USACE documentation available, it appears the poor block workmanship was not corrected before the walls were plastered over with gypsum. The gaps in the wall of Site Photo 6 are apparent by the sunlight shining through the pieces of the far wall. Site Photo 1 is also an example of gypsum plasterwork applied to a block wall with unfilled gaps in between the blocks.

Site Photo 5. Example of poor block laying (PHC Hai Tis'een) (Photo courtesy of the USACE)

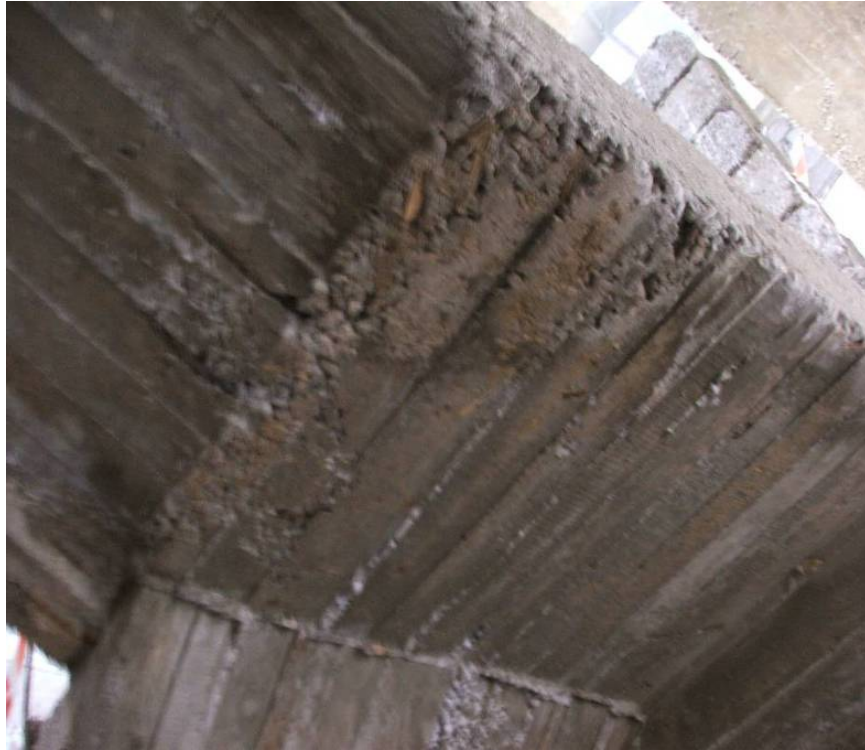
Site Photo 10. Concrete segregation underneath stairwell (PHC Hai Al Wasily)

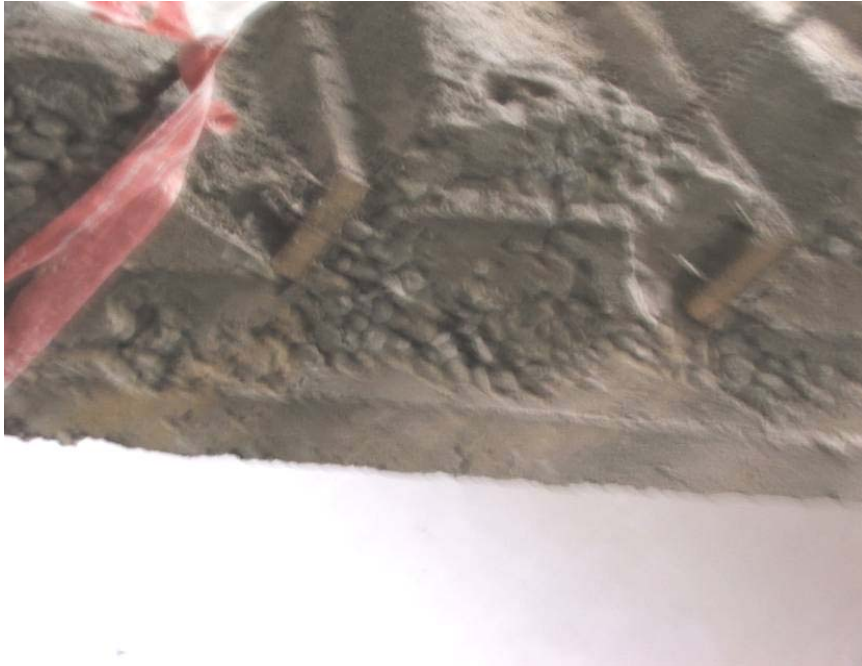
Site Photo 12. Close-up view of concrete segregation on stairwell (PHC Hai Al Wasity)

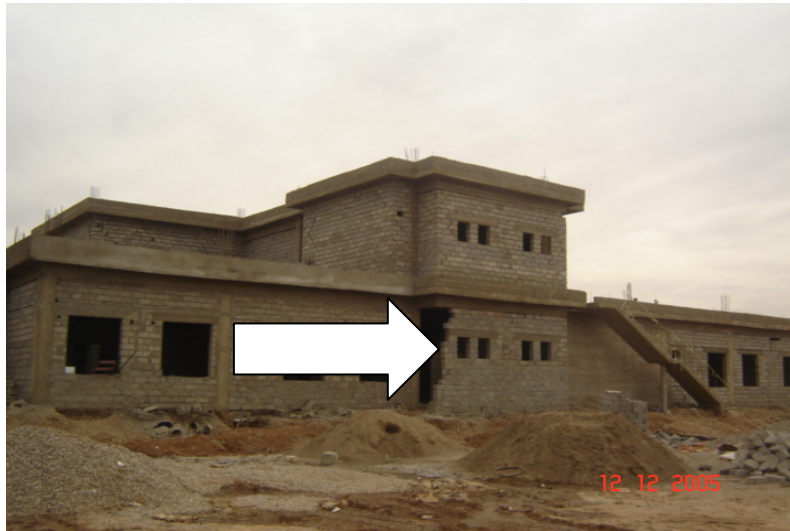
Site Photo 18. View of Hai Alhajjaj on 12 December 2005. According to the PCO construction database, this PHC was 56% complete (Photo courtesy of the USACE)

Based upon Parsons' completion spreadsheet, the PCO construction database, and RMS' completion percentages of 56% and 58%, respectively, for the Hai Alhajjaj PHC (Site Photo 18) appears to be high, considering that the block walls, roofing, utilities and interior finishing work were not complete.

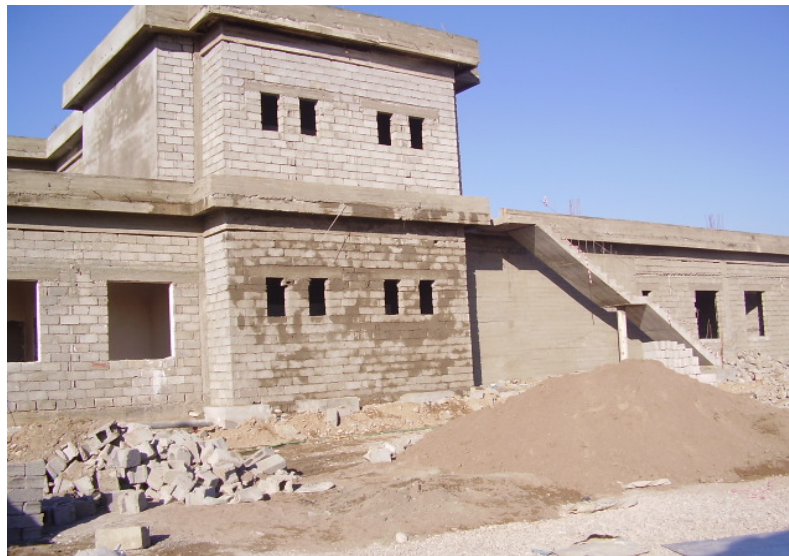
Site Photo 19. View of Shiqaq Hai Musalla on 10 December 2005. According to the PCO construction database, this PHC was 56% complete (Photo courtesy of the USACE)

Based upon Parsons' spreadsheet, the PCO's construction database completion percentage of 56% appears to be high for the Shiqaq Hai Musalla PHC (Site Photo 19). From the available photo and information, the concrete work appears to be completed, which according to Parsons' spreadsheet, puts the PHC at approximately 50% complete.

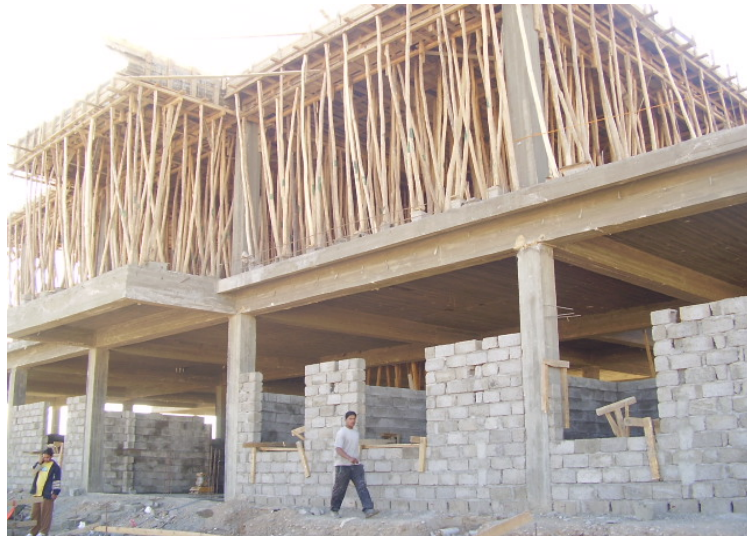
Site Photo 20. View of Hai Tis'een on 7 December 2005. According to the PCO construction database, this PHC was 46% complete (Photo courtesy of the USACE)

The PCO construction database and RMS' completion percentages of 46% and 38%, respectively, for the Hai Tis'een PHC (Site Photo 20) appears high, considering the block work on the ground floor is not complete and that the reinforced concrete work on the first floor is not complete and the upstairs blocking, roofing, utilities and interior finishing had not commenced.

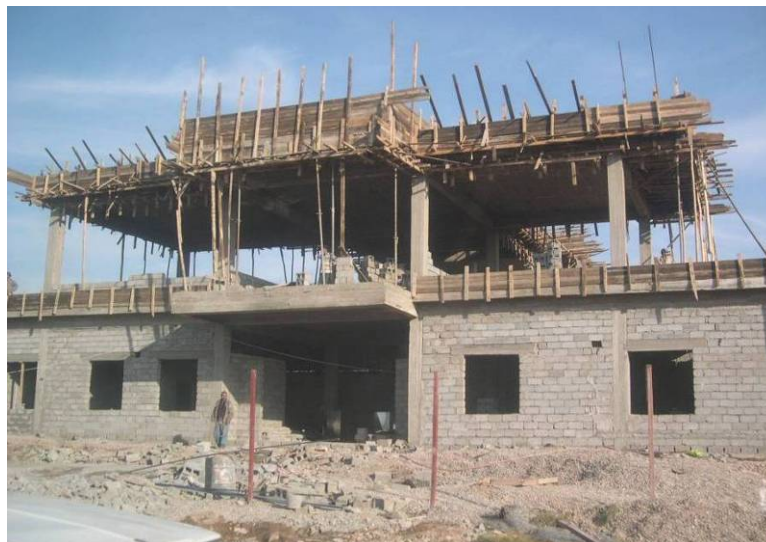
Site Photo 21. View of Hai Al Wasyt on 7 December 2005. According to the PCO construction database, this PHC was 50% complete (Photo courtesy of the USACE)

the reinforced concrete work on the first floor is not complete and the first floor blocking, roofing, utilities and interior finishing work have not commenced.

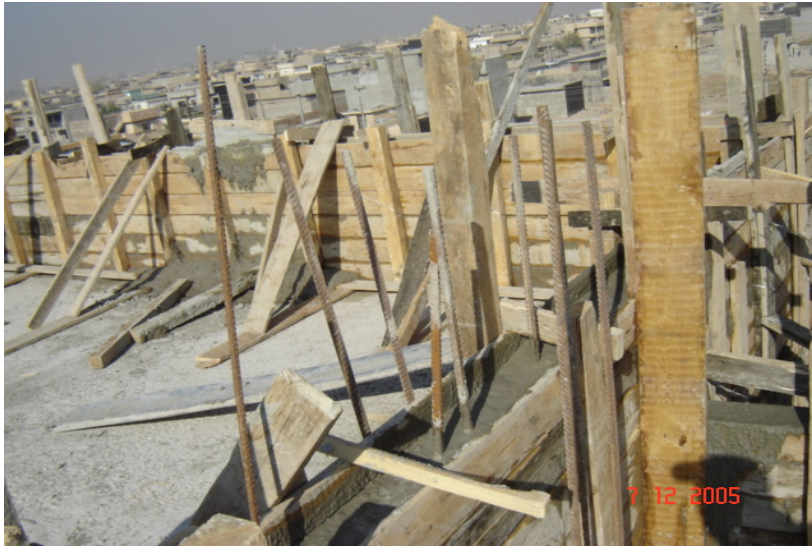
Site Photo 22. View of Hai Alasra Wa Al Mafqoodeen on 7 December 2005. According to the PCO database, this PHC was 50% complete (Photo courtesy of the USACE)

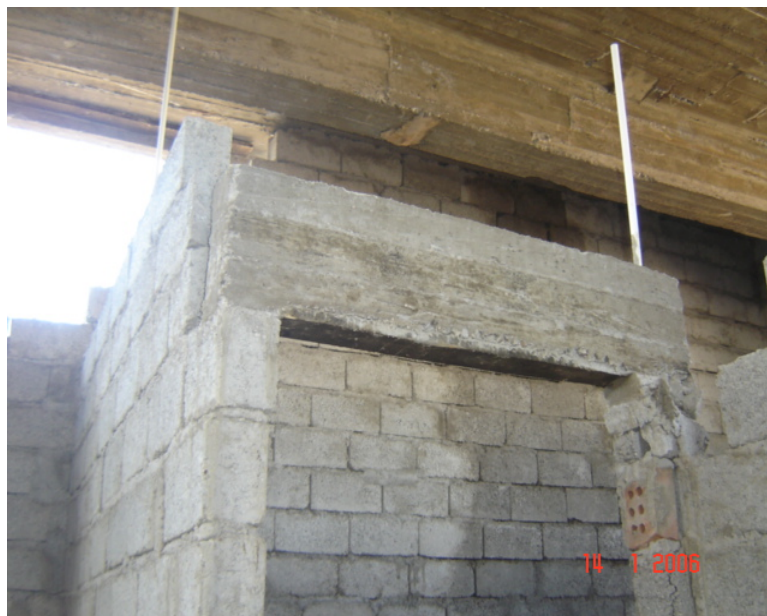
Further, the daily QA reports were not sufficiently complete and accurate. For example, the LN QA daily reports did not always document the existence of construction concerns. Specifically, one LN QA daily report included a photo of poor concrete quality beneath a lintel (Site Photo 23); however, the narrative daily report did not mention this problem nor does it mention if the LN QA engineer brought this problem to the contractor's attention. From reviewing the LN QA daily reports, we were unable to determine if the contractor corrected this problem.

Site Photo 23. Example of a site photo included with the daily report. Taken by the USACE LN QA for PHC Shiqaq Hai Musalla (Photo courtesy of the USACE)

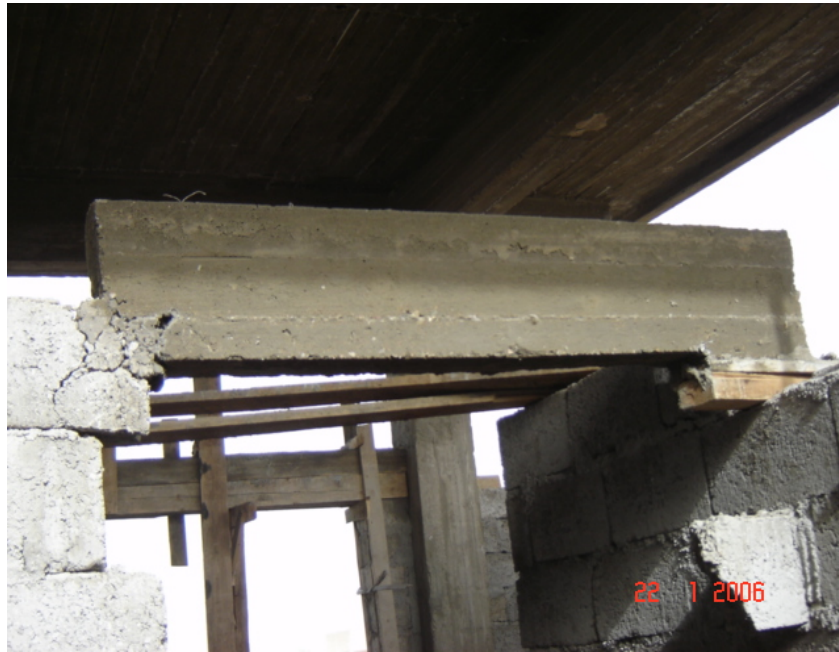
In the instances in which the LN QA engineer documented construction issues within the QA daily reports, there was no certainty that the contractor took corrective actions. For example, on 22 January 2006, the LN QA daily report and site photo documenting the poor installation of a lintel (Site Photo 24). The QA daily report, in the General Remarks section stated, “Some of the lintels have bad installation.” Yet, there is no mention in the daily report that the LN QA addressed this problem with the contractor. The contractor’s QC daily report did not identify this problem and did not mention any discussions with the LN QA regarding this issue. After reviewing the next few days QC and QA daily reports, there was no documentation that the contractor addressed and corrected this issue.

Site Photo 24. Example of a site photo included with the daily report. Taken by the USACE LN QA (Photo courtesy of the USACE)

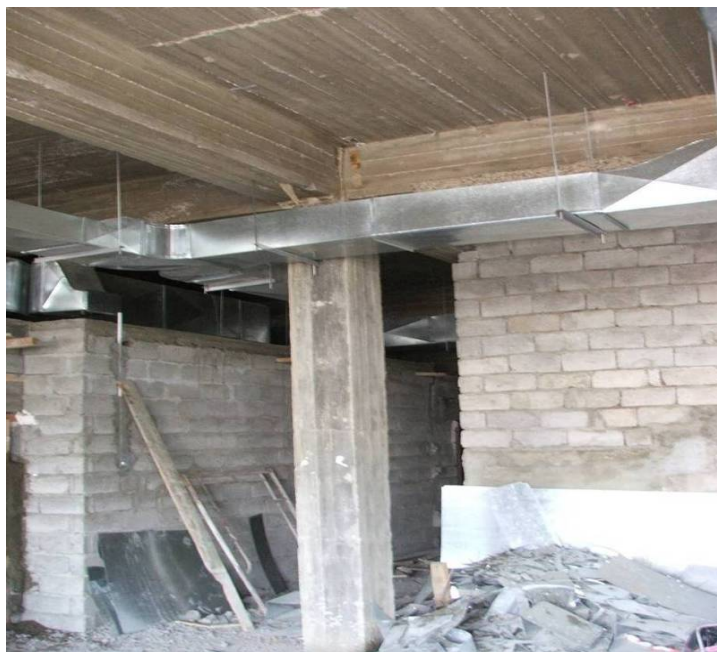
SIGIR Response. We agree that structural integrity is a serious matter. Our site visit identified significant discrepancies with the columns, such as columns with chipped concrete and an interior reinforced concrete column that was not plumb (see Site Photo 4 repeated below). If the Gulf Region Division made inquiries to the contractor’s task manager in October 2005, the site photo from our February 2006 visit documents that the contractor did not correct this issue. According to the Gulf Region Division, the contractor’s LN QCR was to “investigate.” However, the daily QC reports and required deficiency logs do not indicate this problem was ever brought to his attention; consequently, this issue was not adequately resolved. In addition, the fact the LN QCR, who was required to be on site daily, did not identify this issue on his own raises questions about his qualifications for the position. Further, the LN QA engineer, who was required to be on site daily, did not identify this issue, either.

Site Photo 4. Column that is not plumb (PHC Hai Alasra Wa Al Mafqoodeen)

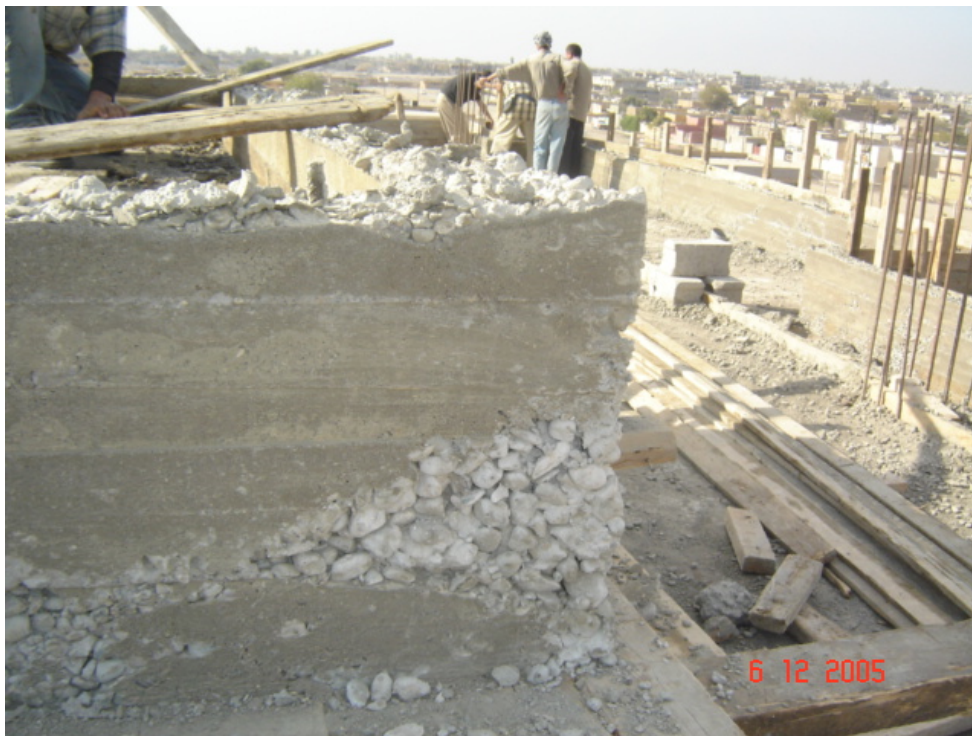
The Gulf Region Division's comments state that, "Poor concrete work has been a significant problem with the PHC contractor's work." However, we found only one instance where the USACE LN QA engineer documented the occurrence of this problem out of all five clinic projects. The LN QA engineer for the Hai Alhajaj PHC provided Site Photo 25 with his daily QA report. The daily QA report stated, "there is segregation appears in the poured parapet." According to the daily QA report, the LN QA engineer answered the question about any verbal instructions given to the contractor with "NO." We reviewed the daily QC reports and there is no mention of any concrete issues raised by the LN QA engineer. In addition, the segregation issue was not listed in the required deficiency log. Therefore, even though the LN QA engineer identified and documented poor concrete workmanship, he did not point the issue out to the contractor. Since the USACE project engineer reviewed the daily QA reports, he should have followed up with the contractor and the LN QA engineer to determine the issues were adequately addressed and corrected.

Site Photo 25. Extensive segregation of concrete in the parapet

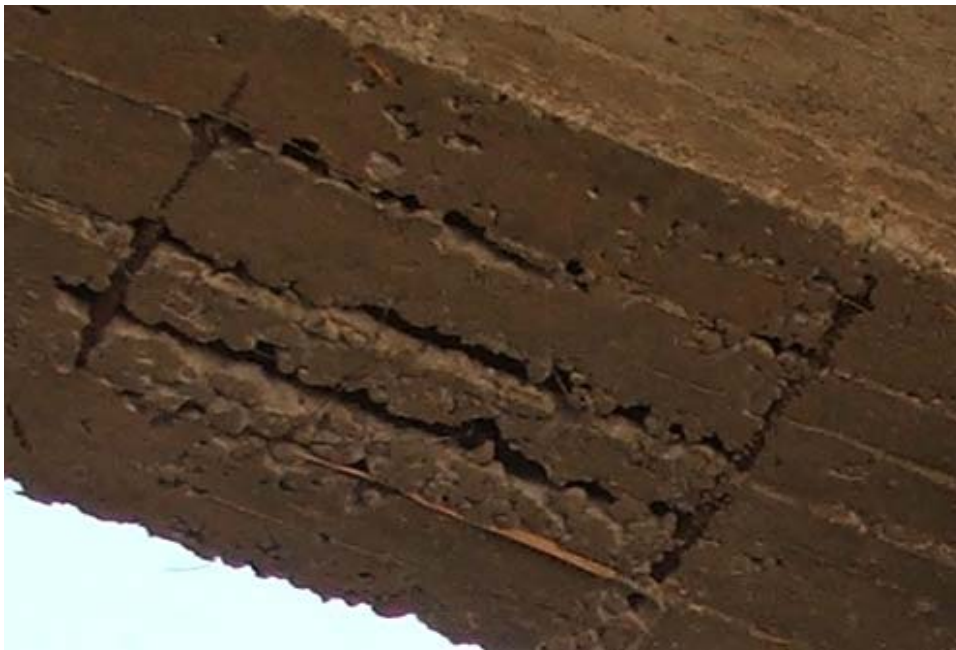
In September 2005, the assessment team met with the Parsons' PHC Task Manager who stated Parsons had become aware of concrete problems throughout the country, which required an analysis to determine potential corrections needed. Parsons provided us with a 21-page presentation, which dealt with the proper pouring of concrete for columns and stairs and potential fixes for "minor" segregation and honeycombing. However, it appears that Parsons' analysis did not identify the significant amount of concrete segregation and honeycombing in the PHCs. One of the techniques for "fixing" the concrete segregation and honeycombing in the columns, beams, and slabs is to put on a "smooth finish." This appears to be similar to the USACE's solution to the issue of poor concrete work on non-load bearing walls, which is to cover it with "mortar or gypsum" and then it will appear "acceptable to the Iraqis."

Site Photo 27. Close-up view of concrete first floor ceiling concrete beam

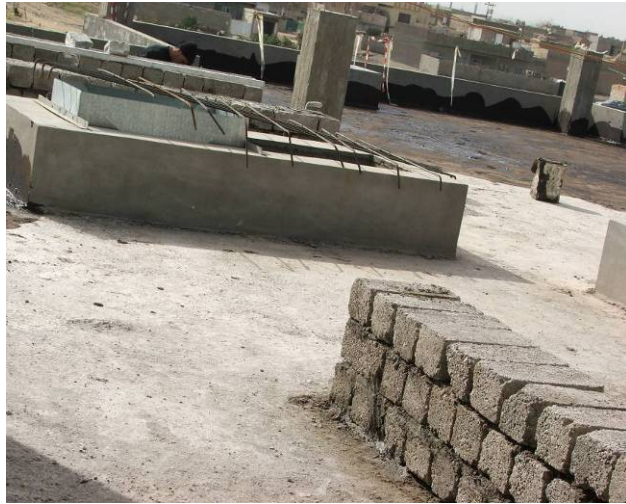
Site Photo 33. Roof partially covered with tar

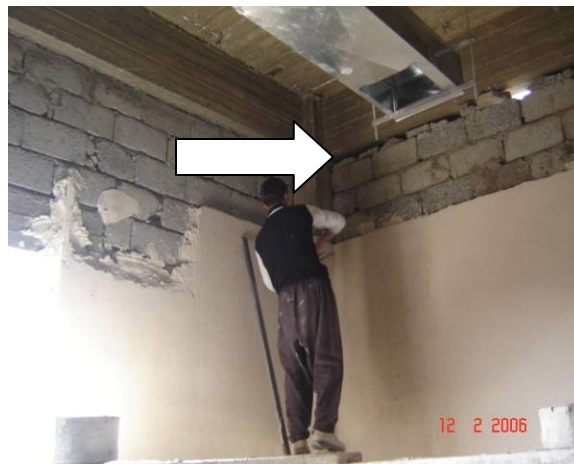
**Site Photo 65. Example of broken and different sized blocks used in wall construction
(Photo courtesy of the USACE)**

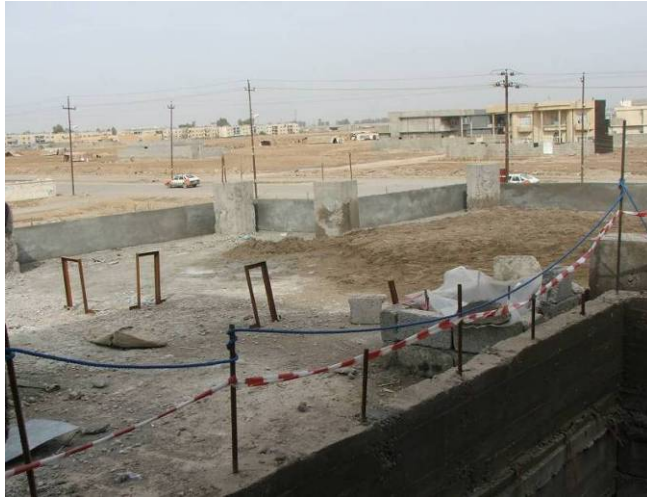
Site Photo 66. Roof in need of cleanup prior to tarring

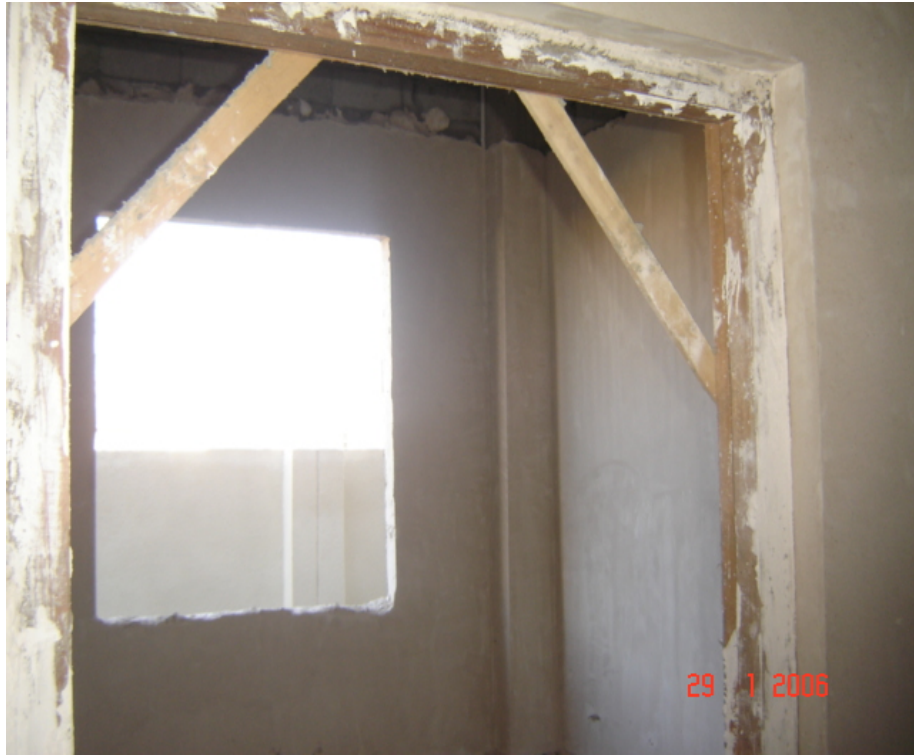
**Site Photo 74. Example of window without window frame and grilles
(Photo courtesy of the USACE)**

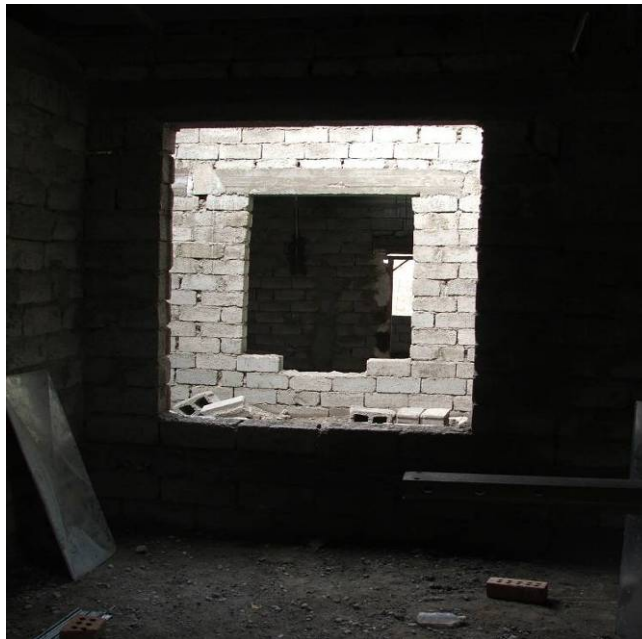
Site Photo 86. Windows without frames
