SUMMARY REPORT
GROUND PROJECT SURVEYS
FOR THE QUARTER ENDED
DECEMBER 31, 2005

SIGIR PA-06-048
APRIL 13, 2006

Summary Report of Ground Project Surveys for the Quarter Ending December 31, 2005

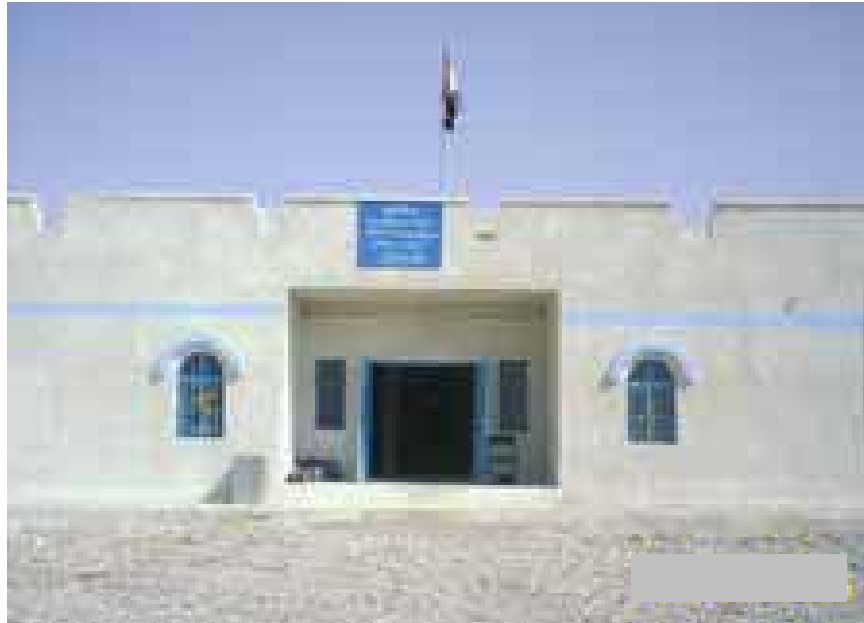
- The front entry gate was inoperative according to reports.
- The floor of the main atrium contained standing water.

Site Photo 1: Exterior view of Project 12137 Border Denial Post

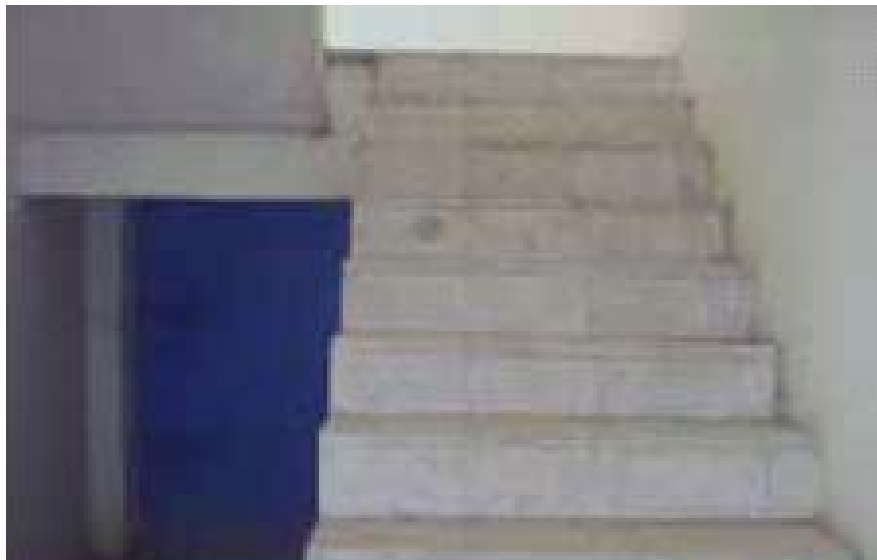
- The interior stairwell was missing handrails (Site Photo 2).
- Cracks were in some interior walls and the external corner tower.

Site Photo 2: Interior stairwell without handrails at Project 12144

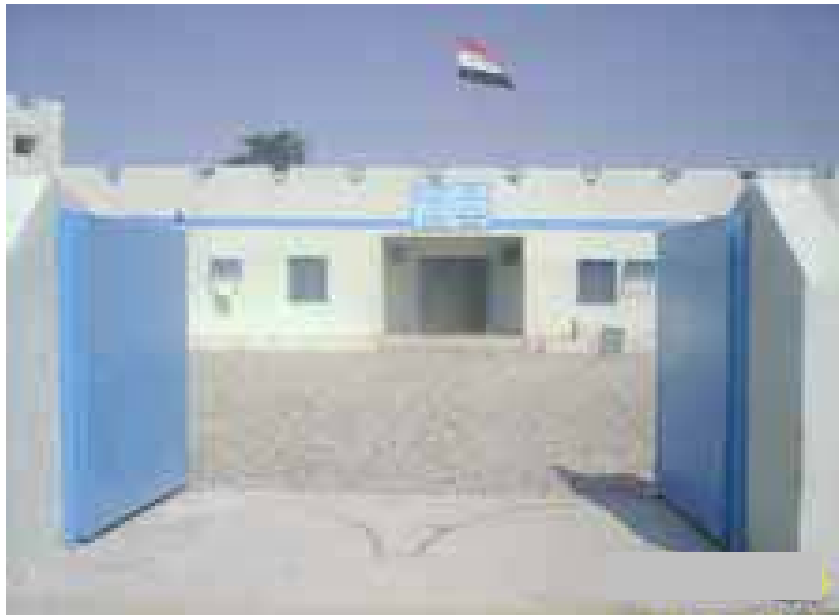
A review of the report and photos provided by the QCQA teams determined that overall, the site associated with Task Order 0034, Project 12161, appeared to be complete and consistent with contract requirements. A perimeter wall surrounded the post, containing the parking area and above ground fuel tank. In addition, there were security bars on the first floor windows and a security cage enclosed the generators. The site also contained above ground water tanks, set on a concrete base, with additional water tanks located on the roof. A septic tank appeared to be located between the berm and outer wall of the post. Site Photo 3 shows the front gate and border post.

Site Photo 3: Front entrance gate and border post Project 12161

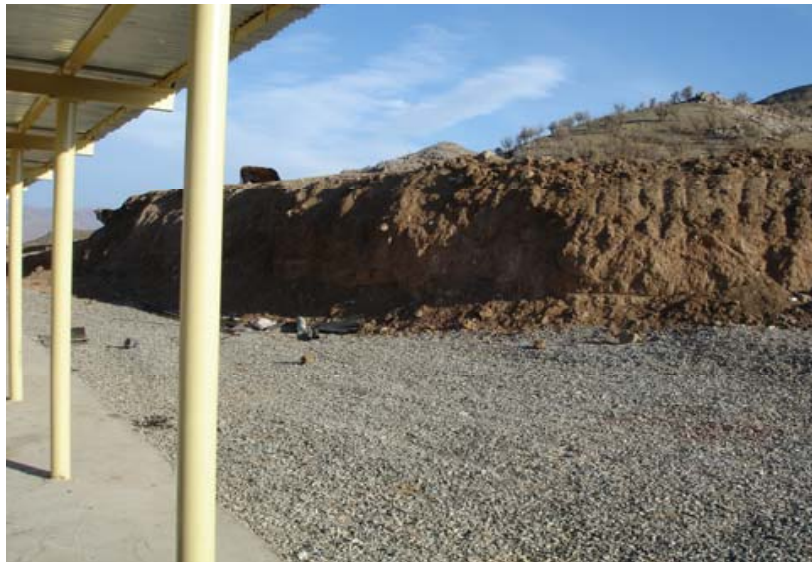
Site Photo 4: Cut bank with no stabilization Project 12787

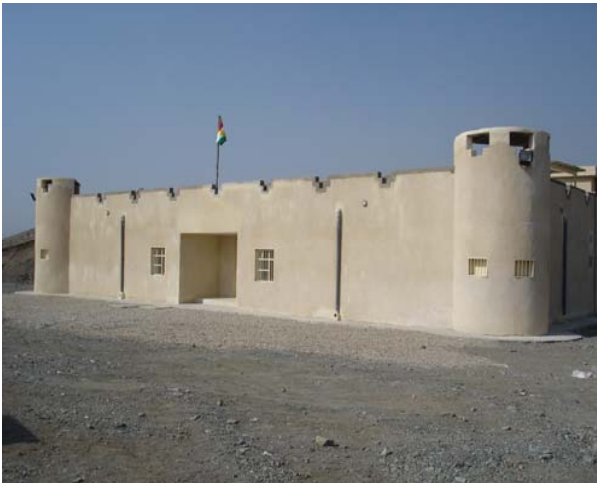
- No perimeter security fences or gates were present. Site Photo 6 shows the front view of project 12840.
- Concrete on the atrium roof showed inconsistent textures, possibly the result of non-continuous pour. Site Photo 7 shows the atrium concrete roof.
- Spot welds on the generator roofing appeared to be poor quality.

Site Photo 6: Front view of Project 12840

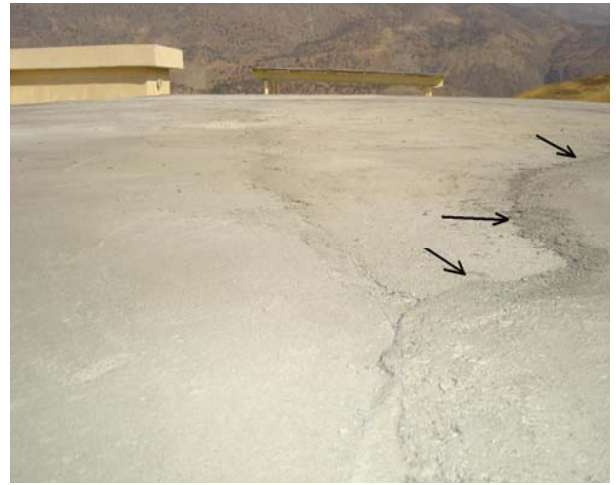
Site Photo 7: Concrete atrium roof showing uneven texture at Project 12840

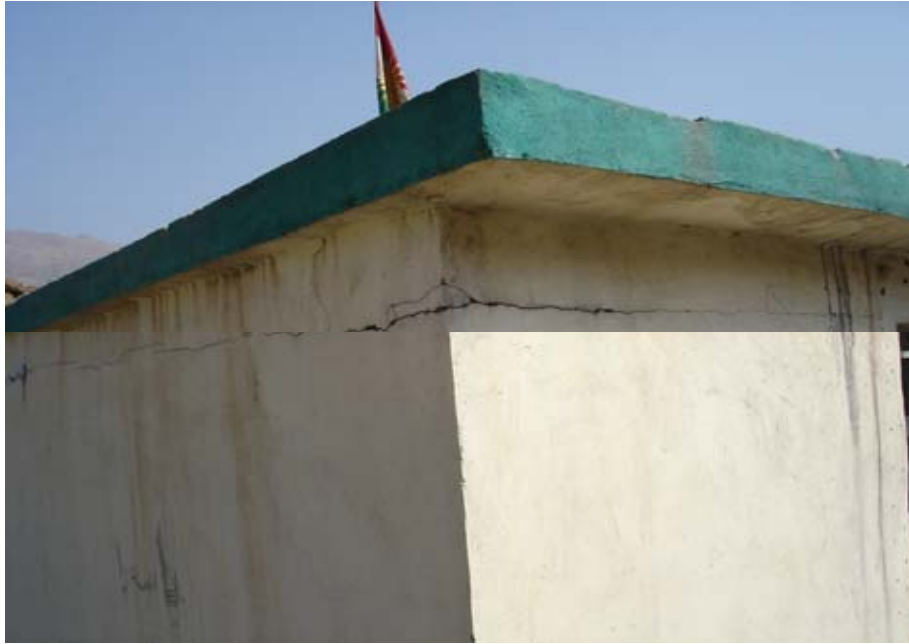
- The site lacked a generator.
- The facility lacked security fences.
- Concrete segregation and re-bar exposure was visible on interior concrete slab ceilings.
- Interior walls showed staining, probably due to water leaking from the ceiling area.
- Extensive cracking was visible on the exterior walls of the building (Site Photo 8).
- The facility showed lack of any recent maintenance or remodeling.

Site Photo 8: Cracks in exterior wall at Project 20565

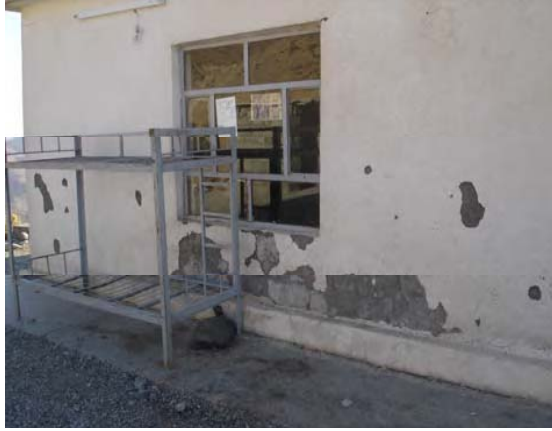
- Although a small generator was on site, fuel storage was not available.
- The plastering of external walls and sidewalks contained cracks and fractures. Site Photo 9 shows the exterior of a building with missing plaster.
- Most of the lights were broken and electrical wires were un-insulated.
- Bathroom fixtures appeared to be inoperative (Site Photo 10).
- The facility lacked security fences.
- The facility showed a lack of any recent maintenance or remodeling.

Site Photo 9: Exterior wall at project at Project 20568

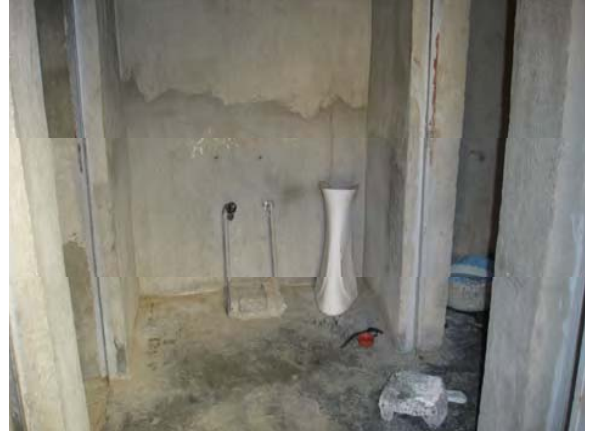
Site Photo 10: Bathroom fixtures at Project 20568

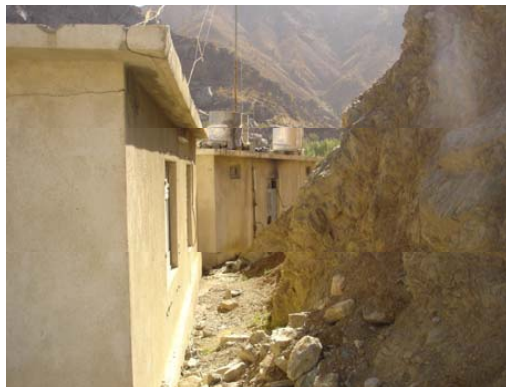
- A slope, created by site leveling, and appearing to be composed of loose material, lacked retaining walls or soil reinforcement. Site Photo 11 shows the cut bank located behind the border post.
- There was no security fence or security lighting, and only one window contained security bars. In addition, the doors appeared to be missing or in need of replacement.
- There were cracks in the building foundation and walls, and one set of stairs was crumbling. In addition, the finish work was in poor condition. Site Photo 12 shows the concrete steps.
- A small generator was on site; however, fuel storage was not available.
- The bathroom was missing some fixtures, and the water and sewer pipes were in need of repair or replacement.
- The facility showed a lack of any recent maintenance or remodeling.

Site Photo 11: Behind border post at Project 20569

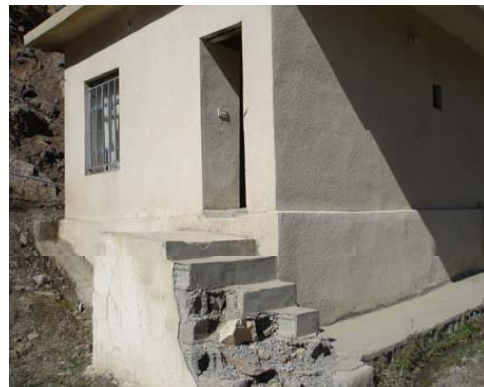
Site Photo 12: Concrete steps at Project 20569

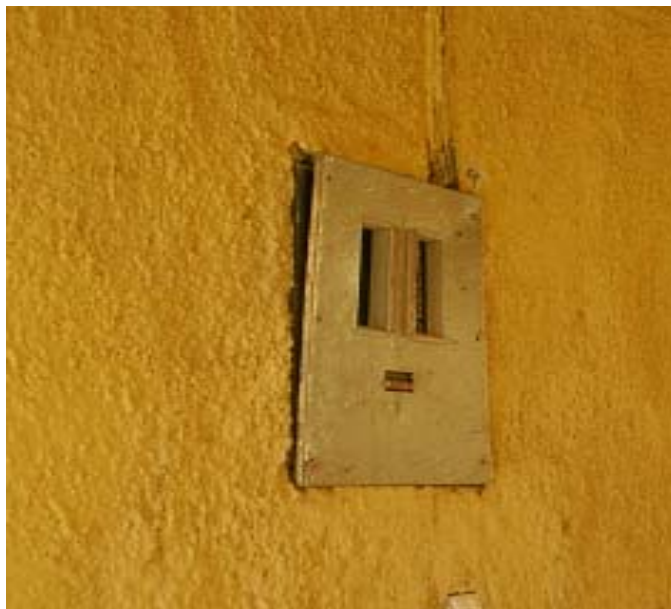
- Interior and exterior wall finish appeared new, however, it was questionable whether repairs were made or walls were just painted over.
- Doors were old and needed replacement. There were no sidewalks.
- Installation of the electrical breaker box was poor. Site Photo 13 shows the electrical circuit breaker panel at Project 10588.

Site Photo 13: Electrical circuit breaker panel at Project 10588

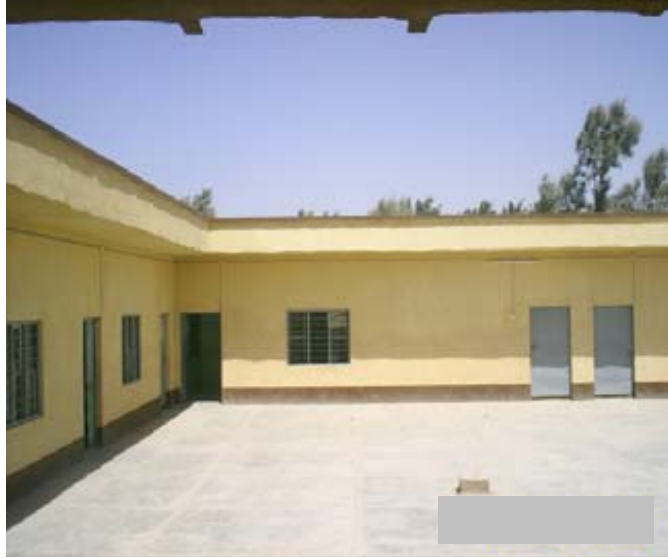
Site Photo 14: Concrete courtyard at Project 10613

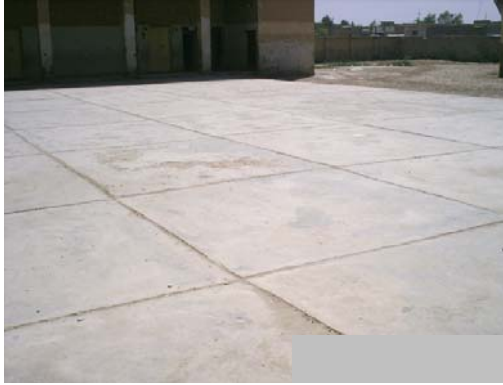
With the possible exception of a new concrete area outside, recent renovations were not obvious. Site Photo 15 shows the concrete courtyard area. We noted the following discrepancies:

Site Photo 15: Concrete courtyard at Project 10630

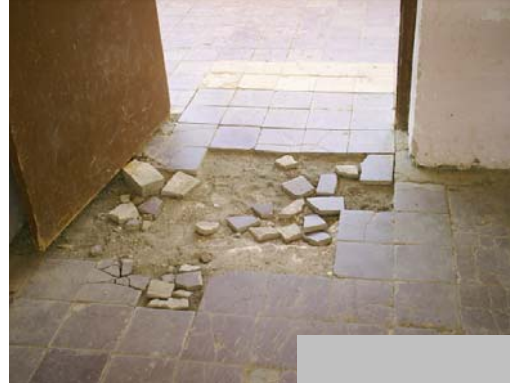
- Paint, woodwork, doors, and floors were not consistent with new construction or recent remodeling. For example, the wall finish was of poor quality, portions of classrooms lacked any tile or floor material, and tiles and grout were missing from other floors. Site Photo 16 shows damaged tile in one of the classrooms.

Site Photo 16: Broken tiles at Project 10630

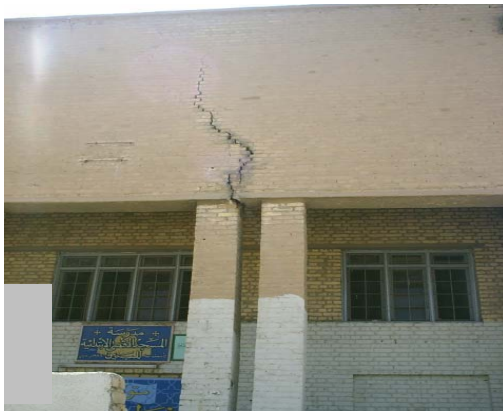
- The concrete pad outside the building lacked sub-base and proper compacting.
- Parts of the school structure showed significant cracking above columns and the perimeter wall was crumbling in some areas. Site Photo 17 shows the cracking above columns.

Site Photo 17: Crack in outer wall of Project 10630

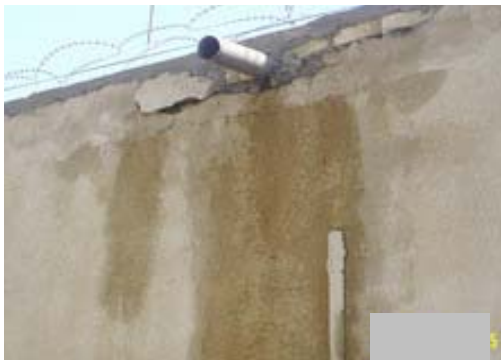
Site Photo 26: Exterior roof drain and deteriorated parapet at Project 18223

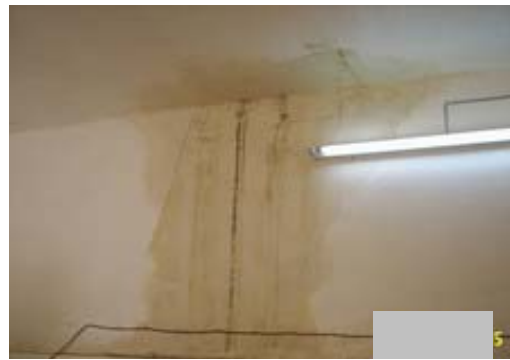
Site Photo 27: Interior staining due to roof leak at Project 18223

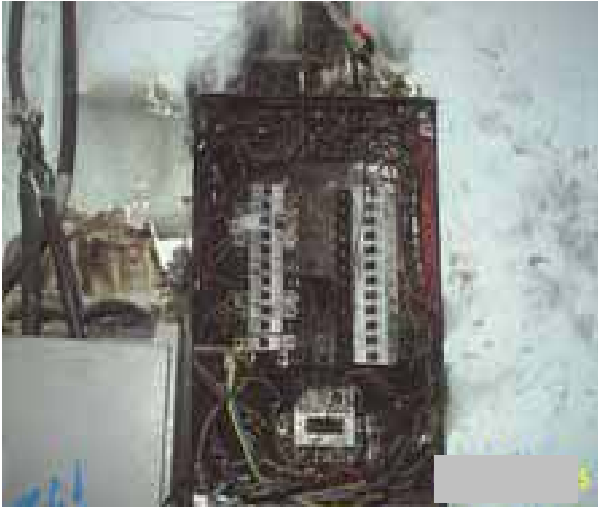
- Light fixtures were not properly mounted and they hung from electrical wires. The electrical circuit box showed poorly installed wiring as seen by partially un-insulated splices. The wall around the electrical circuit box showed signs of burn marks, indicating previous shortages and/or small fires. Site Photo 28 shows the electrical circuit breaker panel.
- No sidewalks were located at the facility.
- There were cracks in the walls and areas with peeling paint. There were unfinished surfaces on walls near the front of the facility. Site Photo 29 shows an unfinished wall section.
- Work did not appear consistent with contract requirements.

Site Photo 28: Electrical circuit breaker panel at Project 18223

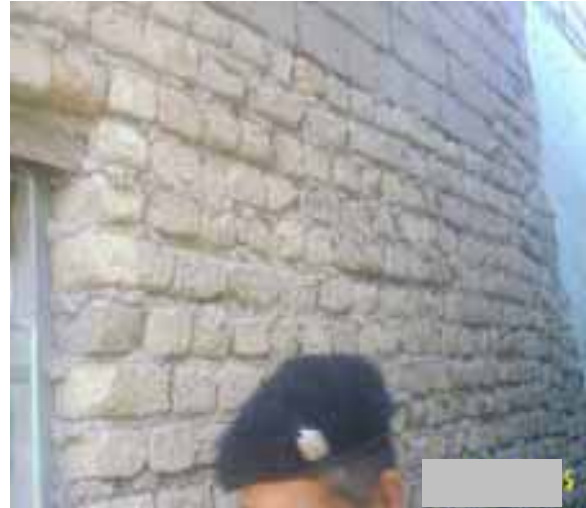
Site Photo 29: Unfinished exterior wall at Project 18223

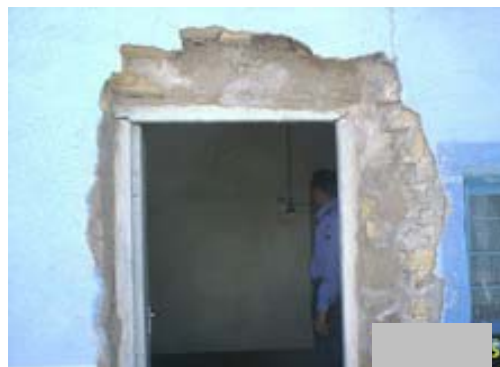
- The exterior perimeter wall did not have plaster finishing or paint.
- The exterior doorway had incomplete finishing work. Site Photo 33 shows the exterior doorway requiring finishing work.

Site Photo 33: Exterior doorway with incomplete finishing work at Project 18248

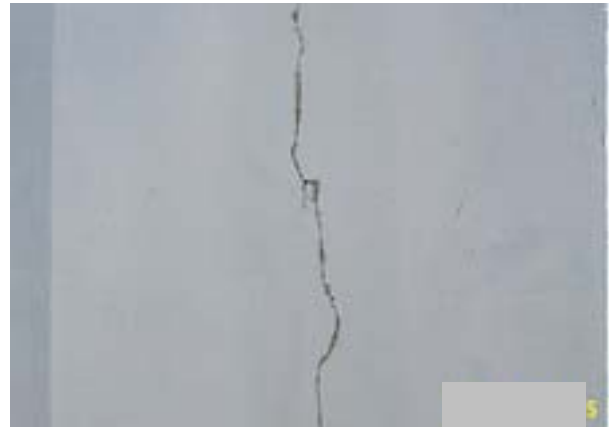
- The contract required the repair of the interior and exterior walls however, the exterior and interior walls contained numerous cracks (Site Photo 37).
- Exterior tiles showed signs of deterioration, indicating the tiles were not replaced.

Site Photo 37: Cracks in exterior wall at Project 18273

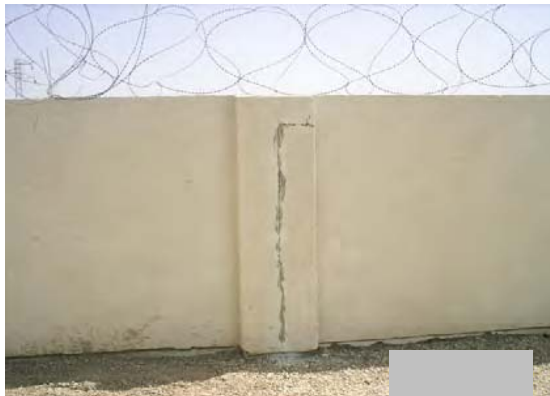
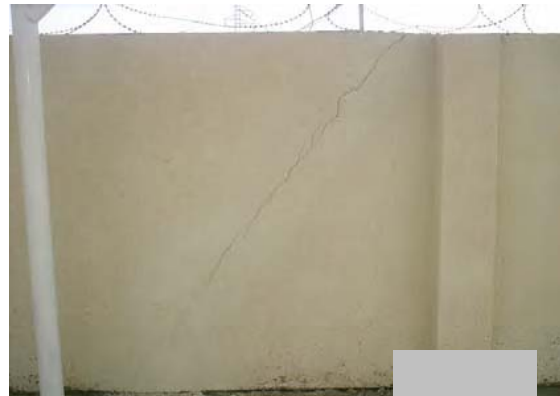
- Numerous cracks were visible in the perimeter wall. Site Photos 38 and 39 show cracks in the perimeter security walls.
- The finishing paint on the checkpoint structures appeared to be incomplete.

Site Photo 38: Cracks in perimeter security wall at Project 19217

Site Photo 39: Cracks in perimeter security wall at Project 19217

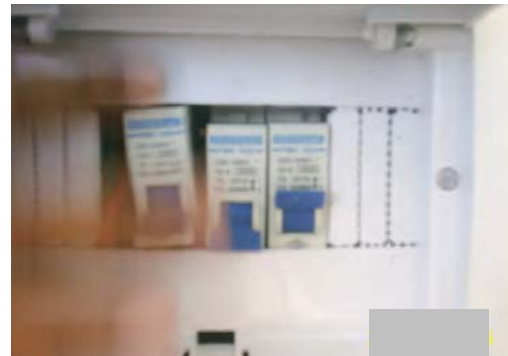
- Lack of conduit for electrical wiring that was routed outside the building.
- Improper installation of circuit breakers and missing electrical outlets at switch locations. Site Photo 43 shows the circuit breaker panel at Project 19220.
- A door was inoperable and a ceiling area appeared unfinished.

Site Photo 43: Circuit breakers at Project 19220

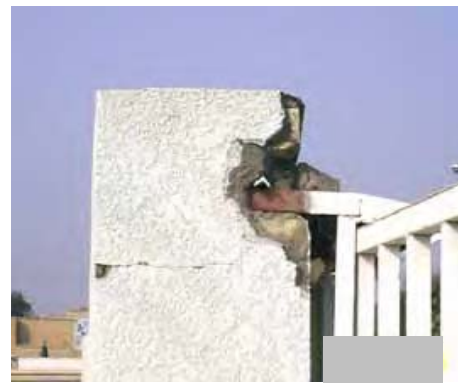
- The sidewalk showed numerous cracks.
- Covers were missing on electrical components.
- A portion of the external wall appeared damaged. Site Photo 47 shows exterior wall damage.

Site Photo 47: Wall damage at Project 19222

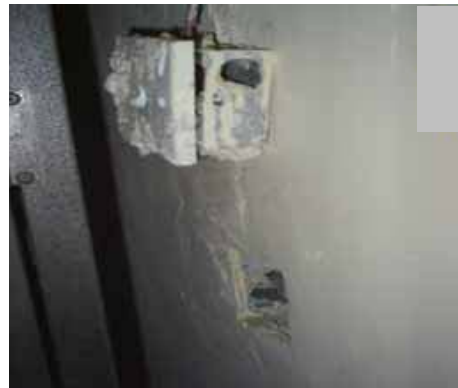
Site Photo 51: Light switch with plaster over surface at Project 20333

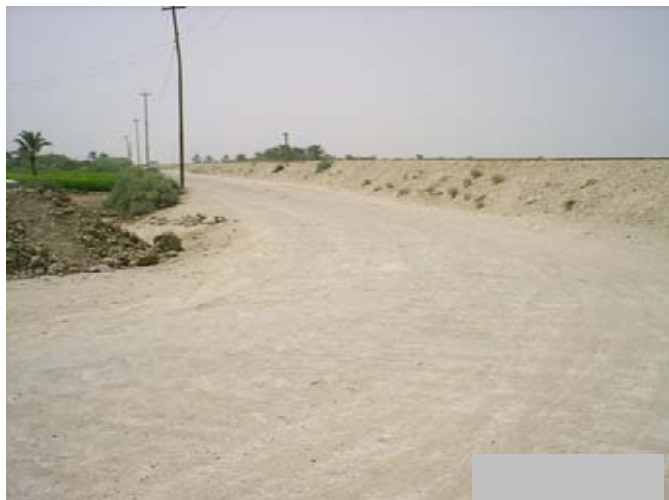
Although the IRMS database listed the project as 100 percent complete, the site visited by the survey team was not a completed road. The site visited was within 725 m from the reported location and intersected the location of the road as shown in the contract. The site visited consisted of 3.5 km of road, with recent sub base installed and no culverts or shoulders. No section of road contained any asphalt pavement. Site Photo 55 shows new road base at the location of Project 17867.

Site Photo 55: Road surface at the location of Project 17867
